# The Road Inventory of Lake Roosevelt National Recreation Area LARO - 9260

## Road Inventory Program

Prepared By:  
Federal Highway Administration  
Eastern Federal Lands Highway Division  
Cycle 3

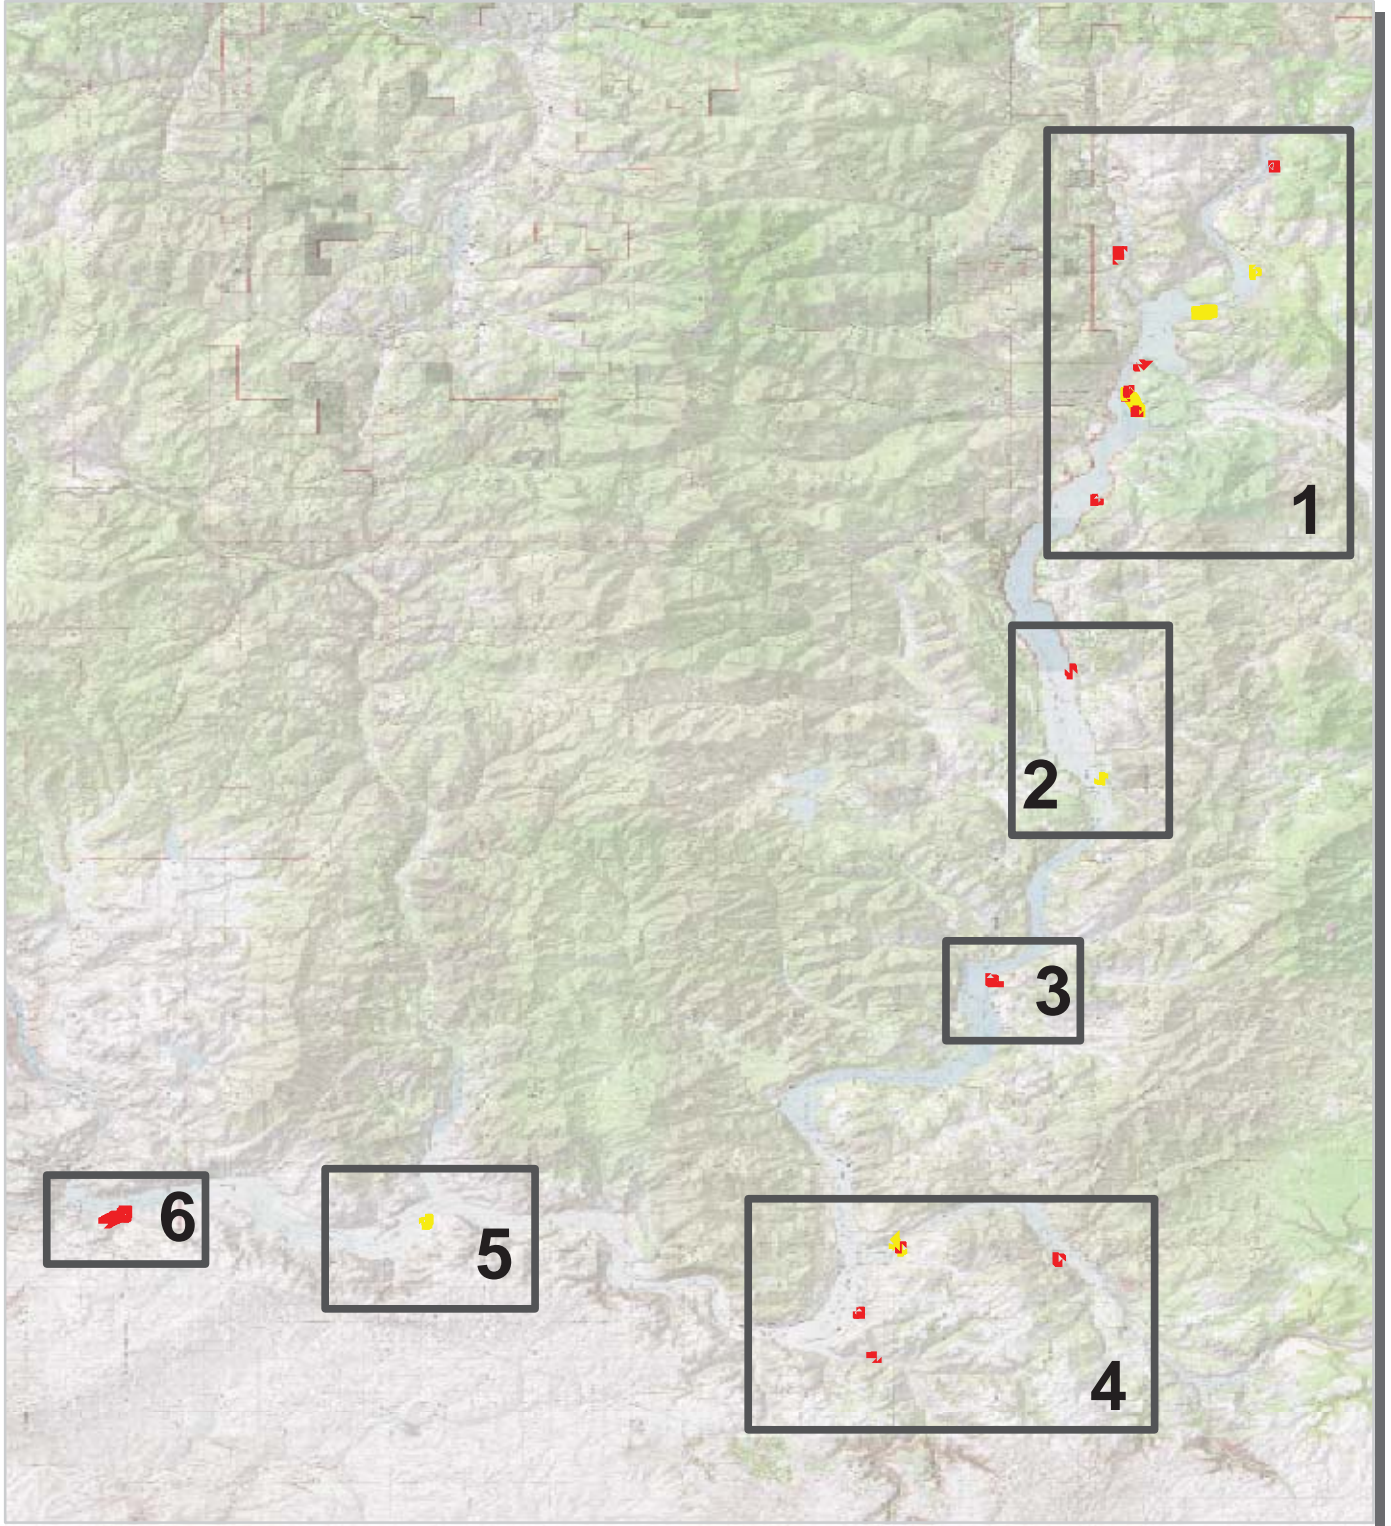
## Route Condition Key Map

### PCR - Mile by Mile

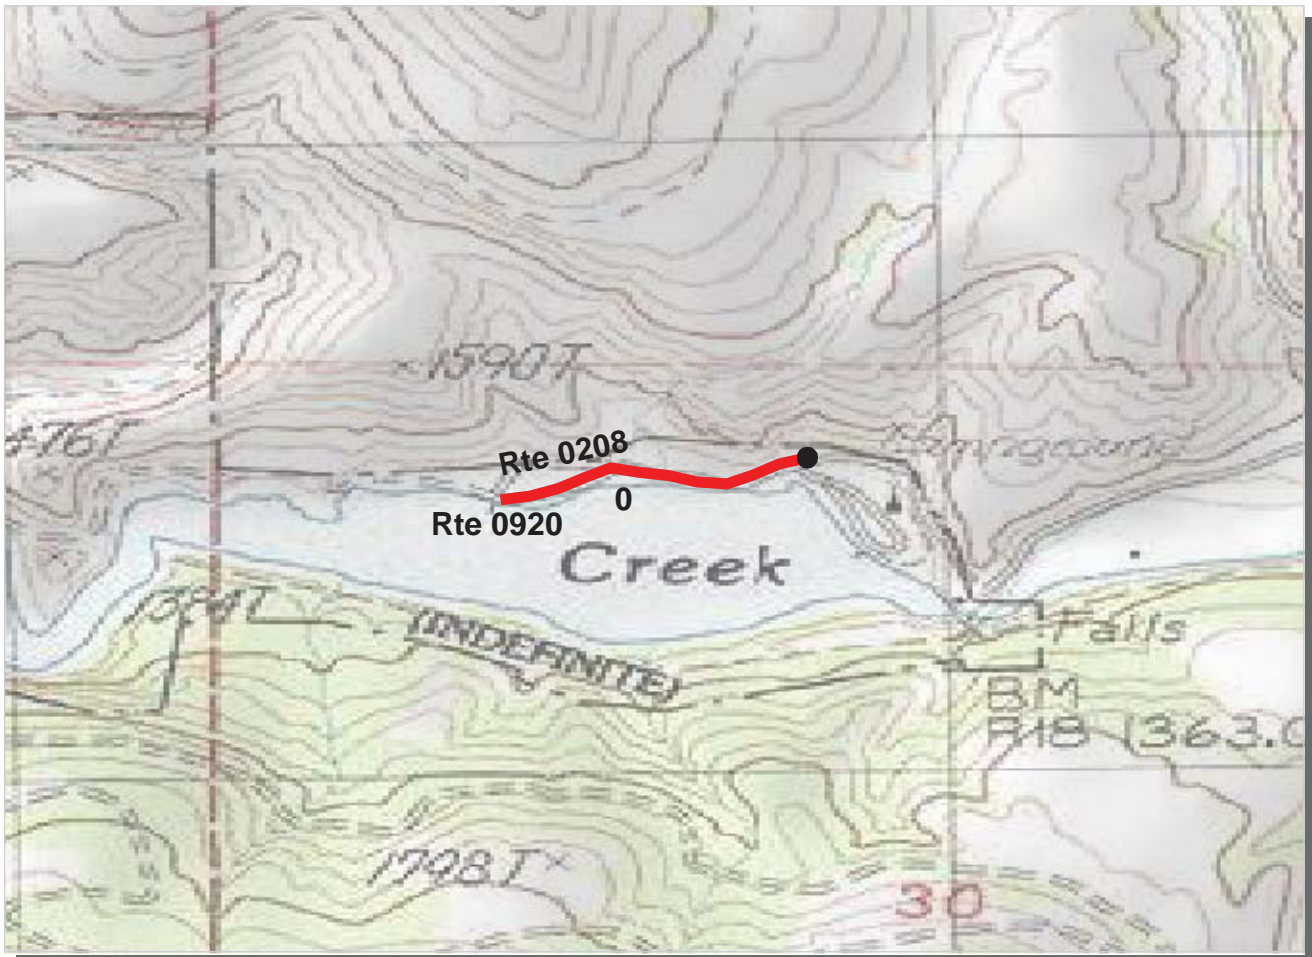
**ROUTE: 0208 HAWK CREEK CAMPGROUND ROAD** **TOTAL LENGTH: 0.24 Miles**

Section Number	0			
Section Length (mi)	0.24			
AADT	**			
SADT	**			
ADT Date	**			
<b>Cross Section Information</b>				
Number of Lanes	1			
Paved Width (ft)	17			
Lane Width (ft)	9			
Shoulder Width (ft)	0			
<b>Roadway Condition Information</b>				
PCR (Pavement Condition Rating)	42			
RCI (Roughness Condition Index)	64			
SCR (Surface Condition Rating)	34			
Alligator Cracking Index	99			
Rutting Index	34			
Patching Index	100			
Transverse Cracking Index	100			
Longitudinal Cracking Index	99			
Shoulder Condition Rating	N/A			
Drainage Condition Rating	GOOD

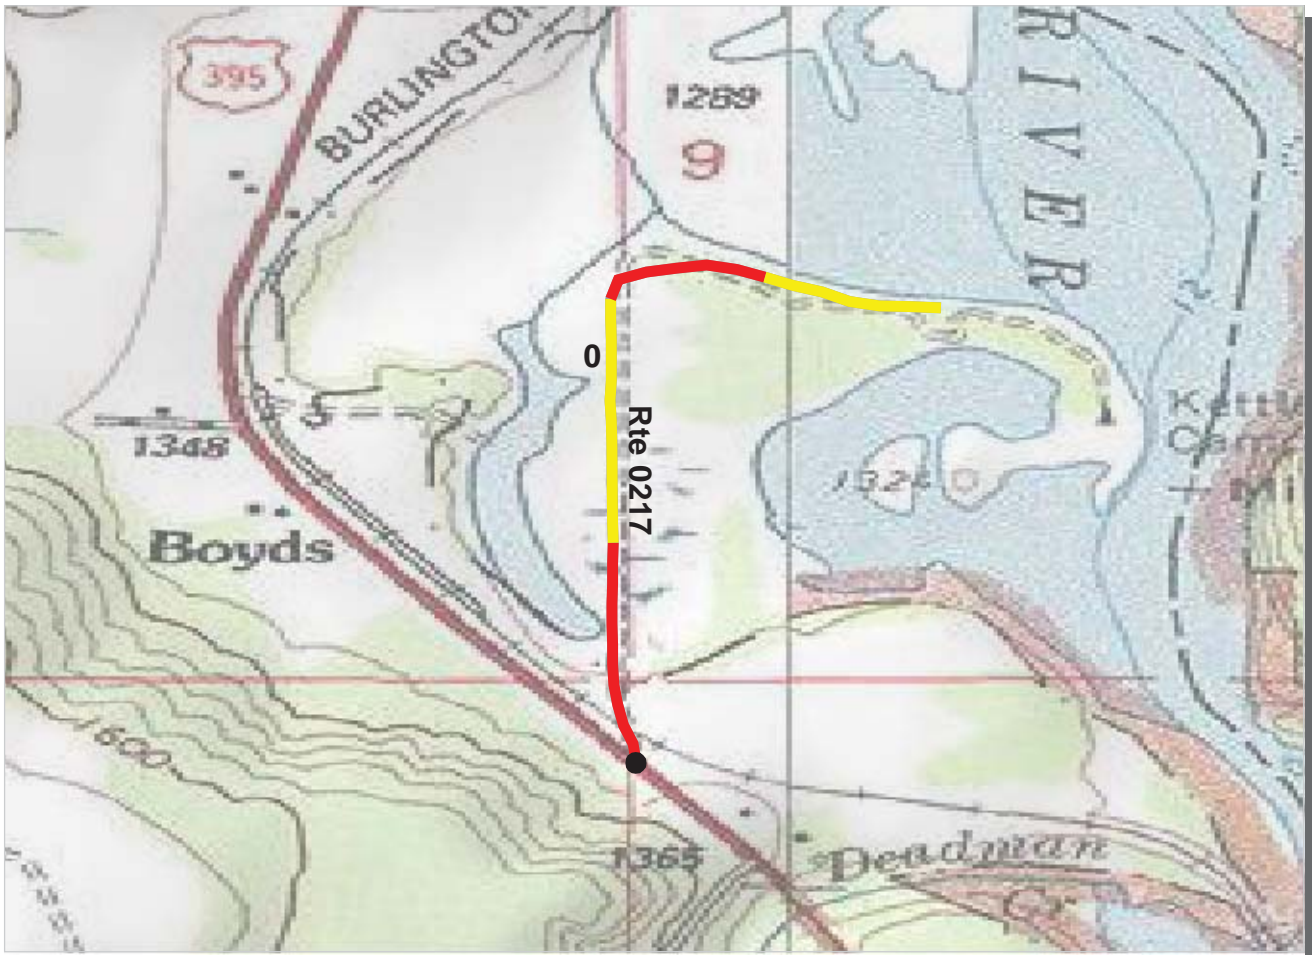
**ROUTE: 0217 KETTLE RIVER CAMPGROUND ROAD**      **TOTAL LENGTH: 0.72 Miles**

Section Number	0				
Section Length (mi)	0.72				
AADT	**				
SADT	**				
ADT Date	**				
<b>Cross Section Information</b>					
Number of Lanes	2				
Paved Width (ft)	17				
Lane Width (ft)	9				
Shoulder Width (ft)	0				
<b>Roadway Condition Information</b>					
PCR (Pavement Condition Rating)	53				
RCI (Roughness Condition Index)	64				
SCR (Surface Condition Rating)	49				
Alligator Cracking Index	99				
Rutting Index	54				
Patching Index	100				
Transverse Cracking Index	98				
Longitudinal Cracking Index	97				
Shoulder Condition Rating	N/A				
Drainage Condition Rating	POOR

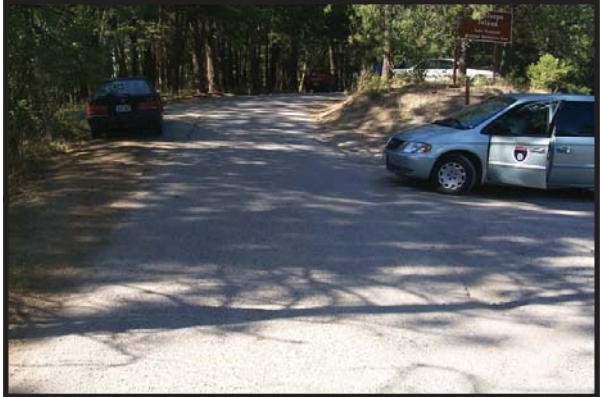
Route	Length (mi)	Width (ft)	Area (sq ft)	Lane Miles *	Condition / PCR	Surface Type
0215A	0.27	12.00	16854	0.29	POOR / 45	OC

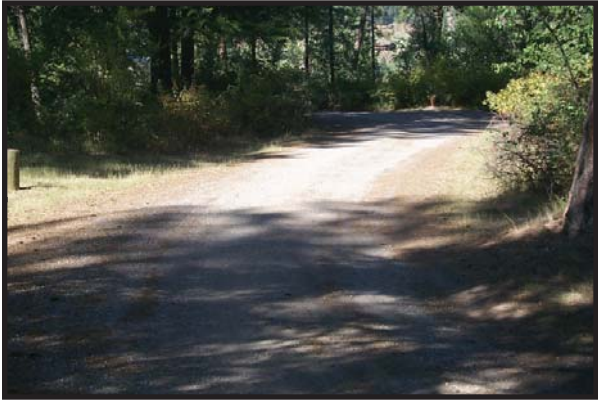
## Route 0215B

Route	Length (mi)	Width (ft)	Area (sq ft)	Lane Miles *	Condition / PCR	Surface Type
0215B	0.09	10.00	4541	0.08	POOR / 45	OC

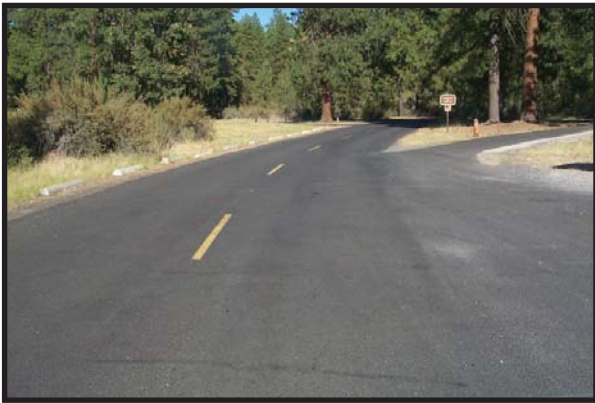
## Route 0228

Route	Length (mi)	Width (ft)	Area (sq ft)	Lane Miles *	Condition / PCR	Surface Type
0228	0.09	25.00	12408	0.21	GOOD / 90	OC

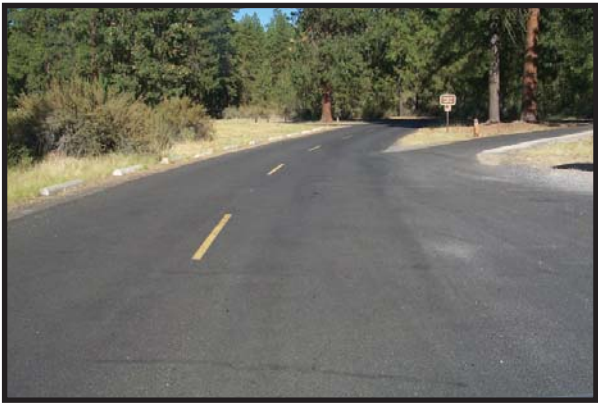
## Route 0232

Route	Length (mi)	Width (ft)	Area (sq ft)	Lane Miles *	Condition / PCR	Surface Type
0232	1.25	10.00	65894	1.13	GOOD / 90	OC

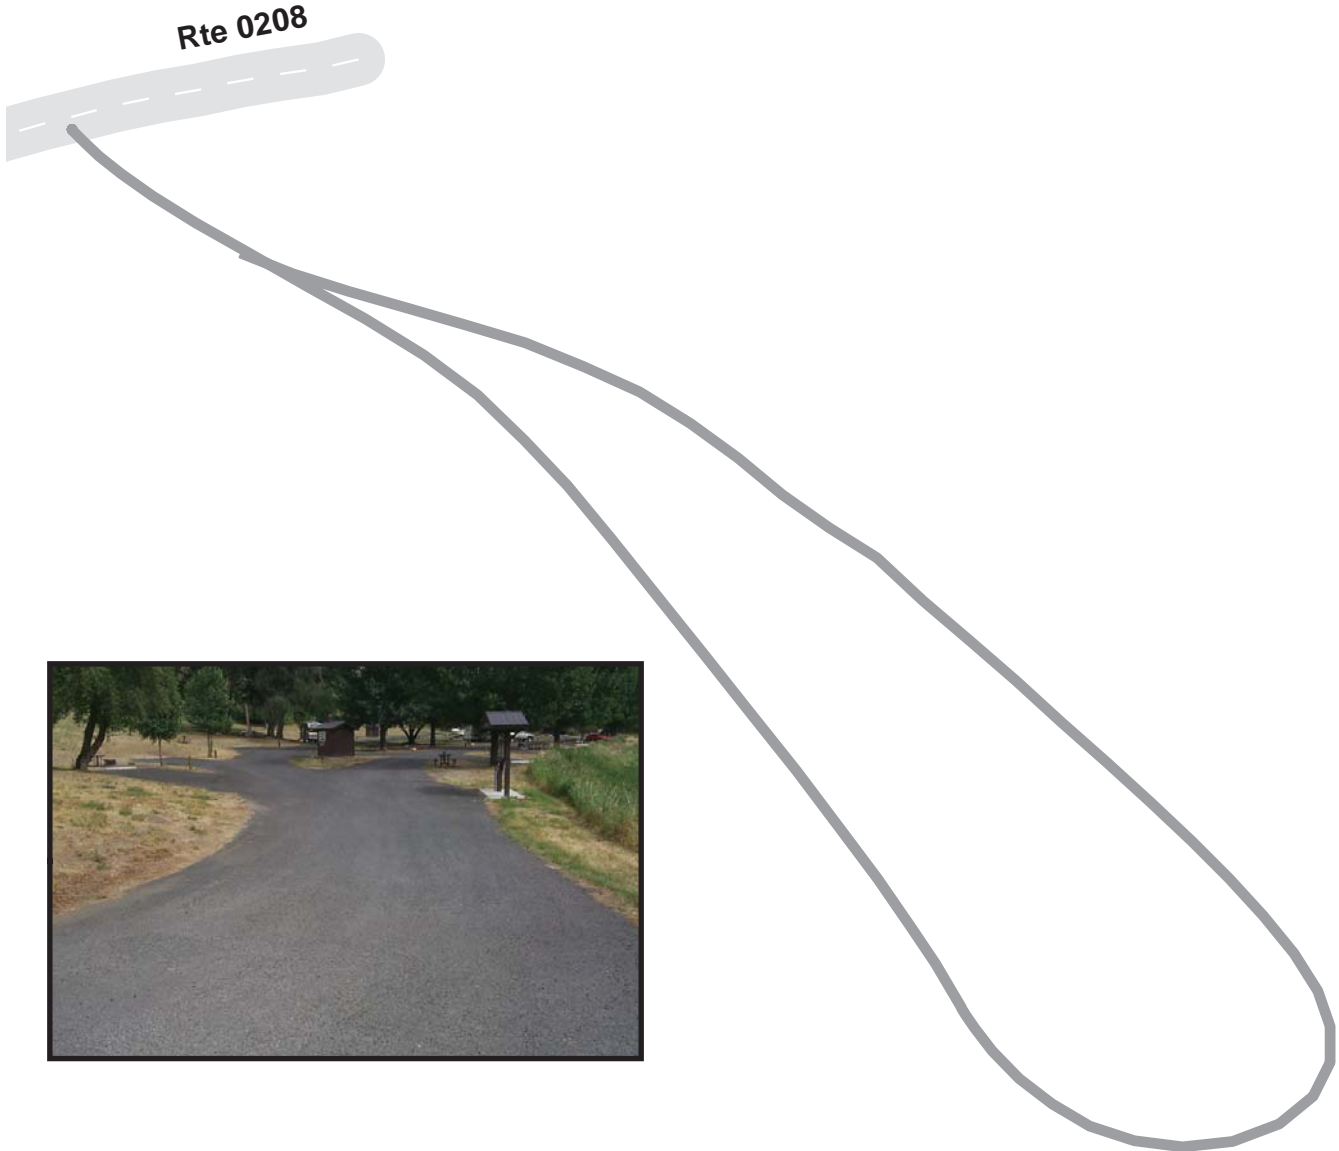
## Route 0233

Route	Length (mi)	Width (ft)	Area (sq ft)	Lane Miles *	Condition / PCR	Surface Type
0233	0.22	20.00	23126	0.40	GOOD / 90	OC

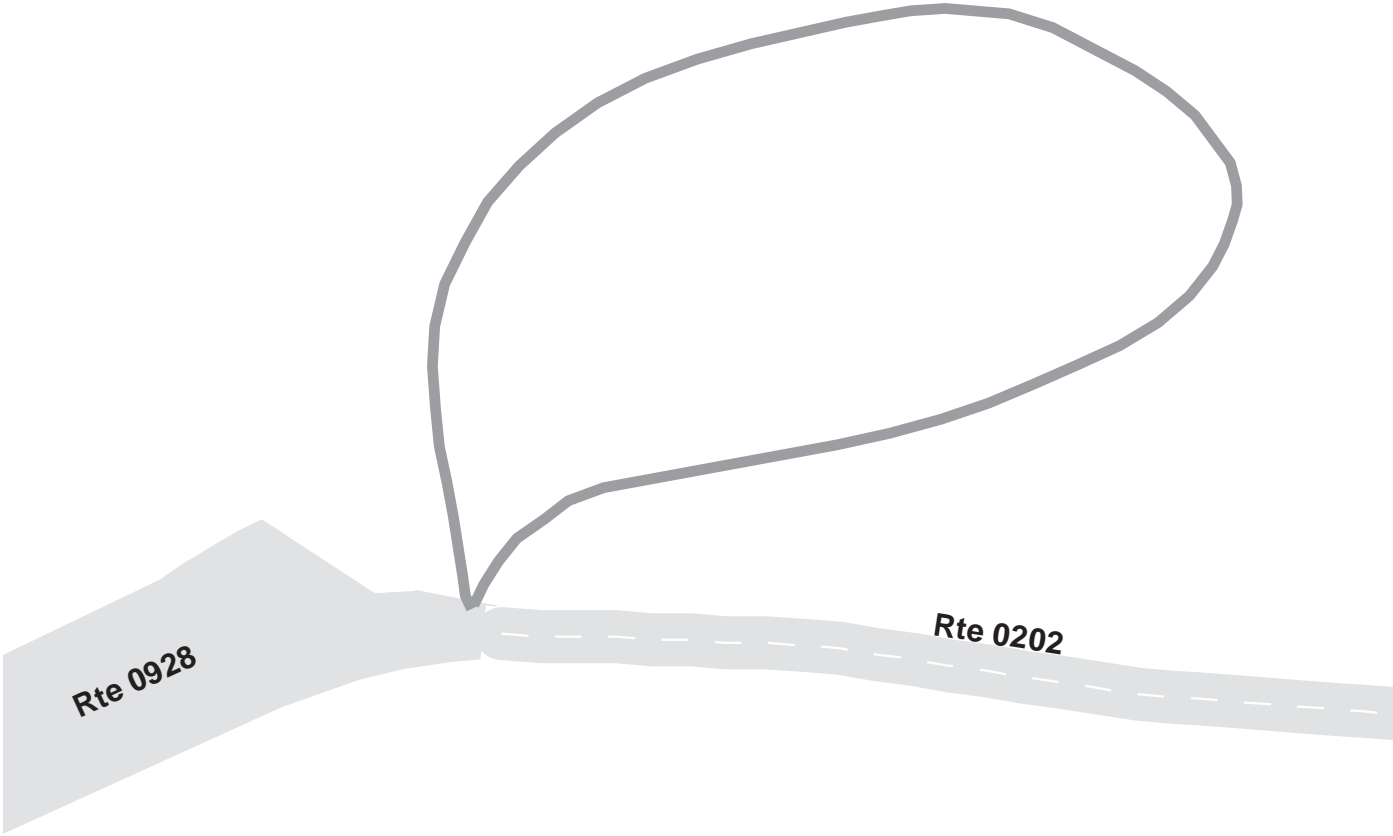
## Route 0239

Route	Length (mi)	Width (ft)	Area (sq ft)	Lane Miles *	Condition / PCR	Surface Type
0239	0.17	16.00	14193	0.24	GOOD / 90	OC

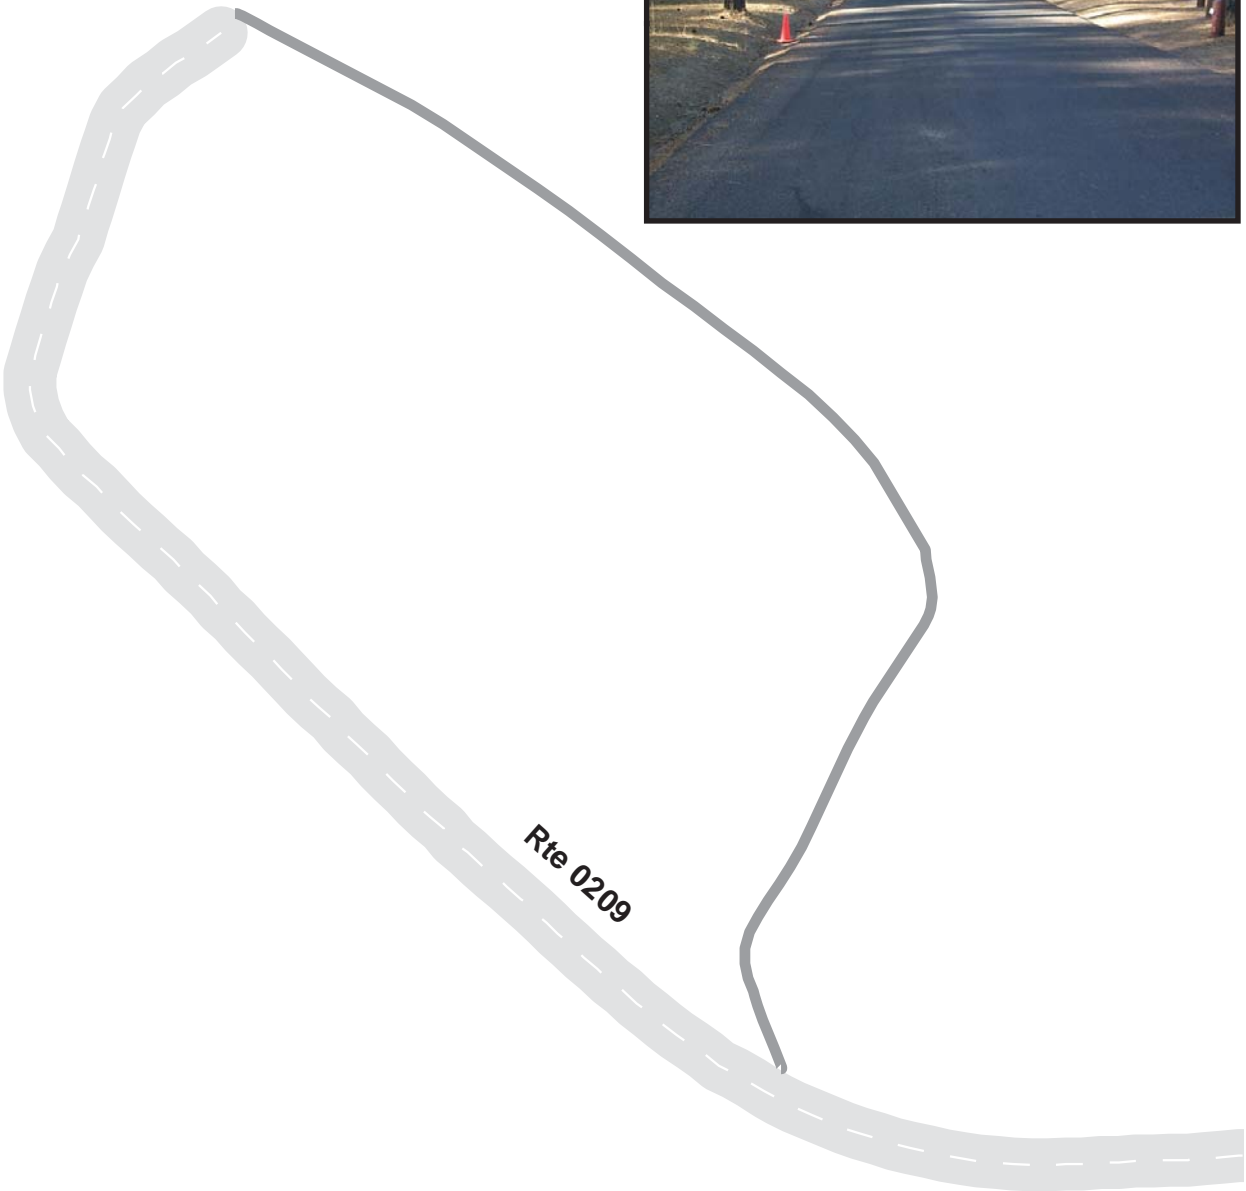
## Route 0240A

Route	Length (mi)	Width (ft)	Area (sq ft)	Lane Miles *	Condition / PCR	Surface Type
0240A	0.25	15.00	19800	0.34	GOOD / 90	OC

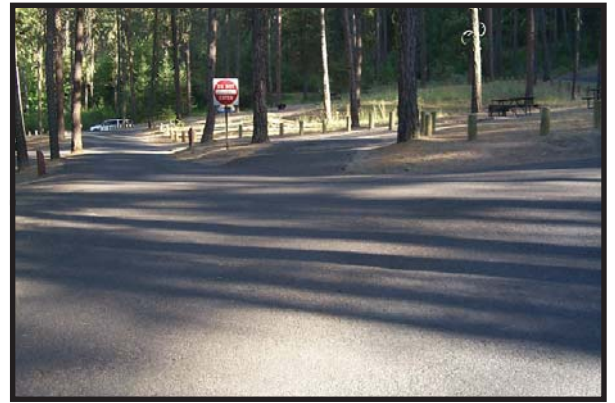
## Route 0240B

Route	Length (mi)	Width (ft)	Area (sq ft)	Lane Miles *	Condition / PCR	Surface Type
0240B	0.16	15.00	12751	0.22	GOOD / 90	OC

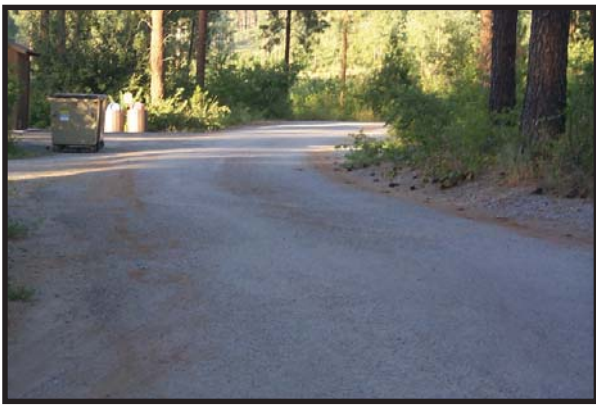
## Route 0241A

Route	Length (mi)	Width (ft)	Area (sq ft)	Lane Miles *	Condition / PCR	Surface Type
0241A	0.32	18.00	30223	0.52	FAIR / 73	OC

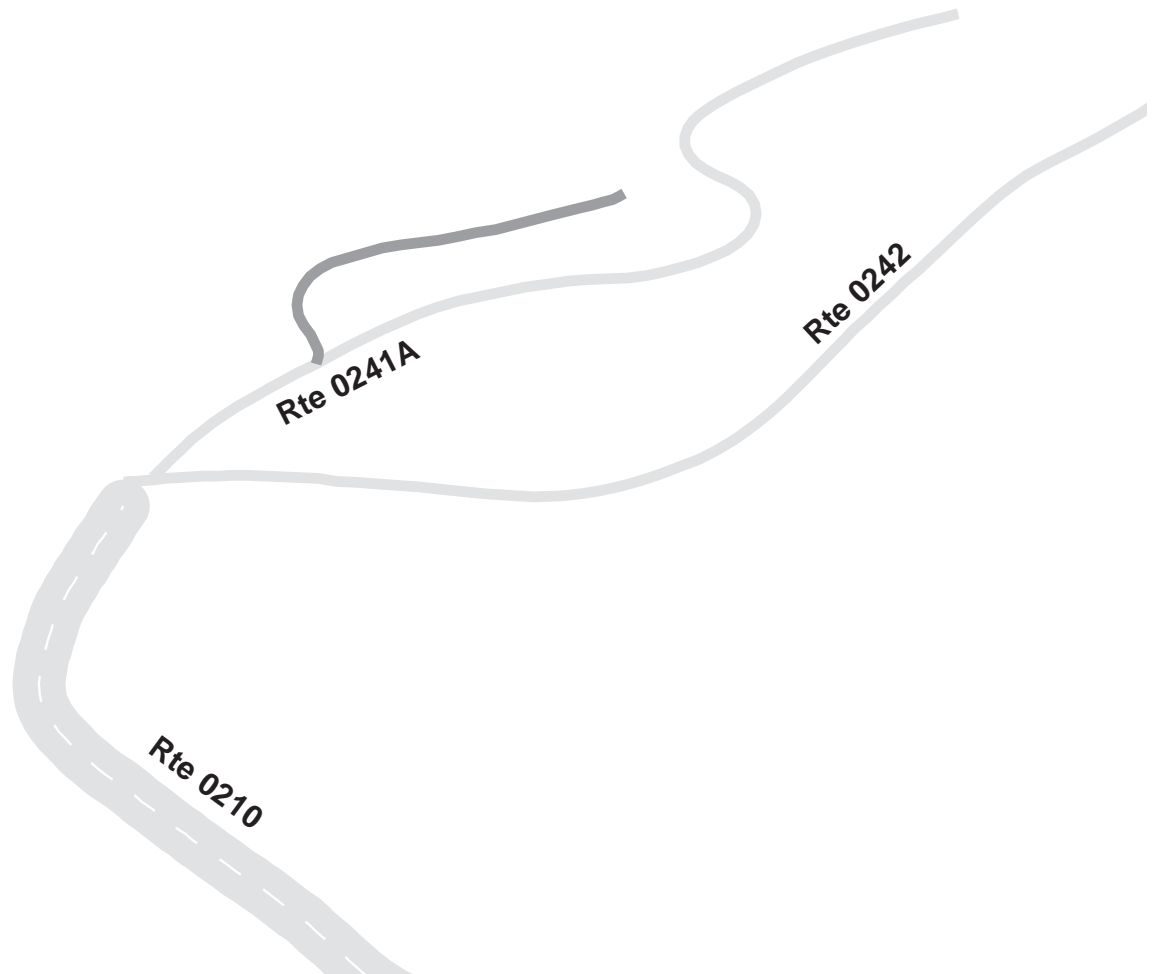
## Route 0241B

Route	Length (mi)	Width (ft)	Area (sq ft)	Lane Miles *	Condition / PCR	Surface Type
0241B	0.12	18.00	11690	0.20	FAIR / 73	OC

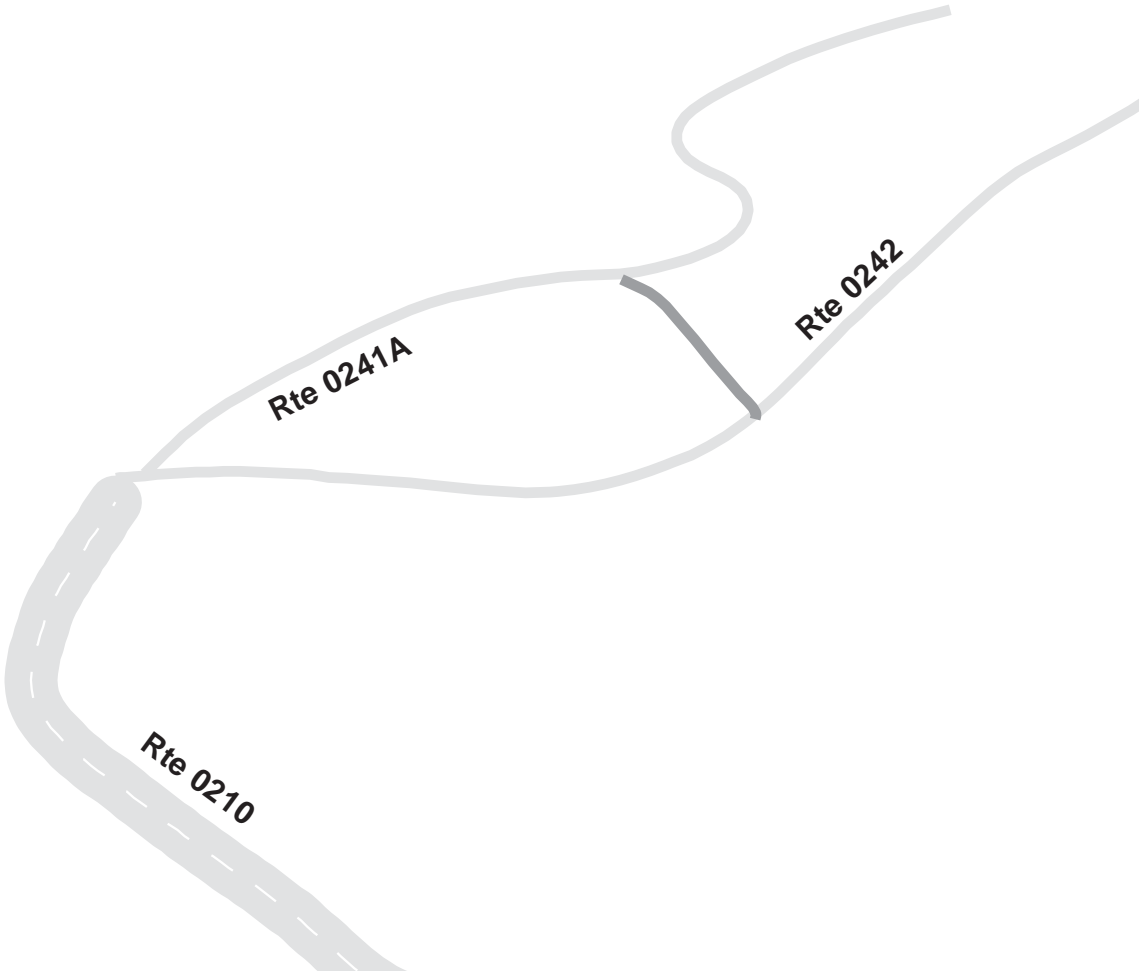
## Route 0241C

Route	Length (mi)	Width (ft)	Area (sq ft)	Lane Miles *	Condition / PCR	Surface Type
0241C	0.07	15.00	5148	0.09	FAIR / 73	OC

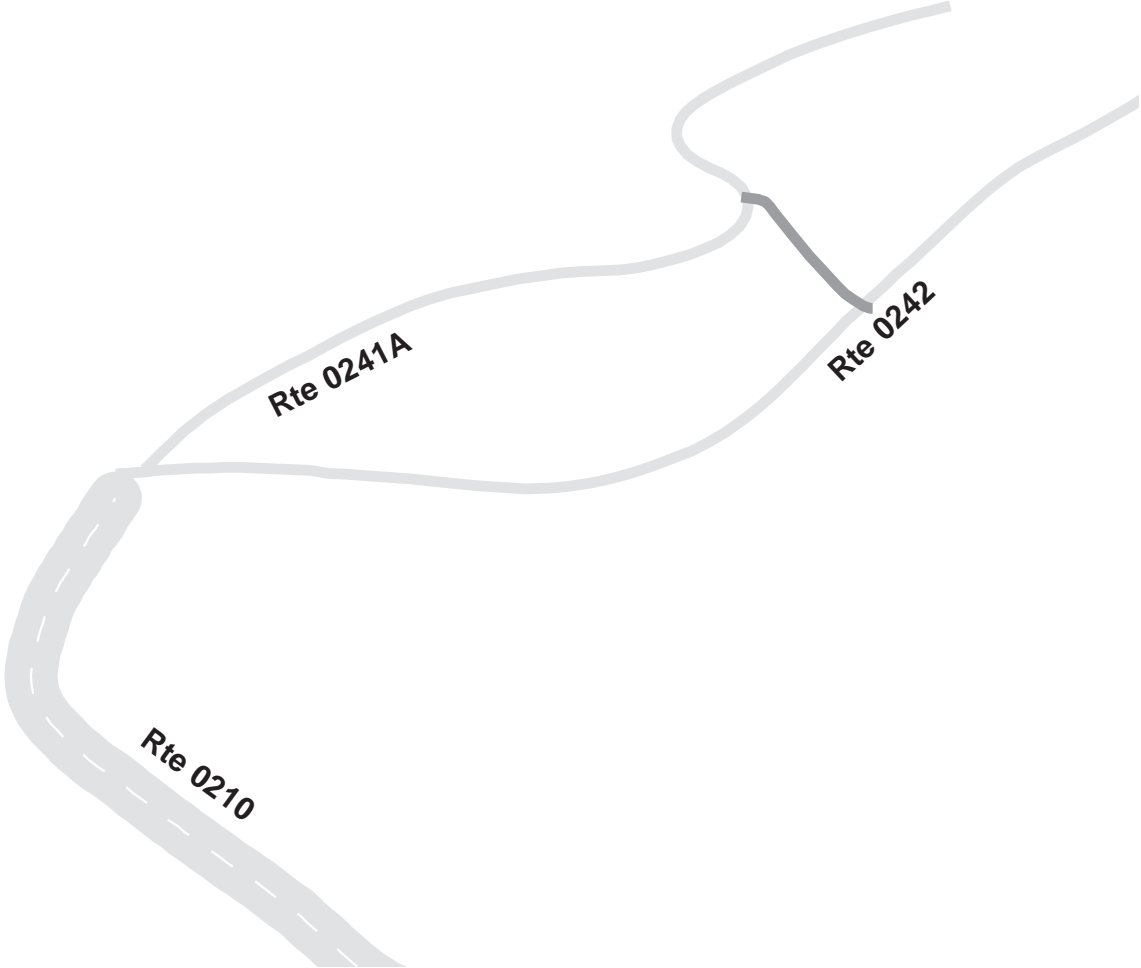
## Route 0241D

Route	Length (mi)	Width (ft)	Area (sq ft)	Lane Miles *	Condition / PCR	Surface Type
0241D	0.06	15.00	4514	0.08	FAIR / 73	OC

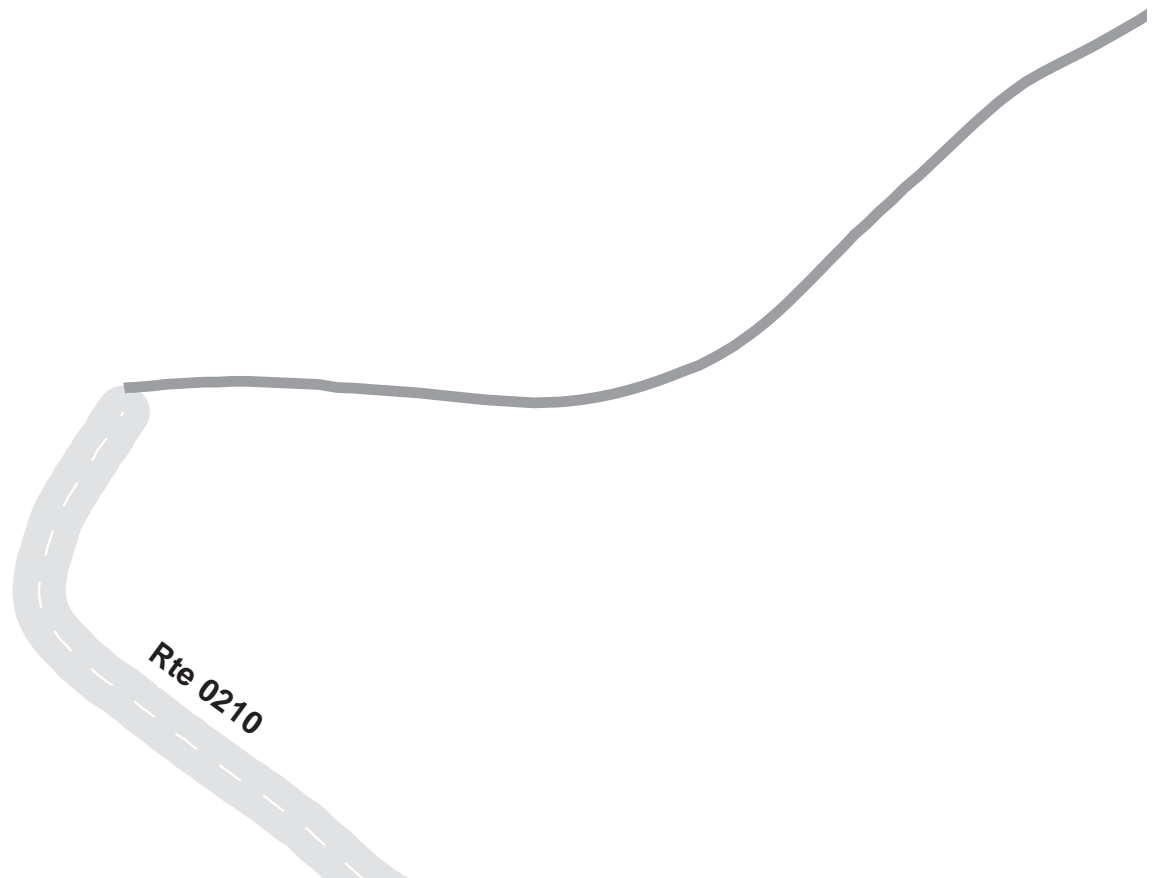
## Route 0242

Route	Length (mi)	Width (ft)	Area (sq ft)	Lane Miles *	Condition / PCR	Surface Type
0242	0.35	20.00	36749	0.63	GOOD / 90	AS

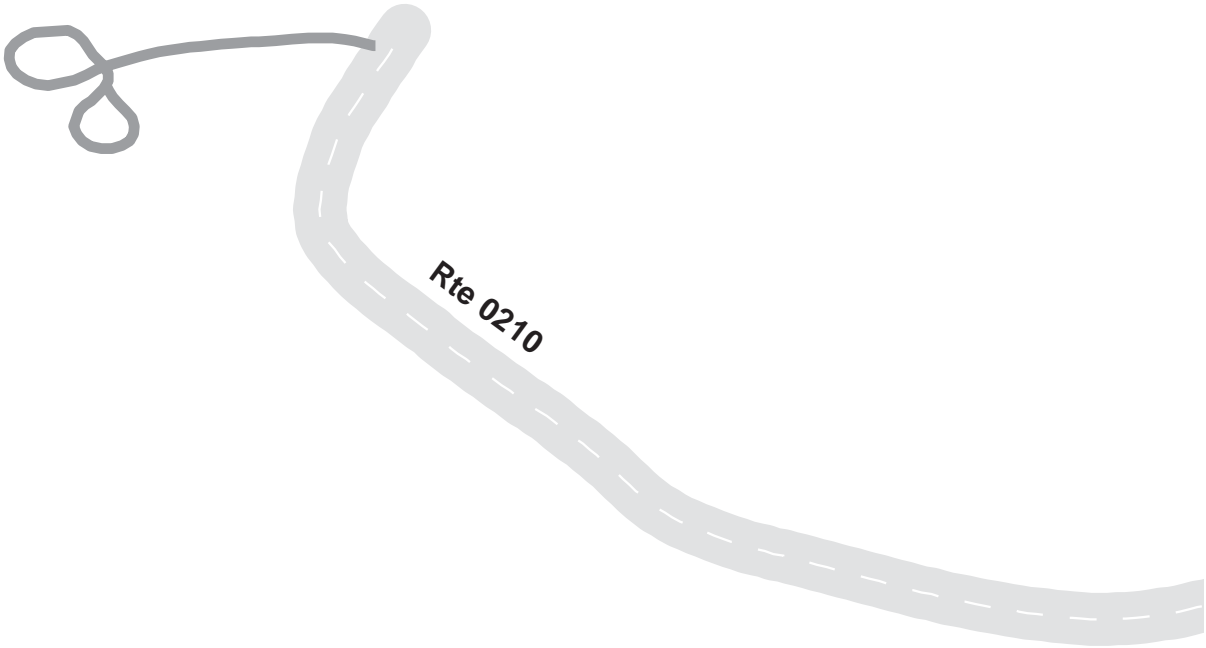
## Route 0243

Route	Length (mi)	Width (ft)	Area (sq ft)	Lane Miles *	Condition / PCR	Surface Type
0243	0.21	16.00	17910	0.31	GOOD / 90	OC

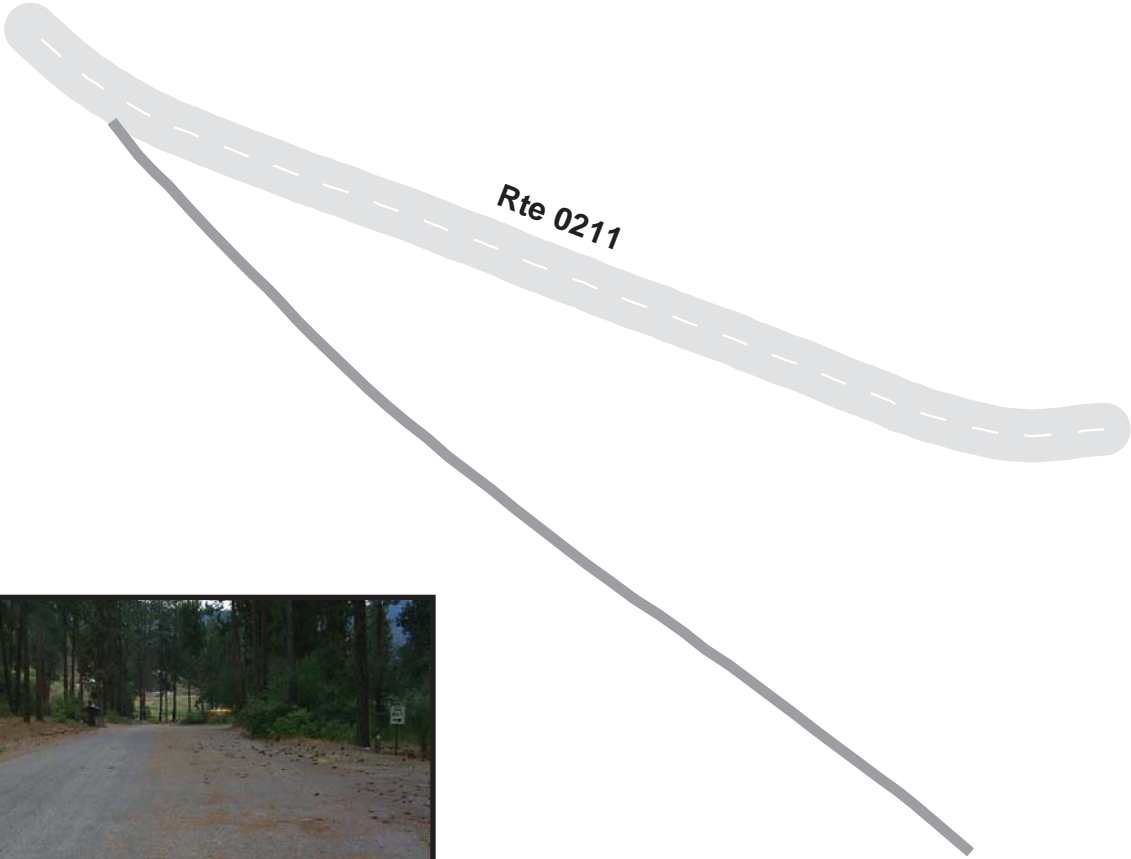
## Route 0244A

Route	Length (mi)	Width (ft)	Area (sq ft)	Lane Miles *	Condition / PCR	Surface Type
0244A	0.31	18.00	29652	0.51	GOOD / 90	OC

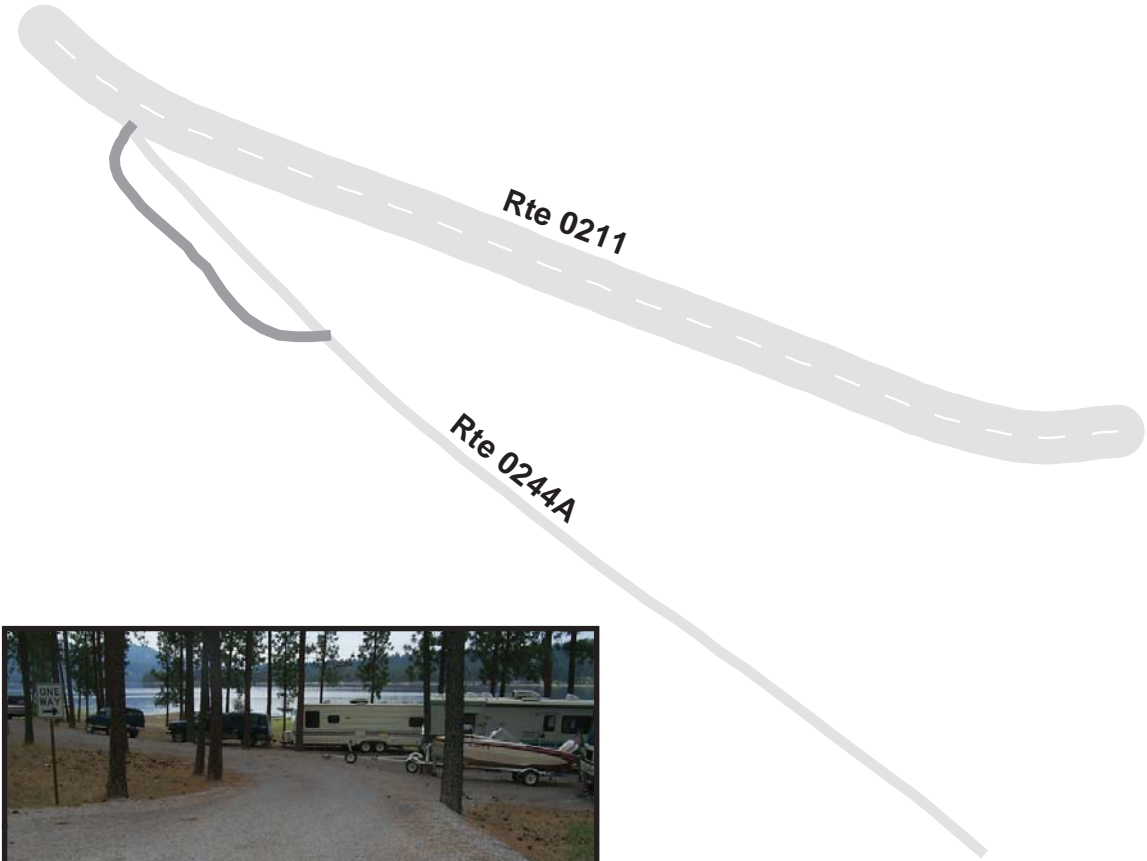
## Route 0244B

Route	Length (mi)	Width (ft)	Area (sq ft)	Lane Miles *	Condition / PCR	Surface Type
0244B	0.10	12.00	6019	0.10	GOOD / 90	OC

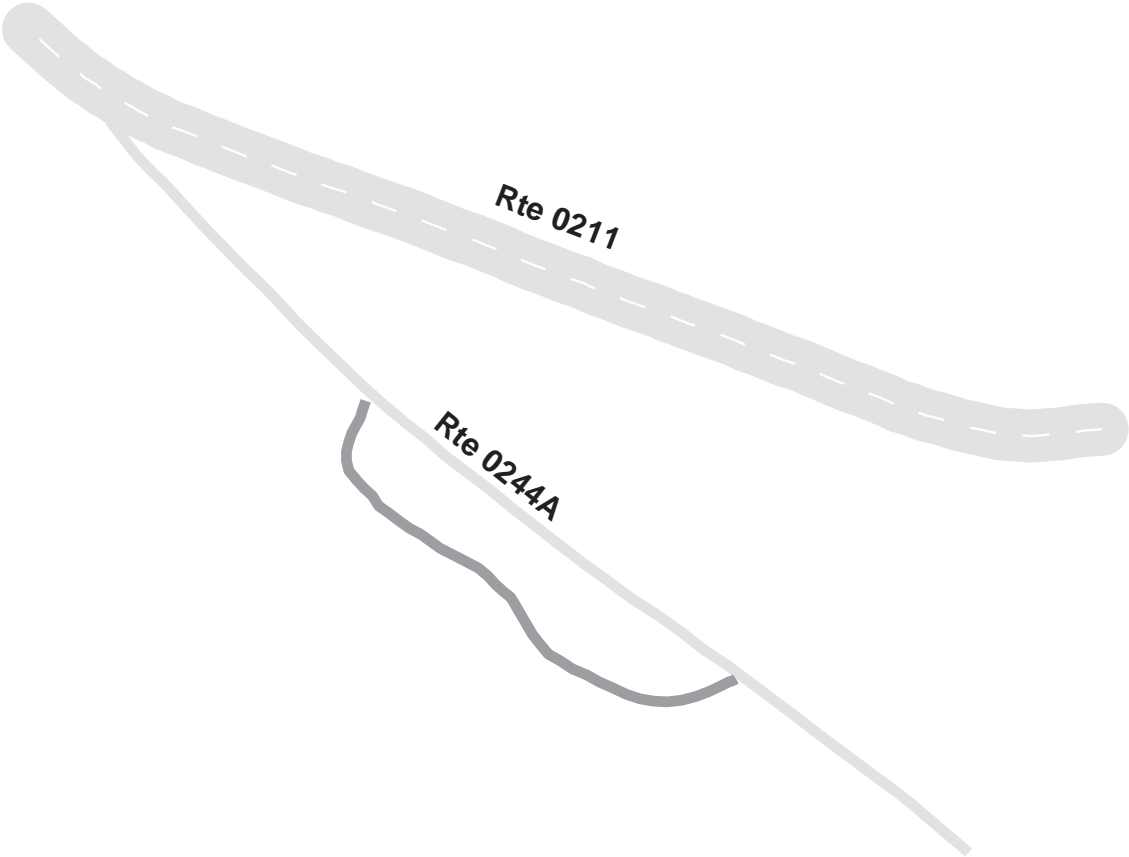
## Route 0244C

Route	Length (mi)	Width (ft)	Area (sq ft)	Lane Miles *	Condition / PCR	Surface Type
0244C	0.15	12.00	9504	0.16	GOOD / 90	OC

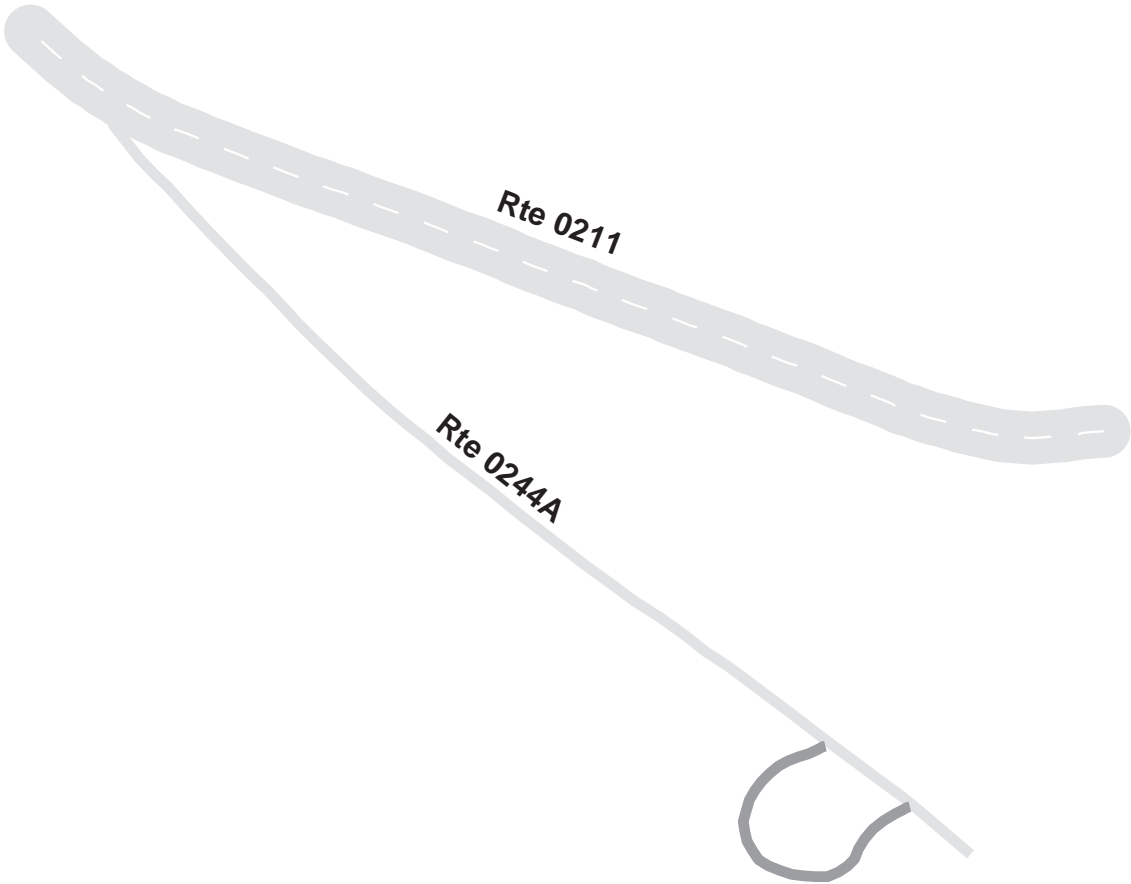
## Route 0244D

Route	Length (mi)	Width (ft)	Area (sq ft)	Lane Miles *	Condition / PCR	Surface Type
0244D	0.09	12.00	5956	0.10	GOOD / 90	OC

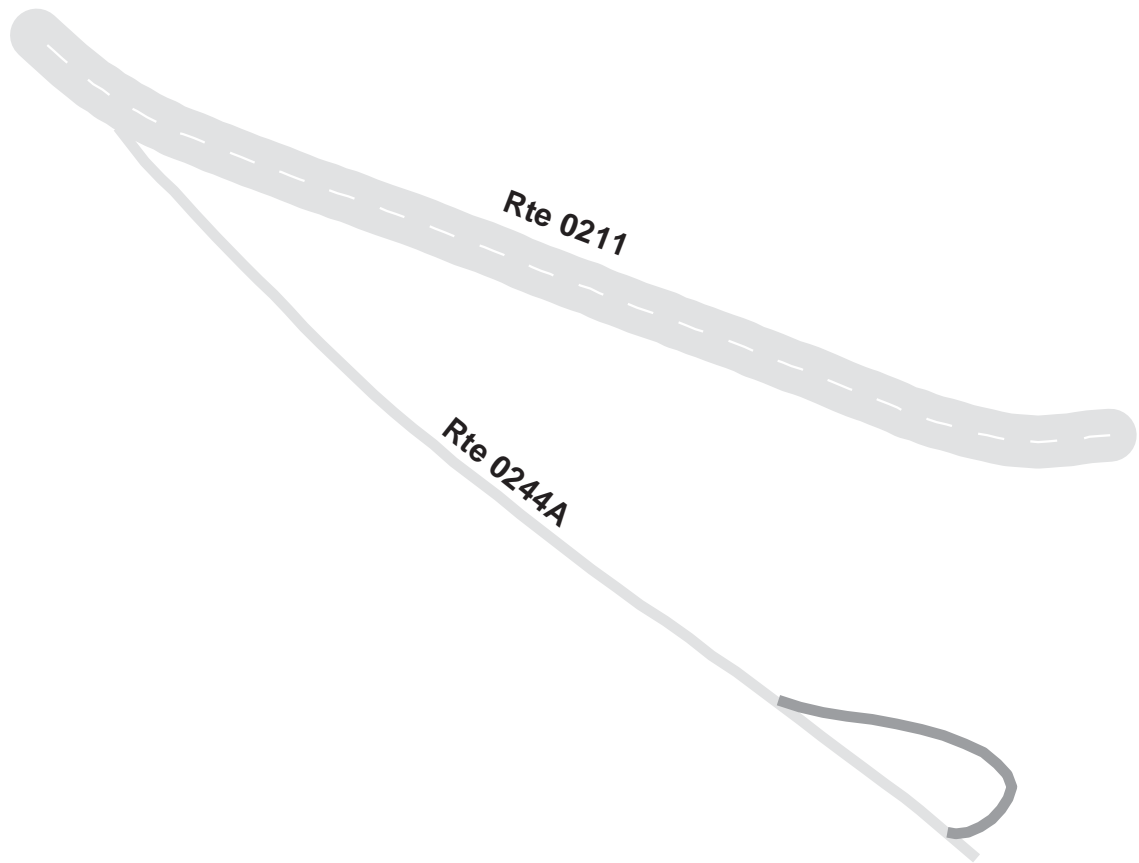
## Route 0244E

Route	Length (mi)	Width (ft)	Area (sq ft)	Lane Miles *	Condition / PCR	Surface Type
0244E	0.09	12.00	5512	0.09	GOOD / 90	OC

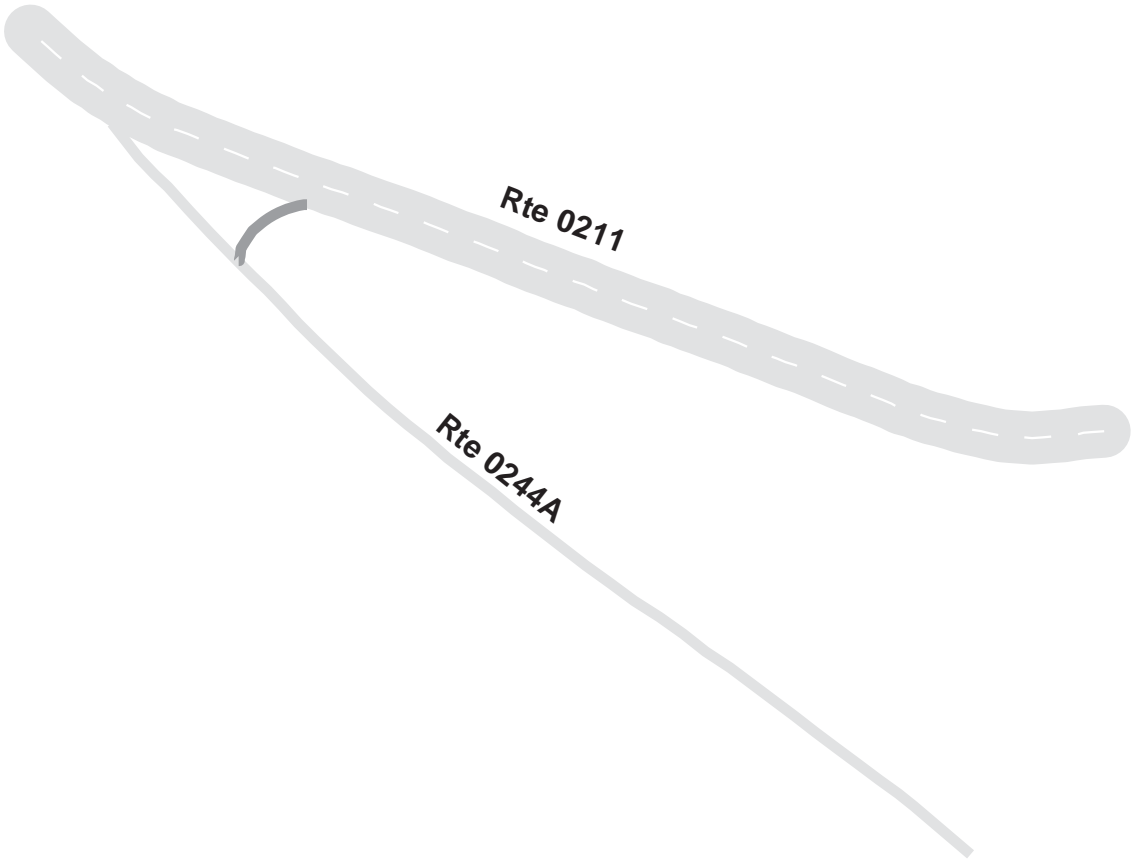
## Route 0244F

Route	Length (mi)	Width (ft)	Area (sq ft)	Lane Miles *	Condition / PCR	Surface Type
0244F	0.03	18.00	2471	0.04	GOOD / 90	OC

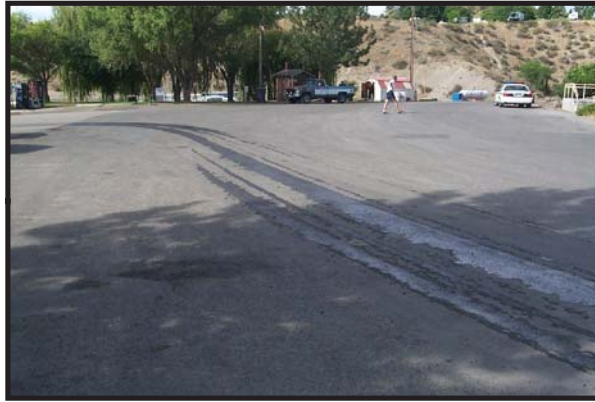
## Route 0920

Route	Public / NonPublic	Date Visited	Area (sq ft)	Lane Miles *	Surface Type	Condition / PCR
0920	Public	7/11/2001	18525	0.32	OC	FAIR / 73

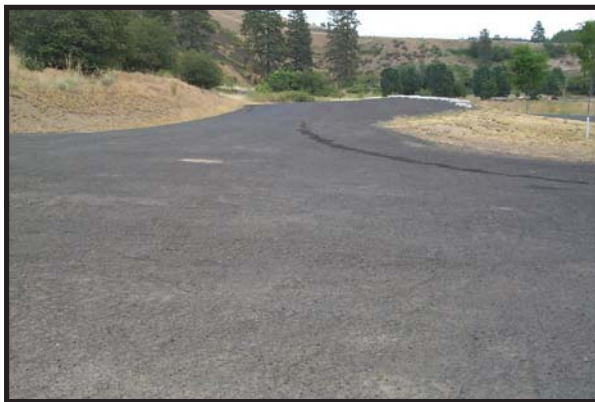
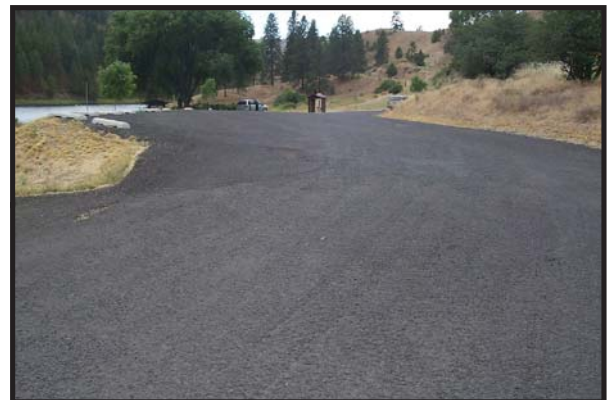
## Route 0921

Route	Public / NonPublic	Date Visited	Area (sq ft)	Lane Miles *	Surface Type	Condition / PCR
0921	Public	7/11/2001	52898	0.91	OC	EXCELLENT / 97
