# The Road Inventory of Lake Roosevelt National Recreation Area LARO - 9260

## Road Inventory Program

Prepared By:  
Federal Highway Administration  
Eastern Federal Lands Highway Division  
Cycle 3

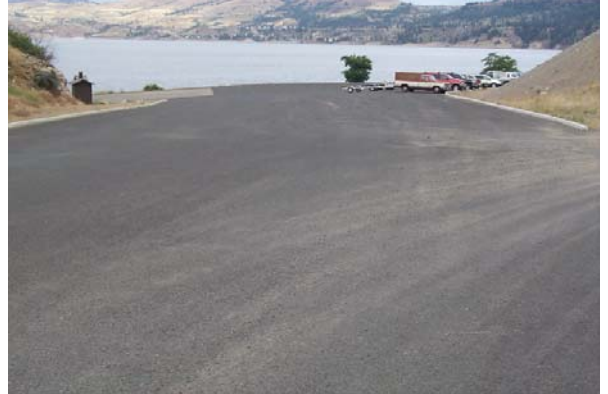
## Route 0922

Route	Public / NonPublic	Date Visited	Area (sq ft)	Lane Miles *	Surface Type	Condition / PCR
0922	Public	7/11/2001	36910	0.64	OC	GOOD / 90

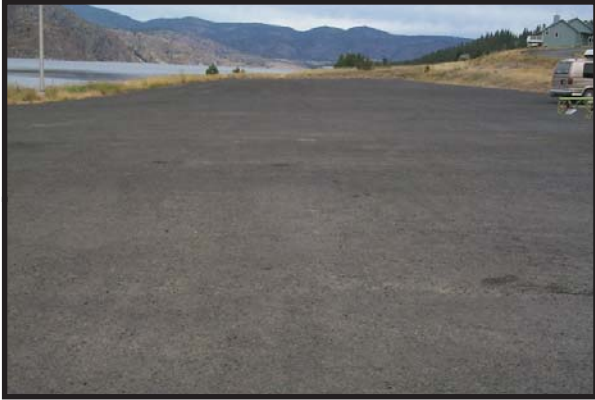
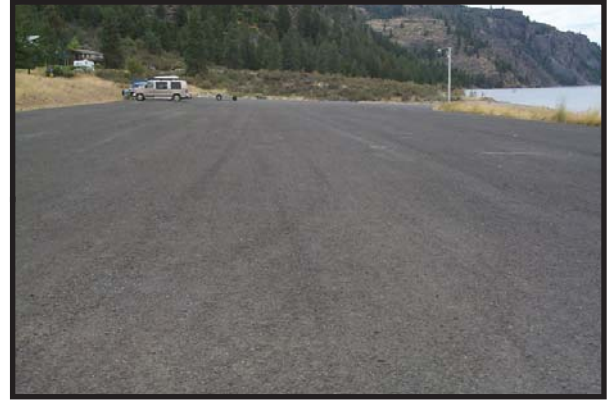
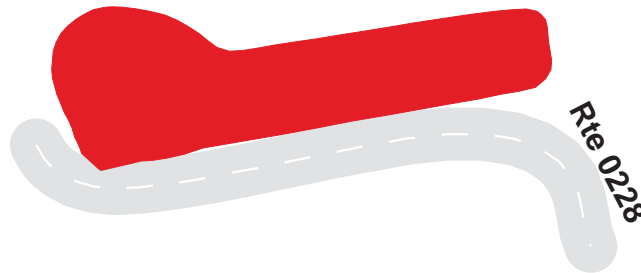
## Route 0923

Route	Public / NonPublic	Date Visited	Area (sq ft)	Lane Miles *	Surface Type	Condition / PCR
0923	Public	7/11/2001	81807	1.41	OC	FAIR / 73

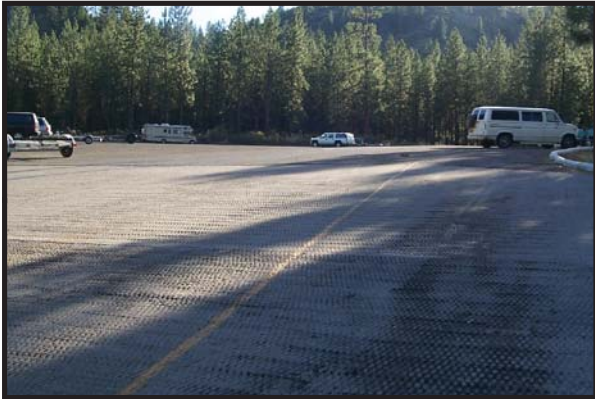
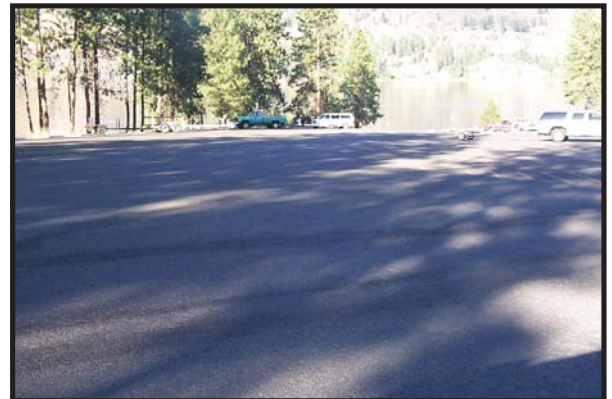
## Route 0924

Route	Public / NonPublic	Date Visited	Area (sq ft)	Lane Miles *	Surface Type	Condition / PCR
0924	Public	7/11/2001	6861	0.12	AS	GOOD / 90

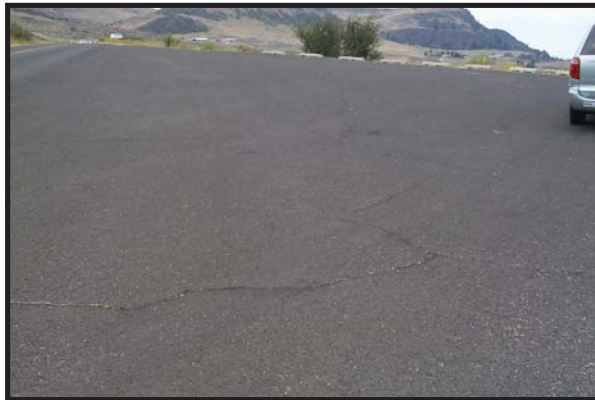
## Route 0925

Route	Public / NonPublic	Date Visited	Area (sq ft)	Lane Miles *	Surface Type	Condition / PCR
0925	Public	7/11/2001	4260	0.07	AS	GOOD / 90

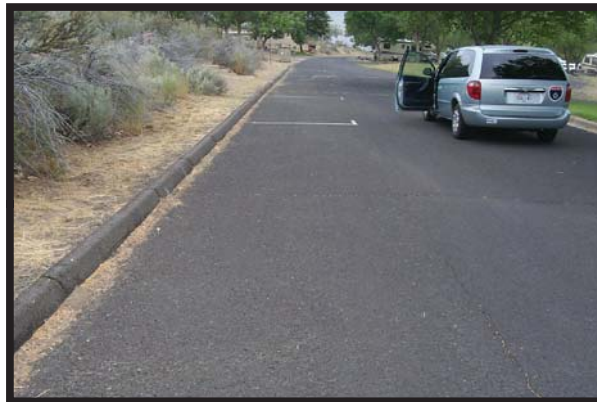
## Route 0926

Route	Public / NonPublic	Date Visited	Area (sq ft)	Lane Miles *	Surface Type	Condition / PCR
0926	Public	7/11/2001	24757	0.43	OC	FAIR / 73

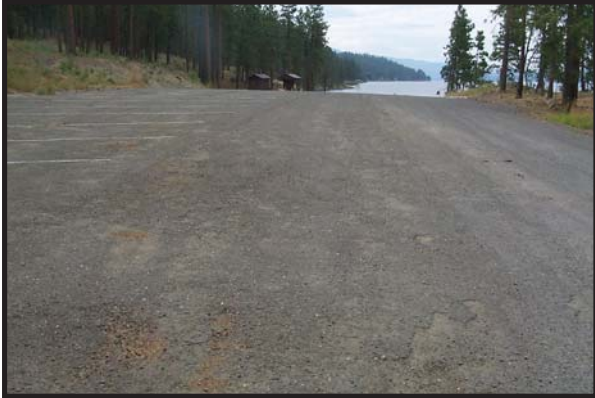
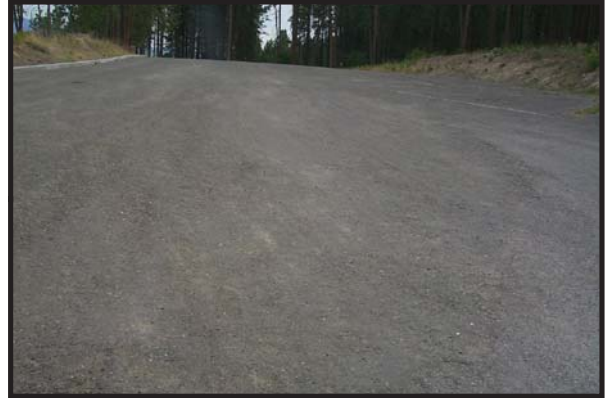
## Route 0927

Route	Public / NonPublic	Date Visited	Area (sq ft)	Lane Miles *	Surface Type	Condition / PCR
0927	Public	7/11/2001	22316	0.38	AS	FAIR / 73

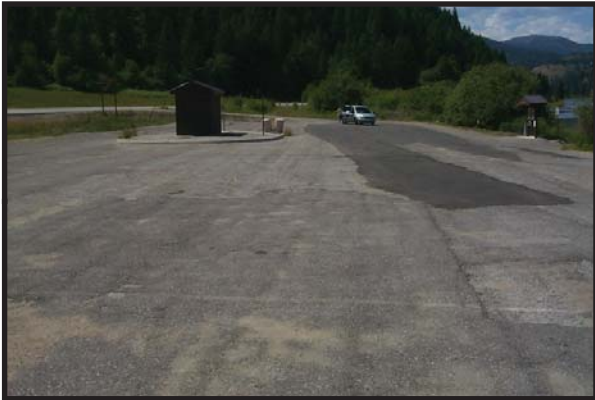
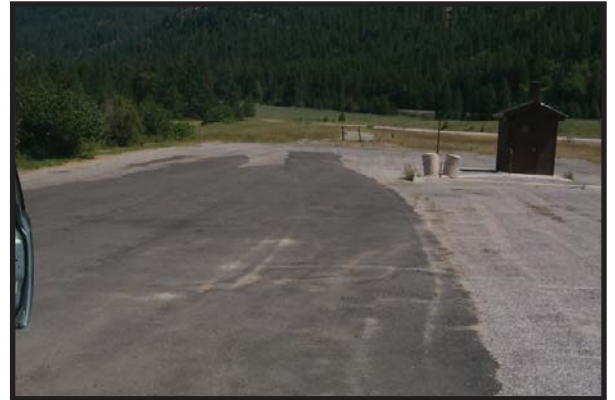
## Route 0928

Route	Public / NonPublic	Date Visited	Area (sq ft)	Lane Miles *	Surface Type	Condition / PCR
0928	Public	7/11/2001	33783	0.58	OC	FAIR / 73

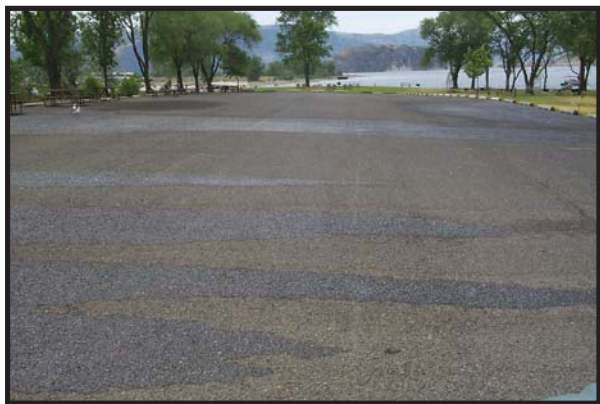
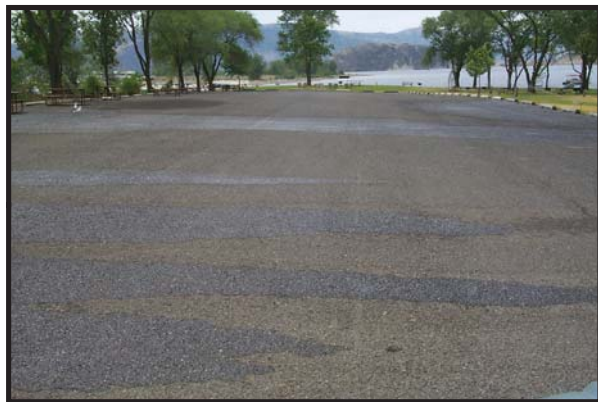
## Route 0929

Route	Public / NonPublic	Date Visited	Area (sq ft)	Lane Miles *	Surface Type	Condition / PCR
0929	Public	7/11/2001	6967	0.12	OC	FAIR / 73

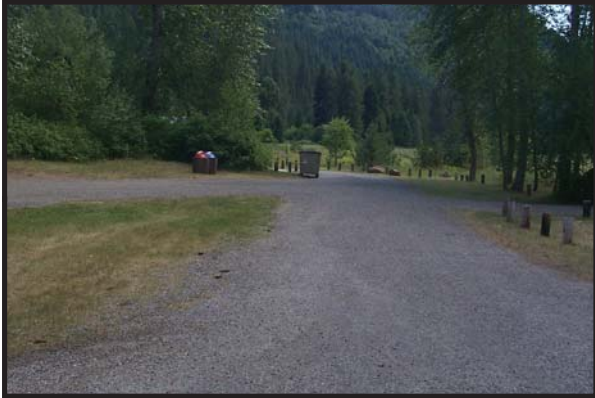
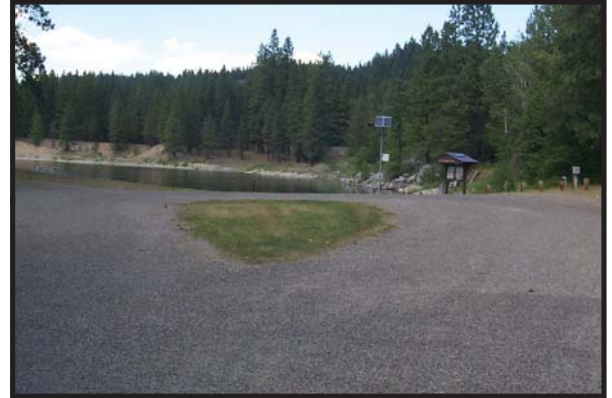
## Route 0930

Route	Public / NonPublic	Date Visited	Area (sq ft)	Lane Miles *	Surface Type	Condition / PCR
0930	Public	7/11/2001	2583	0.04	OC	FAIR / 73

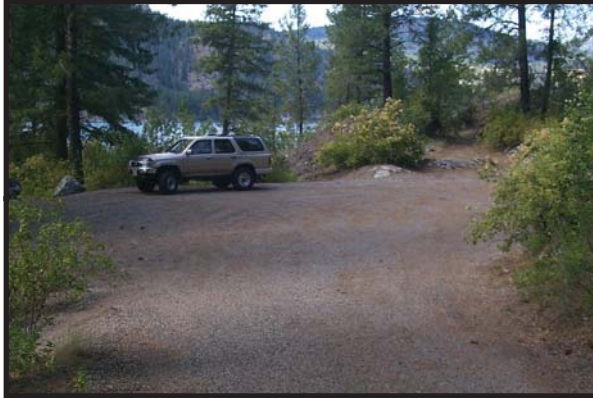
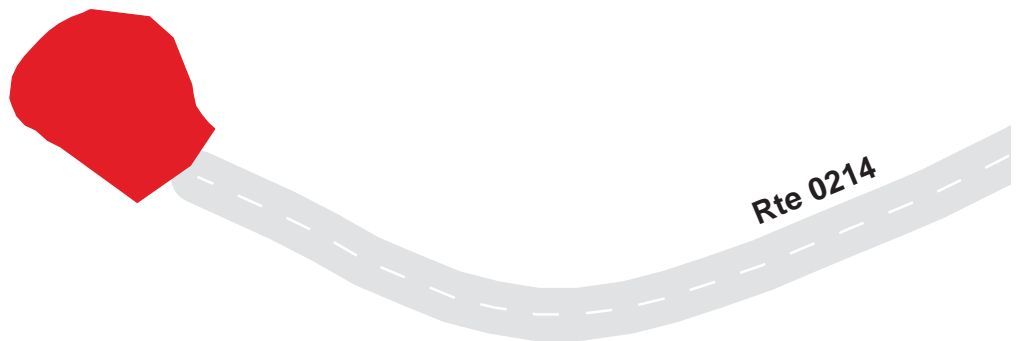
## Route 0931

Route	Public / NonPublic	Date Visited	Area (sq ft)	Lane Miles *	Surface Type	Condition / PCR
0931	Public	7/11/2001	2869	0.05	AS	GOOD / 90

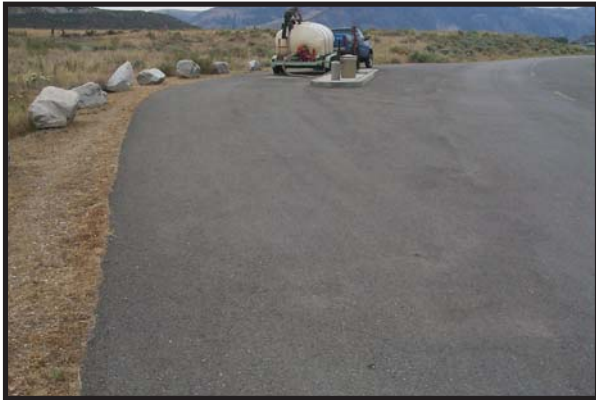
## Route 0932

Route	Public / NonPublic	Date Visited	Area (sq ft)	Lane Miles *	Surface Type	Condition / PCR
0932	Public	7/11/2001	17238	0.30	OC	GOOD / 90

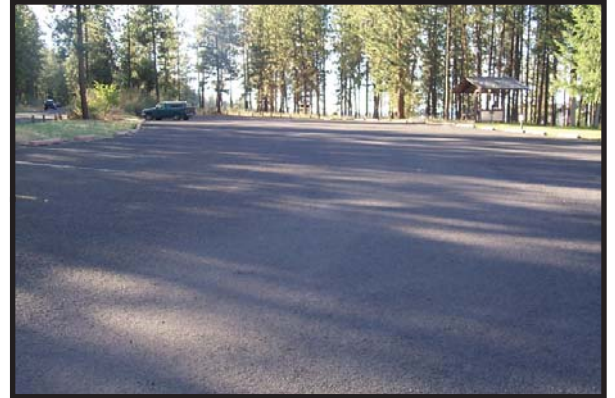
## Route 0933

Route	Public / NonPublic	Date Visited	Area (sq ft)	Lane Miles *	Surface Type	Condition / PCR
0933	Public	7/11/2001	2079	0.04	OC	GOOD / 90

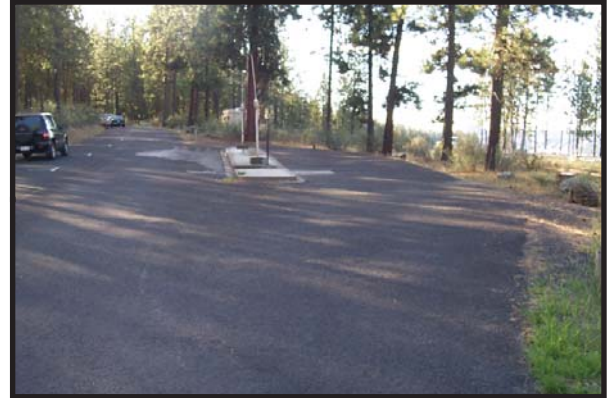
## Route 0934A

Route	Public / NonPublic	Date Visited	Area (sq ft)	Lane Miles *	Surface Type	Condition / PCR
0934A	Public	7/11/2001	2065	0.04	OC	GOOD / 90

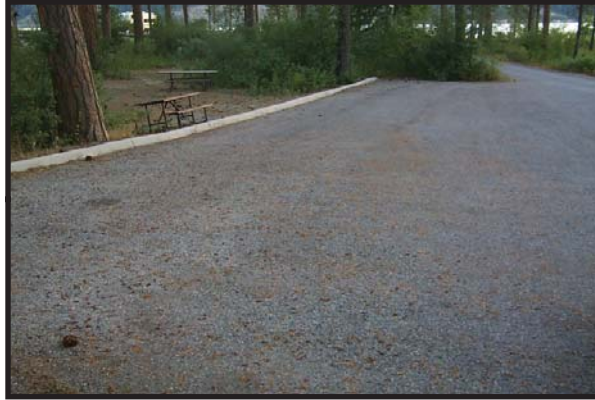
## Route 0934B

Route	Public / NonPublic	Date Visited	Area (sq ft)	Lane Miles *	Surface Type	Condition / PCR
0934B	Public	7/11/2001	3354	0.06	OC	GOOD / 90

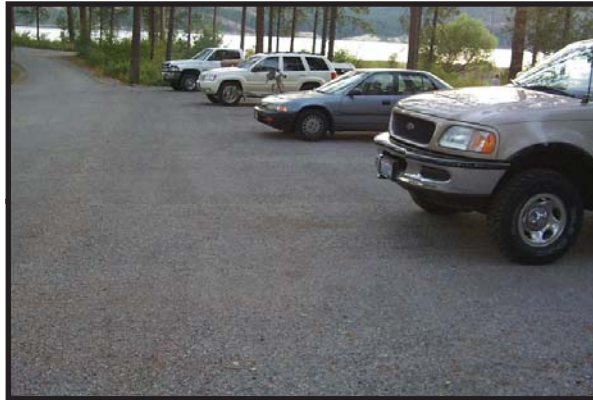
## Route 0935

Route	Public / NonPublic	Date Visited	Area (sq ft)	Lane Miles *	Surface Type	Condition / PCR
0935	Public	7/11/2001	26928	0.46	OC	GOOD / 90

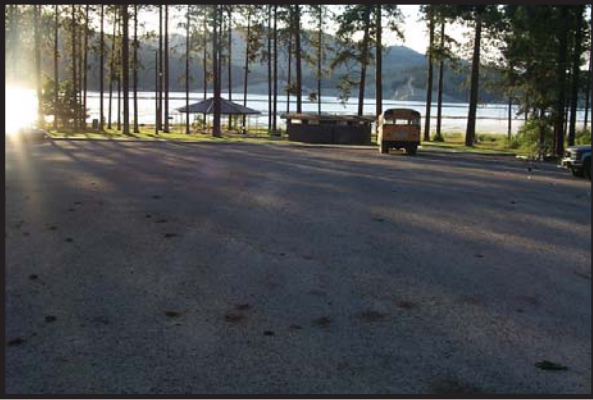
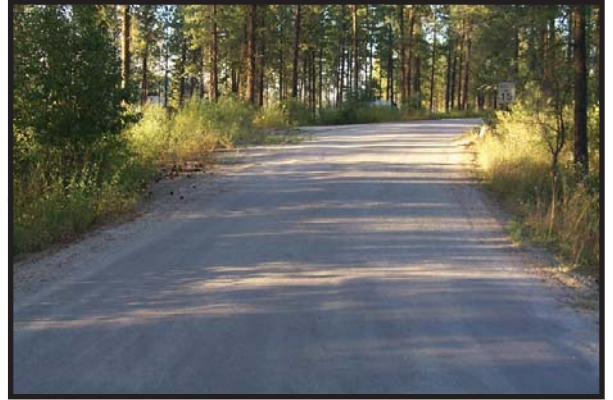
## Route 0936

Route	Public / NonPublic	Date Visited	Area (sq ft)	Lane Miles *	Surface Type	Condition / PCR
0936	Public	7/11/2001	10034	0.17	OC	FAIR / 73

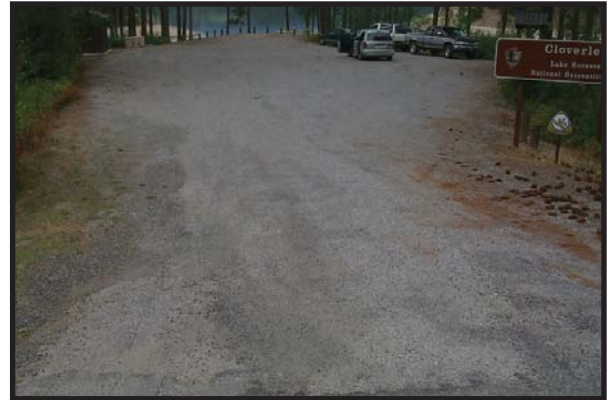
## Route 0937

Route	Public / NonPublic	Date Visited	Area (sq ft)	Lane Miles *	Surface Type	Condition / PCR
0937	Public	7/11/2001	7021	0.12	OC	FAIR / 73

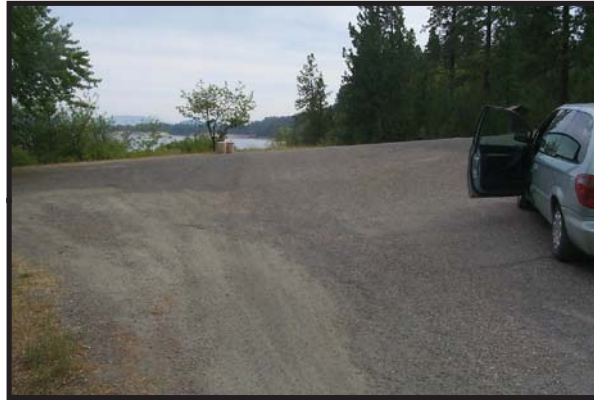
## Route 0938

Route	Public / NonPublic	Date Visited	Area (sq ft)	Lane Miles *	Surface Type	Condition / PCR
0938	Public	7/11/2001	51247	0.88	OC	EXCELLENT / 97

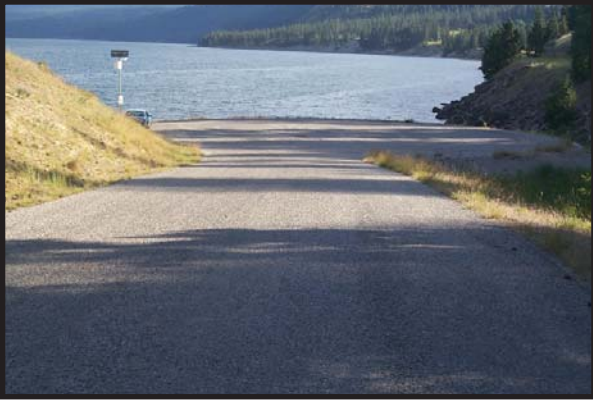
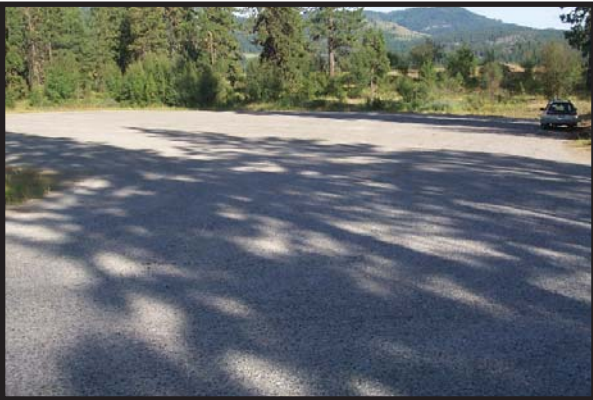
## Route 0939

Route	Public / NonPublic	Date Visited	Area (sq ft)	Lane Miles *	Surface Type	Condition / PCR
0939	Public	7/11/2001	5069	0.09	OC	POOR / 45

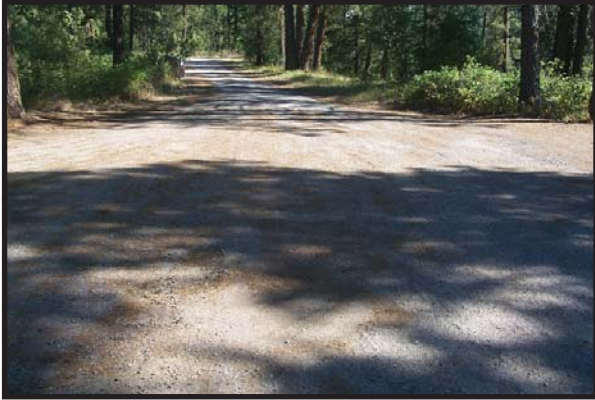
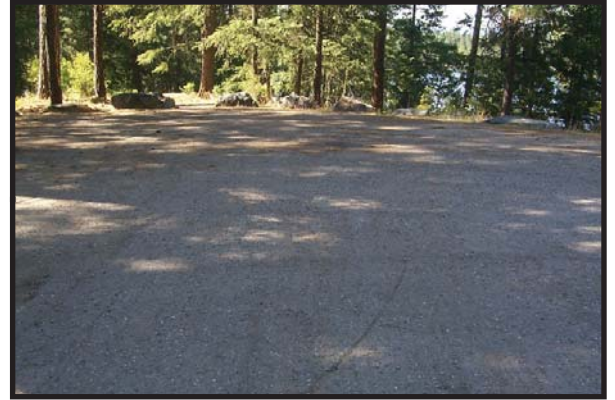
## Route 0940

Route	Public / NonPublic	Date Visited	Area (sq ft)	Lane Miles *	Surface Type	Condition / PCR
0940	Public	7/11/2001	41716	0.72	OC	FAIR / 73

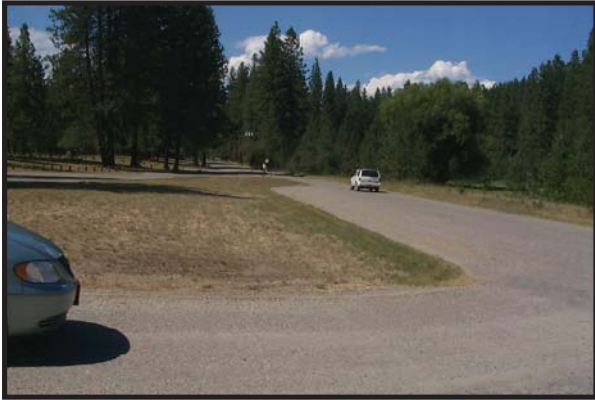
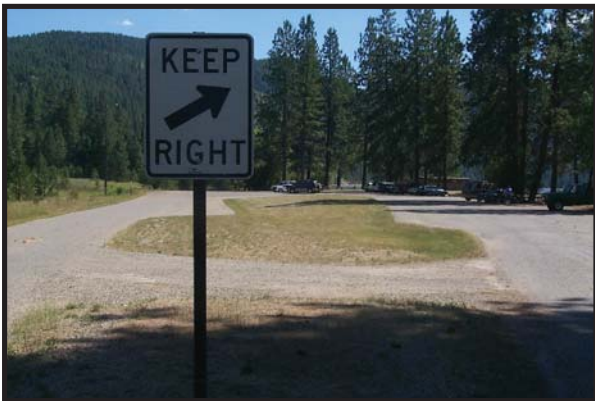
## Route 0941

Route	Public / NonPublic	Date Visited	Area (sq ft)	Lane Miles *	Surface Type	Condition / PCR
0941	Public	7/11/2001	24422	0.42	OC	FAIR / 73

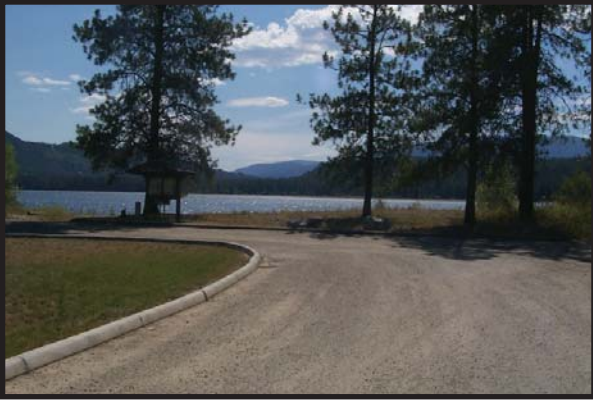
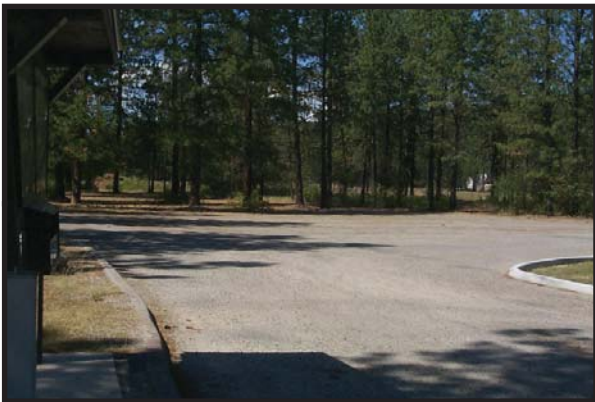
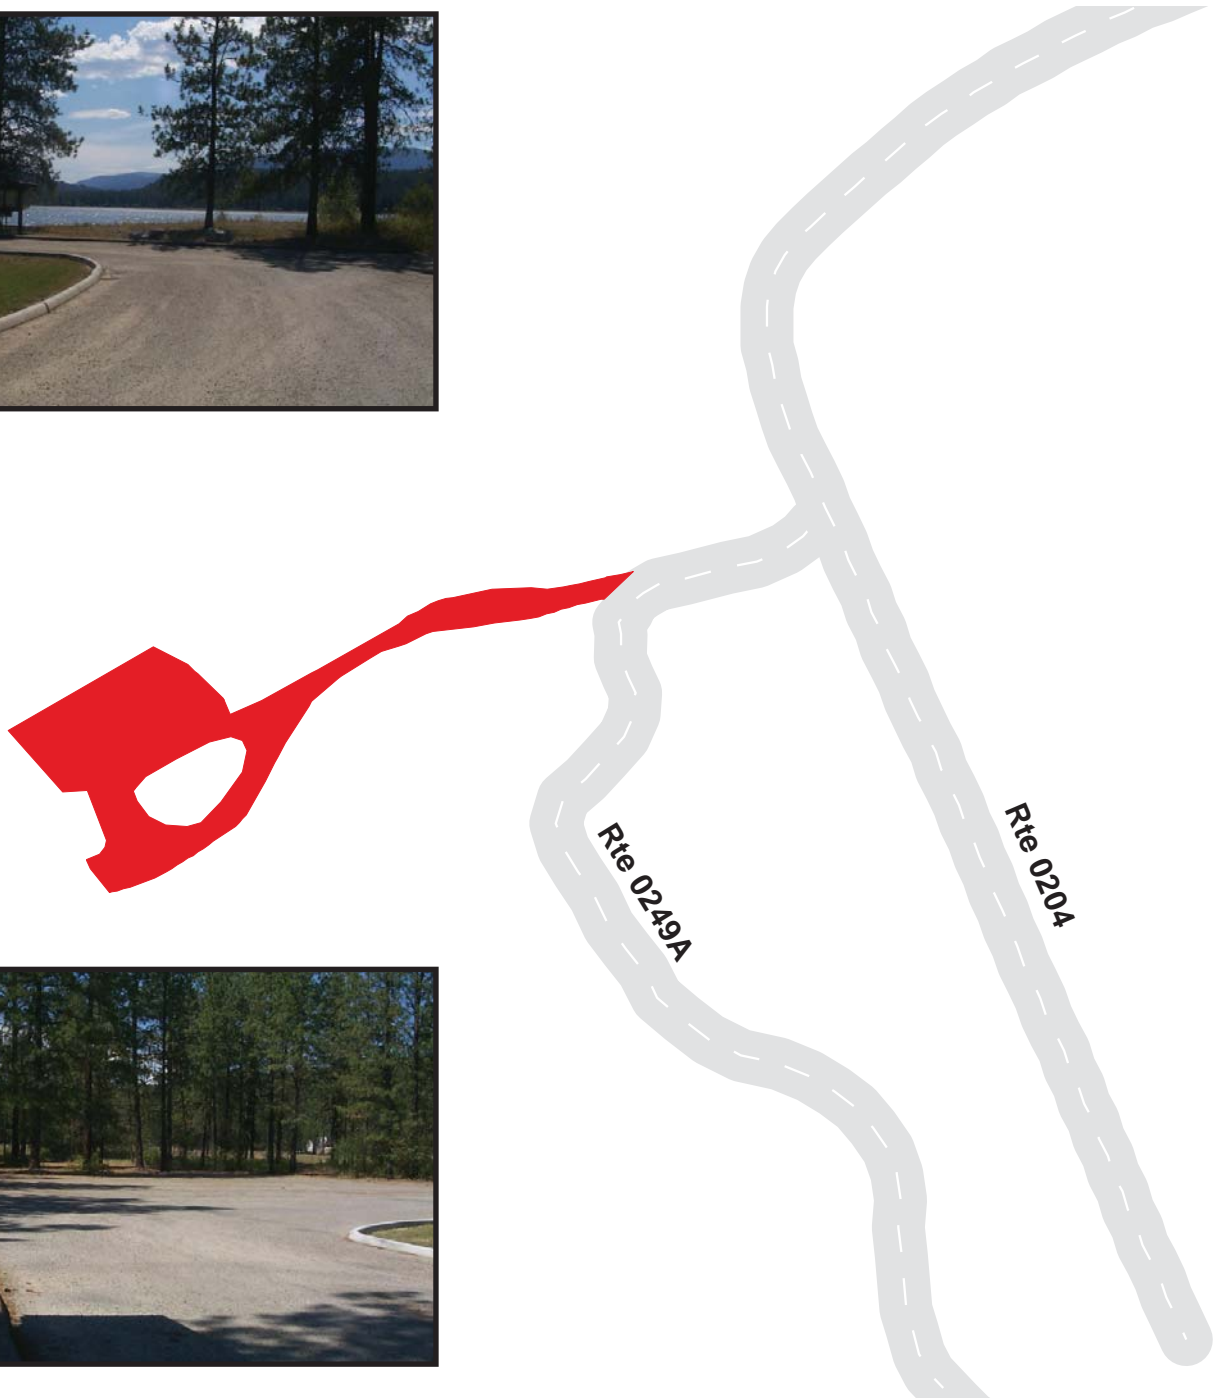
## Route 0942

Route	Public / NonPublic	Date Visited	Area (sq ft)	Lane Miles *	Surface Type	Condition / PCR
0942	Public	7/11/2001	17729	0.31	AS	GOOD / 90

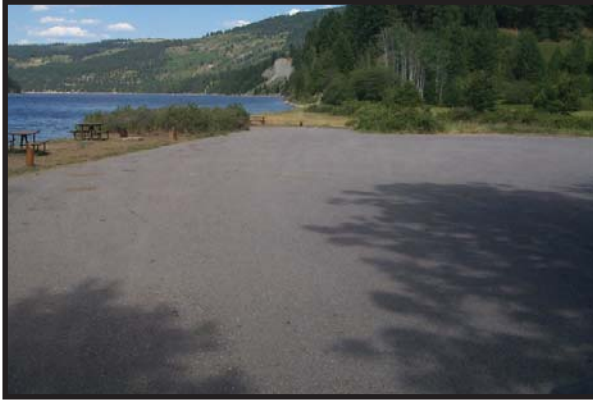
## Route 0943

Route	Public / NonPublic	Date Visited	Area (sq ft)	Lane Miles *	Surface Type	Condition / PCR
0943	Public	7/11/2001	12069	0.21	AS	GOOD / 90

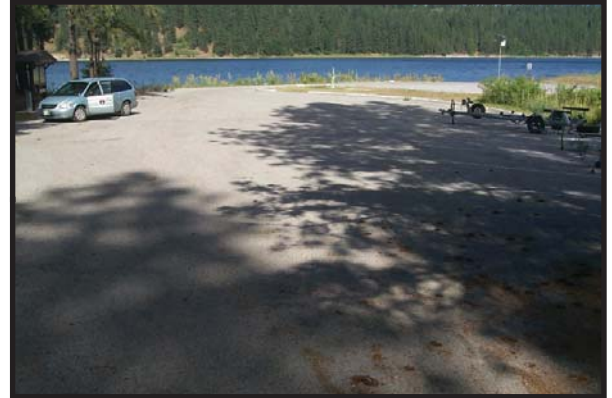
## Route 0944

Route	Public / NonPublic	Date Visited	Area (sq ft)	Lane Miles *	Surface Type	Condition / PCR
0944	Public	7/11/2001	16082	0.28	OC	GOOD / 90

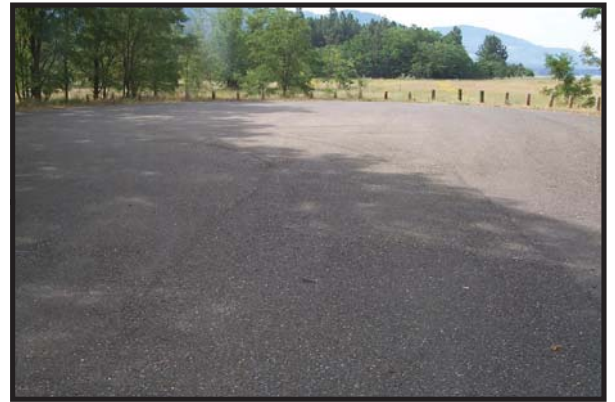
## Route 0953

Route	Public / NonPublic	Date Visited	Area (sq ft)	Lane Miles *	Surface Type	Condition / PCR
0953	Public	7/11/2001	884	0.02	OC	FAIR / 73

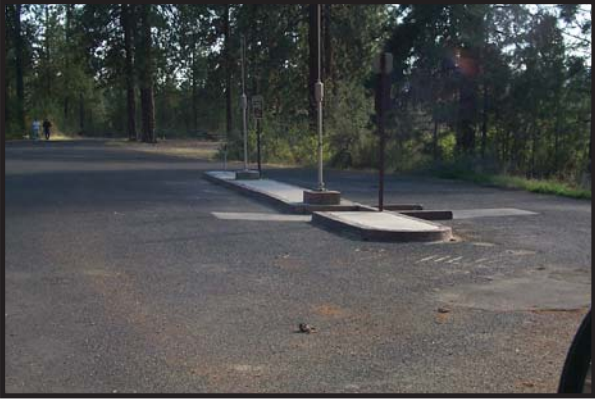
## Route 0955

Route	Public / NonPublic	Date Visited	Area (sq ft)	Lane Miles *	Surface Type	Condition / PCR
0955	Public	7/11/2001	3324	0.06	AS	GOOD / 90

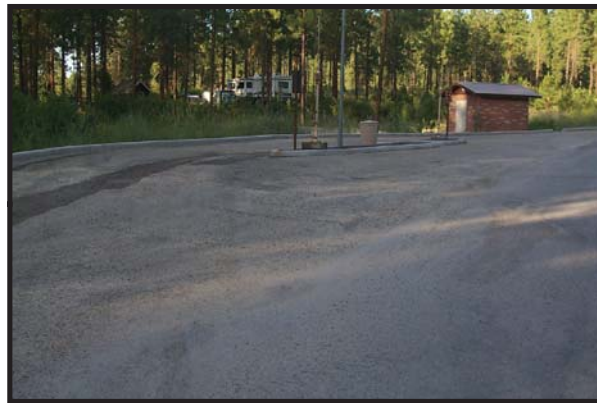
## Route 0956

Route	Public / NonPublic	Date Visited	Area (sq ft)	Lane Miles *	Surface Type	Condition / PCR
0956	Public	7/11/2001	3733	0.06	AS	GOOD / 90
