The Road Inventory of Fort Clatsop National Memorial FOCL - 9420

Road Inventory Program

Prepared By:
Federal Highway Administration
Eastern Federal Lands Highway Division
Cycle 3

Fort Clatsop National Memorial in Oregon

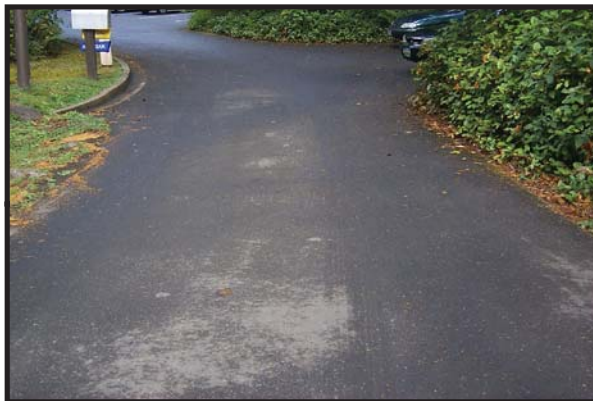
Route 0902

Route	Public / NonPublic	Date Visited	Area (sq ft)	Lane Miles *	Surface Type	Condition / PCR
0902	Public	10/4/2002	22434	0.39	AS	GOOD / 90

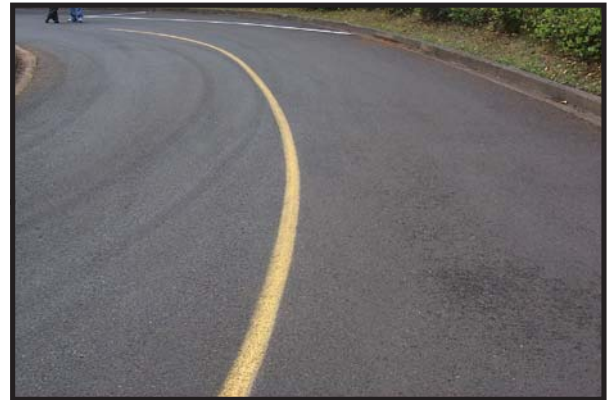
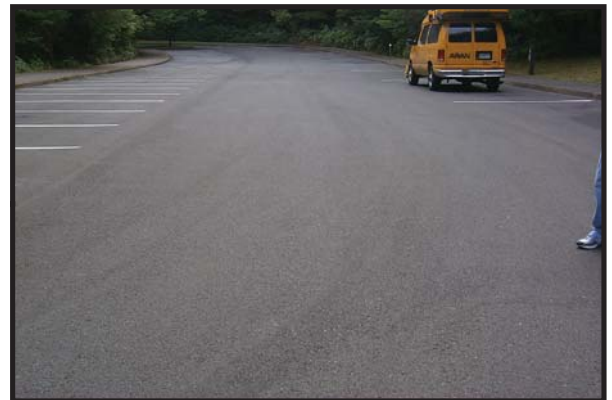
Route 0903

Route	Public / NonPublic	Date Visited	Area (sq ft)	Lane Miles *	Surface Type	Condition / PCR
0903	Public	10/4/2002	18142	0.31	AS	GOOD / 90

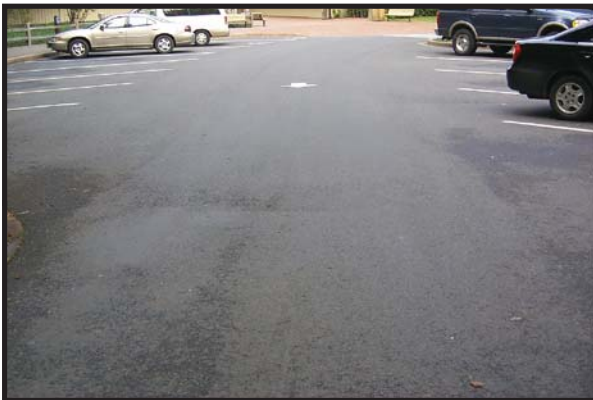
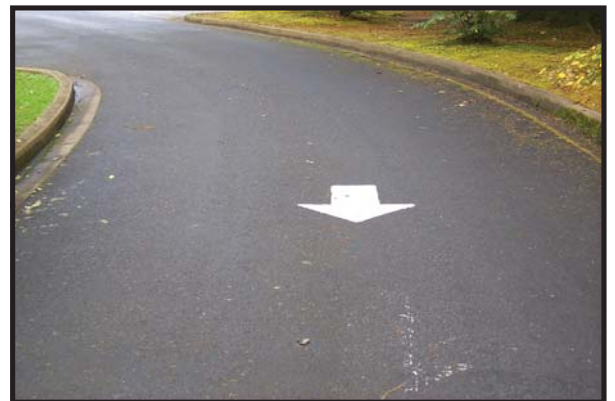
Route 0904

Route	Public / NonPublic	Date Visited	Area (sq ft)	Lane Miles *	Surface Type	Condition / PCR
0904	NonPublic	10/4/2002	9433	0.16	AS	GOOD / 90

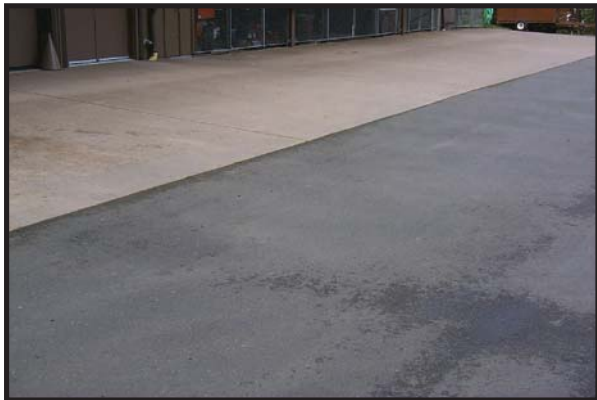
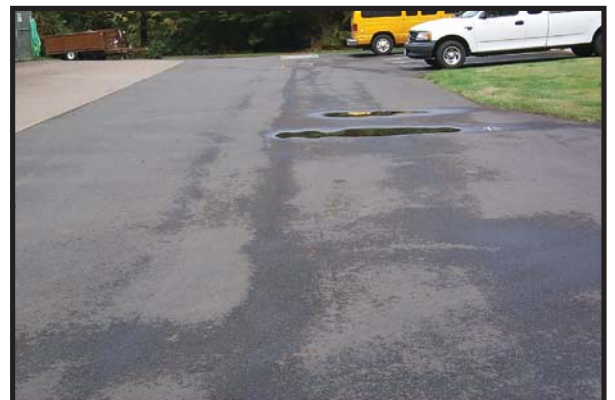
Route 0905

Route	Public / NonPublic	Date Visited	Area (sq ft)	Lane Miles *	Surface Type	Condition / PCR
0905	NonPublic	10/4/2002	1896	0.03	AS	GOOD / 90

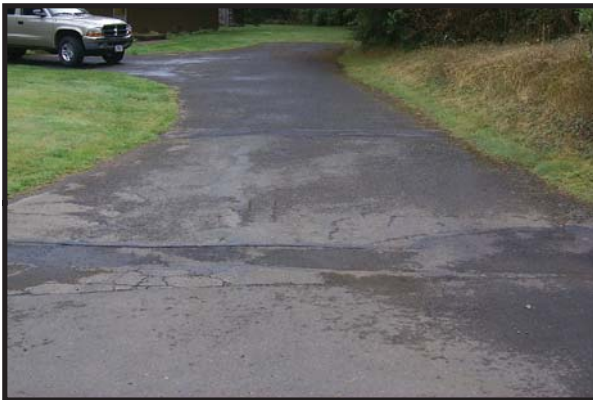
Fort Clatsop National Memorial
Route 0906
 EAST BOUNDARY ENTRANCE SIGN PARKING
 FROM ROUTE 0011

Route	Public / NonPublic	Date Visited	Area (sq ft)	Lane Miles *	Surface Type	Condition / PCR
0906	Public	10/4/2002	953	0.02	AS	GOOD / 90

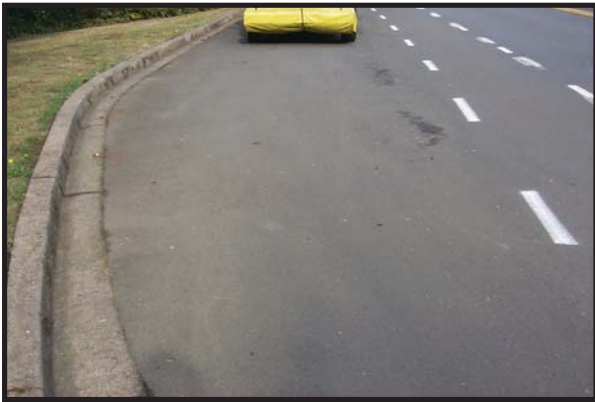
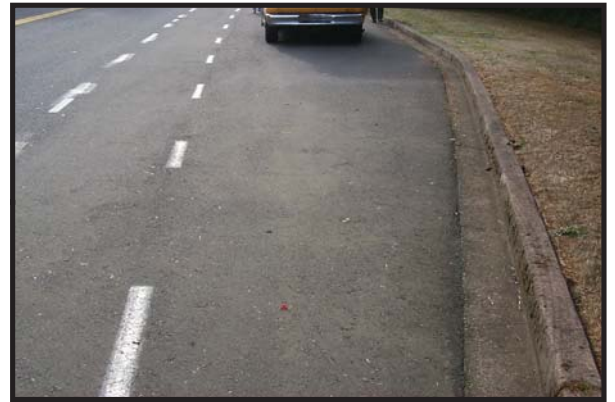
Fort Clatsop National Memorial
Route 0907
 SOUTH BOUNDARY ENTRANCE SIGN PARKING
 FROM ROUTE 0011

Route	Public / NonPublic	Date Visited	Area (sq ft)	Lane Miles *	Surface Type	Condition / PCR
0907	Public	10/4/2002	805	0.01	AS	GOOD / 90

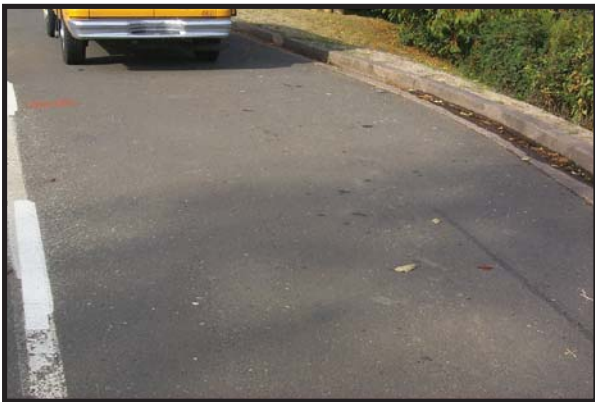
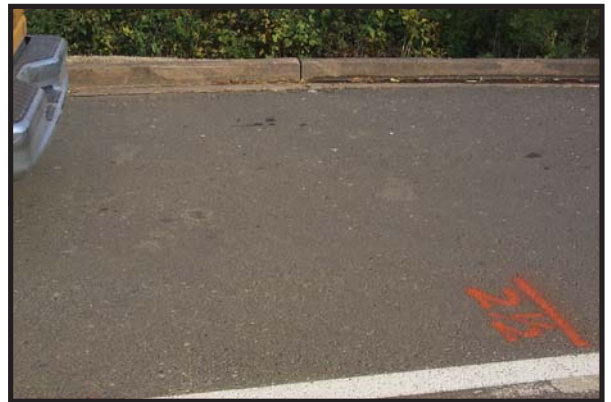
Route 0908

Route	Public / NonPublic	Date Visited	Area (sq ft)	Lane Miles *	Surface Type	Condition / PCR
0908	Public	10/4/2002	4759	0.08	AS	GOOD / 90
