# The Road Inventory of Little Bighorn Battlefield National Monument LIBI – 1380

## Road Inventory Program

Prepared By:  
Federal Highway Administration  
Eastern Federal Lands Highway Division  
Cycle 3

# Little Bighorn Battlefield National Monument in Montana

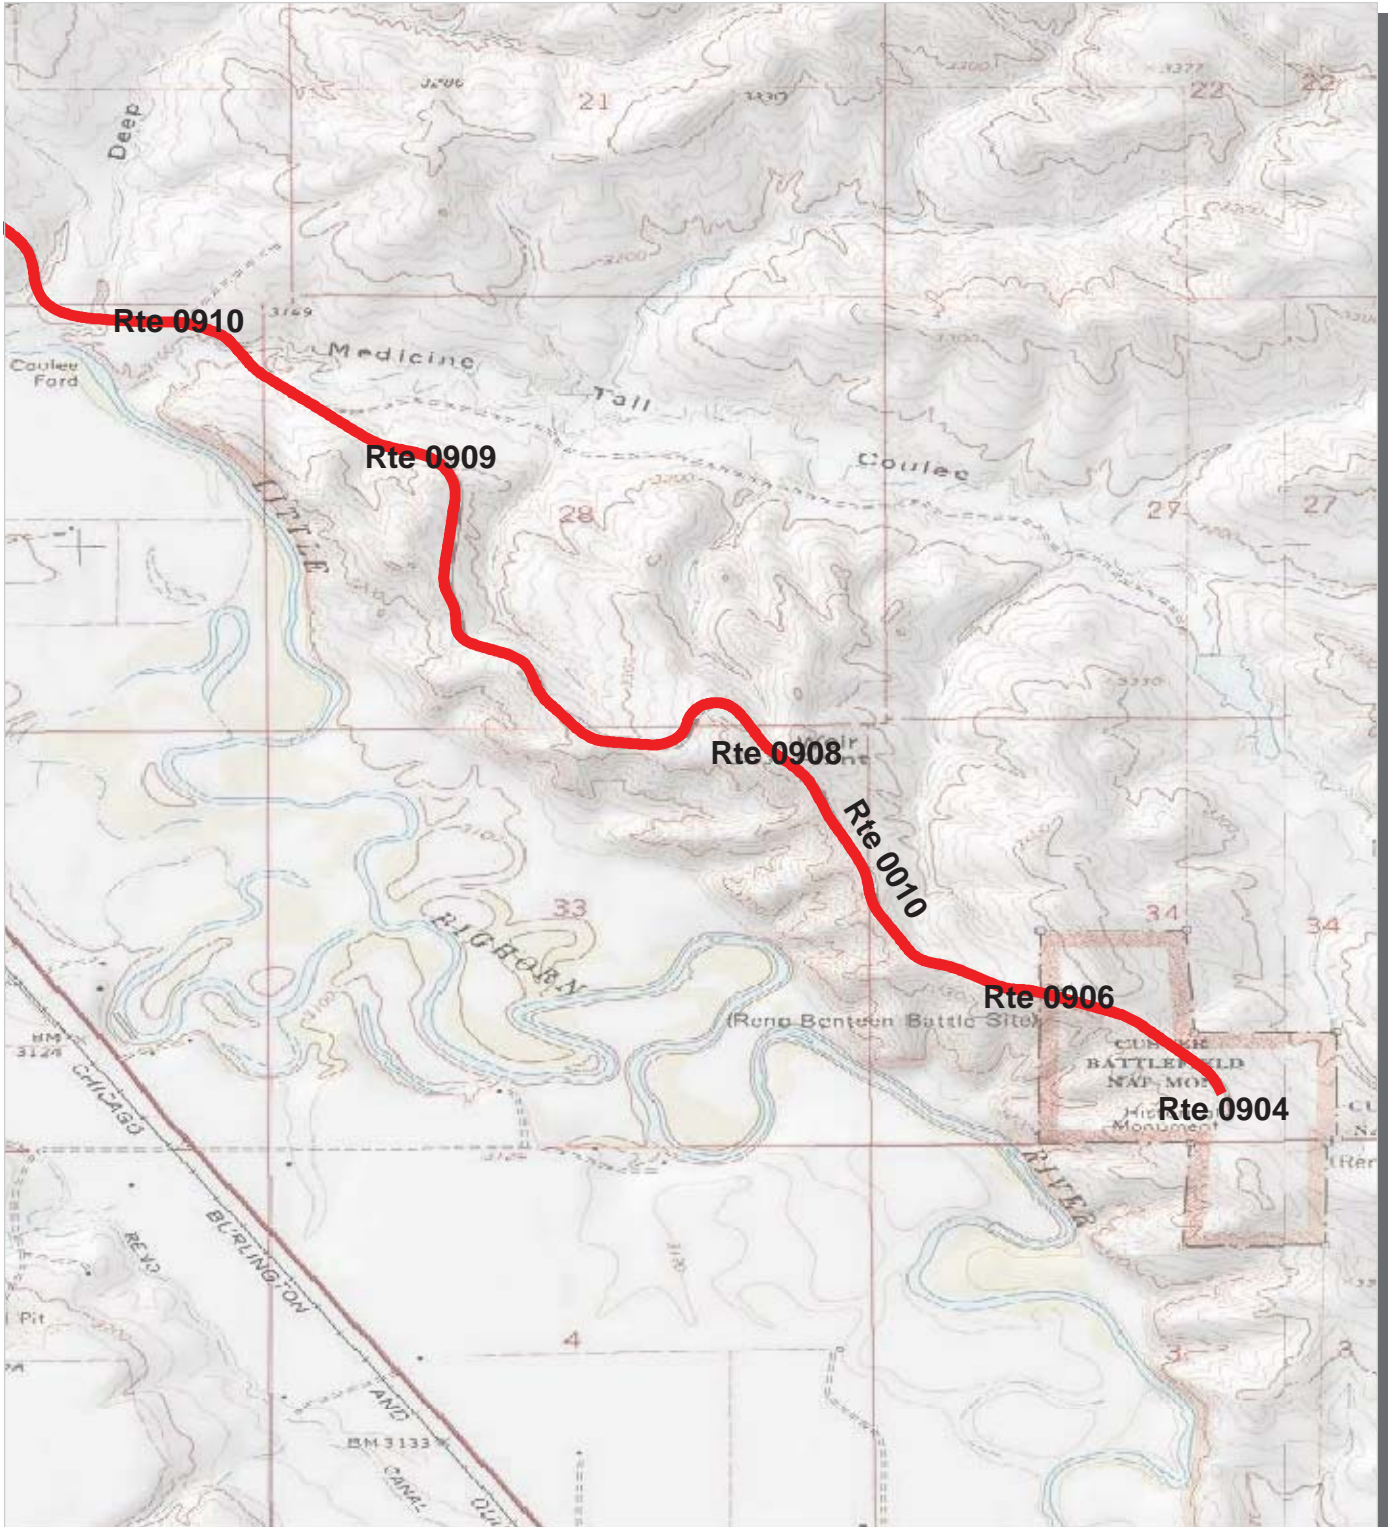
## Route Condition Area Map 2

### PCR - Mile by Mile

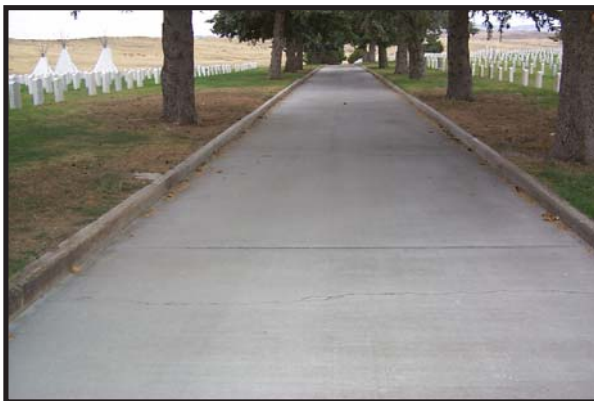
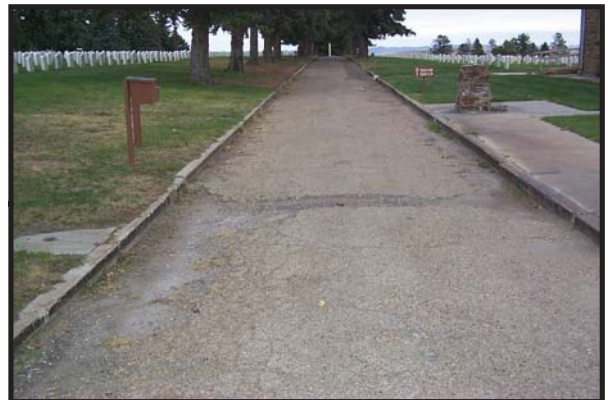
Route	Length (mi)	Width (ft)	Area (sq ft)	Lane Miles *	Condition / PCR	Surface Type
0200	0.15	12.00	9314	0.16	FAIR / 73	CO

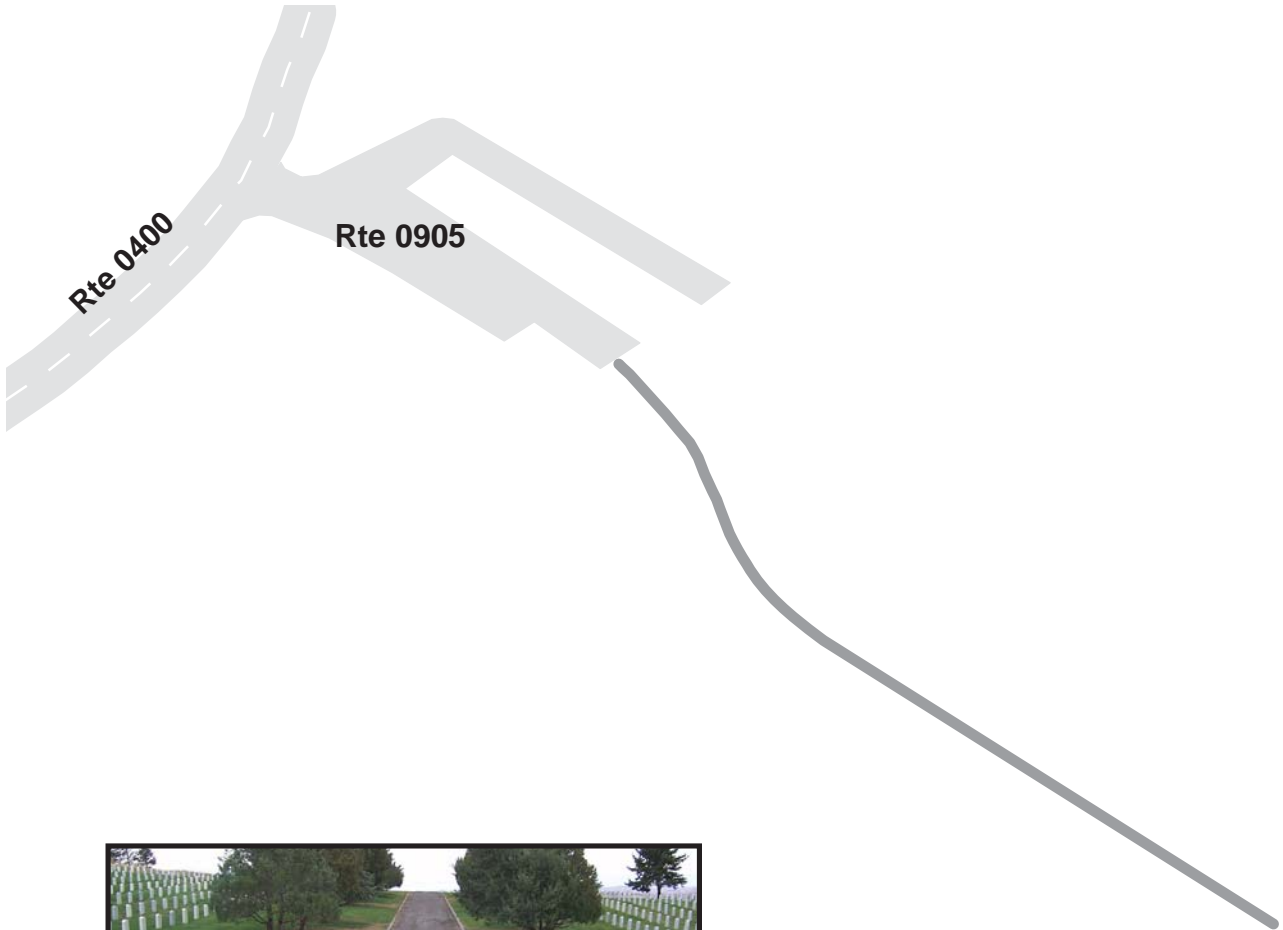
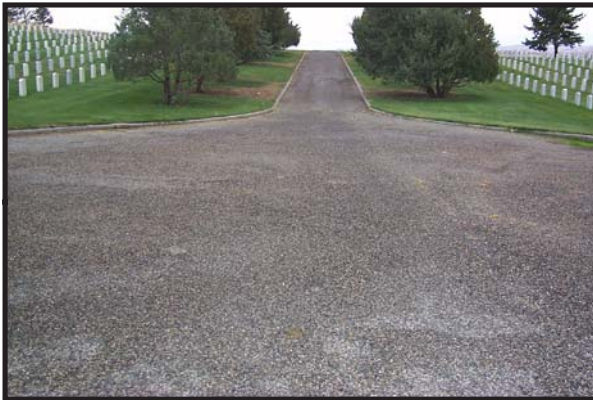
## Route 0201

Route	Length (mi)	Width (ft)	Area (sq ft)	Lane Miles *	Condition / PCR	Surface Type
0201	0.09	11.00	4937	0.09	FAIR / 73	OC
