# The Road Inventory of Lincoln Boyhood National Memorial LIBO - 6400

## Road Inventory Program

Prepared By:  
Federal Highway Administration  
Eastern Federal Lands Highway Division  
Cycle 3

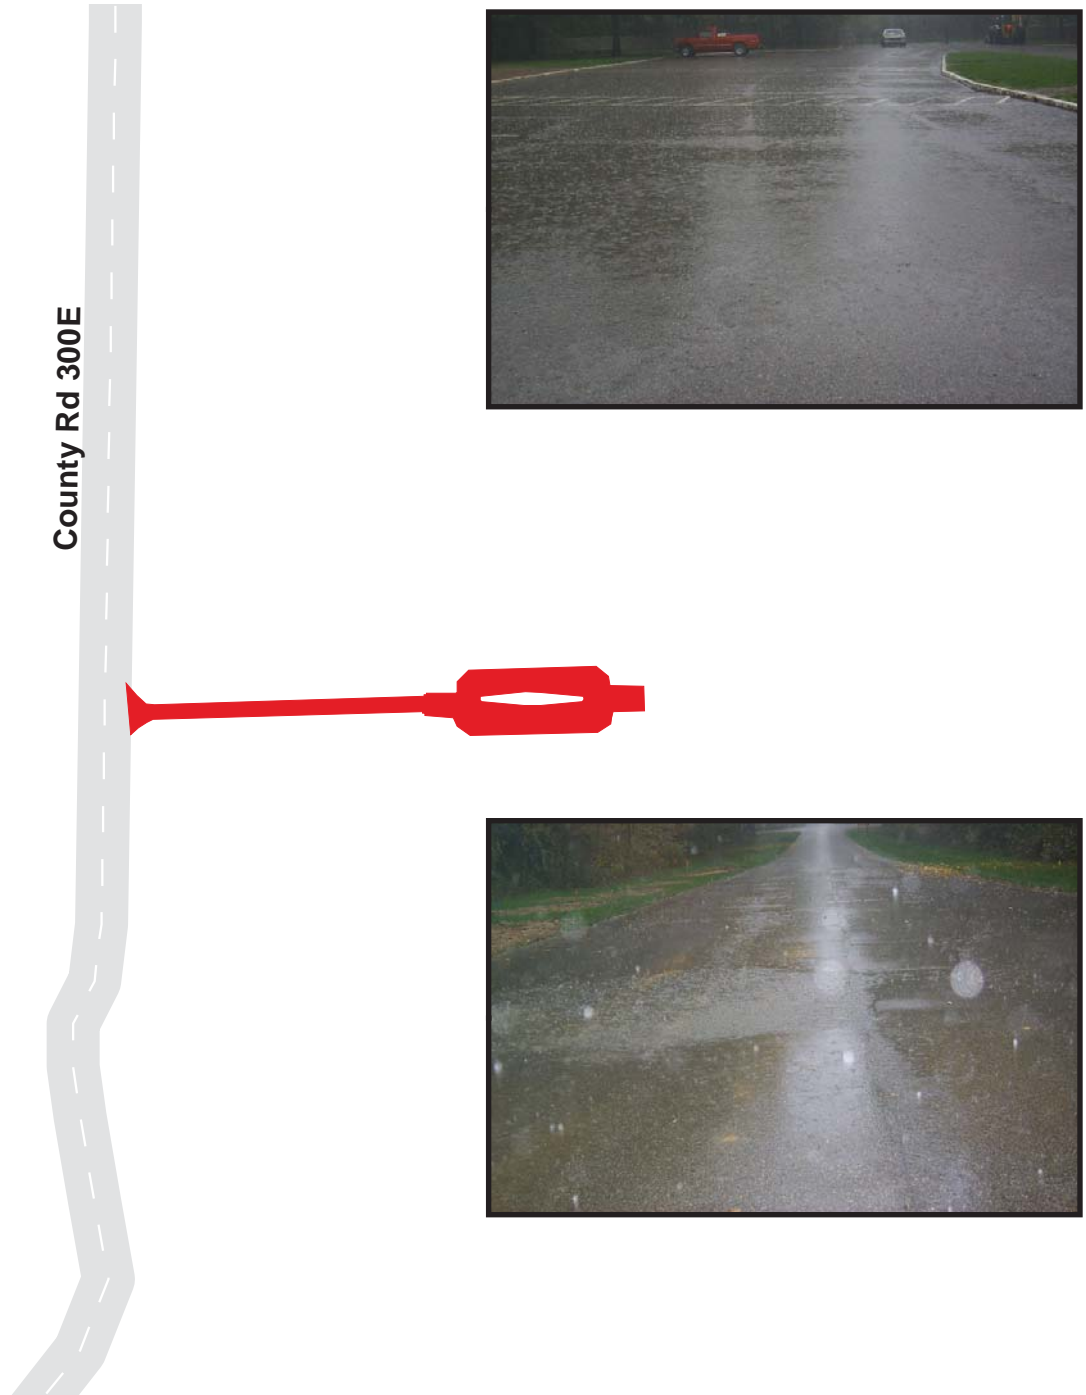
## Route 0900

VISITOR CENTER  
From County Road 300E

Route	Public / NonPublic	Date Visited	Area (sq ft)	Lane Miles *	Surface Type	Condition / PCR
0900	Public	10/25/2002	39444	0.68	AS	GOOD / 90

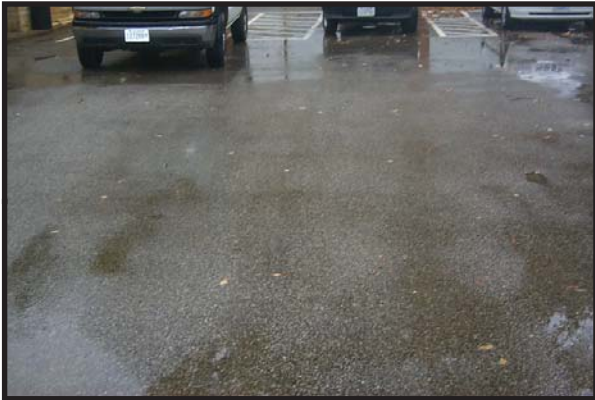
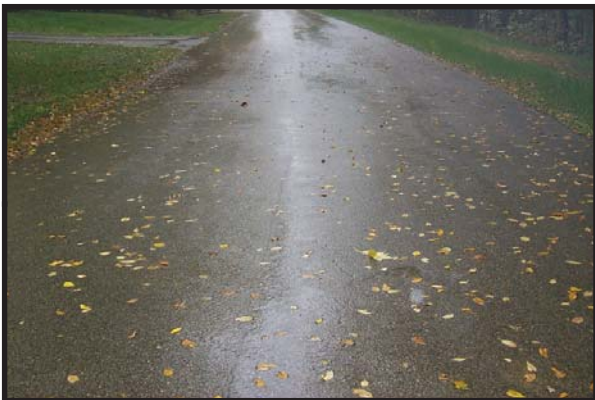
## Route 0901

MAINTENANCE AREA  
From County Road 300E

Route	Public / NonPublic	Date Visited	Area (sq ft)	Lane Miles *	Surface Type	Condition / PCR
0901	NonPublic	10/25/2002	26571	0.46	AS	FAIR / 73

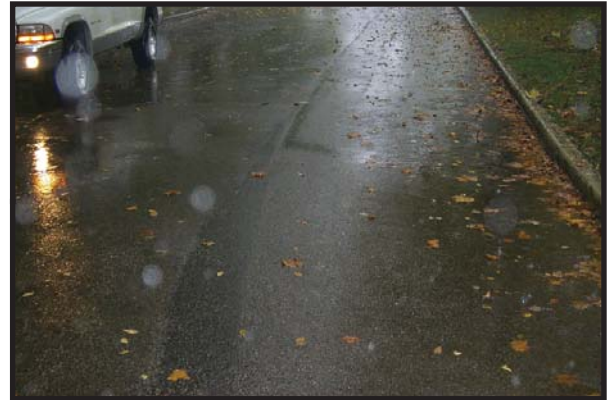
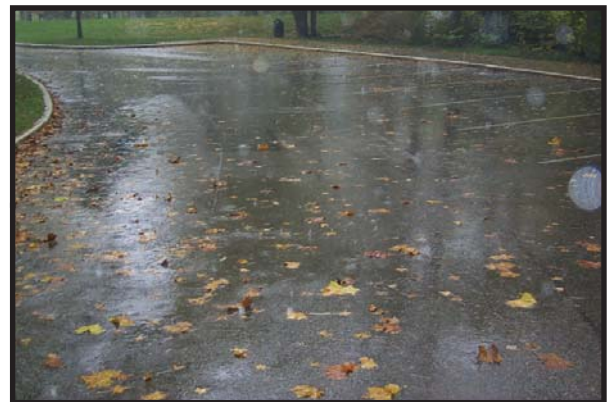
## Route 0902

LIVING HISTORICAL FARM PARKING

Route	Public / NonPublic	Date Visited	Area (sq ft)	Lane Miles *	Surface Type	Condition / PCR
0902	Public	10/25/2002	14919	0.26	AS	GOOD / 90
