# The Road Inventory of Lincoln Home National Historic Site LIHO – 6530

## Road Inventory Program

Prepared By:  
Federal Highway Administration  
Eastern Federal Lands Highway Division  
Cycle 3

# Lincoln Home National Historic Site in Illinois

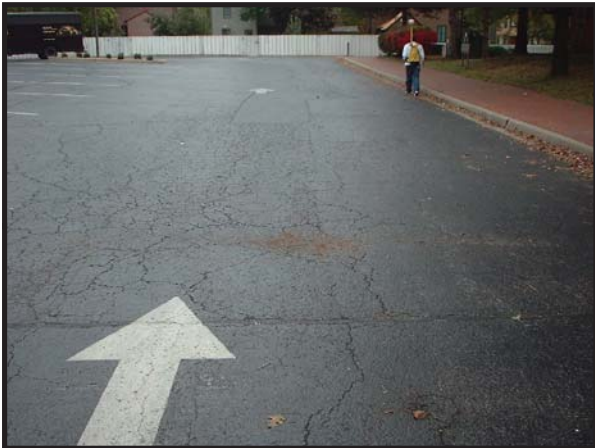
Route	Public / NonPublic	Date Visited	Area (sq ft)	Lane Miles *	Surface Type	Condition / PCR
0900	Public	10/23/2002	14321	0.25	AS	POOR / 45

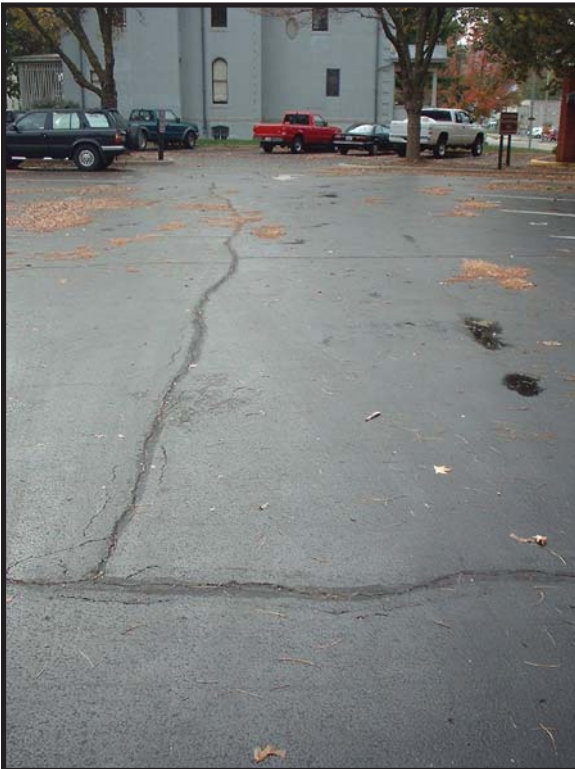
## Route 0901

Route	Public / NonPublic	Date Visited	Area (sq ft)	Lane Miles *	Surface Type	Condition / PCR
0901	Public	10/23/2002	26112	0.45	AS	GOOD / 90

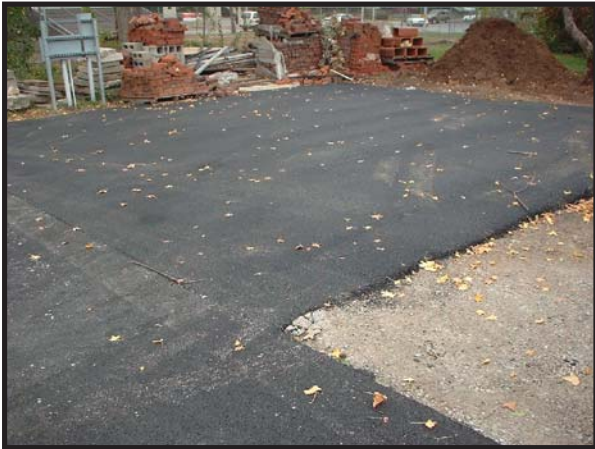
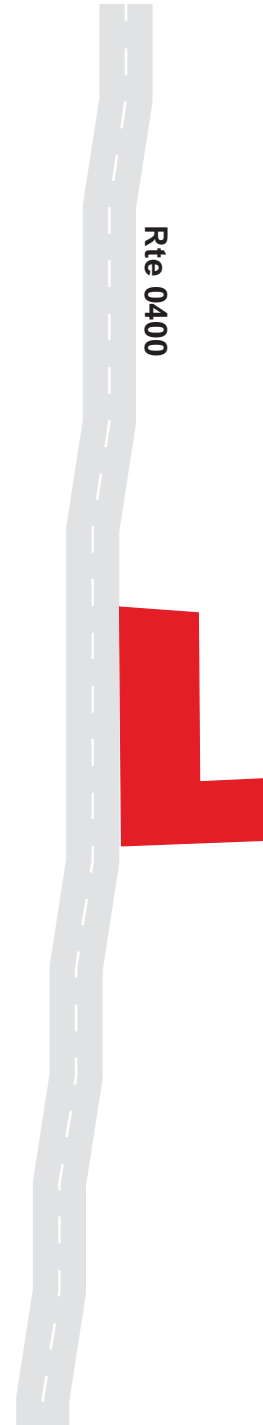
**Lincoln Home National Historic Site**  
**Route 0910A**  
 JACKSON STREET COBBLESTONE AREA A  
 From 7th Street

Route	Public / NonPublic	Date Visited	Area (sq ft)	Lane Miles *	Surface Type	Condition / PCR
0910A	NonPublic	10/23/2002	4277	0.07	OT	GOOD / 90

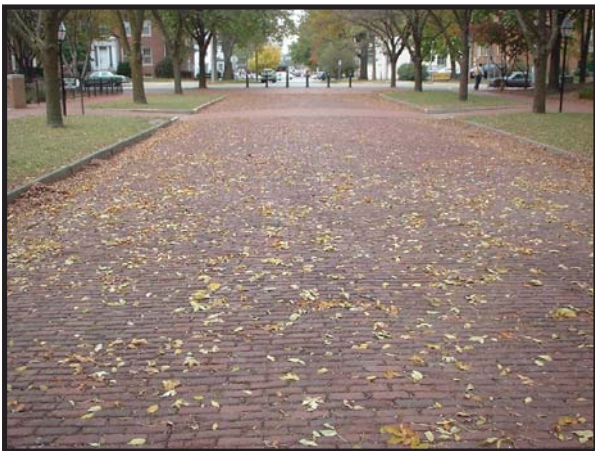
**Lincoln Home National Historic Site**  
**Route 0910B**  
 JACKSON STREET COBBLESTONE AREA B  
 From Route 0403

Route	Public / NonPublic	Date Visited	Area (sq ft)	Lane Miles *	Surface Type	Condition / PCR
0910B	NonPublic	10/23/2002	3792	0.07	OT	FAIR / 73
