The Road Inventory of Little River Canyon National Preserve LIRI - 5279

Prepared By:
Federal Highway Administration
Eastern Federal Lands Highway Division
Cycle 3

Little River Canyon National Preserve in Alabama

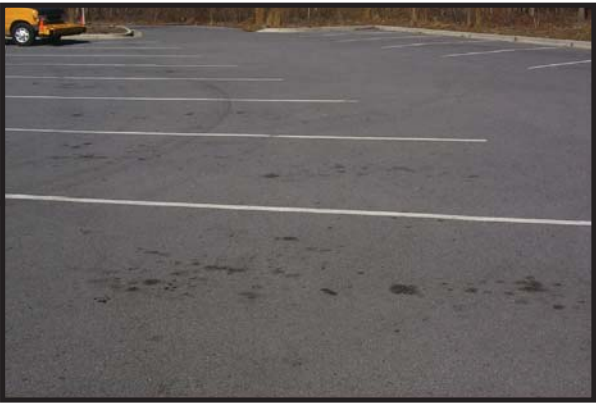
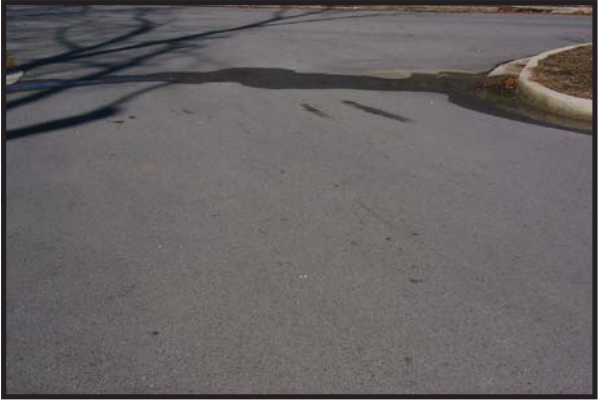
Route	Public / NonPublic	Date Visited	Area (sq ft)	Lane Miles *	Surface Type	Condition / PCR
0900	Public	1/25/2002	23470	0.40	AS	GOOD / 90
