# The Road Inventory of Lowell National Historic Park LOWE - 1780

## Road Inventory Program

Prepared By:  
Federal Highway Administration  
Eastern Federal Lands Highway Division  
Cycle 3

# Lowell National Historical Park in Massachusetts

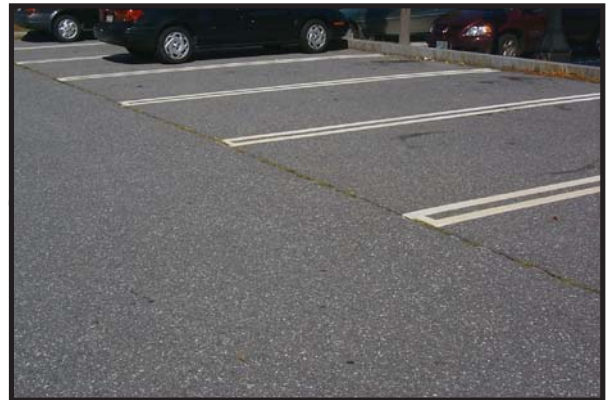
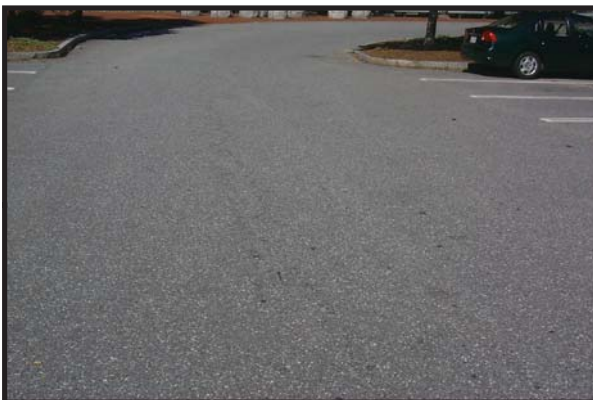
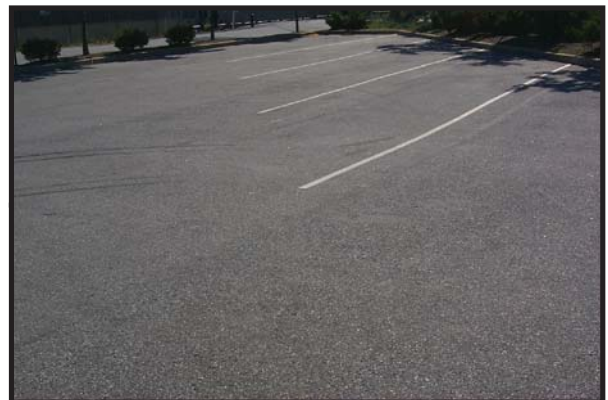
## Route 0900

### VISITOR CENTER PARKING FROM DOTTON STREET

Route	Public / NonPublic	Date Visited	Area (sq ft)	Lane Miles *	Surface Type	Condition / PCR
0900	Public	8/23/2002	86198	1.48	AS	GOOD / 90

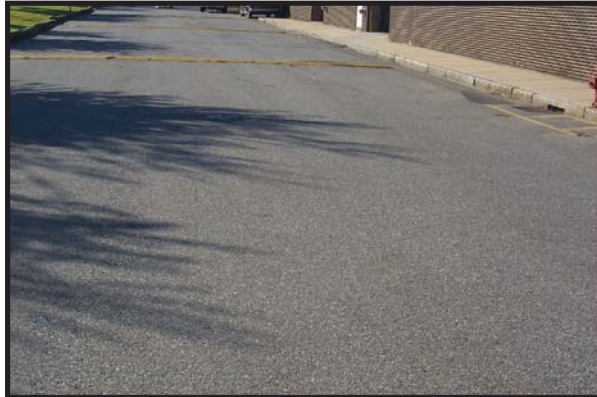
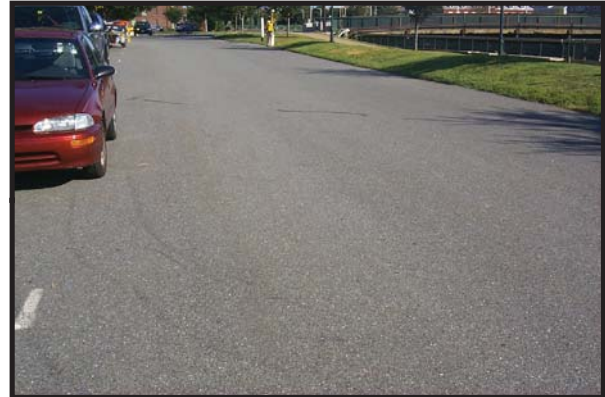
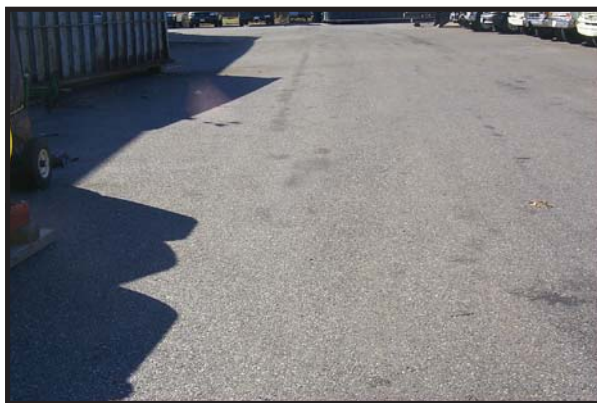
## Route 0901

### MAINTENANCE AREA FROM AIKEN STREET

Route	Public / NonPublic	Date Visited	Area (sq ft)	Lane Miles *	Surface Type	Condition / PCR
0901	NonPublic	8/23/2002	50110	0.86	AS	GOOD / 90
