**The Road Inventory
of
Lyndon B. Johnson
National Historical Park
LYJO - 7350**

Road Inventory Program

Prepared By:
Federal Highway Administration
Eastern Federal Lands Highway Division
Cycle 3

Lyndon B. Johnson National Historical Park in Texas

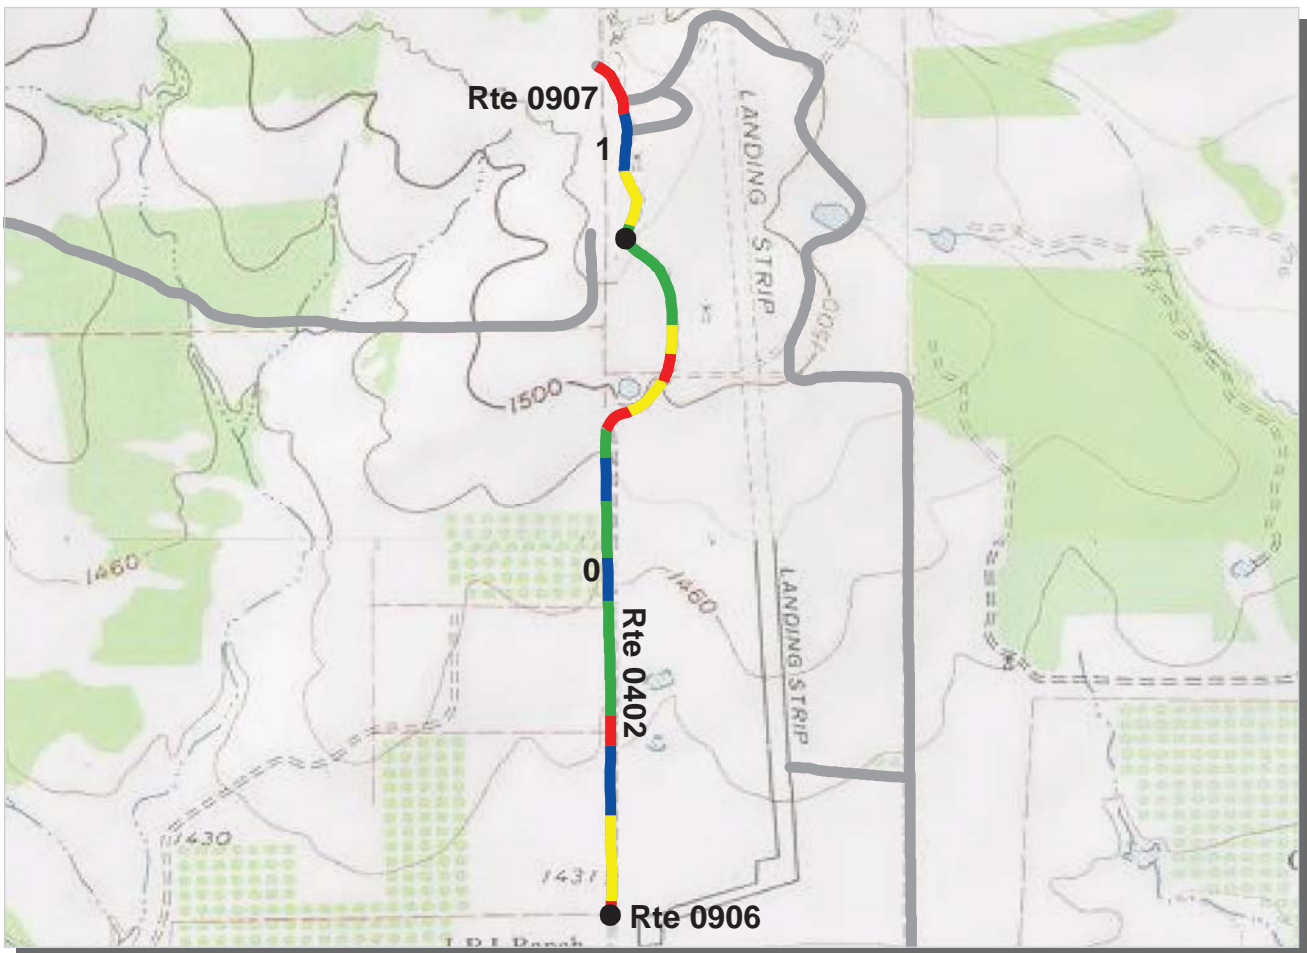
ROUTE: 0402 Malachek Road

Section Number	0	1			
Section Length (mi)	1.00	0.28			
AADT	**				
SADT	**				
ADT Date	**				
Cross Section Information					
Number of Lanes	1	1			
Paved Width (ft)	11	11			
Lane Width (ft)	11	11			
Shoulder Width (ft)	0	0			
Roadway Condition Information					
PCR (Pavement Condition Rating)	83	69			
RCI (Roughness Condition Index)	94	86			
SCR (Surface Condition Rating)	77	67			
Alligator Cracking Index	99	99			
Rutting Index	81	70			
Patching Index	100	100			
Transverse Cracking Index	99	99			
Longitudinal Cracking Index	97	97			
Shoulder Condition Rating	N/A	N/A			
Drainage Condition Rating	N/C	N/C

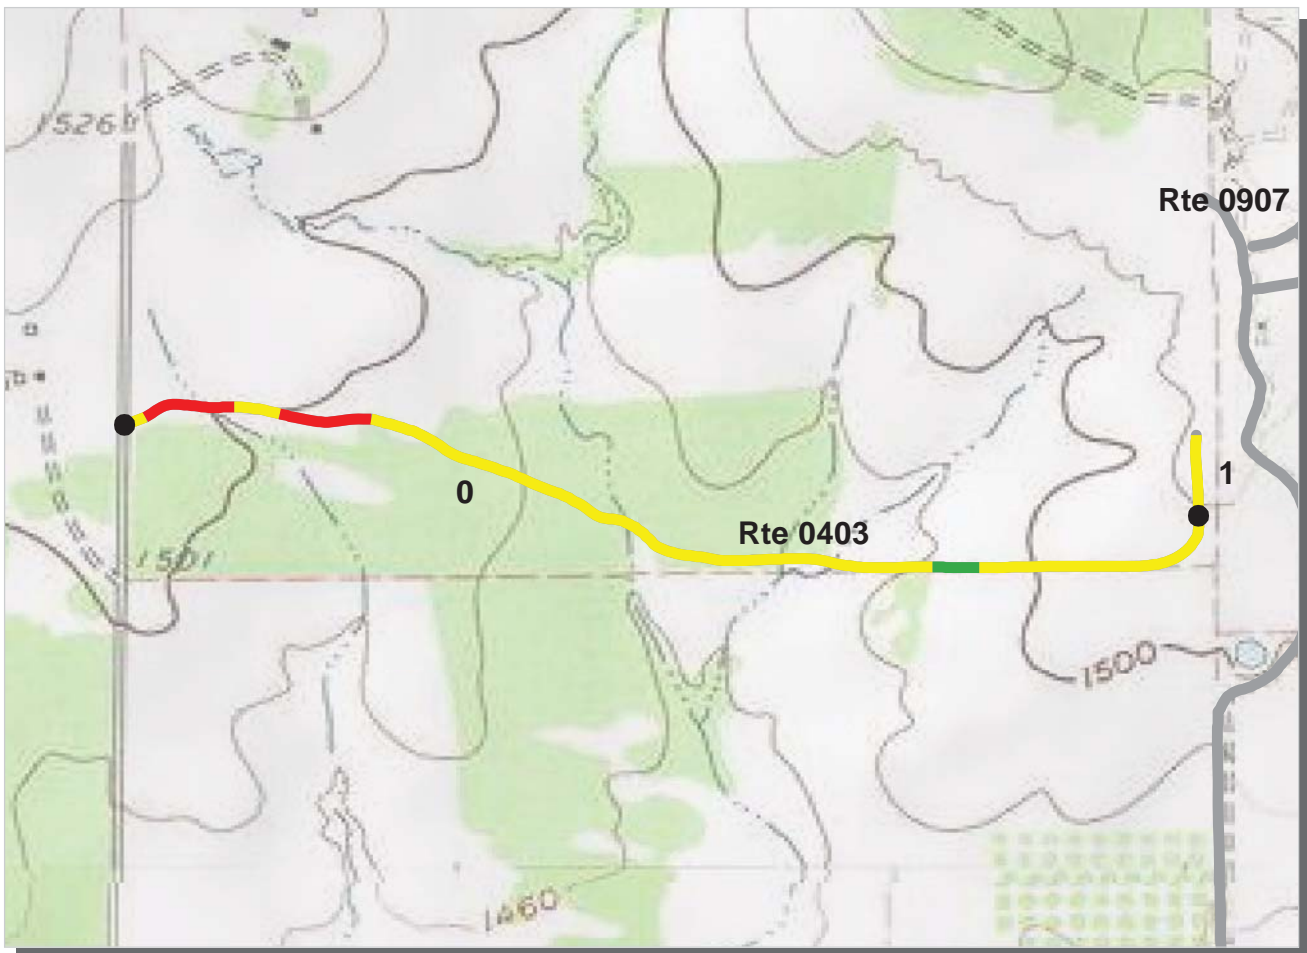
ROUTE: 0403 English Park Road

Section Number	0	1			
Section Length (mi)	1.00	0.10			
AADT	**				
SADT	**				
ADT Date	**				
Cross Section Information					
Number of Lanes	1	1			
Paved Width (ft)	13	13			
Lane Width (ft)	13	13			
Shoulder Width (ft)	0	0			
Roadway Condition Information					
PCR (Pavement Condition Rating)	69	84			
RCI (Roughness Condition Index)	86	88			
SCR (Surface Condition Rating)	59	82			
Alligator Cracking Index	97	100			
Rutting Index	71	85			
Patching Index	100	100			
Transverse Cracking Index	97	99			
Longitudinal Cracking Index	93	97			
Shoulder Condition Rating	N/A	N/A			
Drainage Condition Rating	N/C	N/C

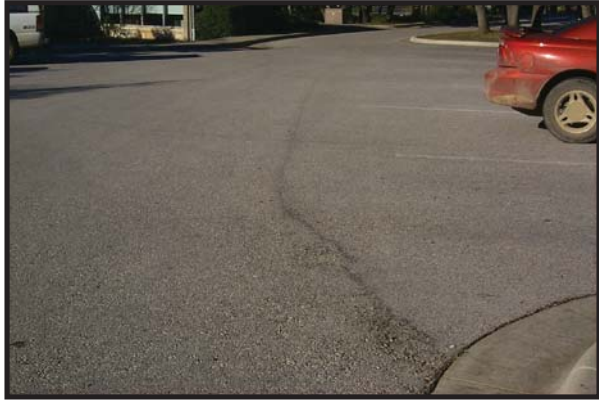
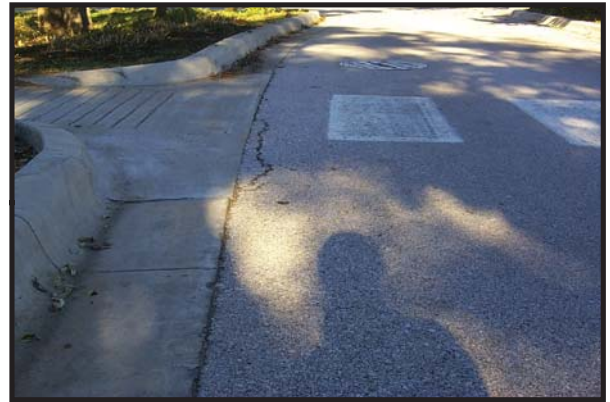
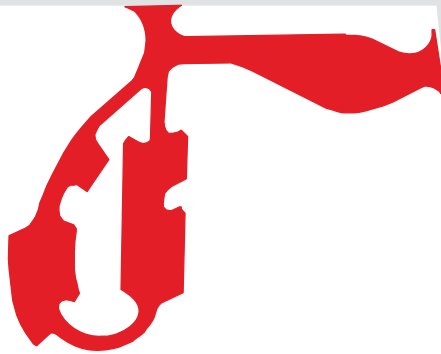
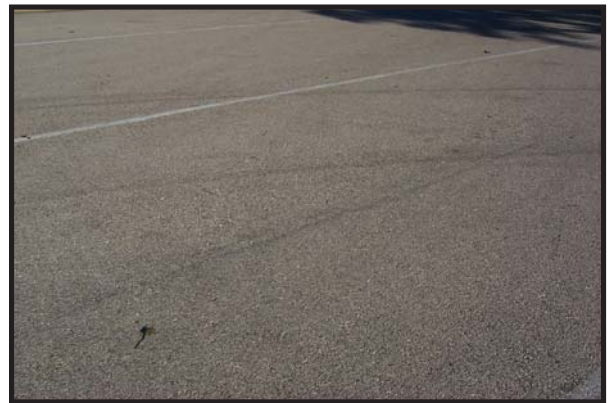
Ladybird Lane

Route	Public / NonPublic	Date Visited	Area (sq ft)	Lane Miles *	Surface Type	Condition / PCR
0900	Public	12/17/2001	35675	0.61	AS	GOOD / 90

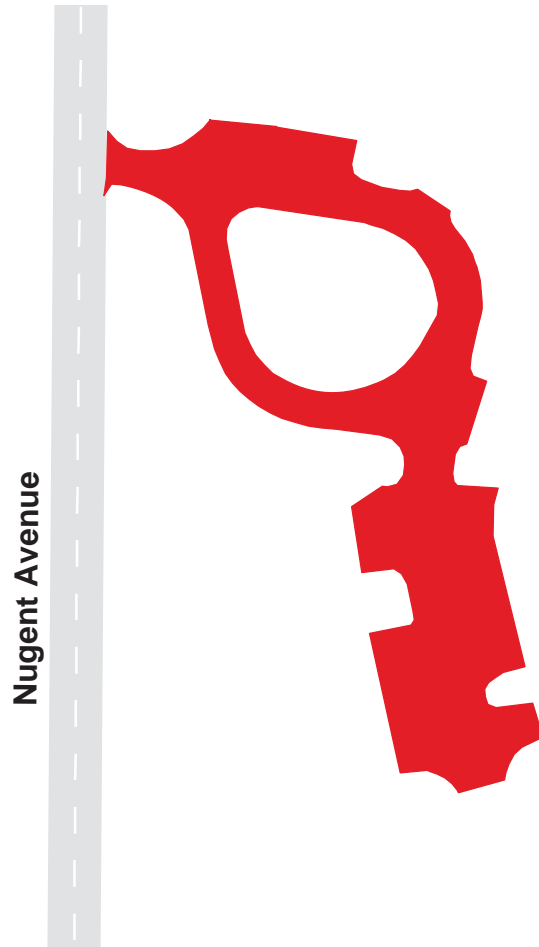
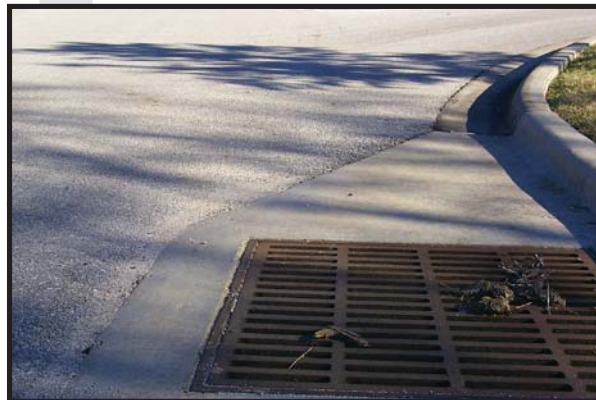
Route 0901

Route	Public / NonPublic	Date Visited	Area (sq ft)	Lane Miles *	Surface Type	Condition / PCR
0901	NonPublic	12/17/2001	13678	0.24	AS	GOOD / 90

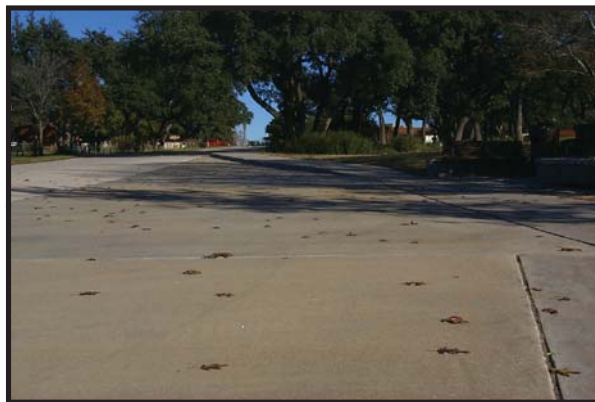
Route 0904

Route	Public / NonPublic	Date Visited	Area (sq ft)	Lane Miles *	Surface Type	Condition / PCR
0904	NonPublic	12/17/2001	1730	0.03	CO	EXCELLENT / 97

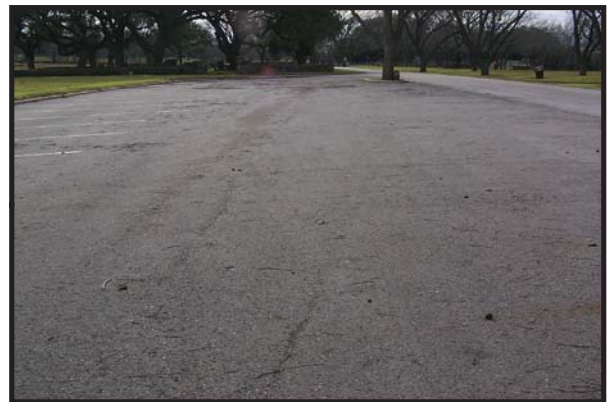
Route 0905

Route	Public / NonPublic	Date Visited	Area (sq ft)	Lane Miles *	Surface Type	Condition / PCR
0905	Public	12/18/2001	9773	0.17	AS	GOOD / 90

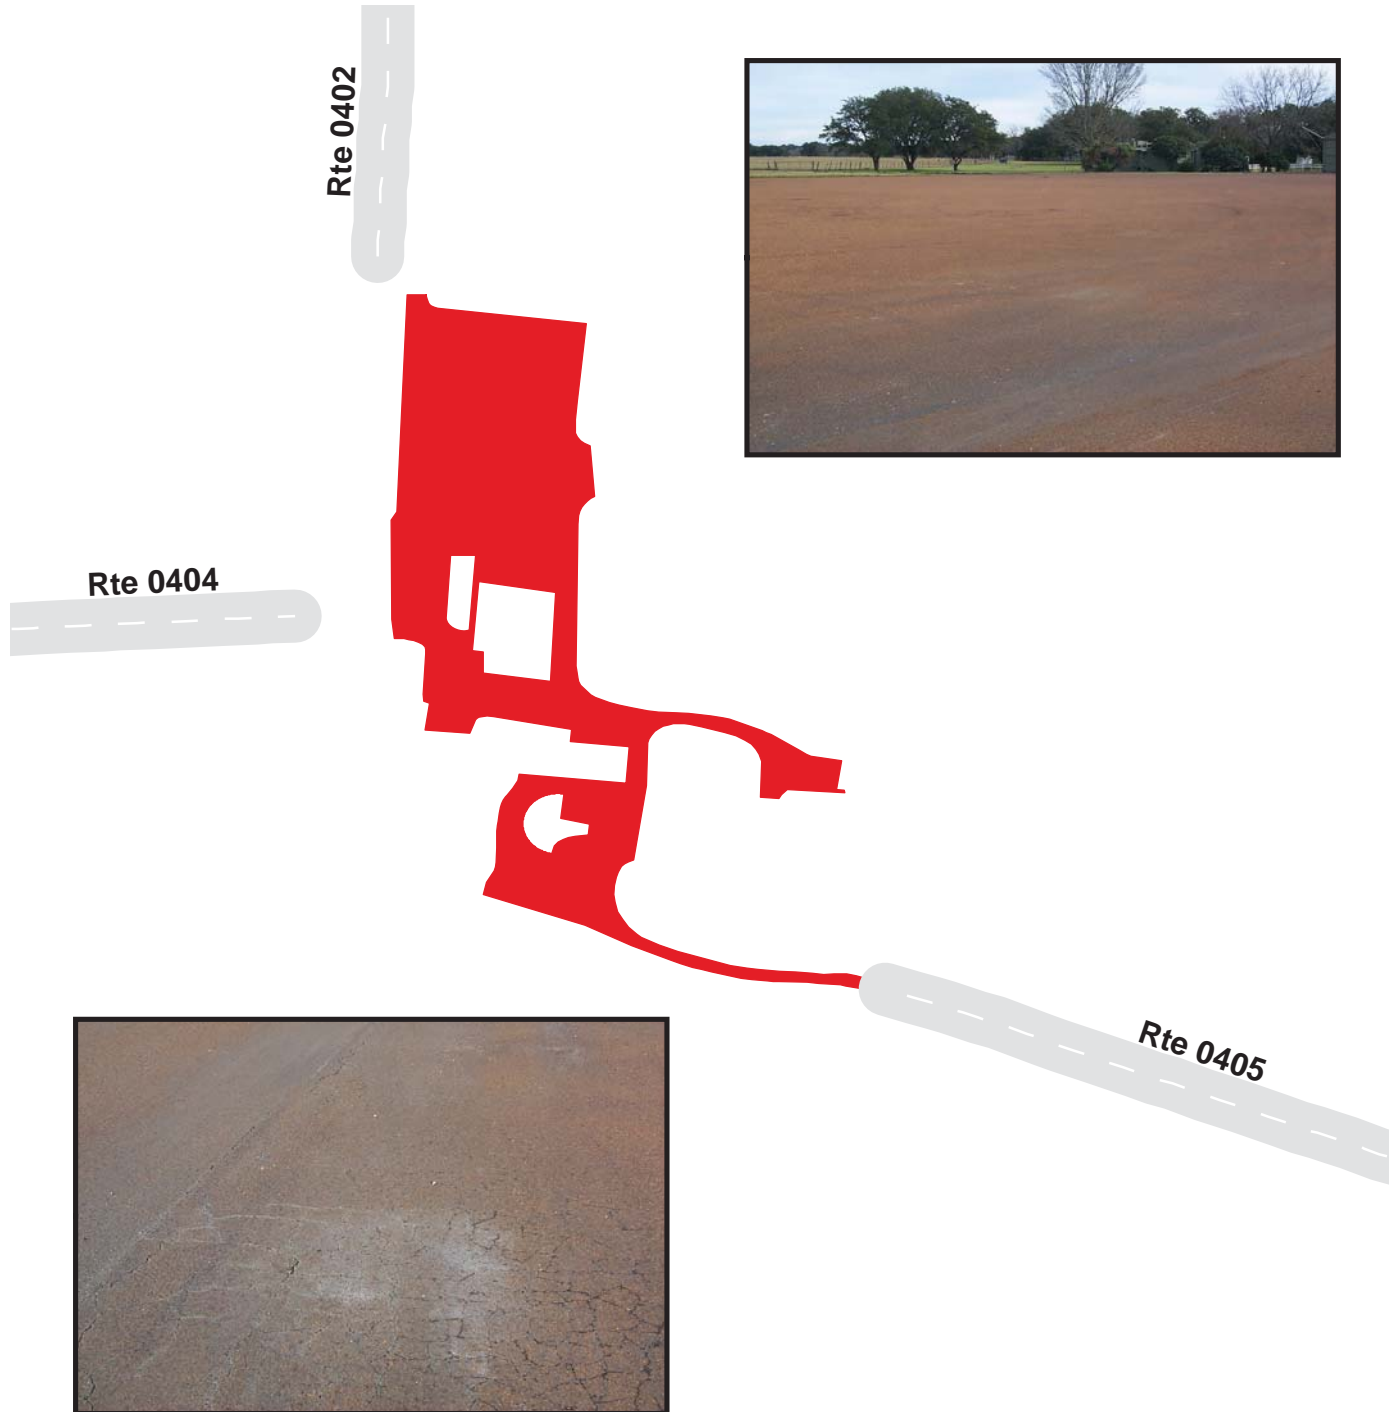
Route 0906

Route	Public / NonPublic	Date Visited	Area (sq ft)	Lane Miles *	Surface Type	Condition / PCR
0906	NonPublic	12/18/2001	92260	1.59	OC	GOOD / 90

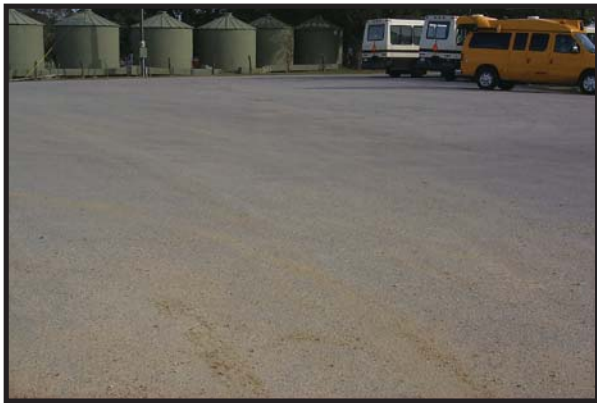
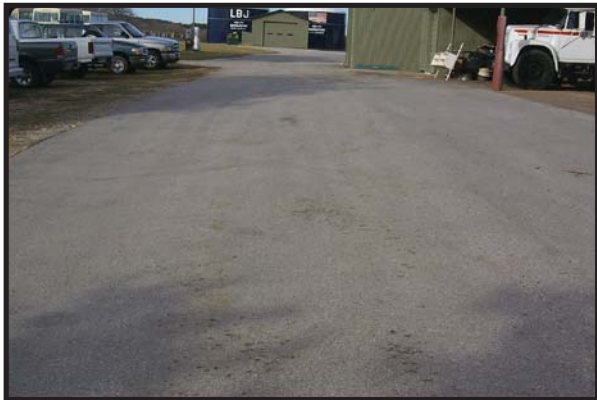
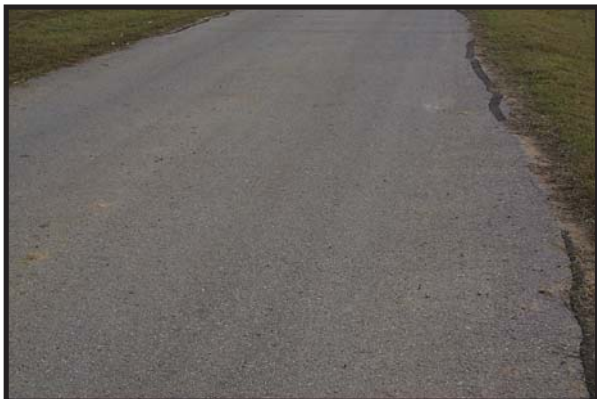
Route 0907

Route	Public / NonPublic	Date Visited	Area (sq ft)	Lane Miles *	Surface Type	Condition / PCR
0907	NonPublic	12/18/2001	53309	0.92	AS	FAIR / 73
