The Road Inventory of Mammoth Cave National Park MACA - 5530

Prepared By:
Federal Highway Administration
Eastern Federal Lands Highway Division
Cycle 3

Mammoth Cave National Park in Kentucky

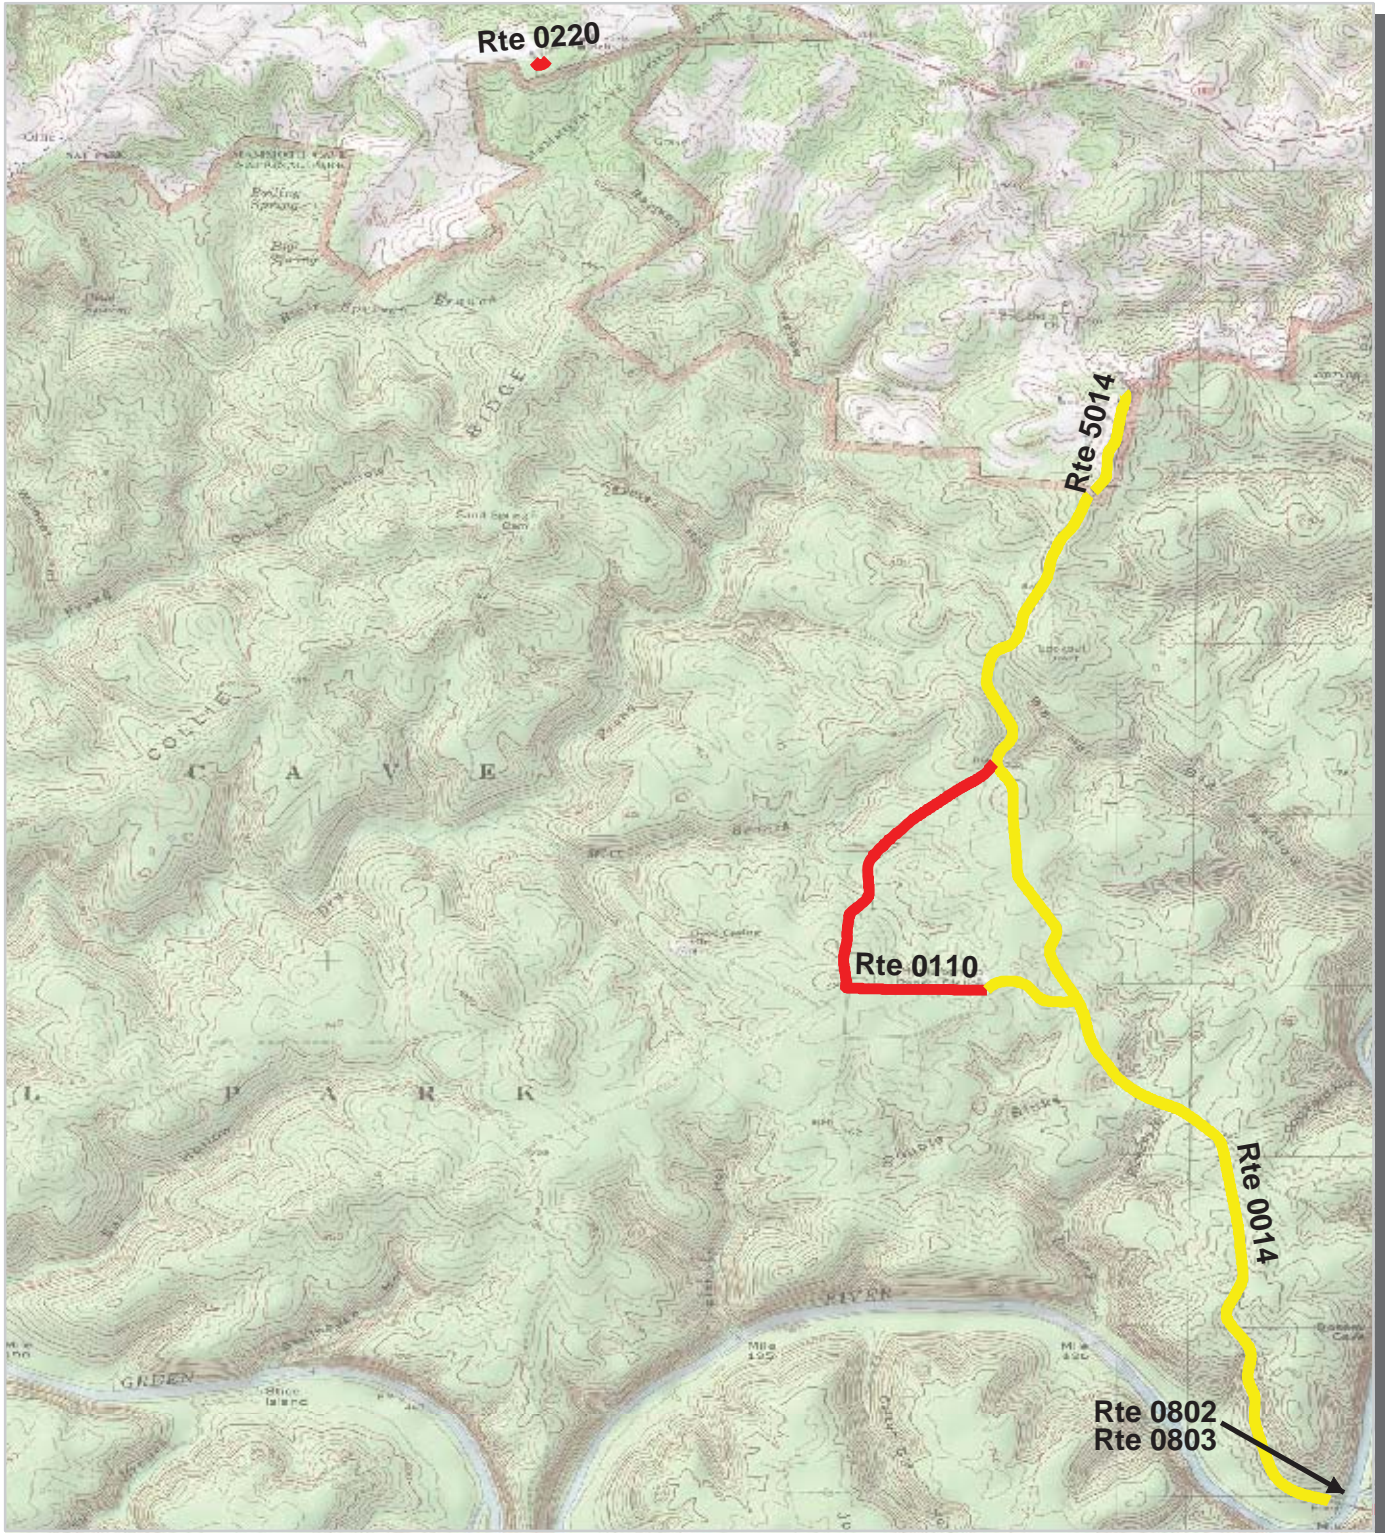
Mammoth Cave National Park Route Condition Area Map 2 PCR - Mile by Mile

PCR	Poor	Fair	Good	Excellent

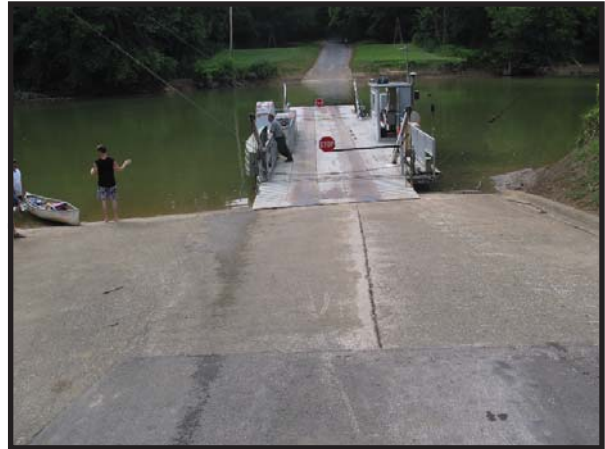
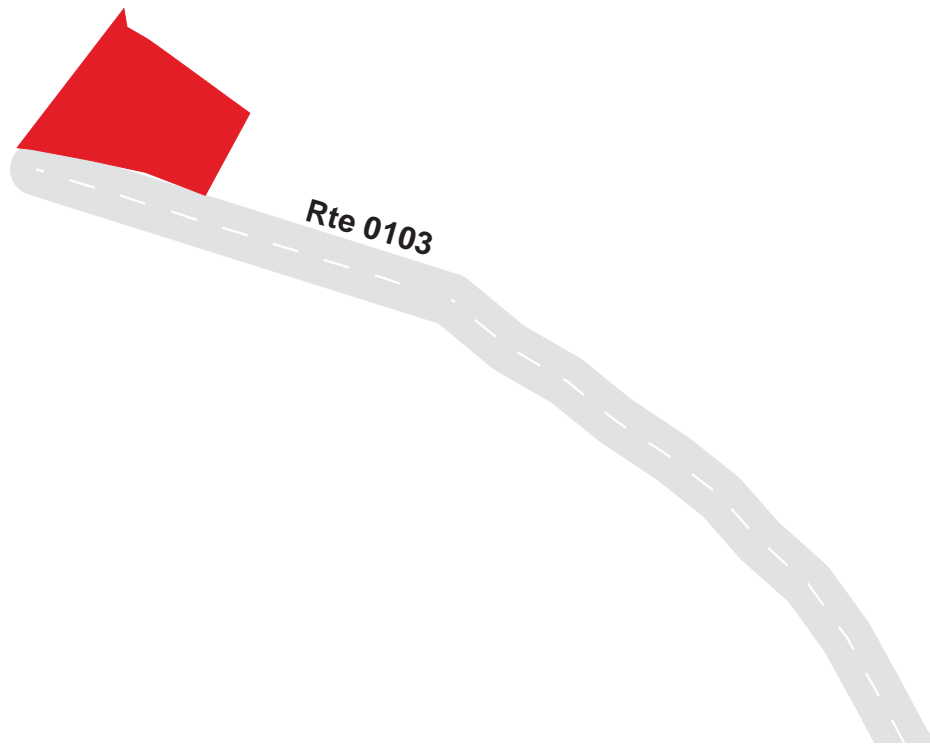
Mammoth Cave National Park
Route 0800
 HOUCHINS FERRY NORTH CROSSING RAMP #1
 At End of Route 0103

Route	Public / NonPublic	Date Visited	Area (sq ft)	Lane Miles *	Surface Type	Condition / PCR
0800	Public	7/2/2003	1420	0.02	CO	GOOD / 90

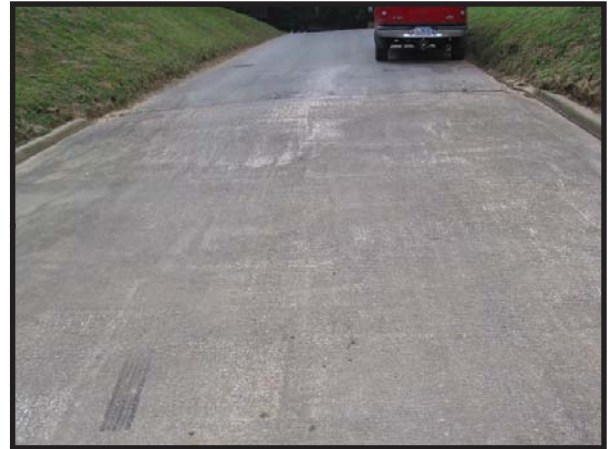
Mammoth Cave National Park
Route 0802
 GREEN RIVER FERRY CROSSING RAMP #2
 At End of Route 0014

Route	Public / NonPublic	Date Visited	Area (sq ft)	Lane Miles *	Surface Type	Condition / PCR
0802	Public	7/2/2003	610	0.01	CO	GOOD / 90

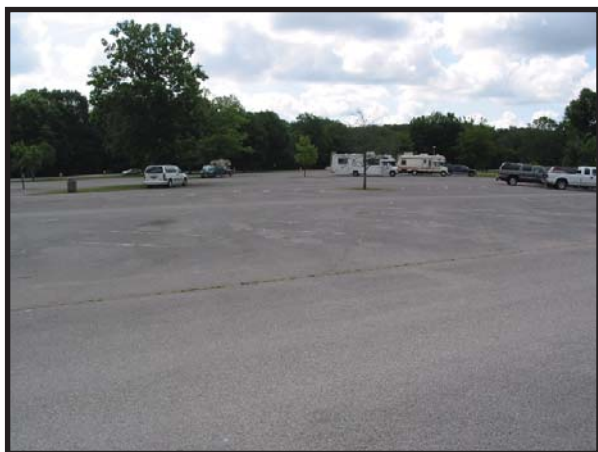
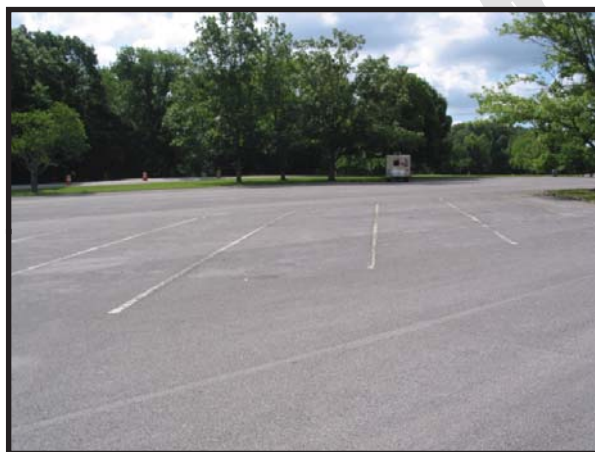
Mammoth Cave National Park
Route 0901B
HOTEL SERVICES AND PARK HQ PARKING
Adjacent To Route 0908

Route	Public / NonPublic	Date Visited	Area (sq ft)	Lane Miles *	Surface Type	Condition / PCR
0901B	NonPublic	7/2/2003	16057	0.28	AS	POOR / 45

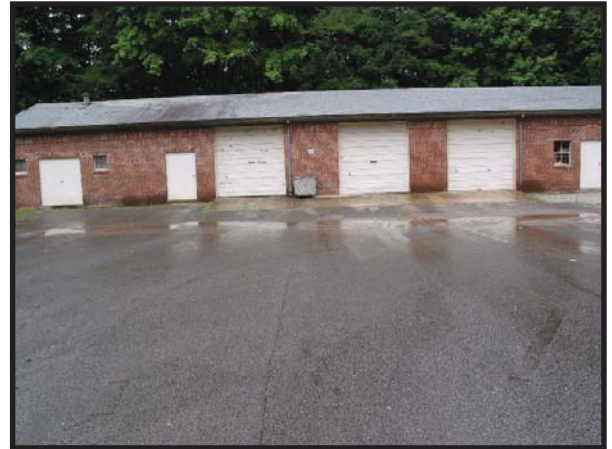
Mammoth Cave National Park
Route 0903A
 RANGER STATION PARKING AREA A
 Adjacent To Route 0417

Route	Public / NonPublic	Date Visited	Area (sq ft)	Lane Miles *	Surface Type	Condition / PCR
0903A	NonPublic	7/1/2003	9979	0.17	AS	GOOD / 90

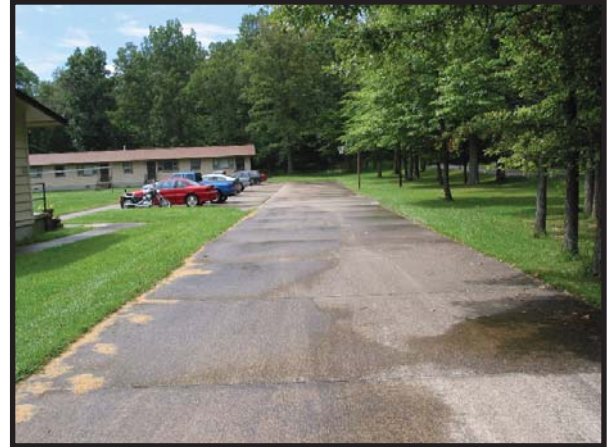
Mammoth Cave National Park
Route 0903C
 RANGER STATION PARKING AREA C
 Adjacent To Route 0903A

Route	Public / NonPublic	Date Visited	Area (sq ft)	Lane Miles *	Surface Type	Condition / PCR
0903C	NonPublic	7/1/2003	3829	0.07	CO	GOOD / 90

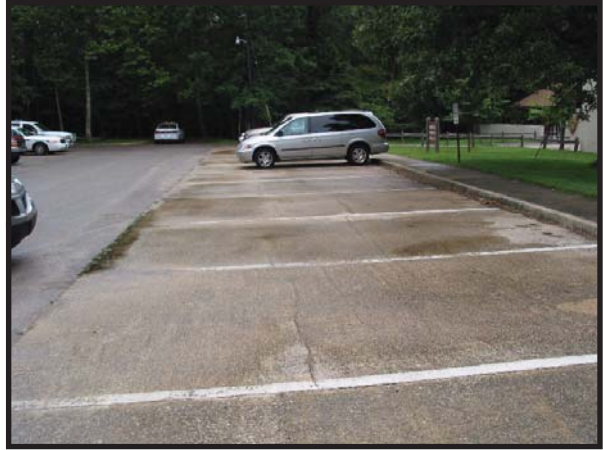
Mammoth Cave National Park
Route 0903D
 RANGER STATION PARKING AREA D
 Adjacent To Route 0417

Route	Public / NonPublic	Date Visited	Area (sq ft)	Lane Miles *	Surface Type	Condition / PCR
0903D	Public	7/1/2003	2834	0.05	CO	GOOD / 90

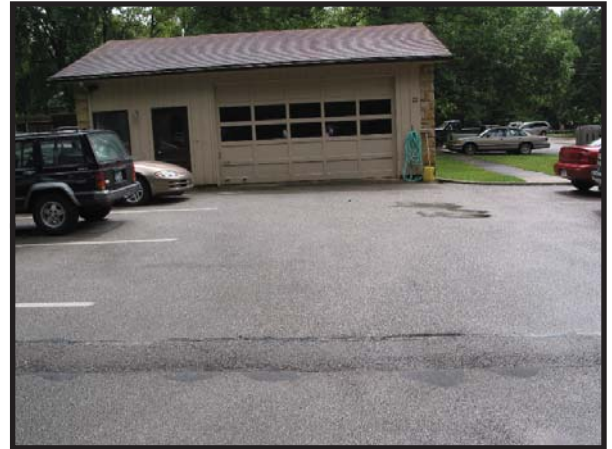
Mammoth Cave National Park
Route 0904A
 HOUCHINS FERRY ROAD SOUTH PARKING
 Adjacent To Route 0103 near End on Right

Route	Public / NonPublic	Date Visited	Area (sq ft)	Lane Miles *	Surface Type	Condition / PCR
0904A	Public	7/1/2003	1603	0.03	AS	GOOD / 90

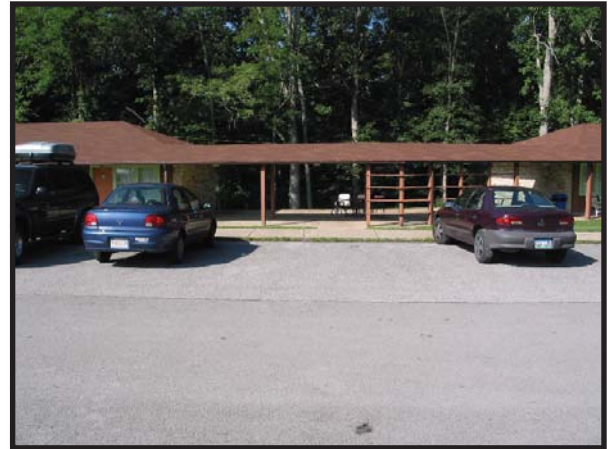
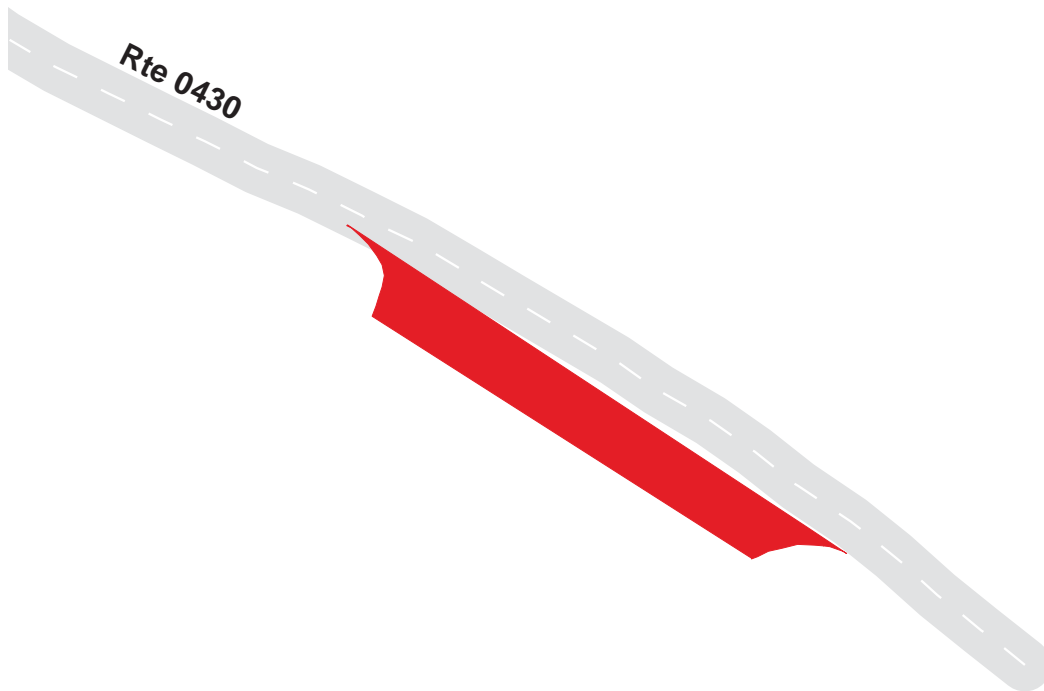
Route 0906A

Route	Public / NonPublic	Date Visited	Area (sq ft)	Lane Miles *	Surface Type	Condition / PCR
0906A	Public	7/2/2003	2377	0.04	AS	FAIR / 73

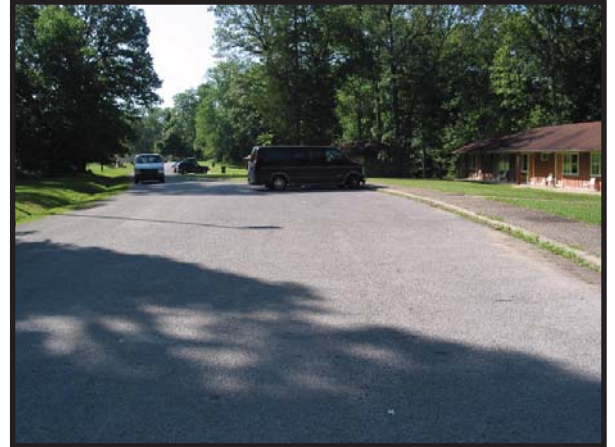
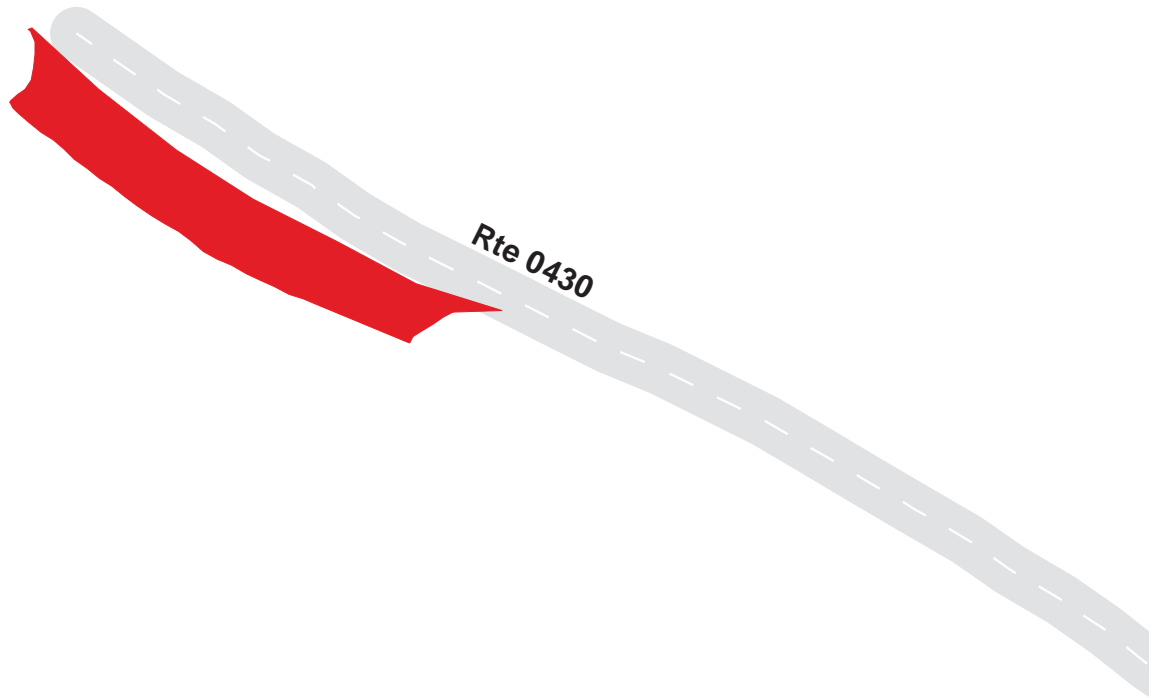
Route 0906B

Route	Public / NonPublic	Date Visited	Area (sq ft)	Lane Miles *	Surface Type	Condition / PCR
0906B	Public	7/2/2003	2648	0.05	AS	FAIR / 73

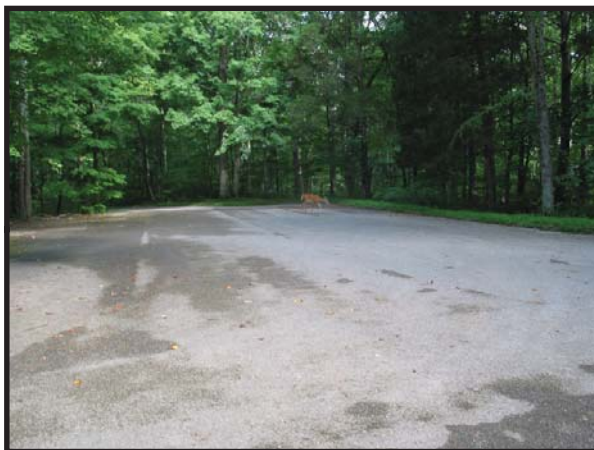
Mammoth Cave National Park
Route 0907B
 PICNIC SHELTER PARKING B
 Adjacent To Route 0203 at MP 0.02 on Left

Route	Public / NonPublic	Date Visited	Area (sq ft)	Lane Miles *	Surface Type	Condition / PCR
0907B	Public	7/2/2003	2323	0.04	AS	GOOD / 90

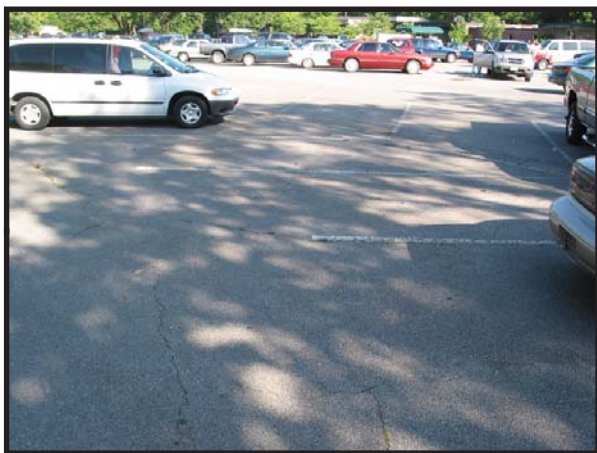
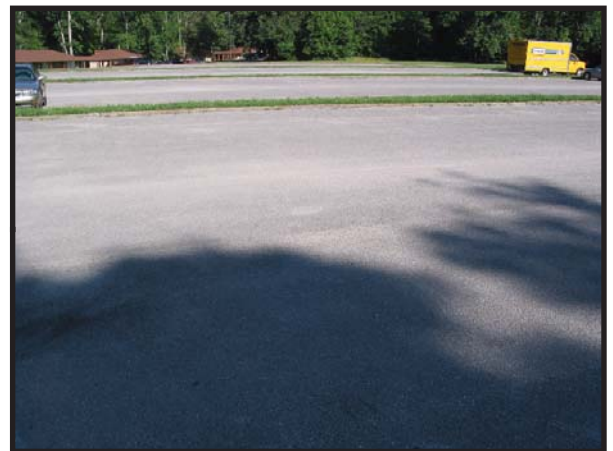
Mammoth Cave National Park
Route 0909
 SLOANS CROSSING PICNIC/POND PARKING
 Adjacent To Route 0010 at MP 2.5

Route	Public / NonPublic	Date Visited	Area (sq ft)	Lane Miles *	Surface Type	Condition / PCR
0909	Public	7/1/2003	9386	0.16	AS	GOOD / 90

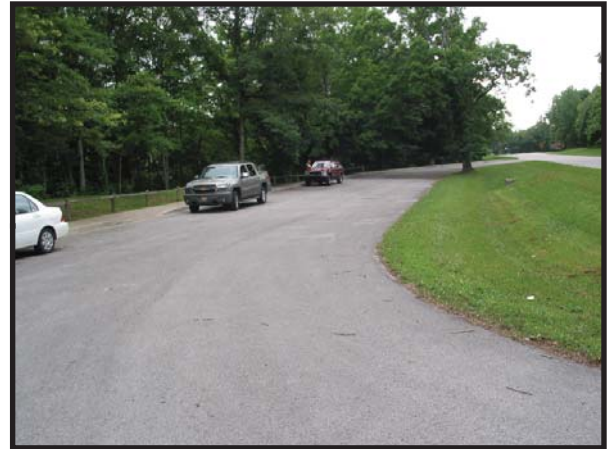
Mammoth Cave National Park
Route 0911
 SOUTH ENTRANCE SIGN PARKING
 Adjacent To Route 0020 at MP 0.4 on Right

Route	Public / NonPublic	Date Visited	Area (sq ft)	Lane Miles *	Surface Type	Condition / PCR
0911	Public	7/1/2003	9751	0.17	AS	GOOD / 90

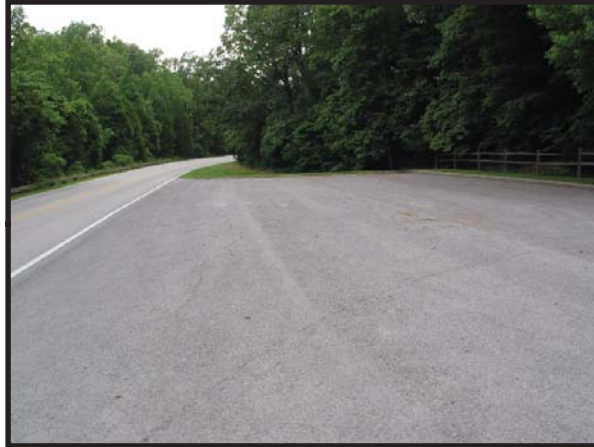
Mammoth Cave National Park
Route 0913
 SAND CAVE PARKING
 Adjacent To Route 0016 at MP 0.15 on Right

Route	Public / NonPublic	Date Visited	Area (sq ft)	Lane Miles *	Surface Type	Condition / PCR
0913	Public	7/1/2003	6313	0.11	AS	GOOD / 90

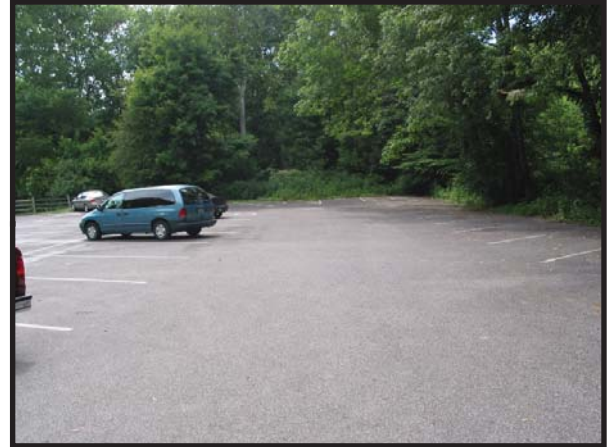
Mammoth Cave National Park
Route 0919
 CEDAR SINK TRAILHEAD PARKING
 Adjacent To Route 0102 at MP 0.57 on Left

Route	Public / NonPublic	Date Visited	Area (sq ft)	Lane Miles *	Surface Type	Condition / PCR
0919	Public	7/1/2003	5798	0.10	AS	GOOD / 90

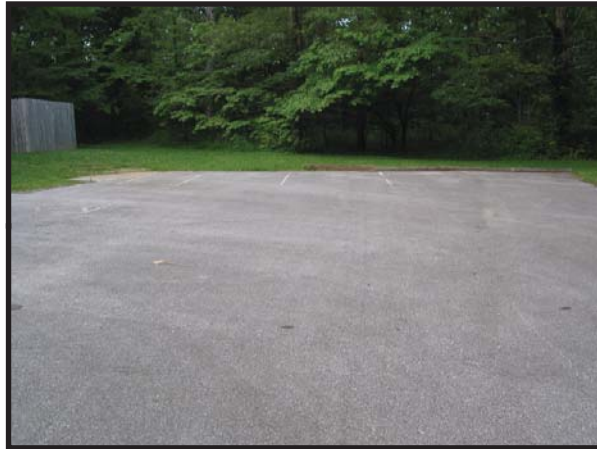
Mammoth Cave National Park
Route 0931A
 PICNIC GROUNDS PARKING AREA A
 Adjacent To Route 0202 at MP 0.10 on Left

Route	Public / NonPublic	Date Visited	Area (sq ft)	Lane Miles *	Surface Type	Condition / PCR
0931A	Public	7/2/2003	1147	0.02	AS	GOOD / 90

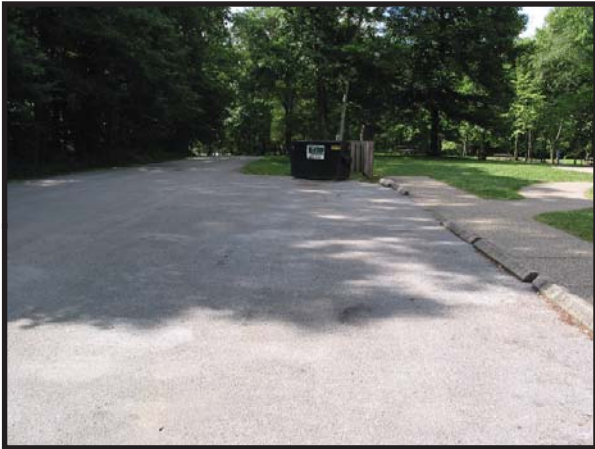
Mammoth Cave National Park
Route 0931B
 PICNIC GROUNDS PARKING AREA B
 Adjacent To Route 0202 at MP 0.11 on Left

Route	Public / NonPublic	Date Visited	Area (sq ft)	Lane Miles *	Surface Type	Condition / PCR
0931B	Public	7/2/2003	1039	0.02	AS	GOOD / 90

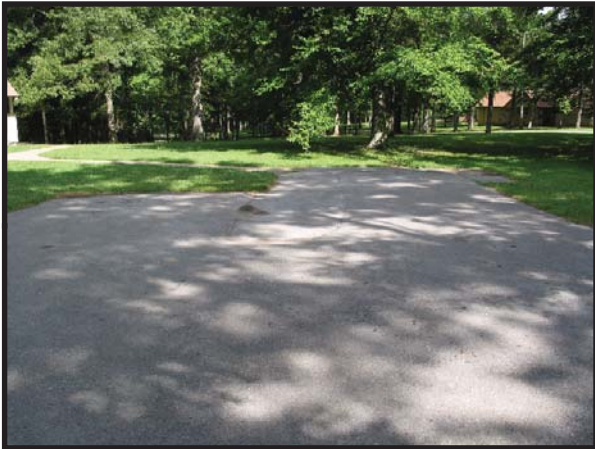
Mammoth Cave National Park
Route 0931C
 PICNIC GROUNDS PARKING AREA C
 Adjacent To Route 0202 at MP 0.21 on Left

Route	Public / NonPublic	Date Visited	Area (sq ft)	Lane Miles *	Surface Type	Condition / PCR
0931C	Public	7/2/2003	3454	0.06	AS	GOOD / 90

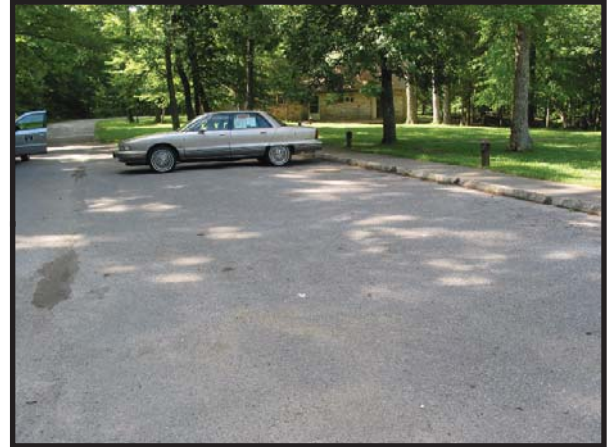
Mammoth Cave National Park
Route 0931D
 PICNIC GROUNDS PARKING AREA D
 Adjacent To Route 0202 at MP 0.23 on Left

Route	Public / NonPublic	Date Visited	Area (sq ft)	Lane Miles *	Surface Type	Condition / PCR
0931D	Public	7/2/2003	1479	0.03	AS	GOOD / 90

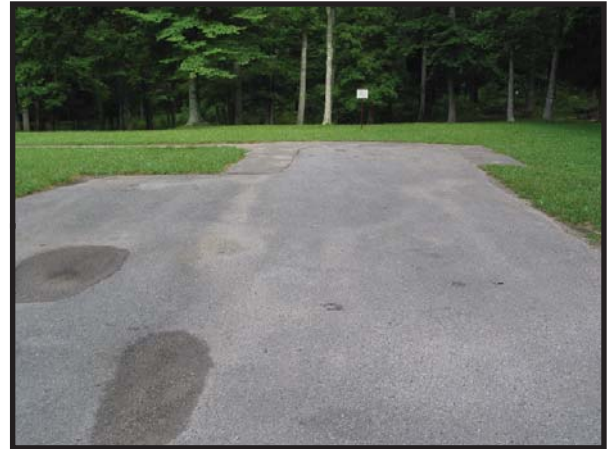
Mammoth Cave National Park
Route 0931E
 PICNIC GROUNDS PARKING AREA E
 Adjacent To Route 0202 at MP 0.40 on Left

Route	Public / NonPublic	Date Visited	Area (sq ft)	Lane Miles *	Surface Type	Condition / PCR
0931E	Public	7/2/2003	2277	0.04	AS	GOOD / 90

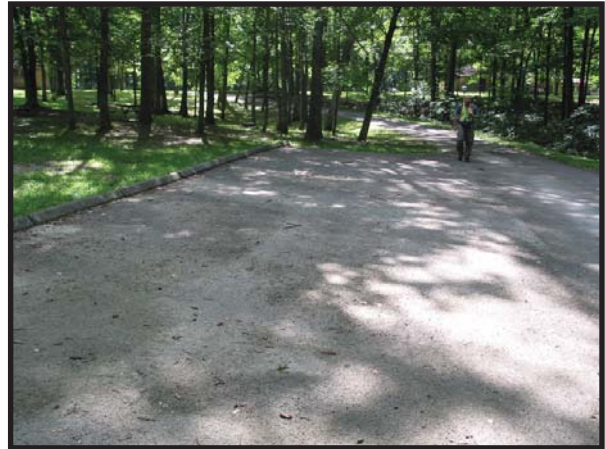
Route 0949

Route	Public / NonPublic	Date Visited	Area (sq ft)	Lane Miles *	Surface Type	Condition / PCR
0949	Public	7/2/2003	4003	0.07	AS	FAIR / 73
