**The Road Inventory
of
Martin Luther King Jr. National Historic Site
MALU - 5560**

Road Inventory Program

Prepared By:
Federal Highway Administration
Eastern Federal Lands Highway Division
Cycle 3

Martin Luther King Jr. National Historic Site in Georgia

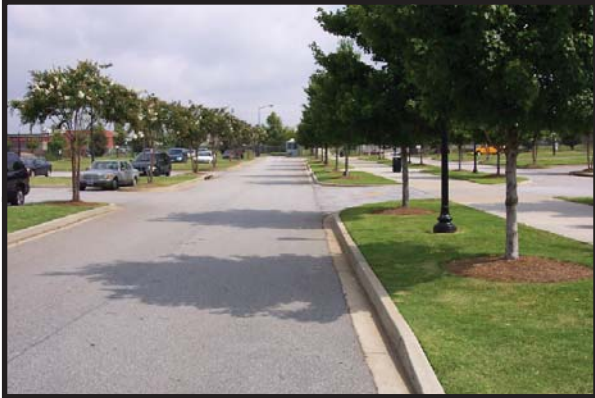
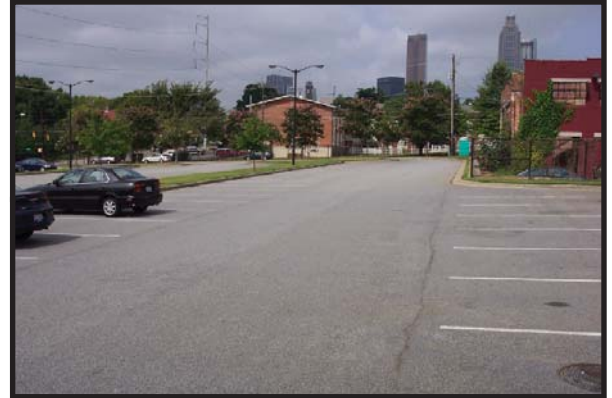
Route 0900

Visitor Center Parking
From John Wesley Dobbs Avenue

Route	Public / NonPublic	Date Visited	Area (sq ft)	Lane Miles *	Surface Type	Condition / PCR
0900	Public	8/16/2004	85636	1.47	AS	GOOD / 90

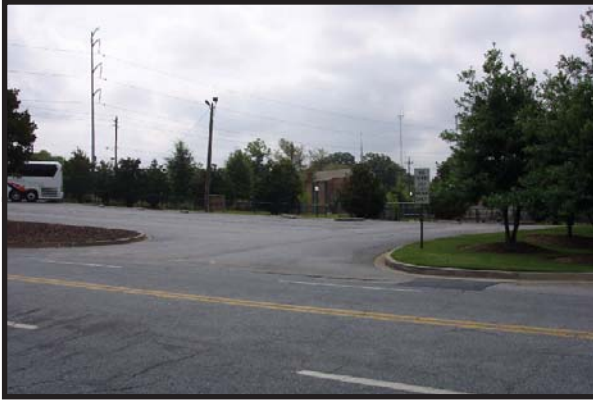
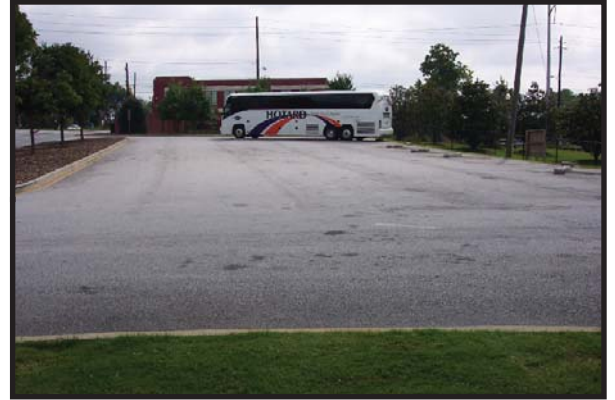
Route 0901

Bus Parking Area A

From John Wesley Dobbs Avenue

Route	Public / NonPublic	Date Visited	Area (sq ft)	Lane Miles *	Surface Type	Condition / PCR
0901	Public	8/16/2004	12573	0.22	AS	GOOD / 90

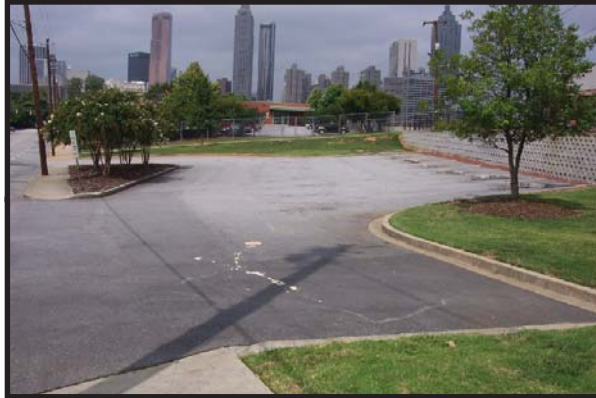
Route 0902

Bus Parking Area B

From John Wesley Dobbs Avenue

Route	Public / NonPublic	Date Visited	Area (sq ft)	Lane Miles *	Surface Type	Condition / PCR
0902	Public	8/16/2004	9473	0.16	AS	GOOD / 90
