The Road Inventory of Manzanar National Historic Site MANZ – 8760

Road Inventory Program

Prepared By:
Federal Highway Administration
Eastern Federal Lands Highway Division
Cycle 3

Manzanar National Historic Site in California

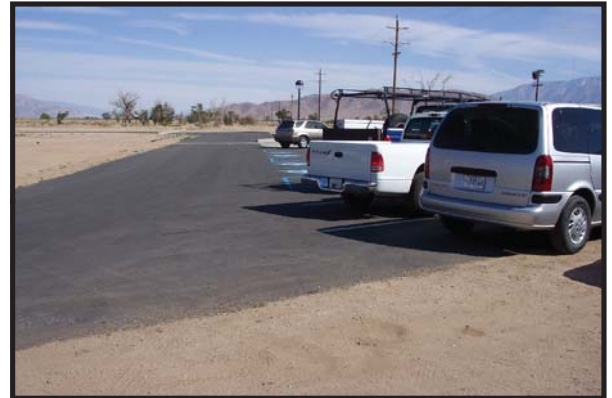
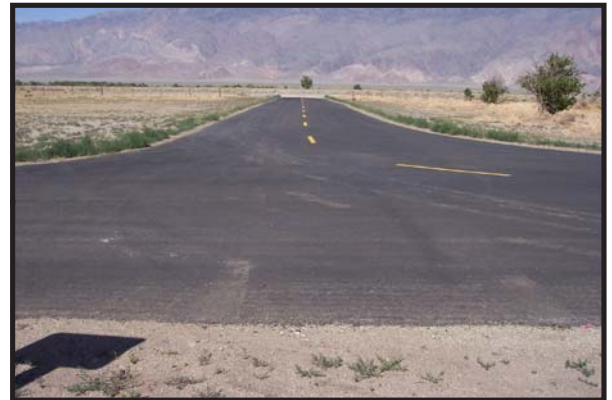
Route 0900

Visitor Center Parking
From Route 0010

Route	Public / NonPublic	Date Visited	Area (sq ft)	Lane Miles *	Surface Type	Condition / PCR
0900	Public	5/18/2004	117754	2.03	AS	GOOD / 90
