**The Road Inventory  
of  
Martin Van Buren National Historic Site  
MAVA – 1950**

**Road Inventory Program**

Prepared By:  
Federal Highway Administration  
Eastern Federal Lands Highway Division  
Cycle 3

# Martin Van Buren National Historic Site in New York

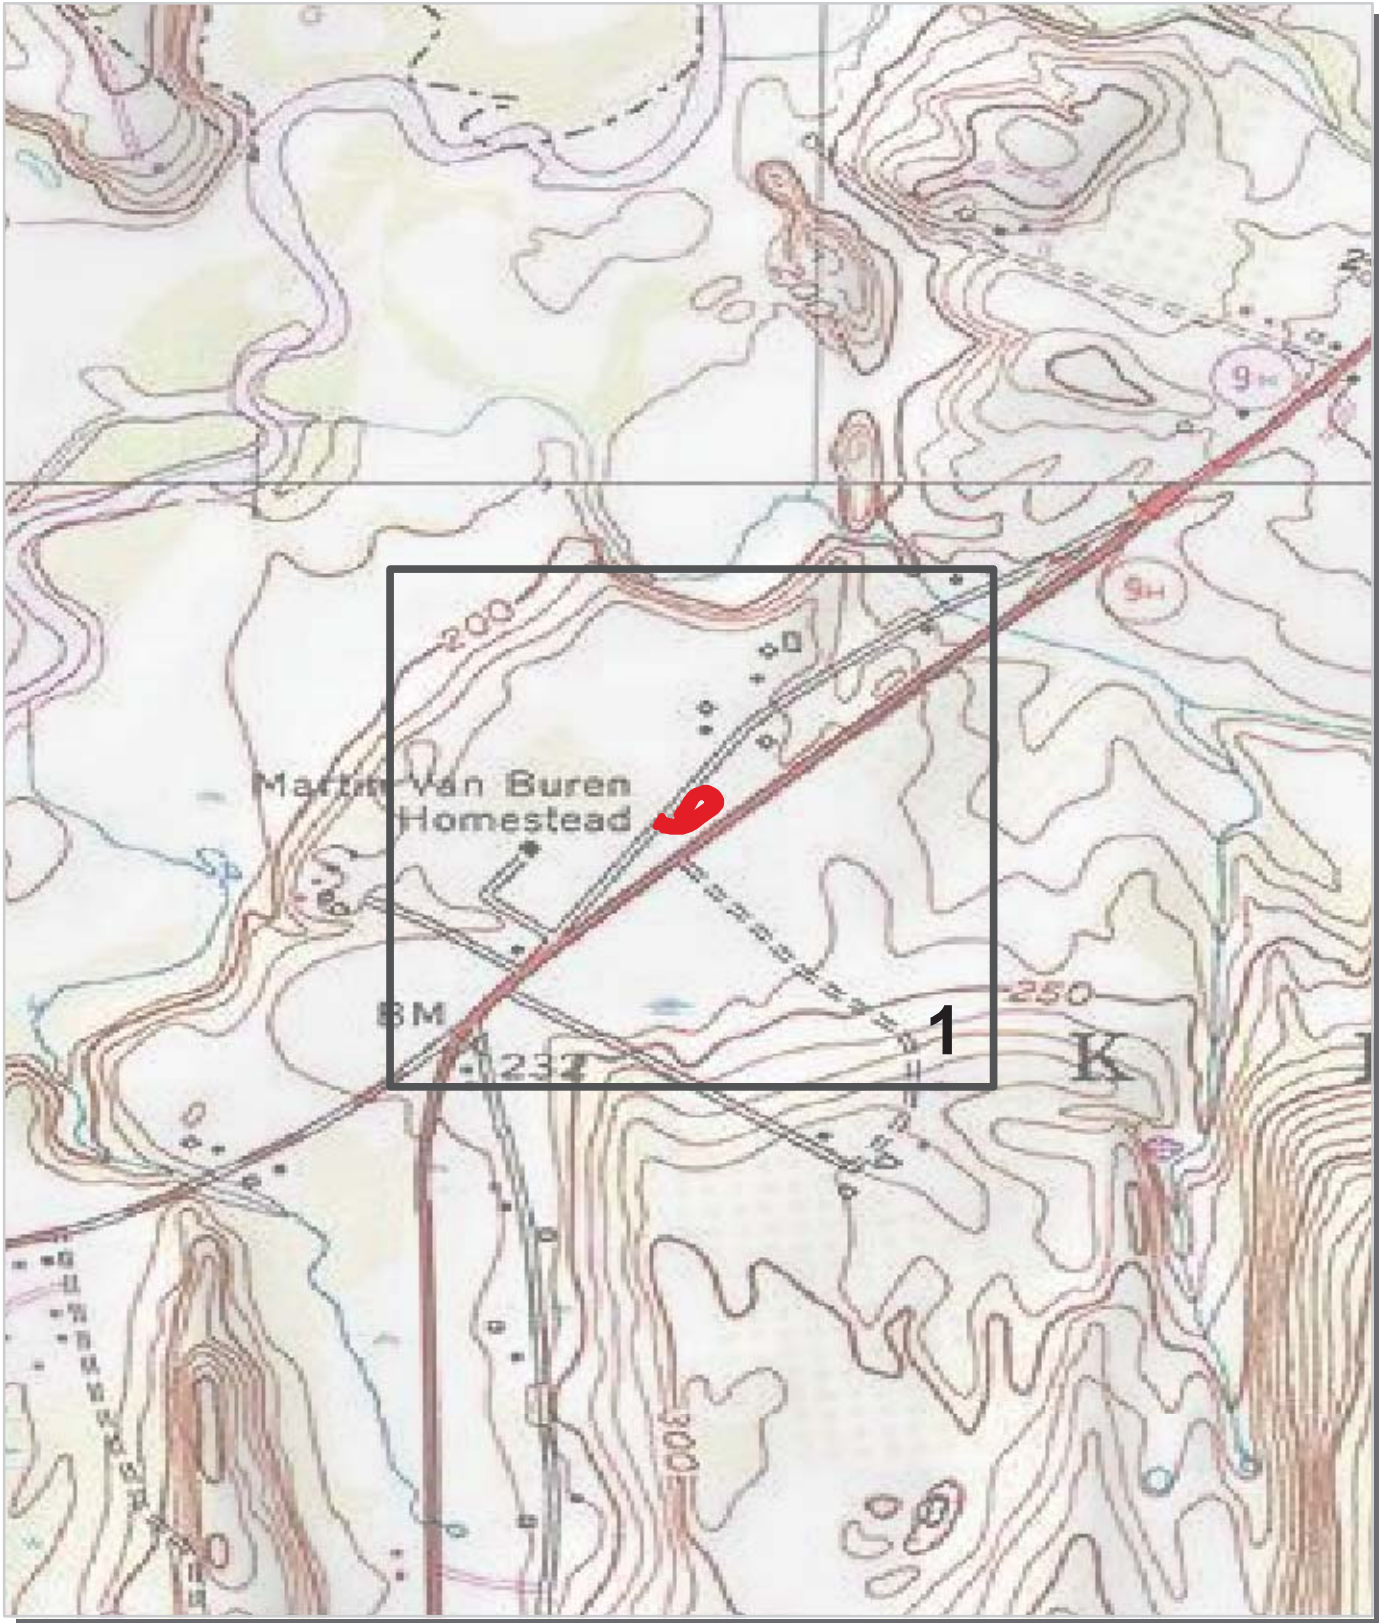
# Martin Van Buren National Historic Site Route Location Key Map

Park Owned Routes

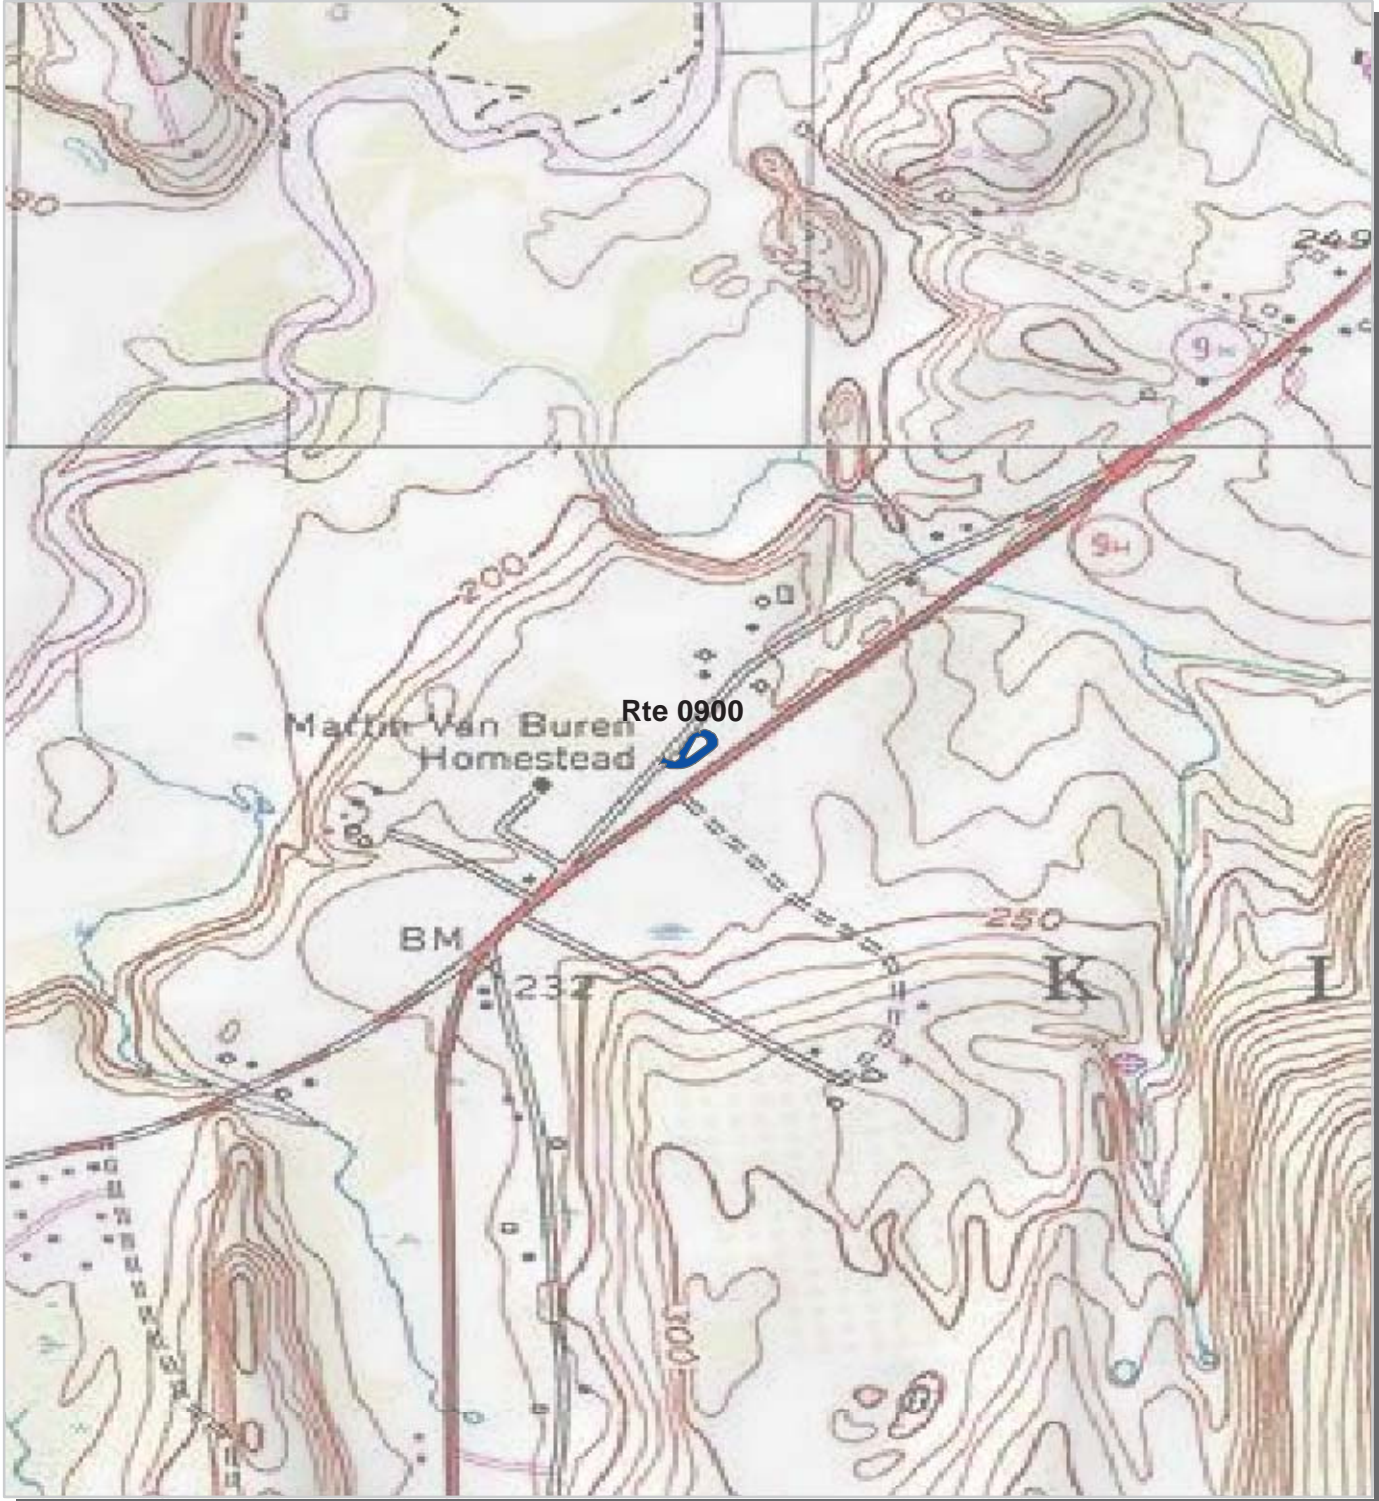
# Martin Van Buren National Historic Site Route Condition Key Map PCR - Mile by Mile

PCR	Poor	<span style="display: inline-block; width: 20px; height: 10px; background-color: red; border: 1px solid black;"></span>	Fair	<span style="display: inline-block; width: 20px; height: 10px; background-color: yellow; border: 1px solid black;"></span>	Good	<span style="display: inline-block; width: 20px; height: 10px; background-color: green; border: 1px solid black;"></span>	Excellent	<span style="display: inline-block; width: 20px; height: 10px; background-color: blue; border: 1px solid black;"></span>
	(<=60)		(61 - 84)		(85 - 94)		(95 - 100)

\* If the PCR rating is not available for a section, the SCR rating will be displayed. See appendix for definitions and formulas.

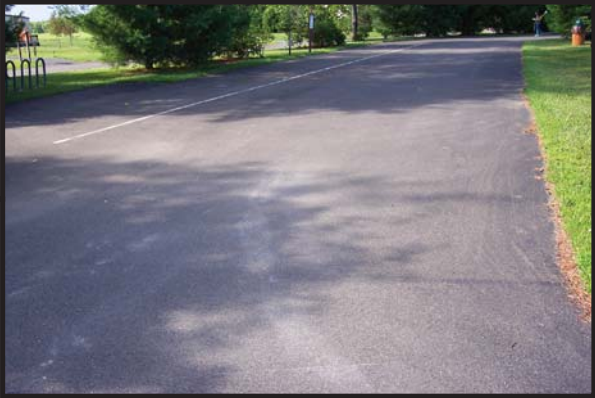
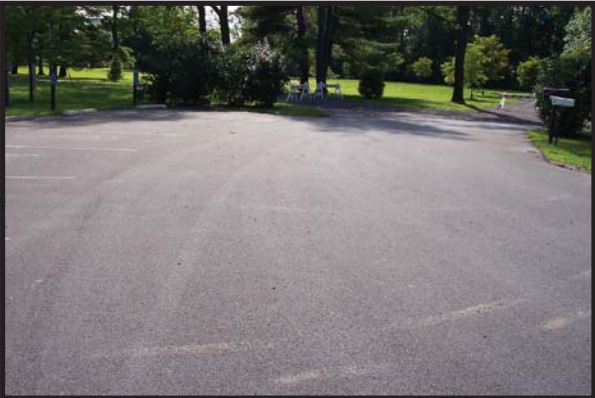
## Route 0900

Visitor Parking  
From Route 0010

Route	Public / NonPublic	Date Visited	Area (sq ft)	Lane Miles *	Surface Type	Condition / PCR
0900	Public	7/16/2004	20073	0.35	AS	EXCELLENT / 97
