# The Road Inventory of Mesa Verde National Park MEVE - 1490

## Road Inventory Program

Prepared By:  
Federal Highway Administration  
Eastern Federal Lands Highway Division  
Cycle 3

# Mesa Verde National Park in Colorado

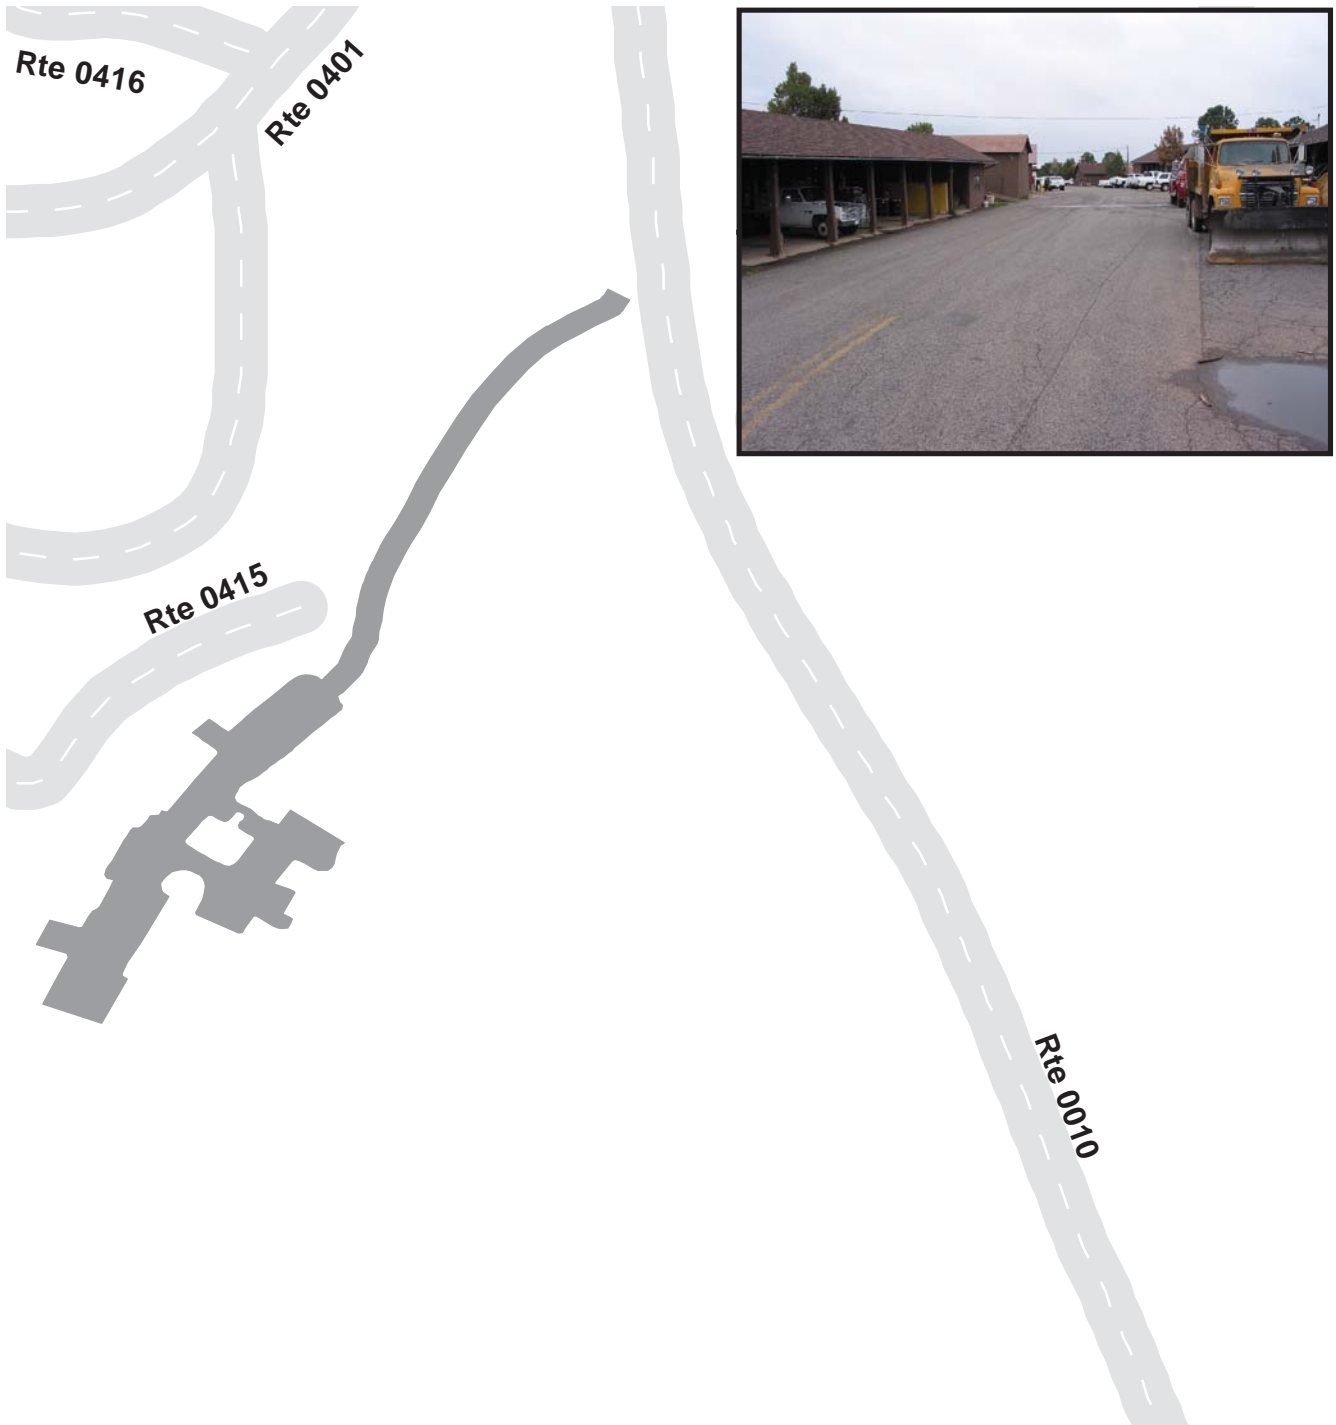
Route	Length (mi)	Width (ft)	Area (sq ft)	Lane Miles *	Condition / PCR	Surface Type
0400	0.46	0.00	44535	0.77	FAIR / 73	AS

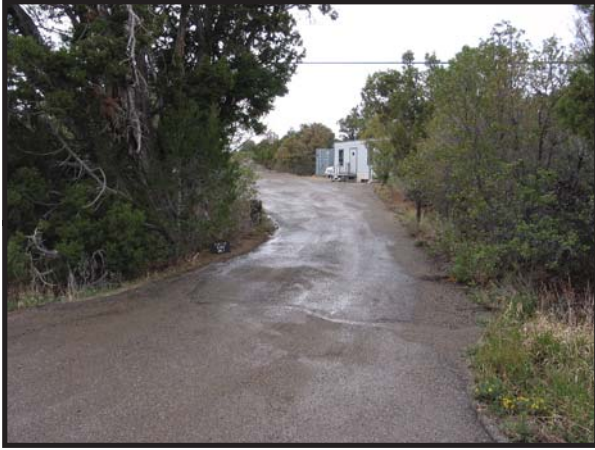
## Route 0413

Route	Length (mi)	Width (ft)	Area (sq ft)	Lane Miles *	Condition / PCR	Surface Type
0413	0.33	0.00	20079	0.35	FAIR / 73	NC

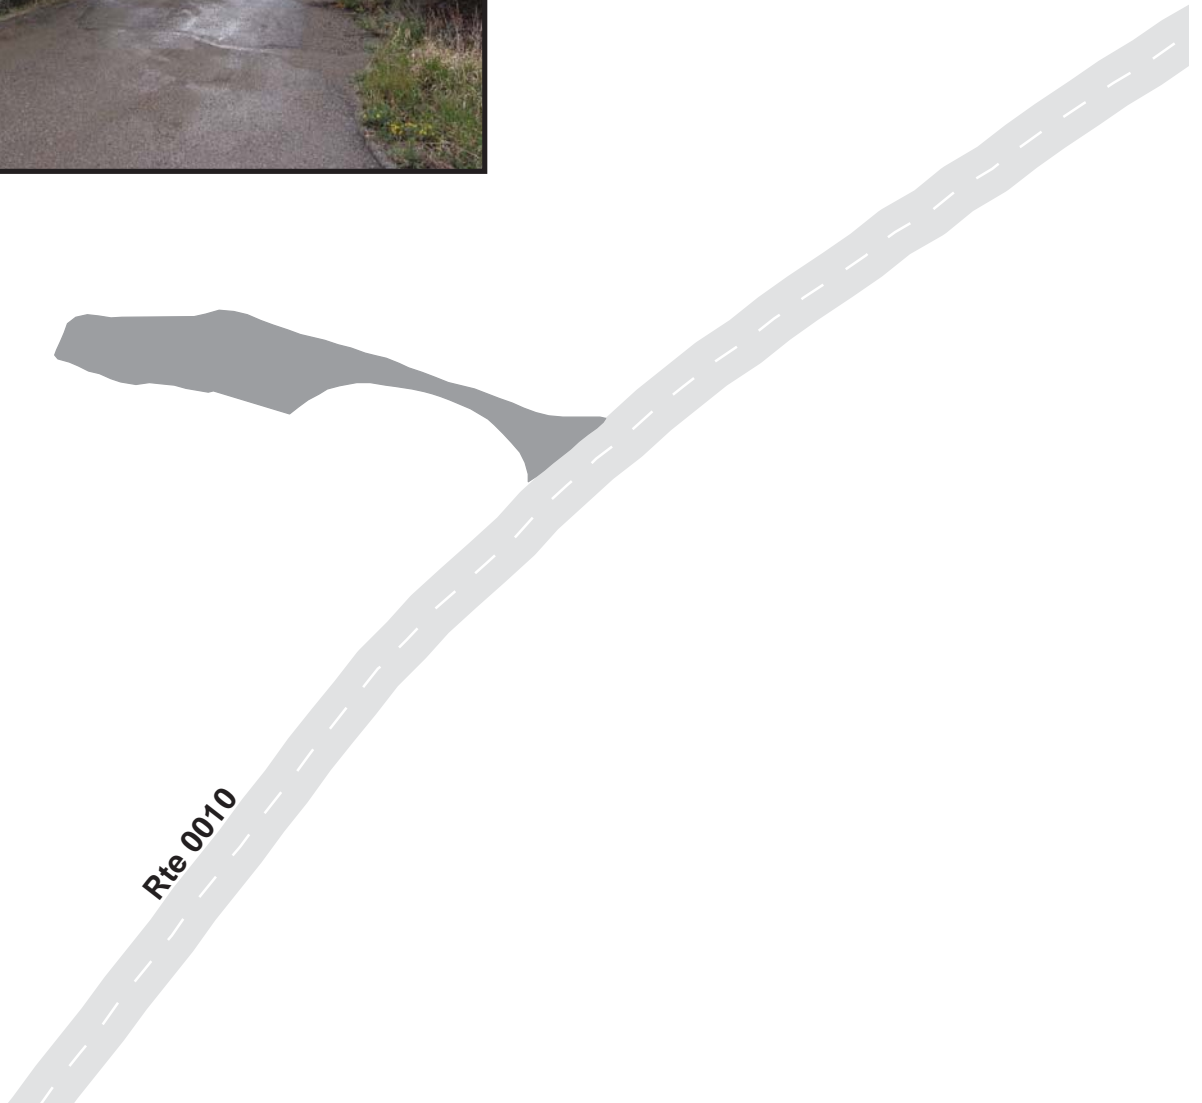
**Mesa Verde National Park**  
**Route 0406**  
 Pump Station Road  
 From Route 0010 at MP 0.7 on Right

Route	Length (mi)	Width (ft)	Area (sq ft)	Lane Miles *	Condition / PCR	Surface Type
0406	0.08	0.00	5034	0.09	GOOD / 90	AS

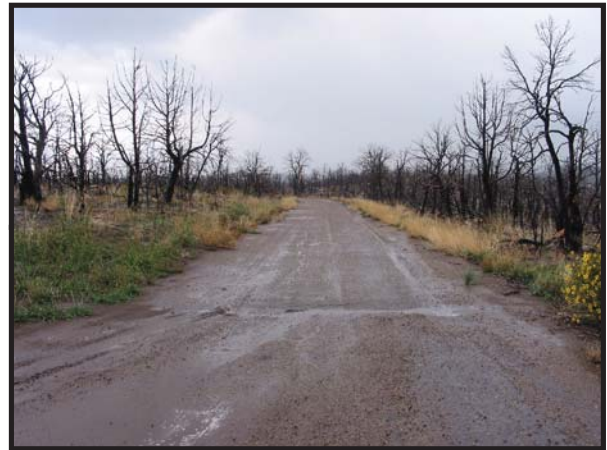
## Route 0900

Route	Public / NonPublic	Date Visited	Area (sq ft)	Lane Miles *	Surface Type	Condition / PCR
0900	Public	10/2/2002	34004	0.59	AS	GOOD / 90

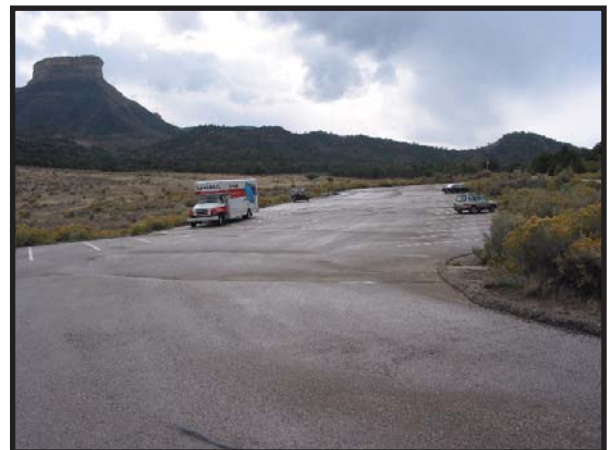
## Route 0901

Route	Public / NonPublic	Date Visited	Area (sq ft)	Lane Miles *	Surface Type	Condition / PCR
0901	NonPublic	10/2/2002	4801	0.08	AS	GOOD / 90

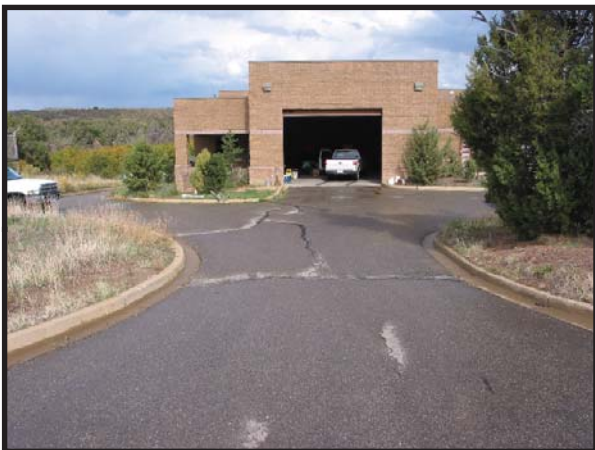
## Route 0902

Route	Public / NonPublic	Date Visited	Area (sq ft)	Lane Miles *	Surface Type	Condition / PCR
0902	Public	10/2/2002	10827	0.19	AS	GOOD / 90

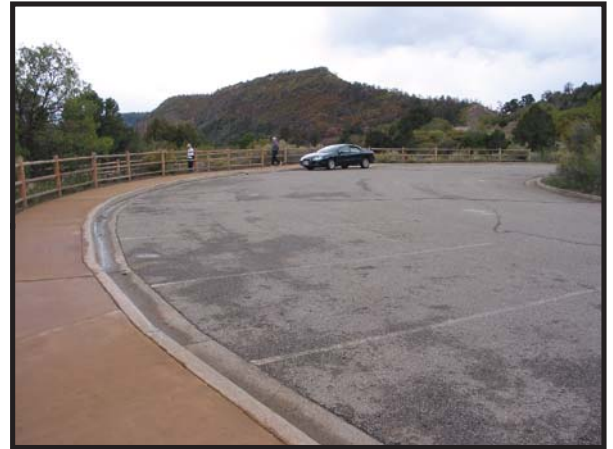
## Route 0903

Route	Public / NonPublic	Date Visited	Area (sq ft)	Lane Miles *	Surface Type	Condition / PCR
0903	Public	10/2/2002	6664	0.11	OC	FAIR / 73

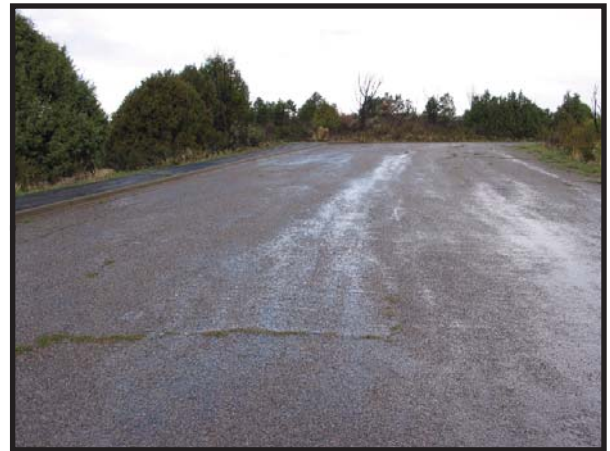
## Route 0904

Route	Public / NonPublic	Date Visited	Area (sq ft)	Lane Miles *	Surface Type	Condition / PCR
0904	Public	10/2/2002	9624	0.17	AS	FAIR / 73

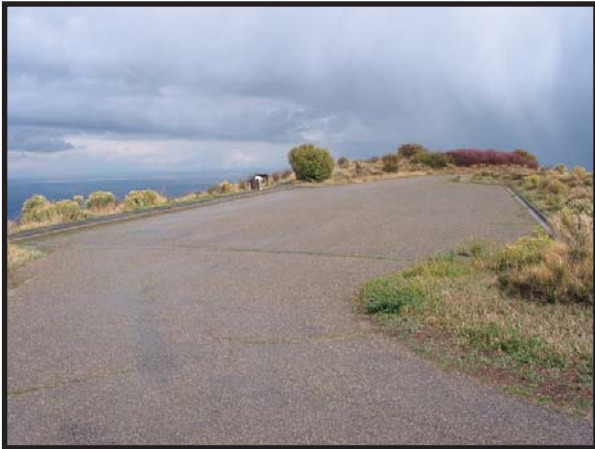
## Route 0905

Route	Public / NonPublic	Date Visited	Area (sq ft)	Lane Miles *	Surface Type	Condition / PCR
0905	Public	10/2/2002	9366	0.16	AS	FAIR / 73

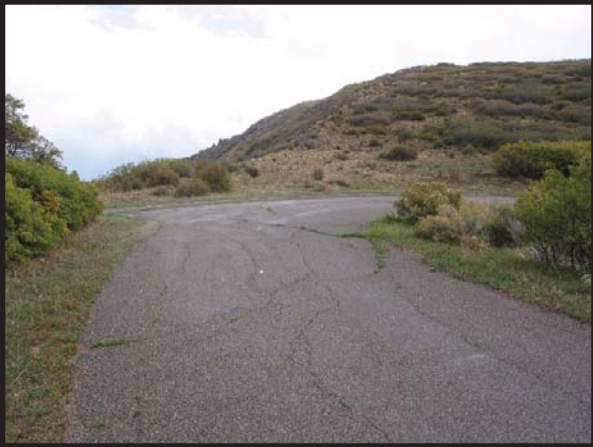
## Route 0906

Route	Public / NonPublic	Date Visited	Area (sq ft)	Lane Miles *	Surface Type	Condition / PCR
0906	Public	10/2/2002	7073	0.12	AS	FAIR / 73

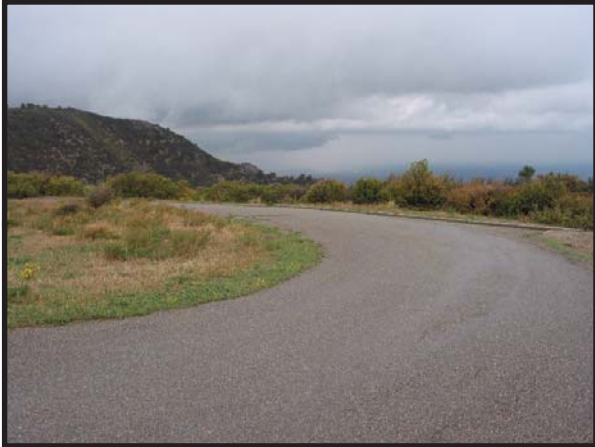
## Route 0907

Route	Public / NonPublic	Date Visited	Area (sq ft)	Lane Miles *	Surface Type	Condition / PCR
0907	Public	10/2/2002	9856	0.17	AS	FAIR / 73

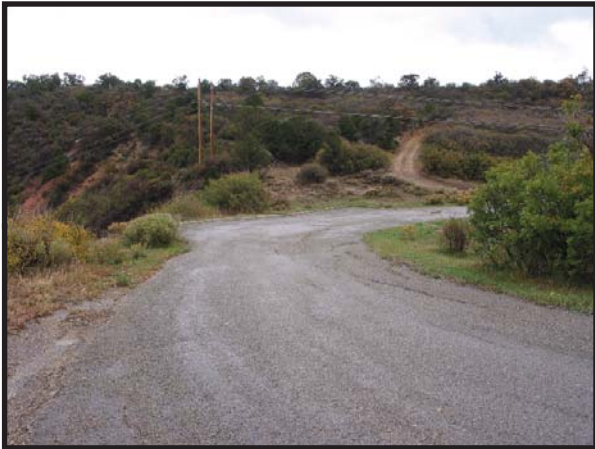
## Route 0908

Route	Public / NonPublic	Date Visited	Area (sq ft)	Lane Miles *	Surface Type	Condition / PCR
0908	Public	10/4/2002	84035	1.45	AS	POOR / 45

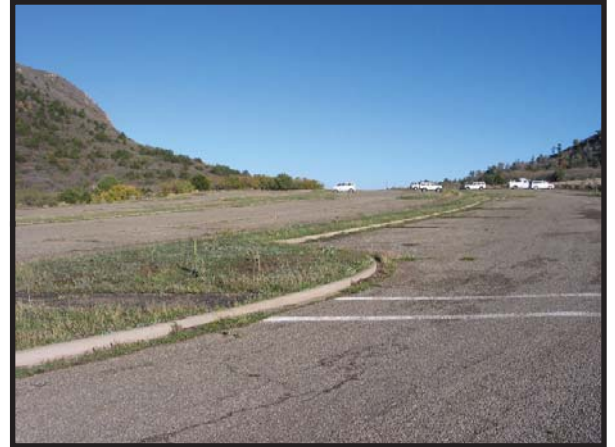
## Route 0909

Route	Public / NonPublic	Date Visited	Area (sq ft)	Lane Miles *	Surface Type	Condition / PCR
0909	Public	10/4/2002	12471	0.21	AS	FAIR / 73

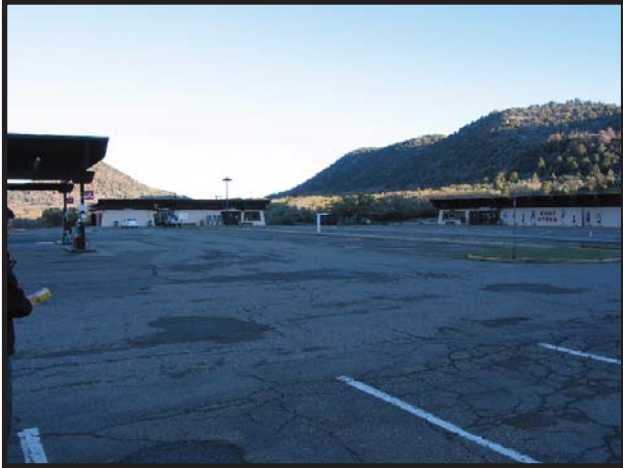
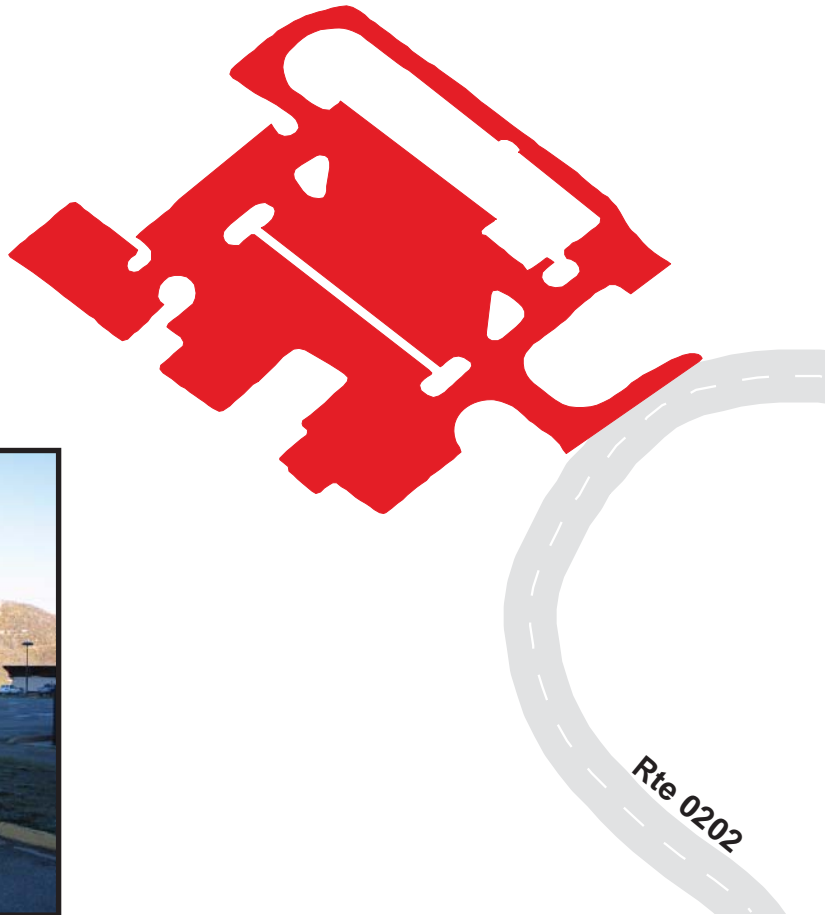
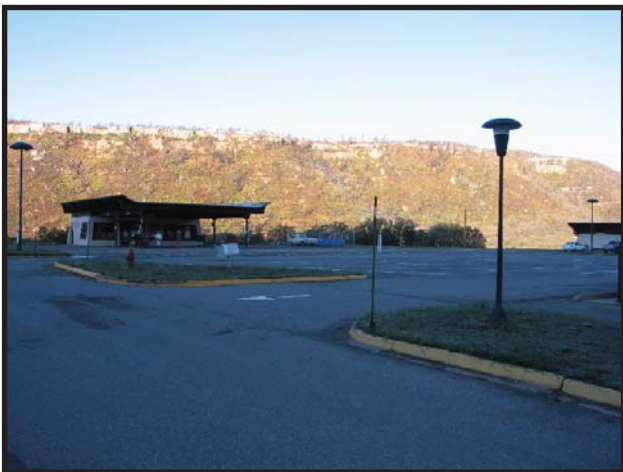
## Route 0910

Route	Public / NonPublic	Date Visited	Area (sq ft)	Lane Miles *	Surface Type	Condition / PCR
0910	Public	10/4/2002	80093	1.38	AS	POOR / 45

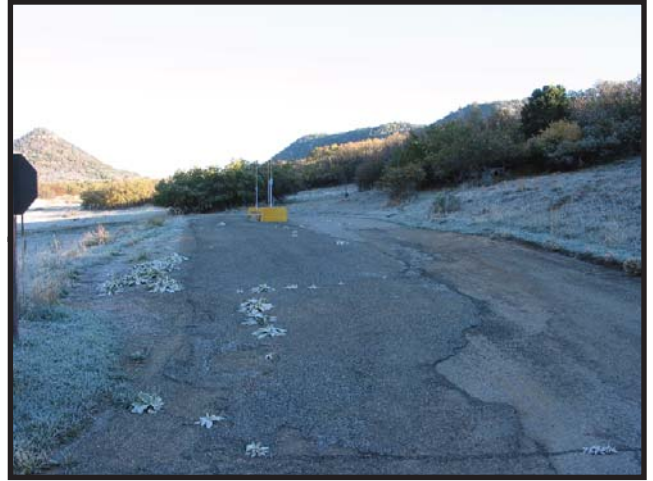
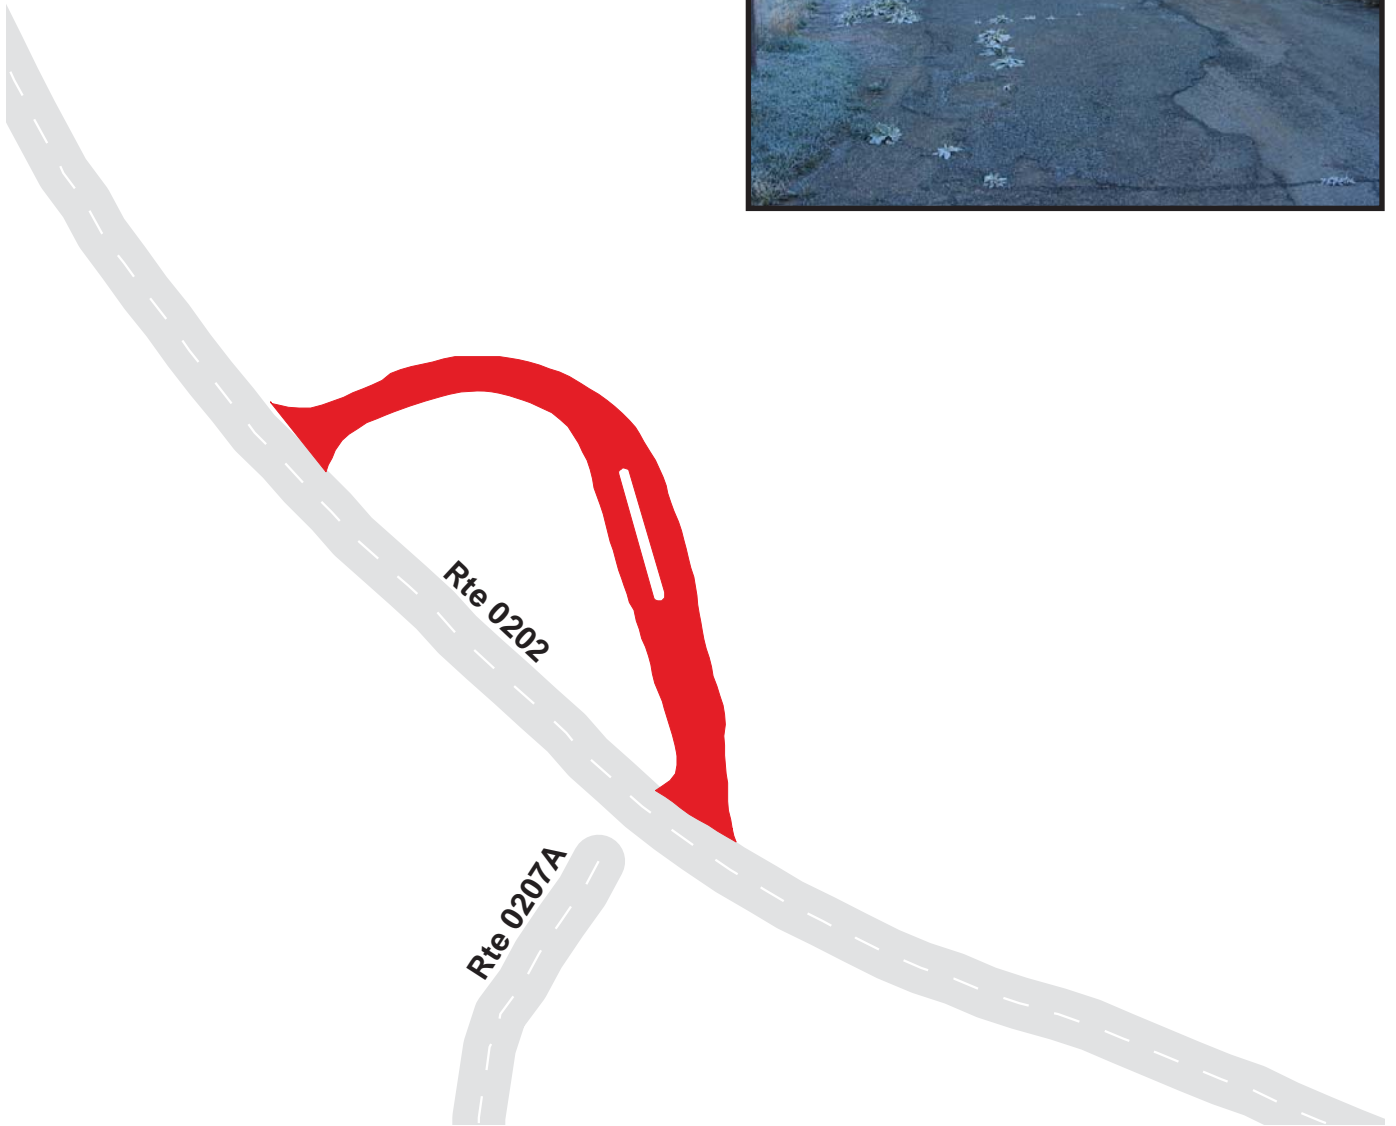
## Route 0911

Route	Public / NonPublic	Date Visited	Area (sq ft)	Lane Miles *	Surface Type	Condition / PCR
0911	Public	10/4/2002	7626	0.13	AS	POOR / 45

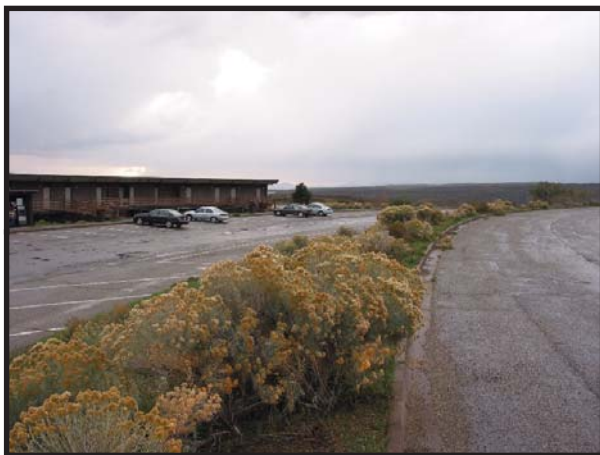
## Route 0914

Route	Public / NonPublic	Date Visited	Area (sq ft)	Lane Miles *	Surface Type	Condition / PCR
0914	Public	10/2/2002	14978	0.26	AS	POOR / 45

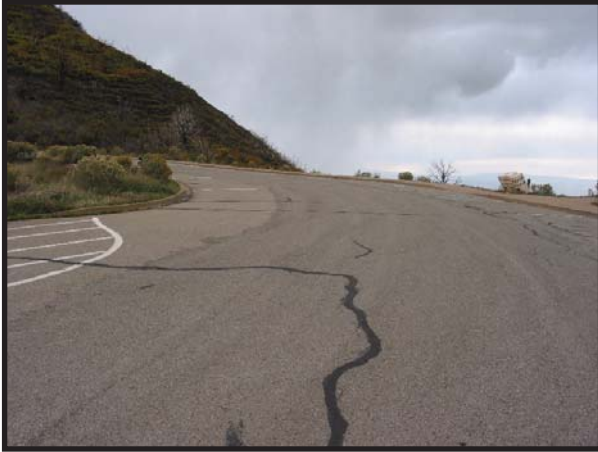
## Route 0916

Route	Public / NonPublic	Date Visited	Area (sq ft)	Lane Miles *	Surface Type	Condition / PCR
0916	NonPublic	10/3/2002	16932	0.29	AS	GOOD / 90

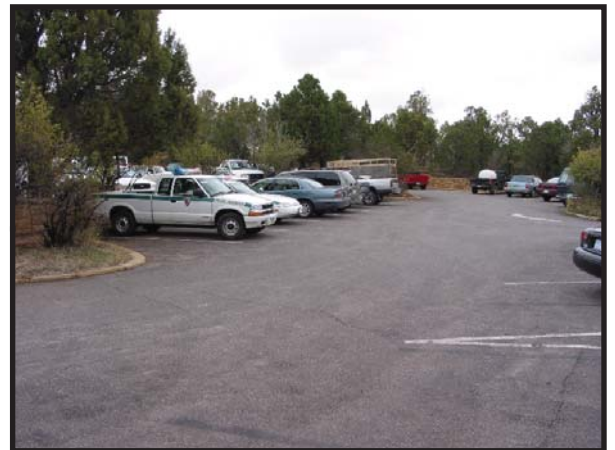
## Route 0917

Route	Public / NonPublic	Date Visited	Area (sq ft)	Lane Miles *	Surface Type	Condition / PCR
0917	NonPublic	10/2/2002	3918	0.07	AS	POOR / 45

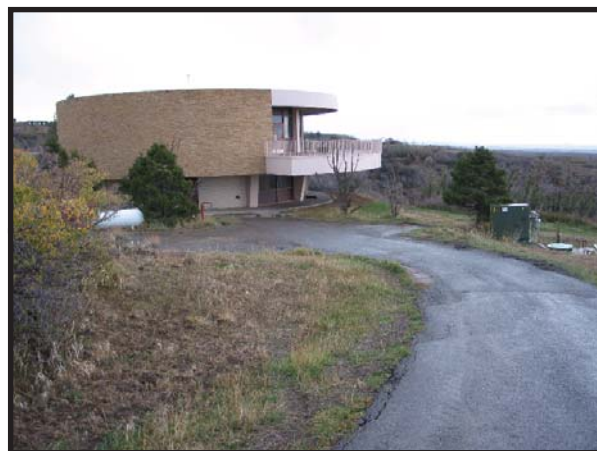
## Route 0918

Route	Public / NonPublic	Date Visited	Area (sq ft)	Lane Miles *	Surface Type	Condition / PCR
0918	Public	10/2/2002	63251	1.09	AS	FAIR / 73

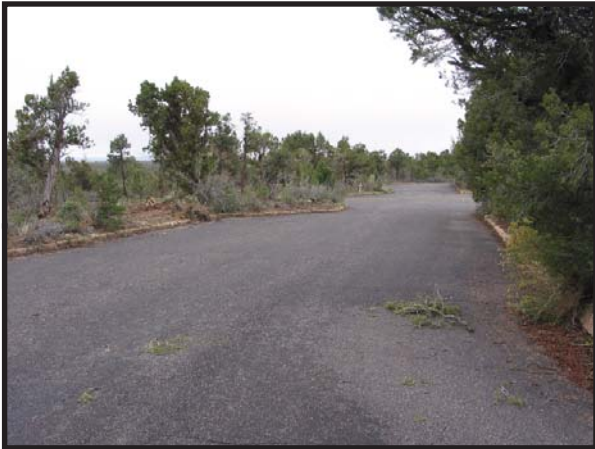
## Route 0919B

Route	Public / NonPublic	Date Visited	Area (sq ft)	Lane Miles *	Surface Type	Condition / PCR
0919B	Public	10/3/2002	2031	0.03	AS	FAIR / 73

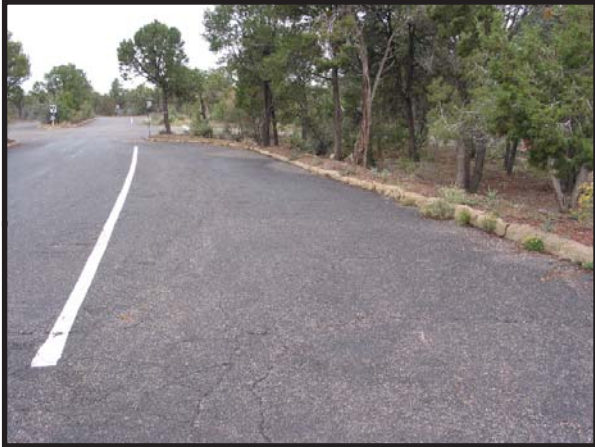
## Route 0919C

Route	Public / NonPublic	Date Visited	Area (sq ft)	Lane Miles *	Surface Type	Condition / PCR
0919C	Public	10/3/2002	2946	0.05	AS	FAIR / 73

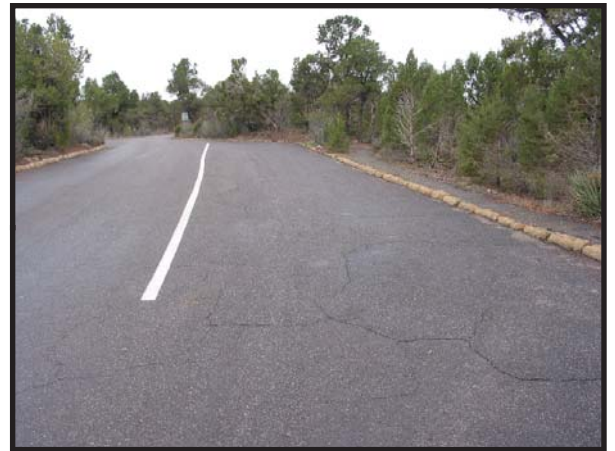
## Route 0920

Route	Public / NonPublic	Date Visited	Area (sq ft)	Lane Miles *	Surface Type	Condition / PCR
0920	Public	10/3/2002	22187	0.38	AS	GOOD / 90
