The Road Inventory of Minidoka Internment National Monument MIIN - 9360

Road Inventory Program

Prepared By:
Federal Highway Administration
Eastern Federal Lands Highway Division
Cycle 3

Minidoka Internment National Monument in Idaho

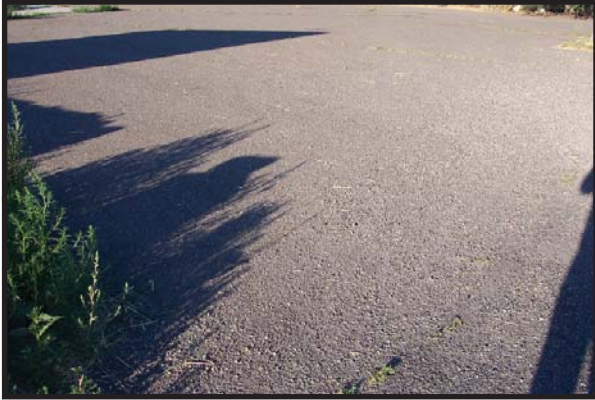
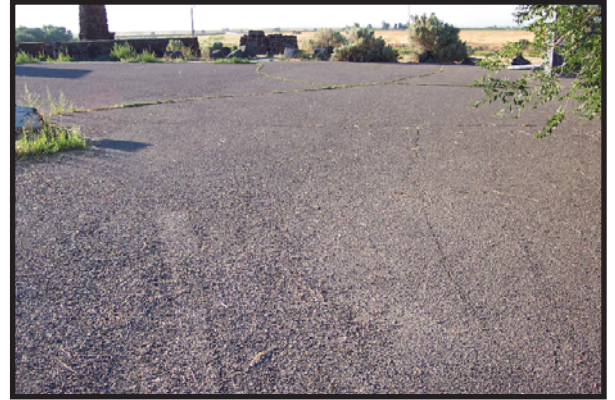
Route 0900

Guard Station Parking
From Hunt Road

Route	Public / NonPublic	Date Visited	Area (sq ft)	Lane Miles *	Surface Type	Condition / PCR
0900	Public	5/16/2004	5813	0.10	AS	FAIR / 73
