The Road Inventory of Minute Man National Historical Park MIMA - 1820

Road Inventory Program

Prepared By:
Federal Highway Administration
Eastern Federal Lands Highway Division
Cycle 3

Minute Man National Historical Park in Massachusetts

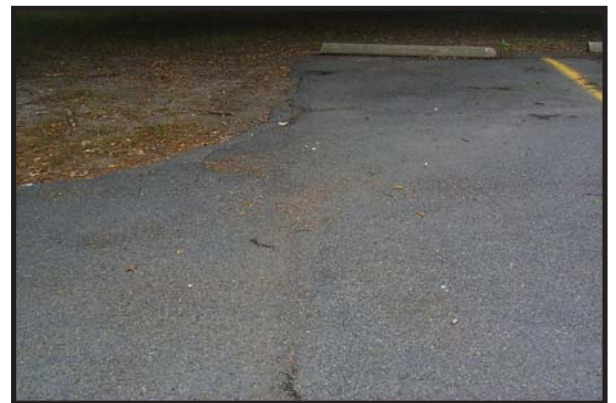
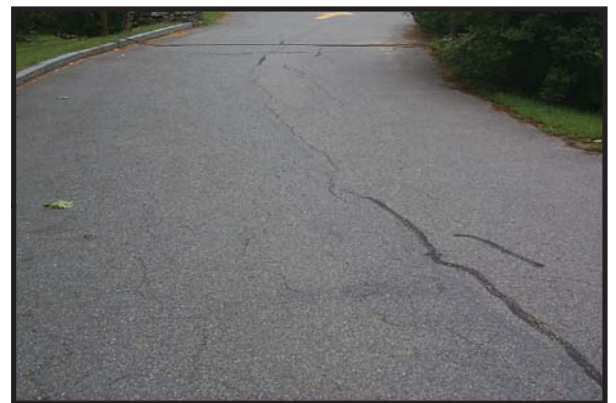
Route 0900

Route	Public / NonPublic	Date Visited	Area (sq ft)	Lane Miles *	Surface Type	Condition / PCR
0900	Public	8/24/2002	23286	0.40	AS	FAIR / 73

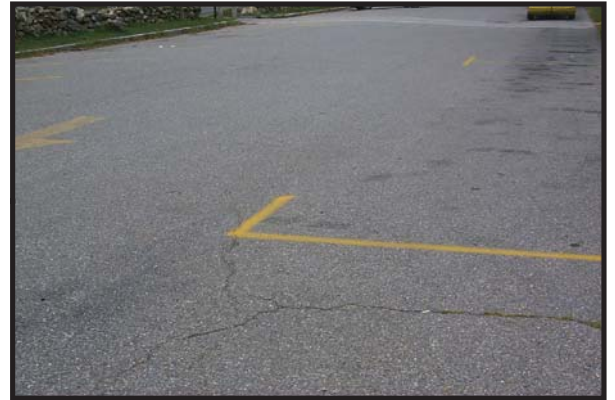
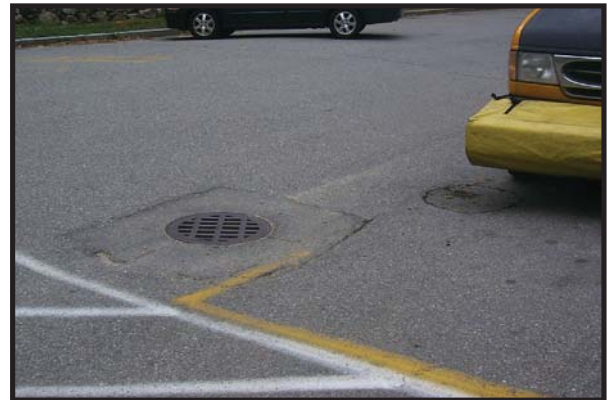
Route 0901

Route	Public / NonPublic	Date Visited	Area (sq ft)	Lane Miles *	Surface Type	Condition / PCR
0901	Public	8/24/2002	31183	0.54	AS	GOOD / 90

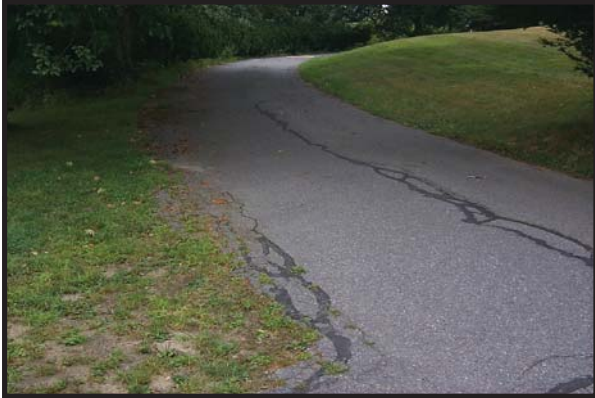
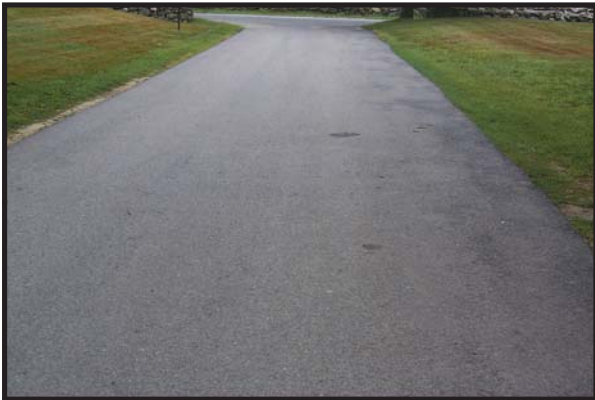
Route 0902

Route	Public / NonPublic	Date Visited	Area (sq ft)	Lane Miles *	Surface Type	Condition / PCR
0902	NonPublic	8/24/2002	9534	0.16	AS	FAIR / 73

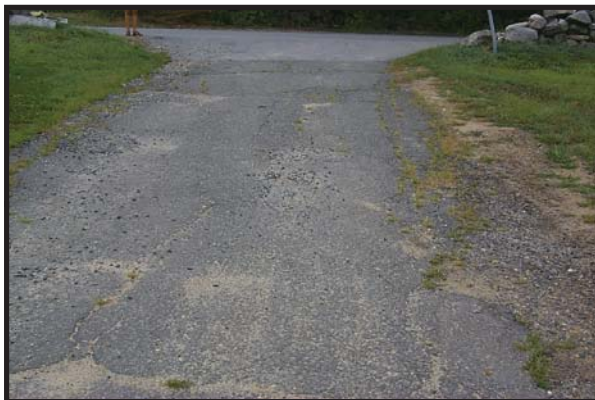
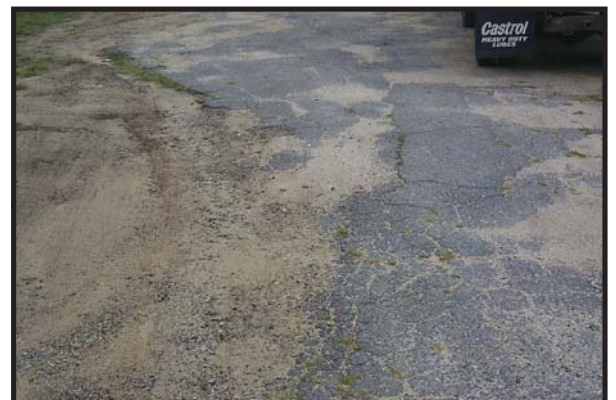
Route 0903

Route	Public / NonPublic	Date Visited	Area (sq ft)	Lane Miles *	Surface Type	Condition / PCR
0903	NonPublic	8/24/2002	2291	0.04	AS	POOR / 45

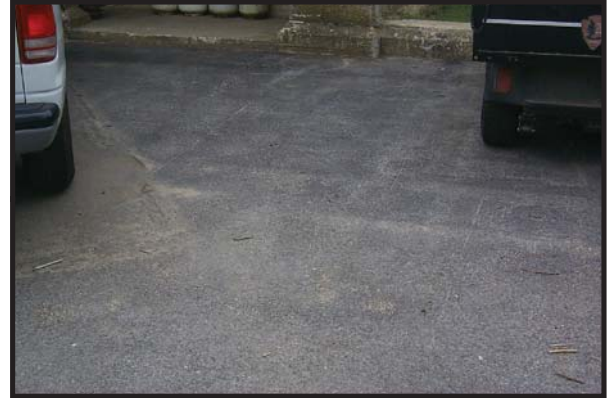
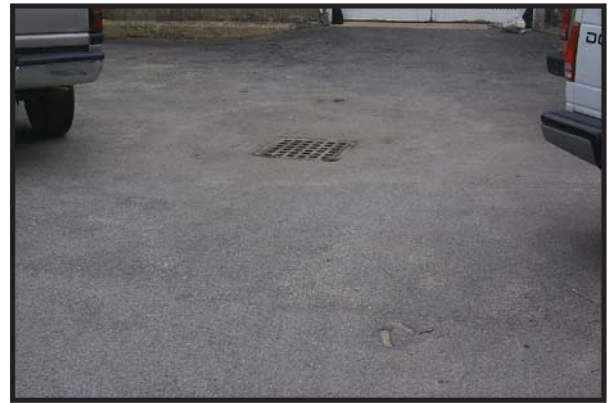
Route 0904

Route	Public / NonPublic	Date Visited	Area (sq ft)	Lane Miles *	Surface Type	Condition / PCR
0904	NonPublic	8/24/2002	1768	0.03	AS	GOOD / 90

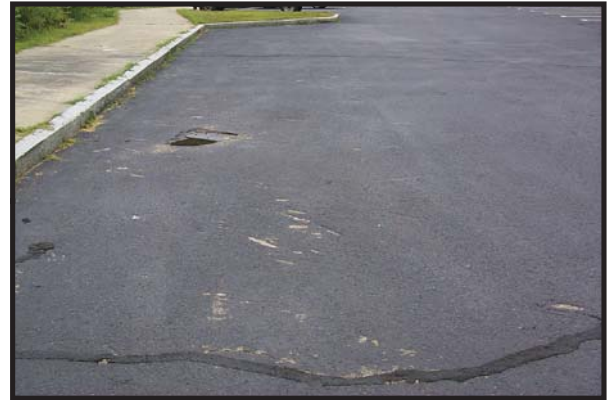
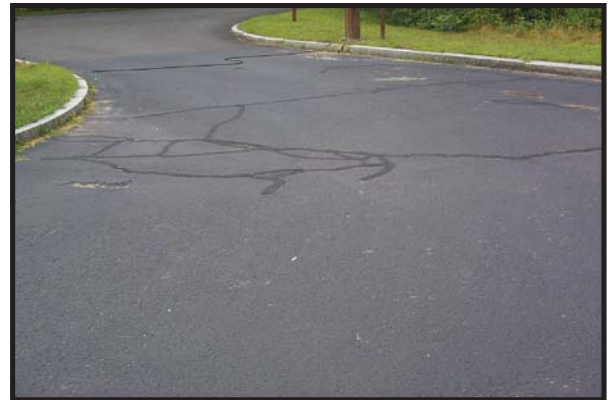
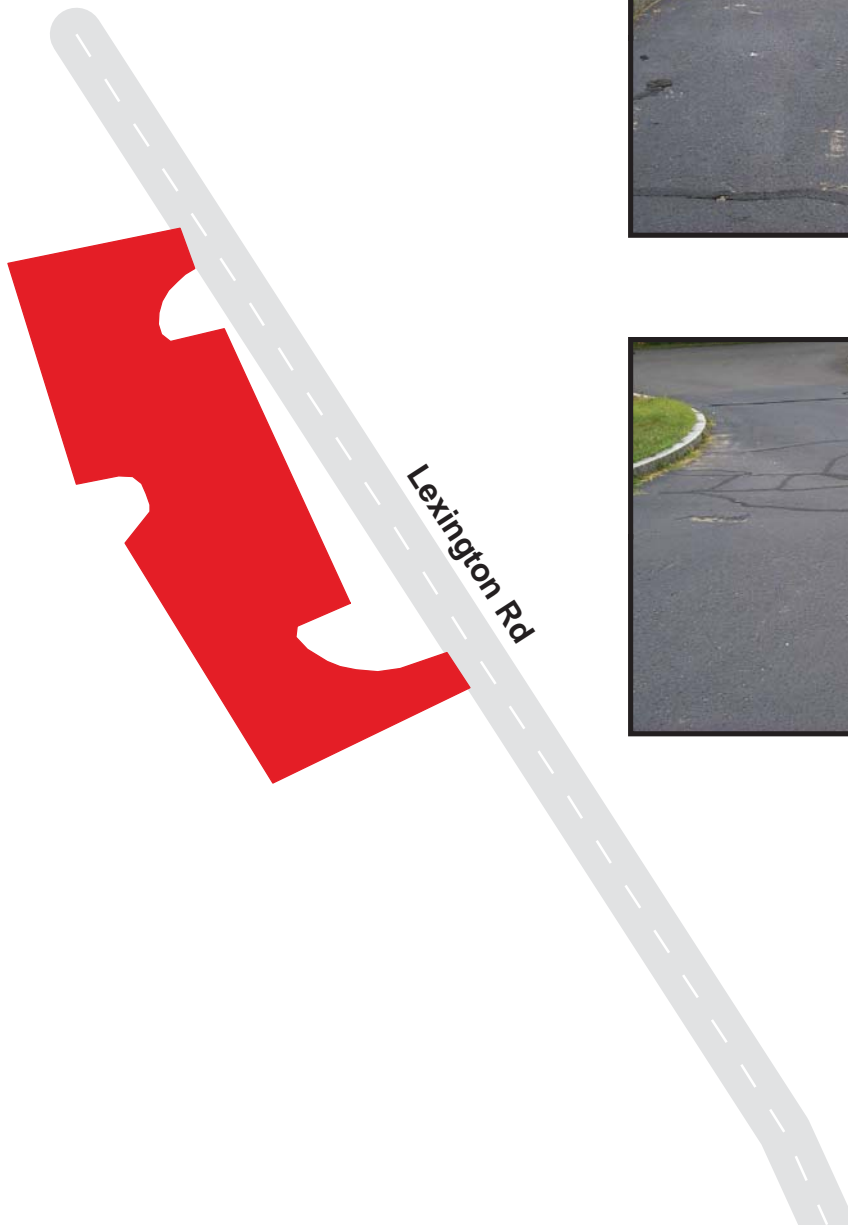
Route 0907

Route	Public / NonPublic	Date Visited	Area (sq ft)	Lane Miles *	Surface Type	Condition / PCR
0907	Public	8/24/2002	13103	0.23	AS	GOOD / 90

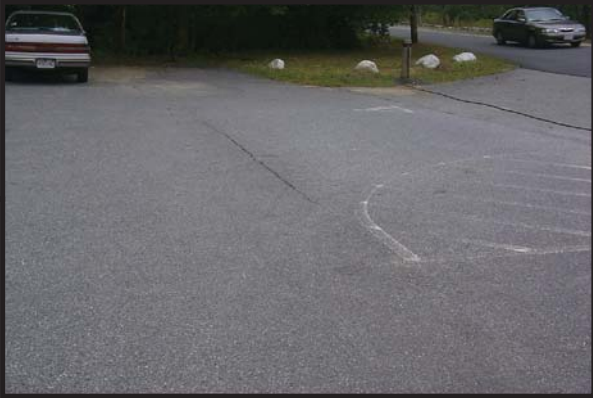
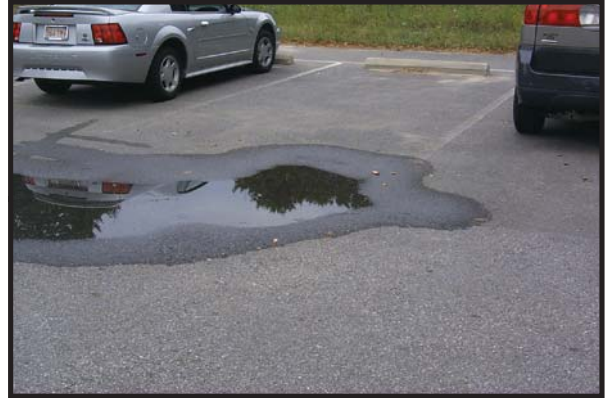
Route 0911

Route	Public / NonPublic	Date Visited	Area (sq ft)	Lane Miles *	Surface Type	Condition / PCR
0911	Public	8/24/2002	11395	0.20	AS	GOOD / 90

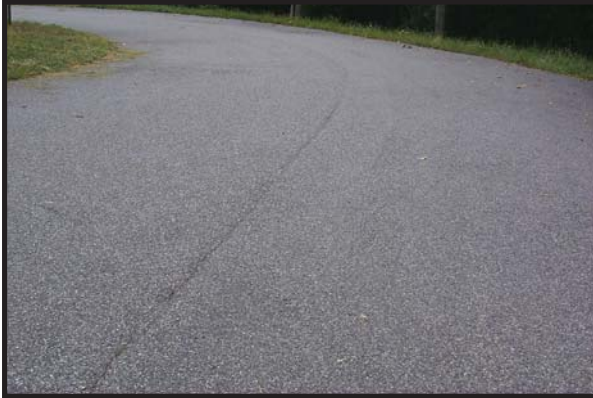
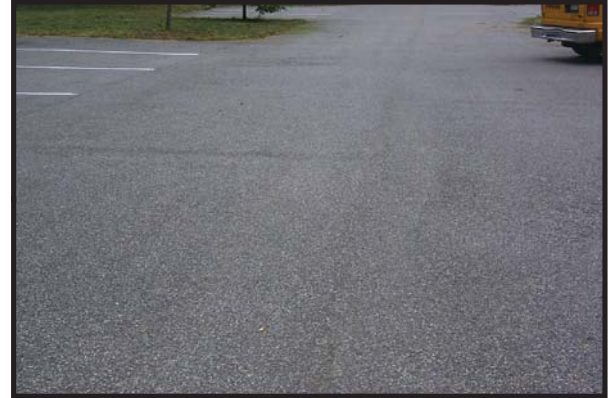
Route 0926

Route	Public / NonPublic	Date Visited	Area (sq ft)	Lane Miles *	Surface Type	Condition / PCR
0926	Public	8/24/2002	24481	0.42	AS	GOOD / 90

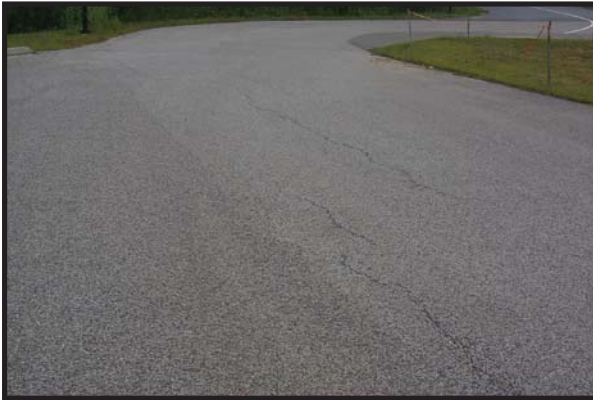
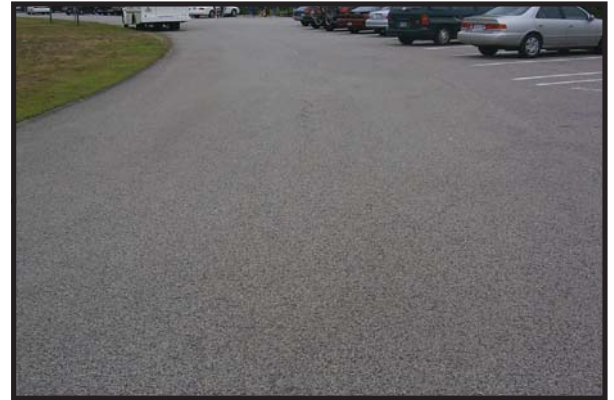
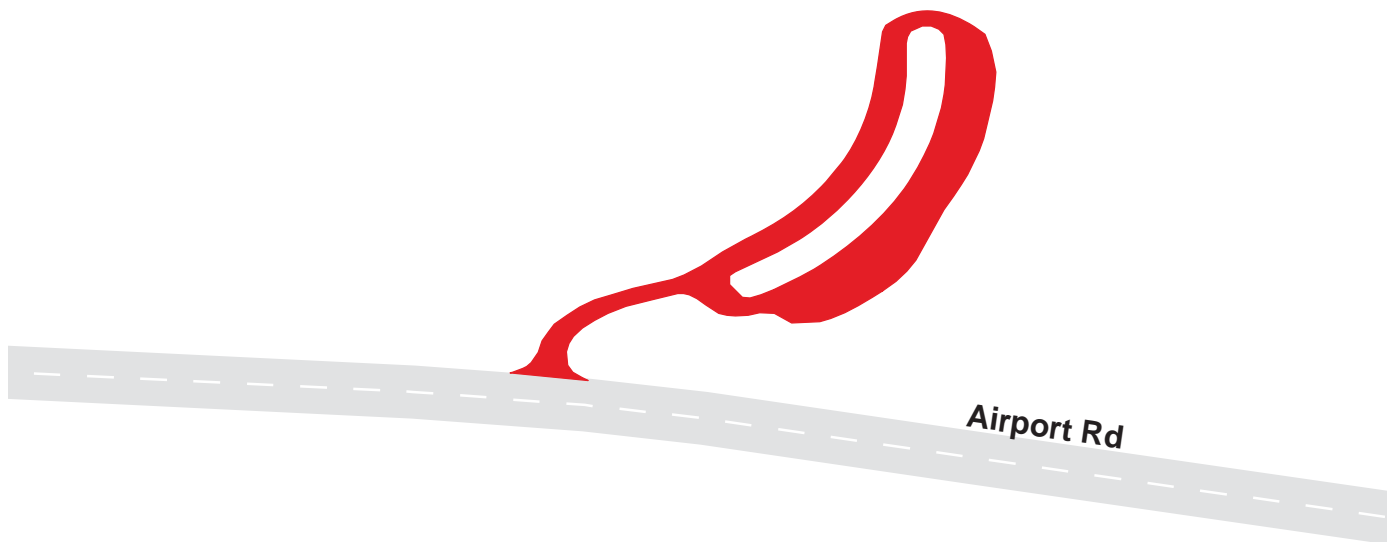
Route 0930

Route	Public / NonPublic	Date Visited	Area (sq ft)	Lane Miles *	Surface Type	Condition / PCR
0930	Public	8/24/2002	48336	0.83	AS	GOOD / 90

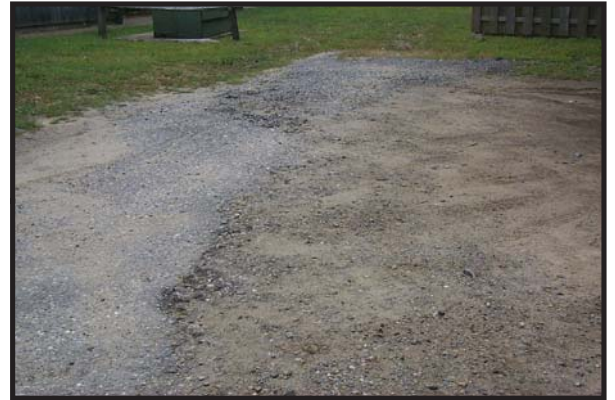
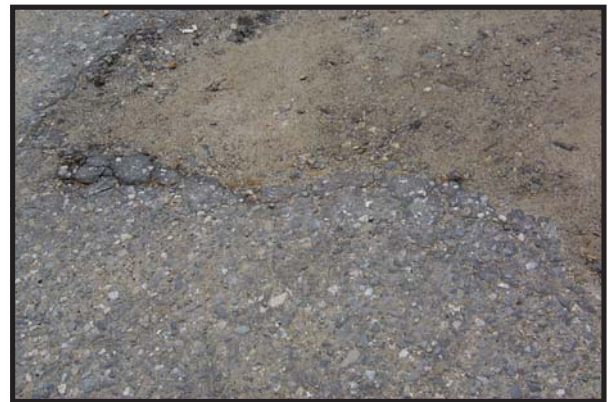
Route 0932

Route	Public / NonPublic	Date Visited	Area (sq ft)	Lane Miles *	Surface Type	Condition / PCR
0932	Public	8/24/2002	5709	0.10	AS	POOR / 45
