The Road Inventory of Minuteman Missile National Historic Site MIMI - 1305

Prepared By:
Federal Highway Administration
Eastern Federal Lands Highway Division
Cycle 3

Minuteman Missile National Historic Site in South Dakota

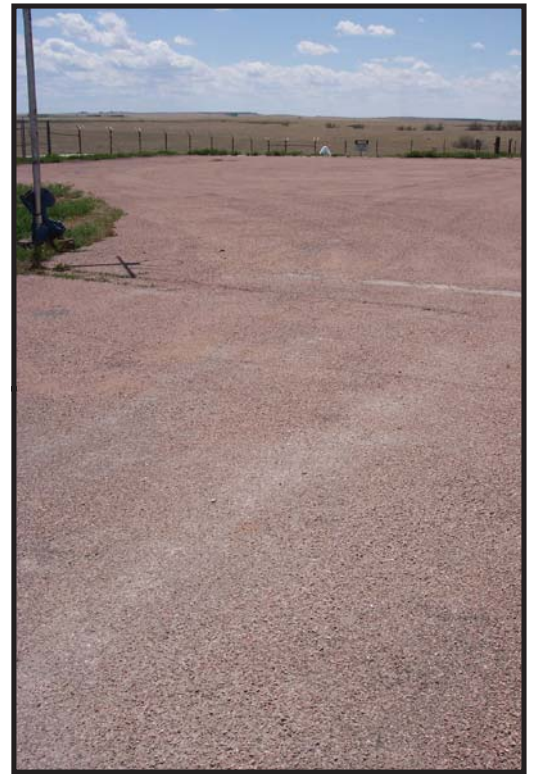
Route 0900

DELTA-01 Site Overflow Parking A

Route	Public / NonPublic	Date Visited	Area (sq ft)	Lane Miles *	Surface Type	Condition / PCR
0900	Public	5/14/2004	19198	0.33	OC	FAIR / 73

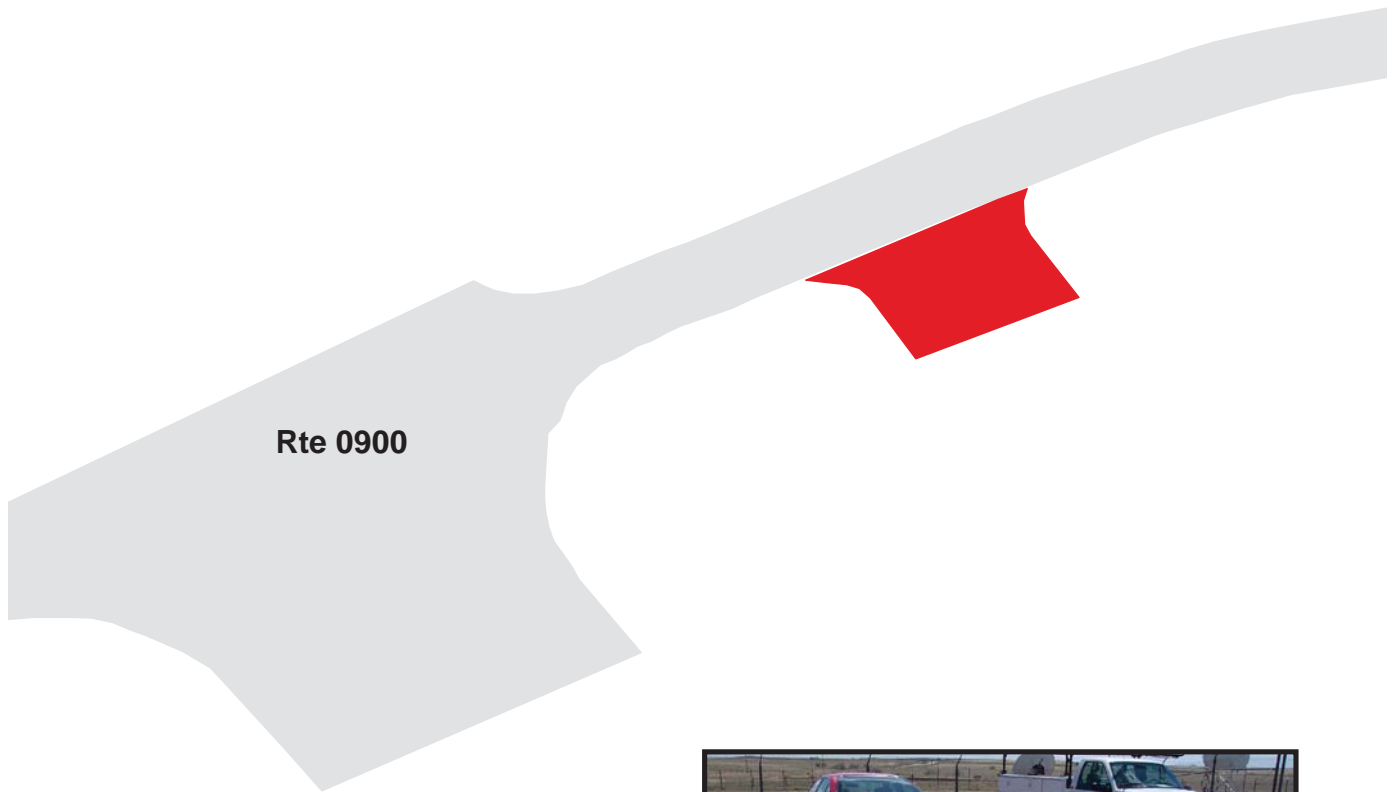
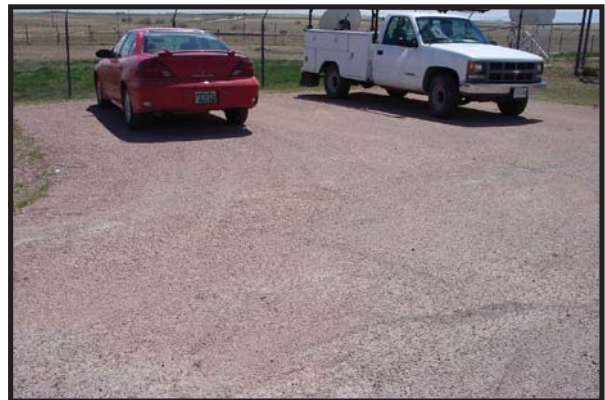
Route 0901

DELTA-01 Site Visitor Parking
From Route 0900

Route	Public / NonPublic	Date Visited	Area (sq ft)	Lane Miles *	Surface Type	Condition / PCR
0901	Public	5/14/2004	1179	0.02	OC	FAIR / 73

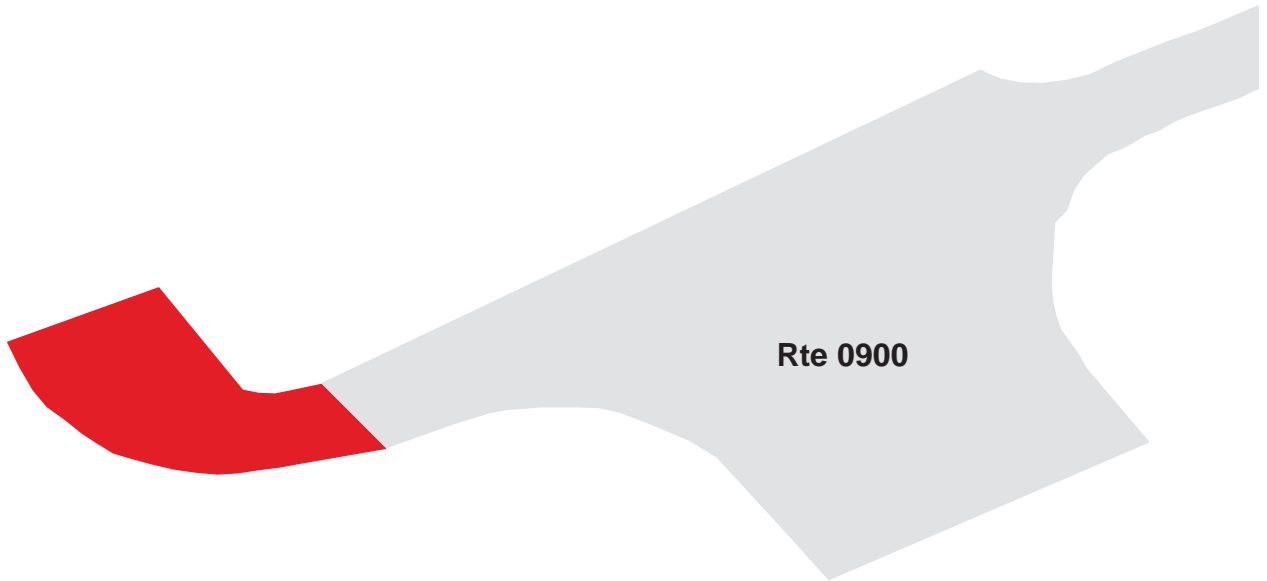
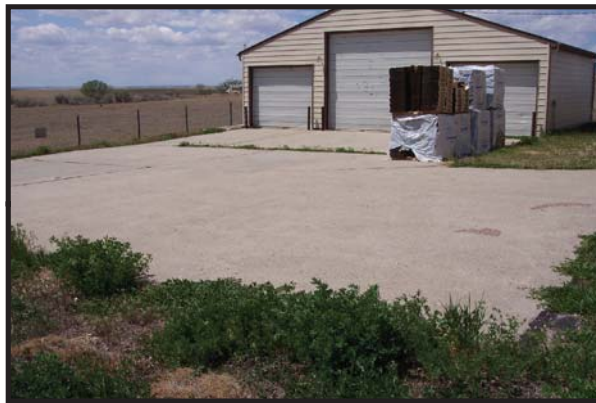
Route 0902

DELTA-01 Site Overflow Parking B

Route	Public / NonPublic	Date Visited	Area (sq ft)	Lane Miles *	Surface Type	Condition / PCR
0902	Public	5/14/2004	2000	0.03	CO	FAIR / 73
