# The Road Inventory of Montezuma Castle National Monument MOCA - 8650

## Road Inventory Program

Prepared By:  
Federal Highway Administration  
Eastern Federal Lands Highway Division  
Cycle 3

# Montezuma Castle National Monument in Arizona

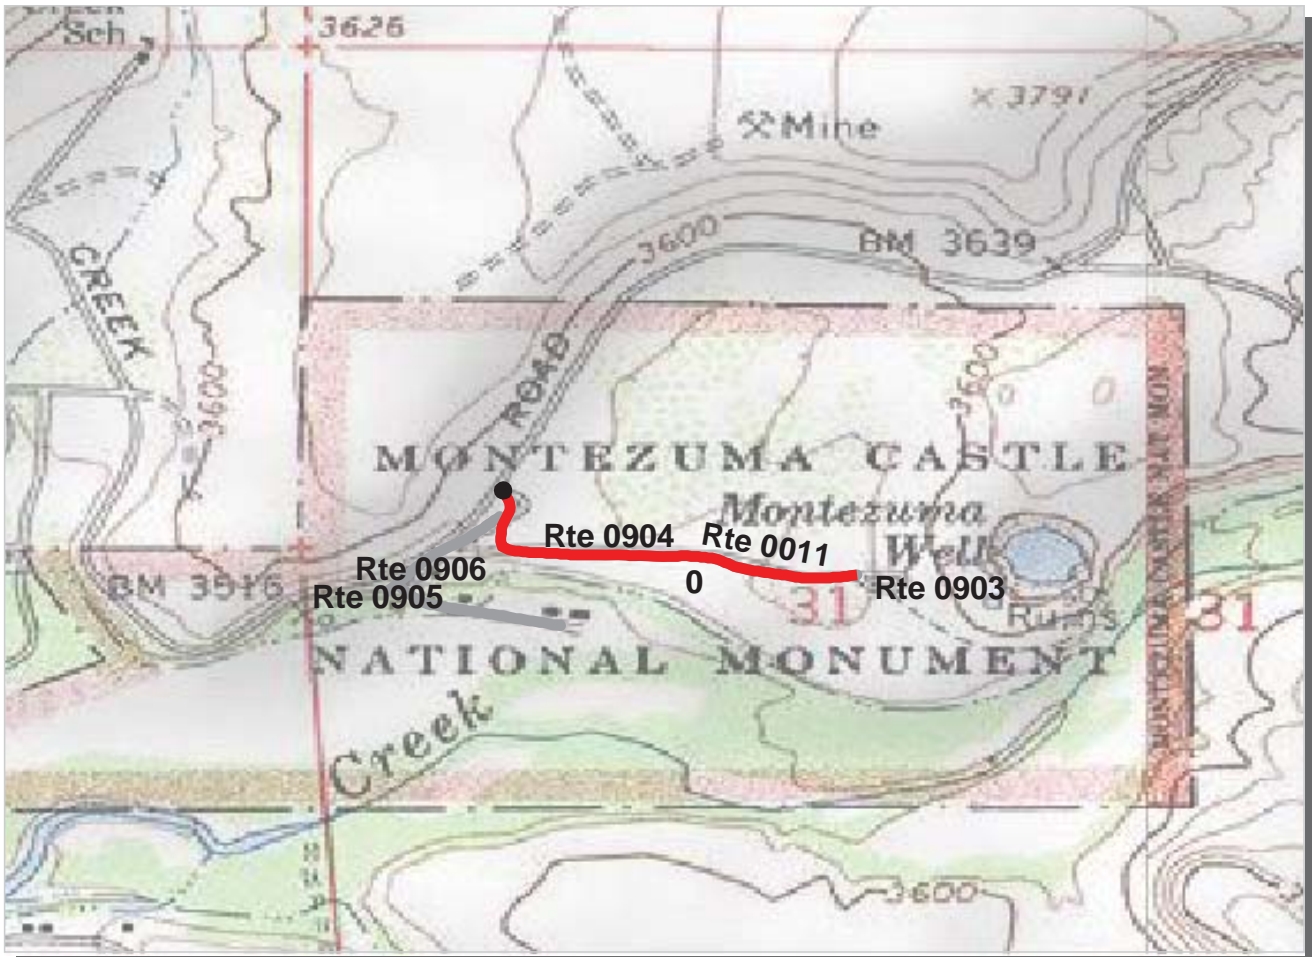
**ROUTE: 0011 Montezuma Well Access Road** **TOTAL LENGTH: 0.38 Miles**

Section Number	0				
Section Length (mi)	0.38				
AADT	**				
SADT	**				
ADT Date	**				
<b>Cross Section Information</b>					
Number of Lanes	2				
Paved Width (ft)	20				
Lane Width (ft)	12				
Shoulder Width (ft)	0				
<b>Roadway Condition Information</b>					
PCR (Pavement Condition Rating)	28				
RCI (Roughness Condition Index)	45				
SCR (Surface Condition Rating)	23				
Alligator Cracking Index	99				
Rutting Index	35				
Patching Index	100				
Transverse Cracking Index	91				
Longitudinal Cracking Index	95				
Shoulder Condition Rating	N/A				
Drainage Condition Rating	N/C

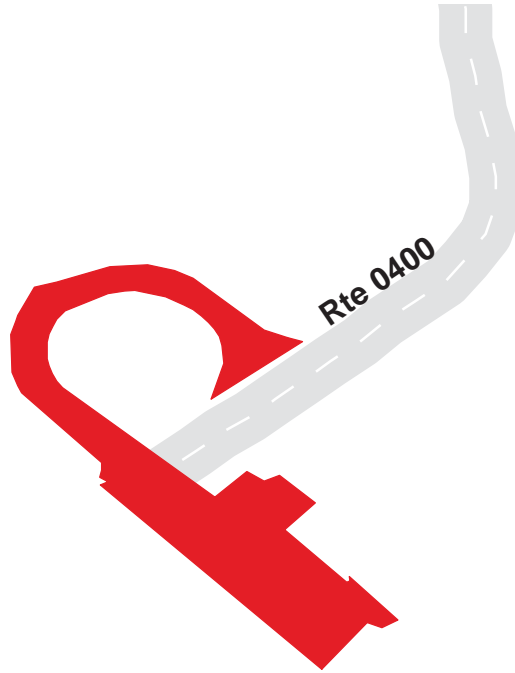
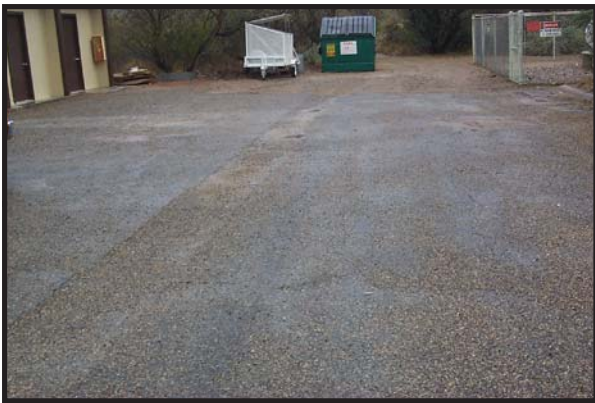
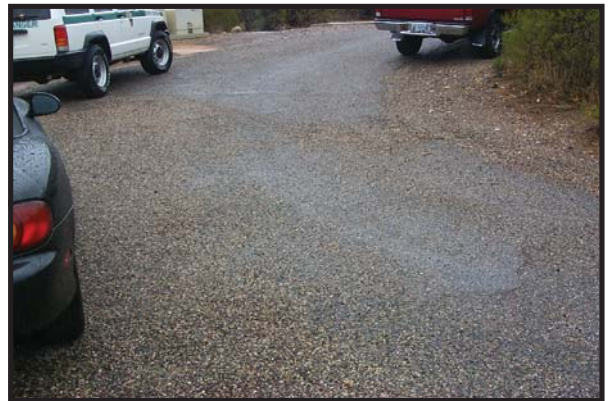
## Route 0901

Route	Public / NonPublic	Date Visited	Area (sq ft)	Lane Miles *	Surface Type	Condition / PCR
0901	Public	12/4/2001	10387	0.18	NC	FAIR / 73

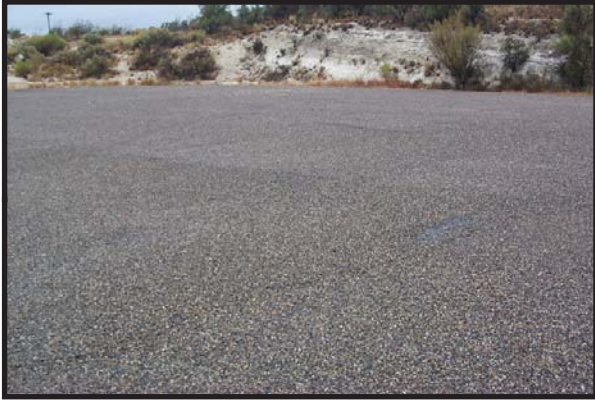
## Route 0902

Route	Public / NonPublic	Date Visited	Area (sq ft)	Lane Miles *	Surface Type	Condition / PCR
0902	NonPublic	12/4/2001	11114	0.19	NC	GOOD / 90

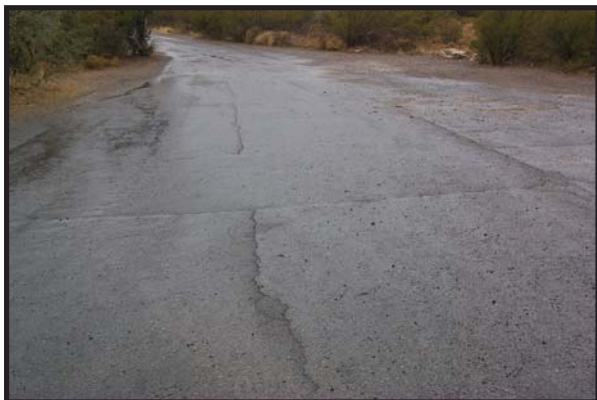
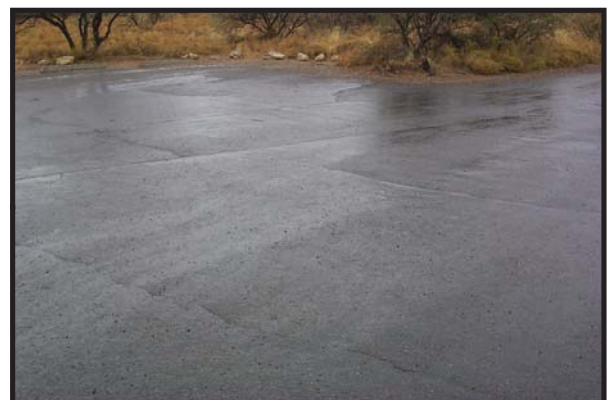
## Route 0903

Route	Public / NonPublic	Date Visited	Area (sq ft)	Lane Miles *	Surface Type	Condition / PCR
0903	Public	12/4/2001	15109	0.26	NC	GOOD / 90

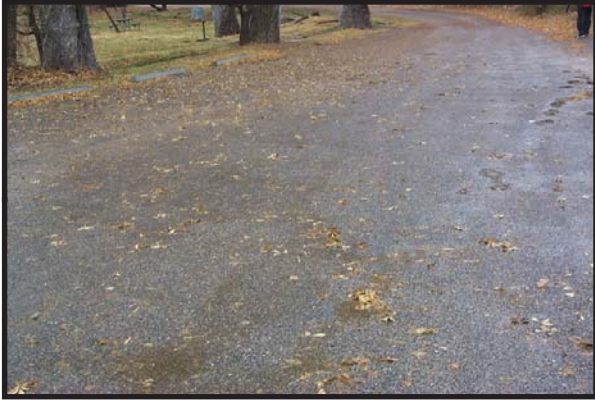
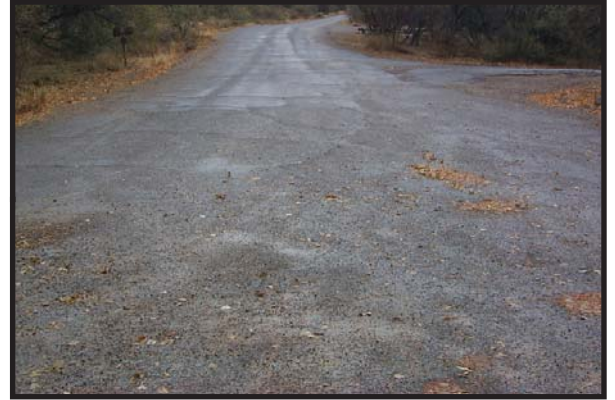
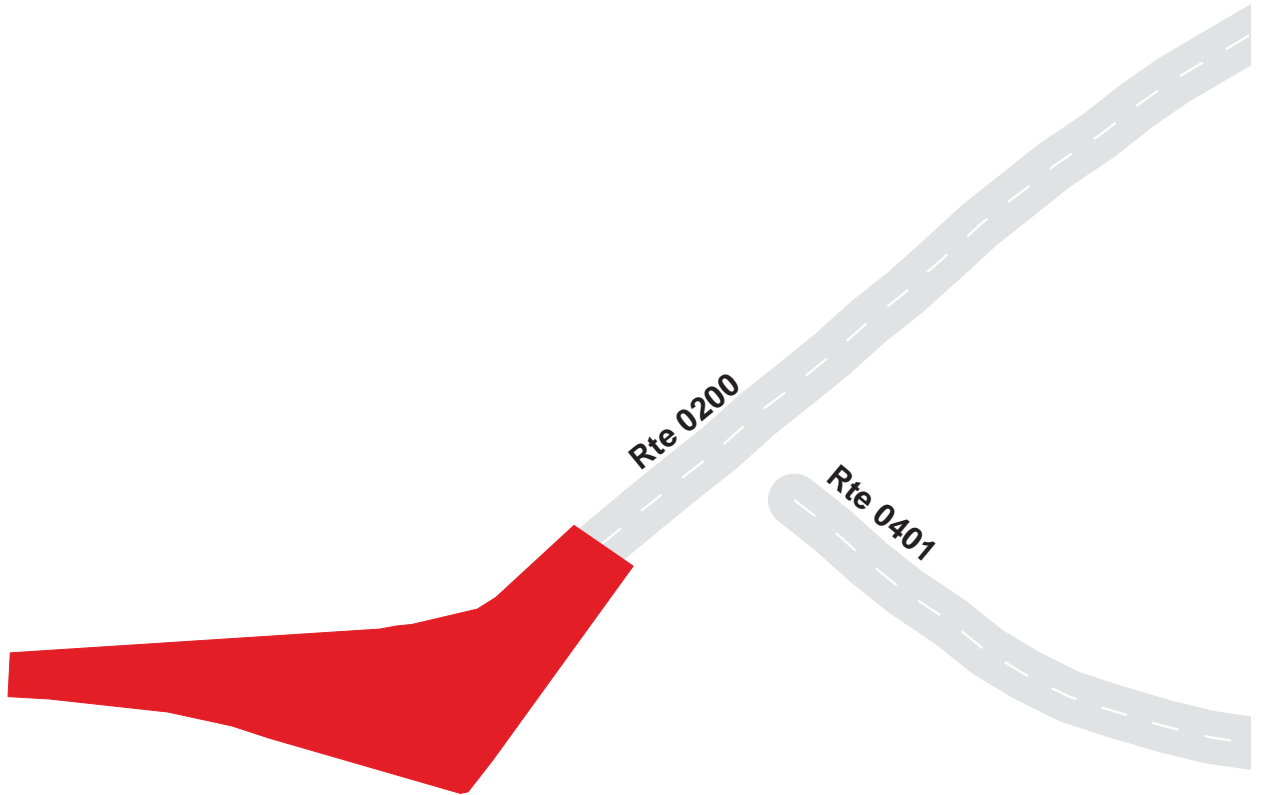
## Route 0905

Route	Public / NonPublic	Date Visited	Area (sq ft)	Lane Miles *	Surface Type	Condition / PCR
0905	Public	12/4/2001	7443	0.13	NC	FAIR / 73

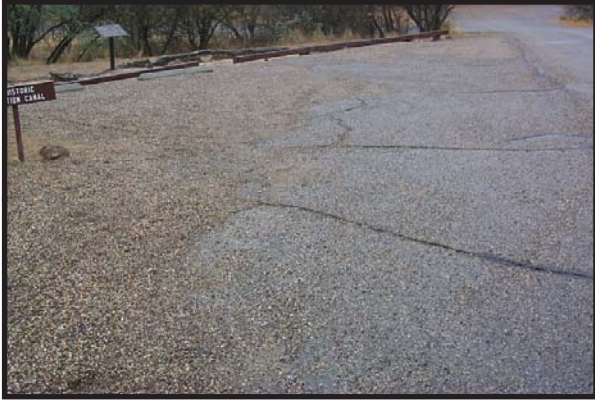
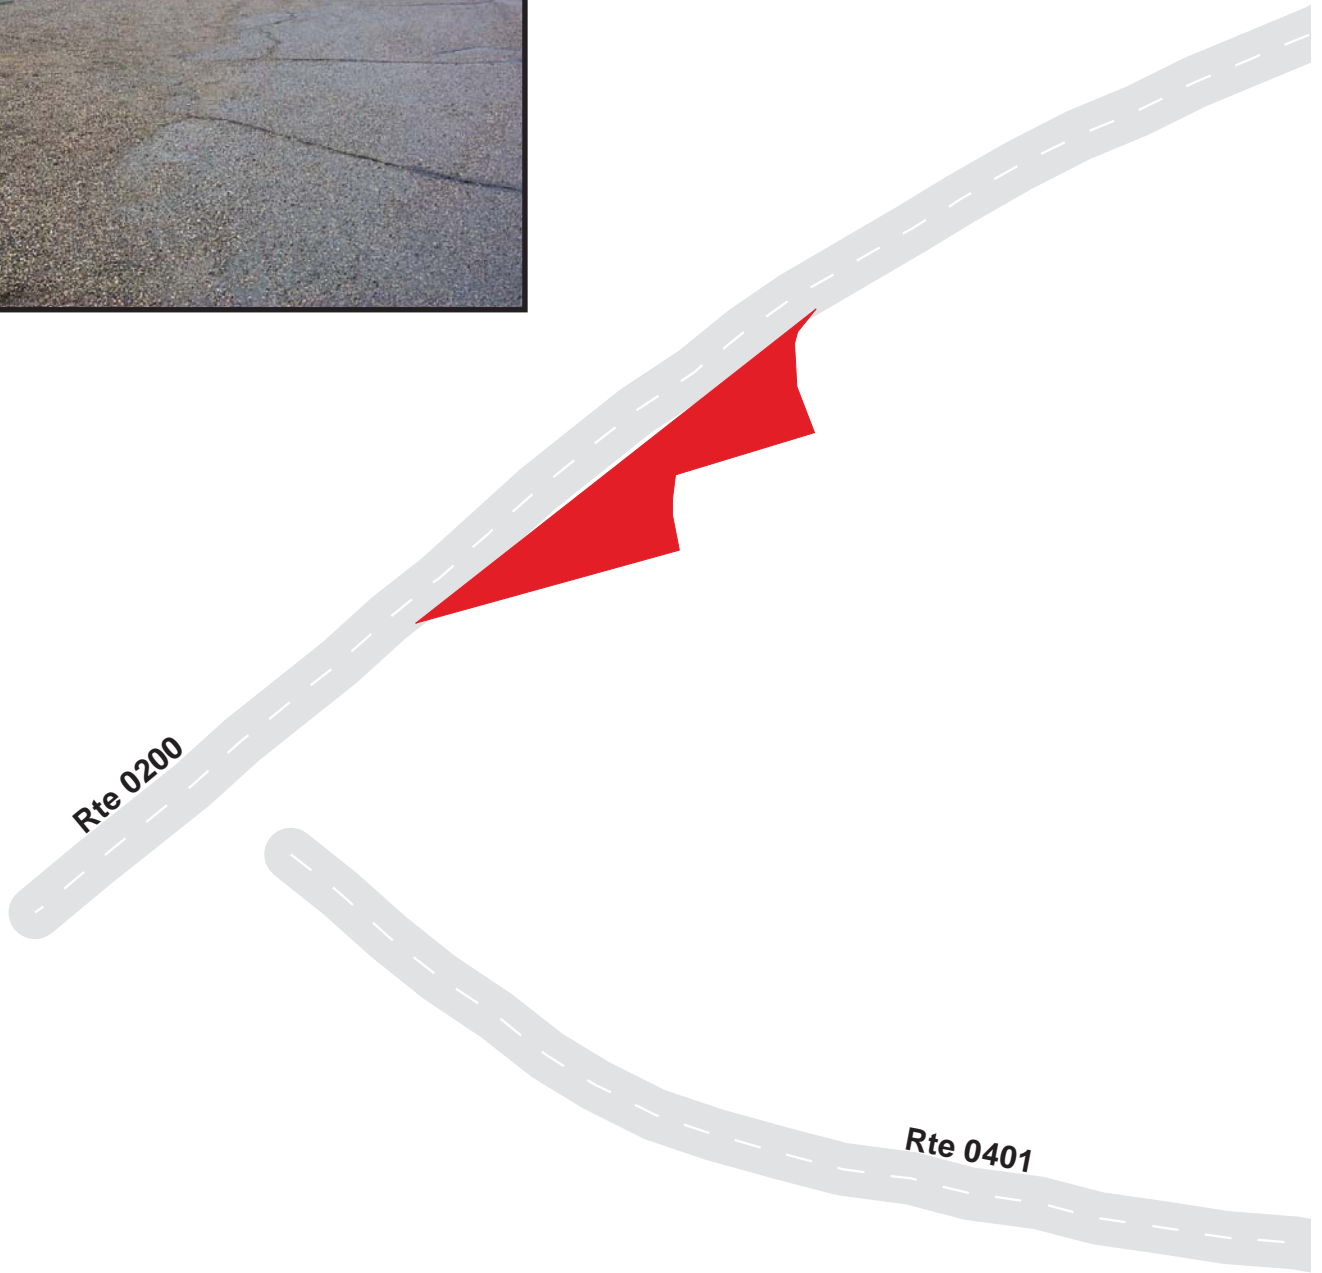
## Route 0906

Route	Public / NonPublic	Date Visited	Area (sq ft)	Lane Miles *	Surface Type	Condition / PCR
0906	Public	12/4/2001	1832	0.03	NC	POOR / 45
