The Road Inventory of Moore's Creek National Battlefield MOCR - 5550

Road Inventory Program

Prepared By:
Federal Highway Administration
Eastern Federal Lands Highway Division
Cycle 3

Moore's Creek National Battlefield in North Carolina

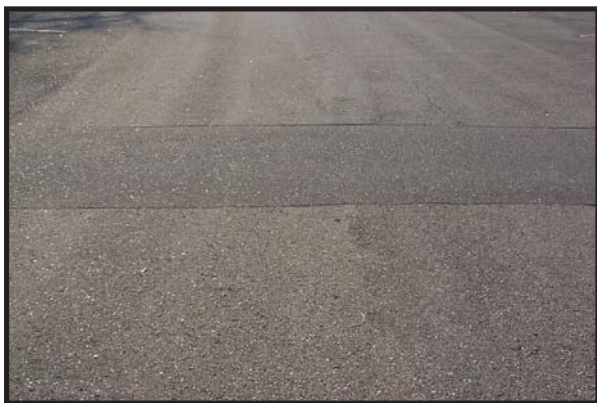
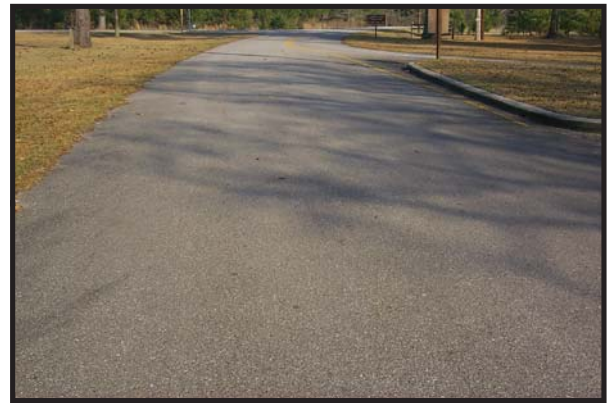
Route 0900

Route	Public / NonPublic	Date Visited	Area (sq ft)	Lane Miles *	Surface Type	Condition / PCR
0900	Public	3/15/2002	28811	0.50	AS	GOOD / 90

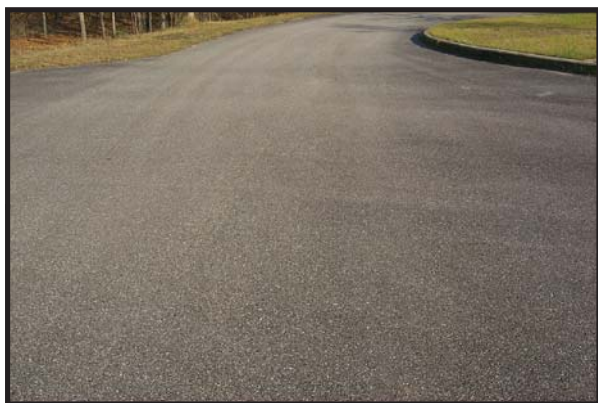
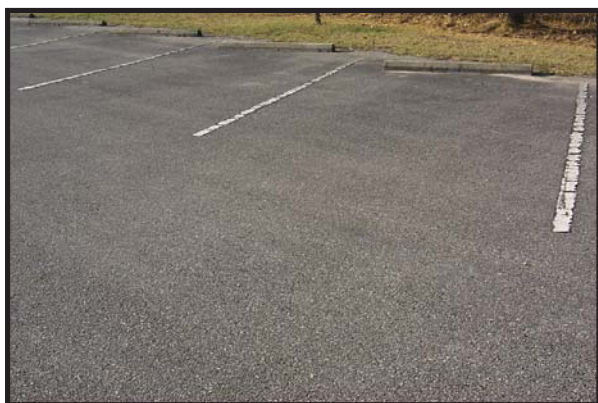
Route 0901

Route	Public / NonPublic	Date Visited	Area (sq ft)	Lane Miles *	Surface Type	Condition / PCR
0901	Public	3/15/2002	33259	0.57	AS	GOOD / 90

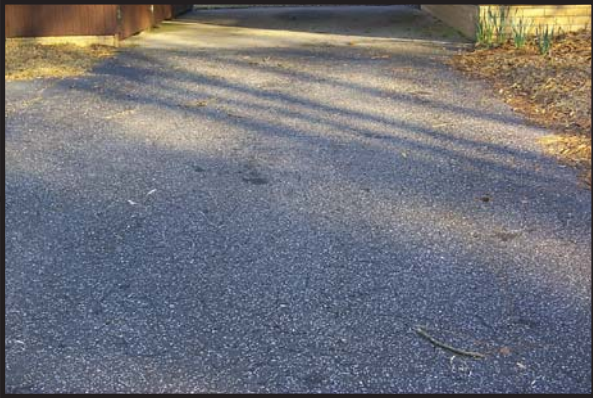
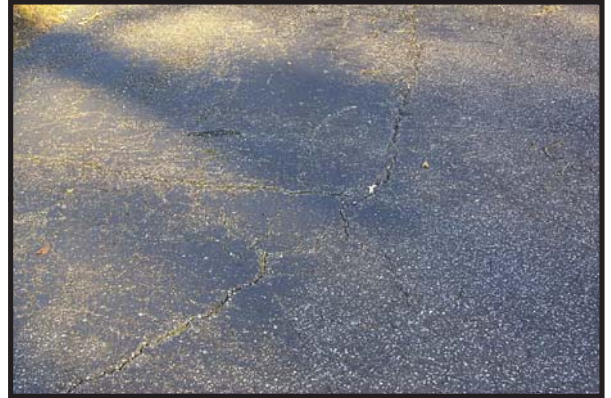
Route 0902

Route	Public / NonPublic	Date Visited	Area (sq ft)	Lane Miles *	Surface Type	Condition / PCR
0902	NonPublic	3/15/2002	4984	0.09	AS	FAIR / 73

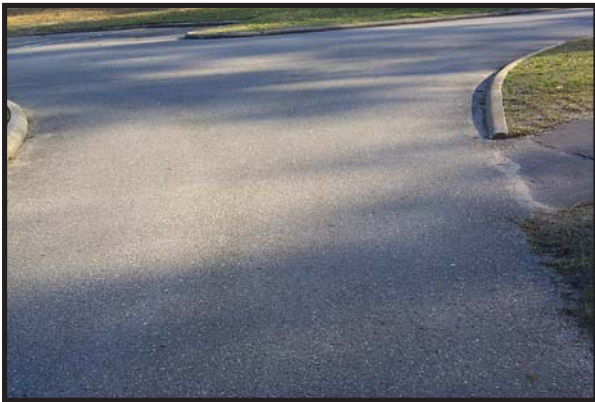
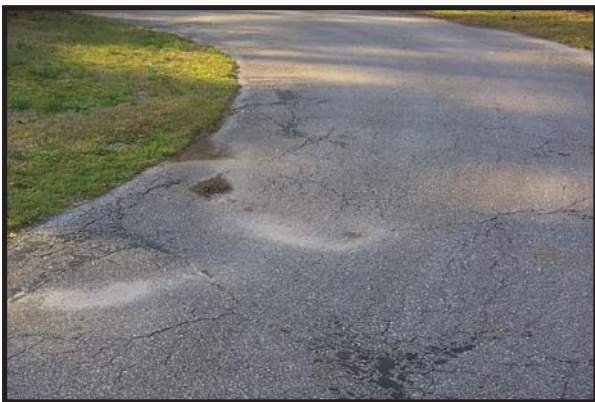
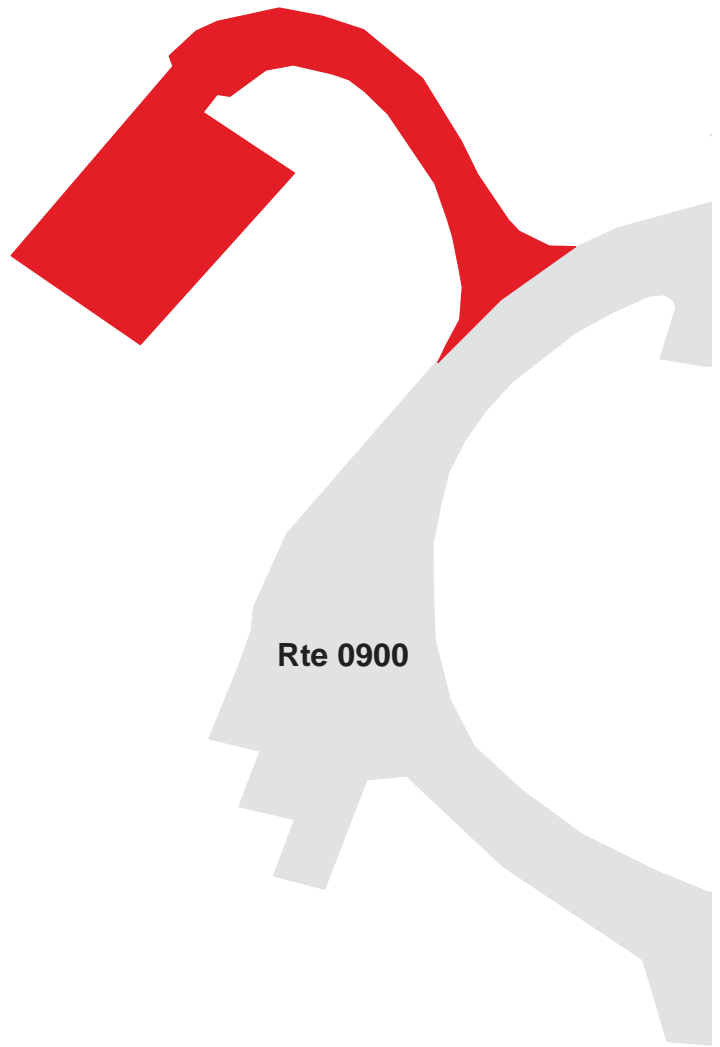
Route 0903

Route	Public / NonPublic	Date Visited	Area (sq ft)	Lane Miles *	Surface Type	Condition / PCR
0903	NonPublic	3/15/2002	3605	0.06	AS	FAIR / 73
