The Road Inventory of Monocacy National Battlefield MONO – 3130

Road Inventory Program

Prepared By:
Federal Highway Administration
Eastern Federal Lands Highway Division
Cycle 3

Monocacy National Battlefield in Maryland

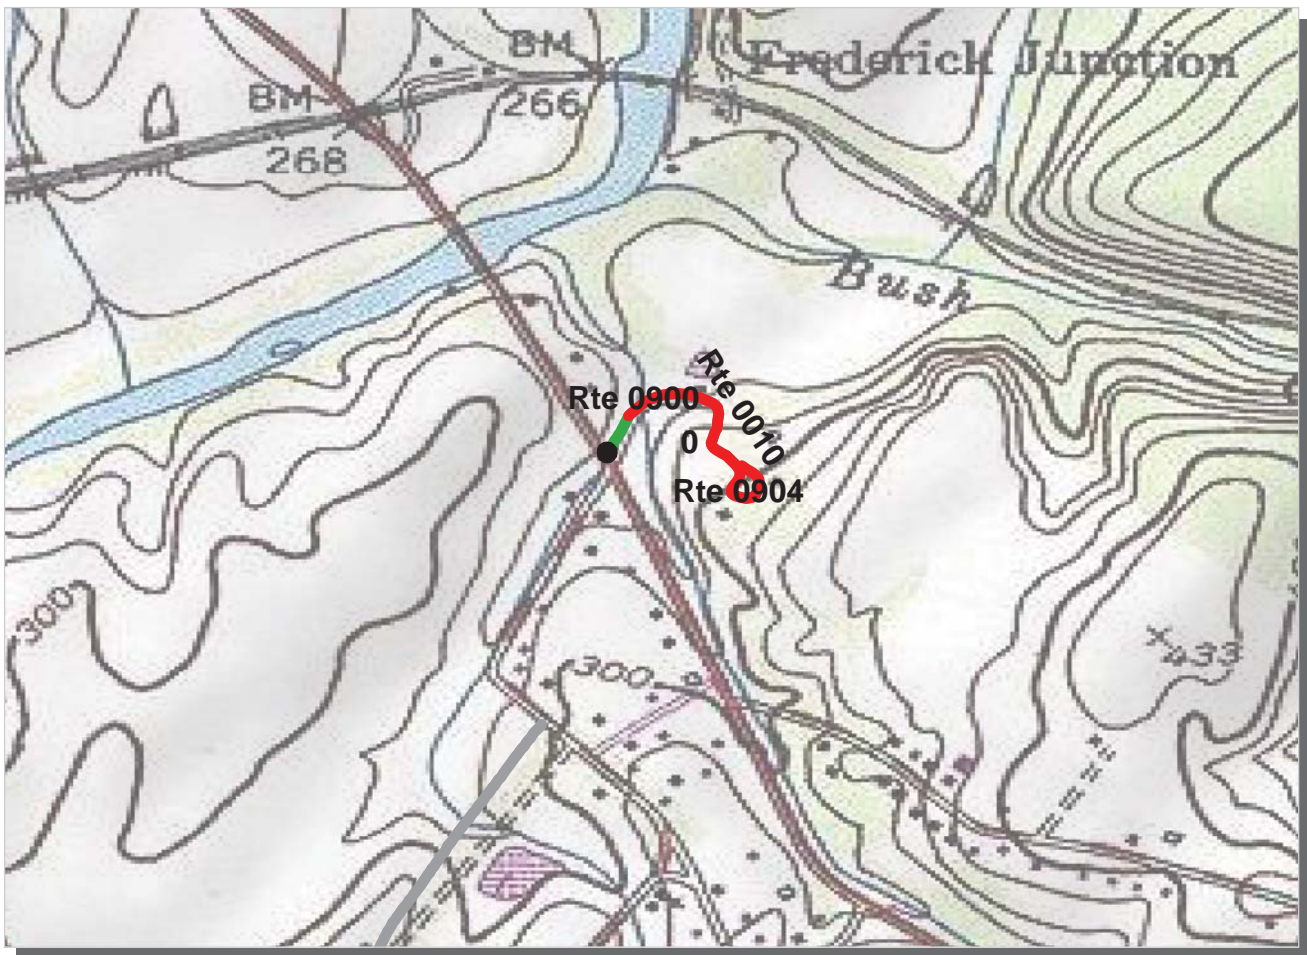
ROUTE: 0010 Entrance Road

Section Number	0				
Section Length (mi)	0.29				
AADT	**				
SADT	**				
ADT Date	**				
Cross Section Information					
Number of Lanes	1				
Paved Width (ft)	10				
Lane Width (ft)	10				
Shoulder Width (ft)	5				
Roadway Condition Information					
PCR (Pavement Condition Rating)	18				
RCI (Roughness Condition Index)	NC				
SCR (Surface Condition Rating)	18				
Alligator Cracking Index	47				
Rutting Index	49				
Patching Index	99				
Transverse Cracking Index	97				
Longitudinal Cracking Index	97				
Shoulder Condition Rating	GOOD				
Drainage Condition Rating	GOOD

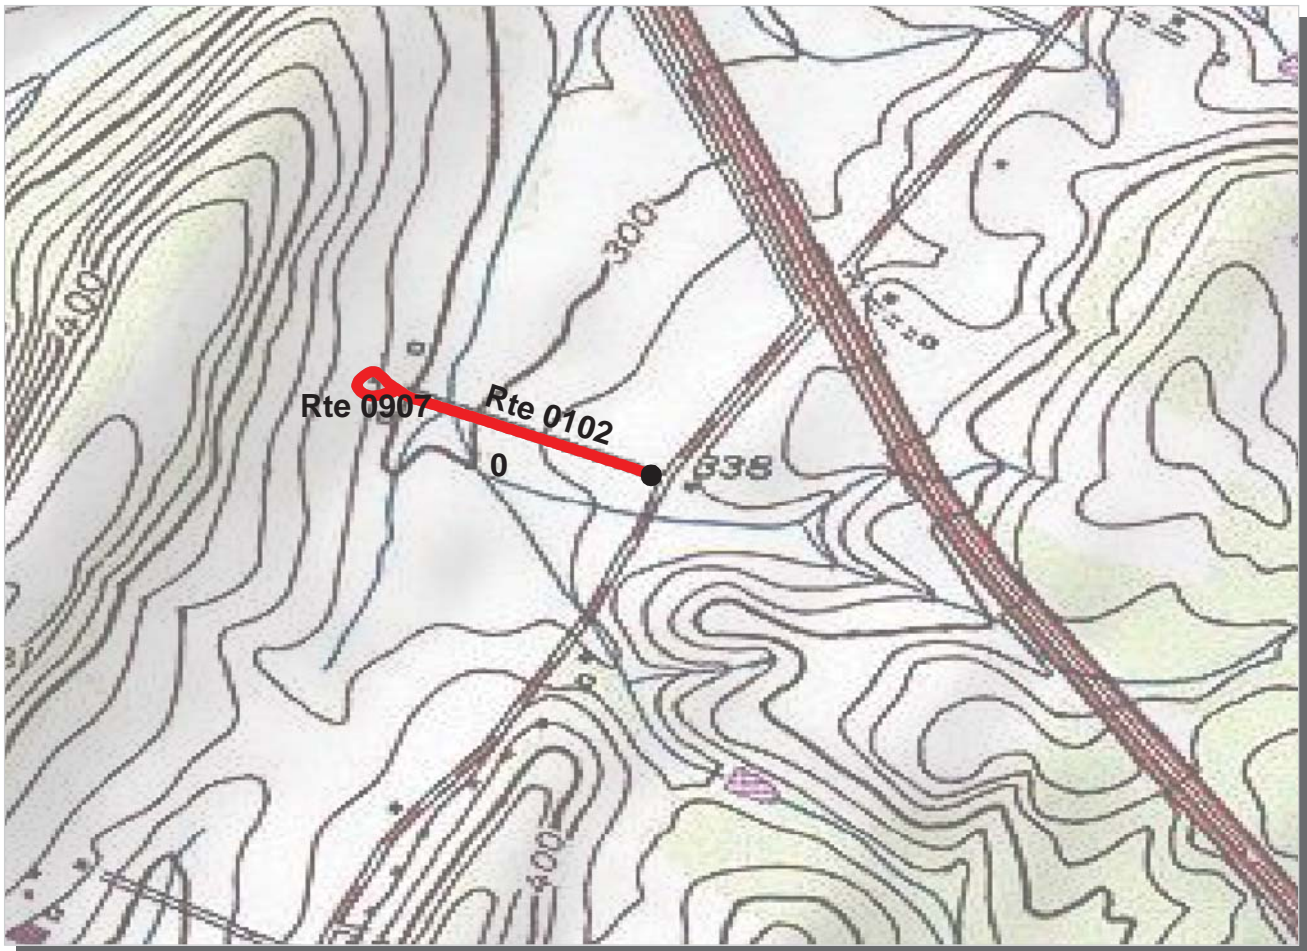
ROUTE: 0102 Baker Farm Lane

Section Number	0				
Section Length (mi)	0.31				
AADT	**				
SADT	**				
ADT Date	**				
Cross Section Information					
Number of Lanes	1				
Paved Width (ft)	10				
Lane Width (ft)	10				
Shoulder Width (ft)	5				
Roadway Condition Information					
PCR (Pavement Condition Rating)	29				
RCI (Roughness Condition Index)	50				
SCR (Surface Condition Rating)	23				
Alligator Cracking Index	54				
Rutting Index	45				
Patching Index	99				
Transverse Cracking Index	94				
Longitudinal Cracking Index	97				
Shoulder Condition Rating	GOOD				
Drainage Condition Rating	GOOD

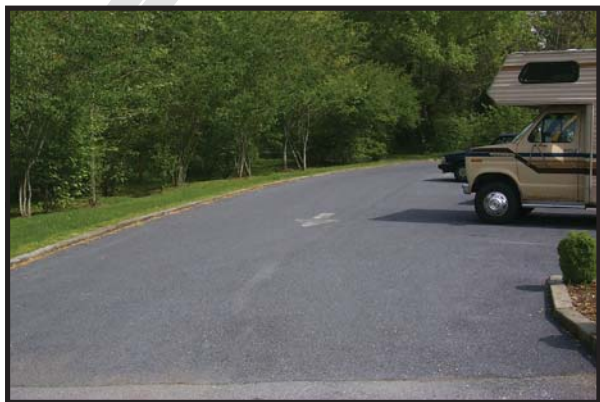
Route	Public / NonPublic	Date Visited	Area (sq ft)	Lane Miles *	Surface Type	Condition / PCR
0900	Public	5/6/2002	8295	0.14	AS	EXCELLENT / 97

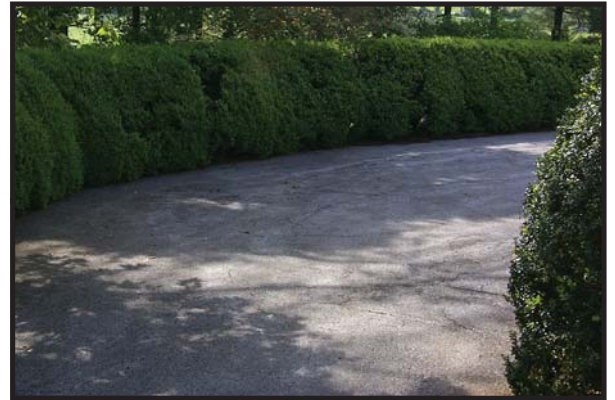
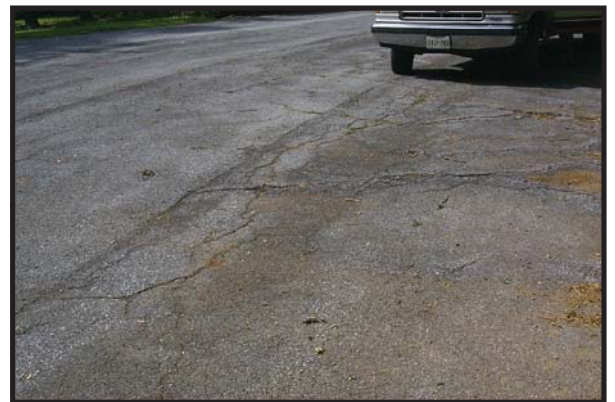
Route 0905

Route	Public / NonPublic	Date Visited	Area (sq ft)	Lane Miles *	Surface Type	Condition / PCR
0905	NonPublic	5/6/2002	4252	0.07	AS	FAIR / 73

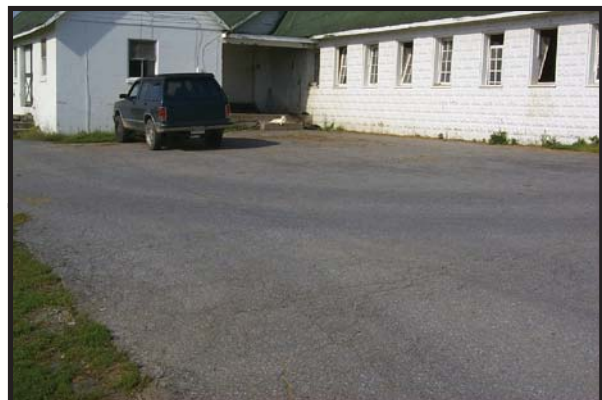
Route 0907

Route	Public / NonPublic	Date Visited	Area (sq ft)	Lane Miles *	Surface Type	Condition / PCR
0907	NonPublic	5/6/2002	2601	0.04	AS	POOR / 45
