The Road Inventory of Mount Rainier National Park MORA - 9450

Road Inventory Program

Prepared By:
Federal Highway Administration
Eastern Federal Lands Highway Division
Cycle 3

Mount Rainier National Park in Washington

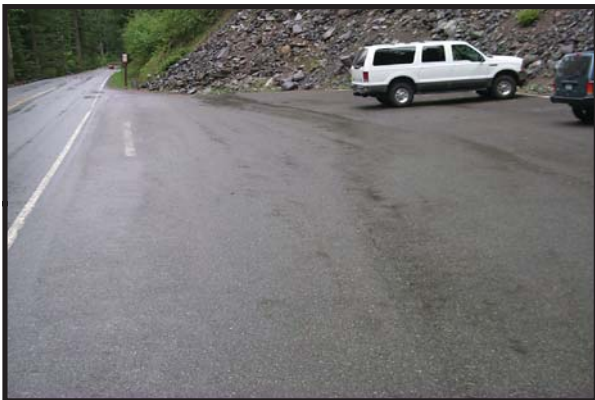
Route 0201

Route	Length (mi)	Width (ft)	Area (sq ft)	Lane Miles *	Condition / PCR	Surface Type
0201	0.97	0.00	56594	0.97	FAIR / 73	AS

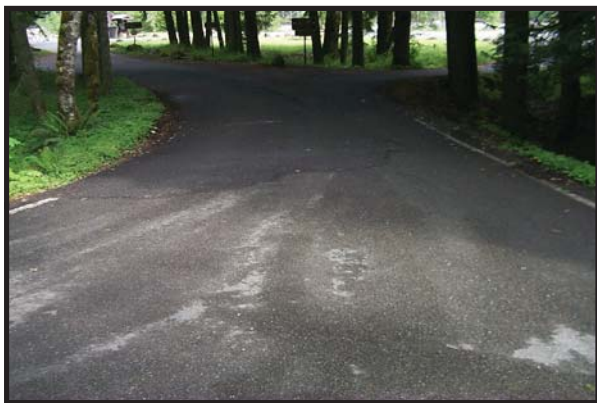
Route 0202

Route	Length (mi)	Width (ft)	Area (sq ft)	Lane Miles *	Condition / PCR	Surface Type
0202	0.86	0.00	159804	2.75	GOOD / 90	AS

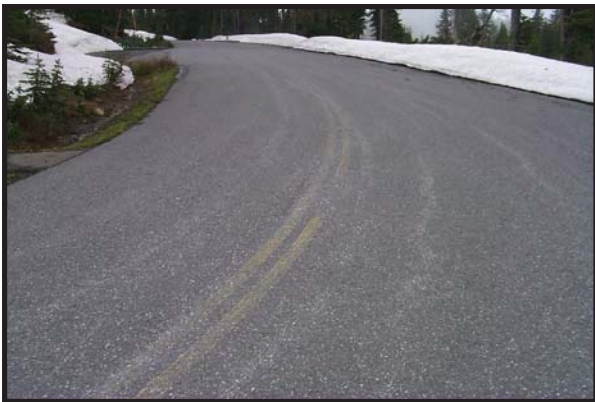
Route 0205

Route	Length (mi)	Width (ft)	Area (sq ft)	Lane Miles *	Condition / PCR	Surface Type
0205	0.39	26.00	53676	0.92	GOOD / 90	AS

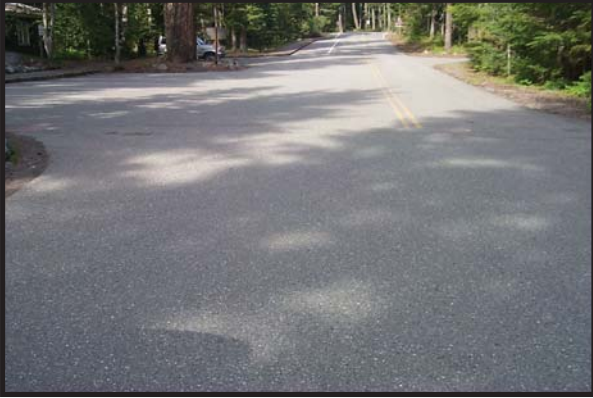
Route 0205A

Route	Length (mi)	Width (ft)	Area (sq ft)	Lane Miles *	Condition / PCR	Surface Type
0205A	0.27	13.00	18739	0.32	GOOD / 90	AS

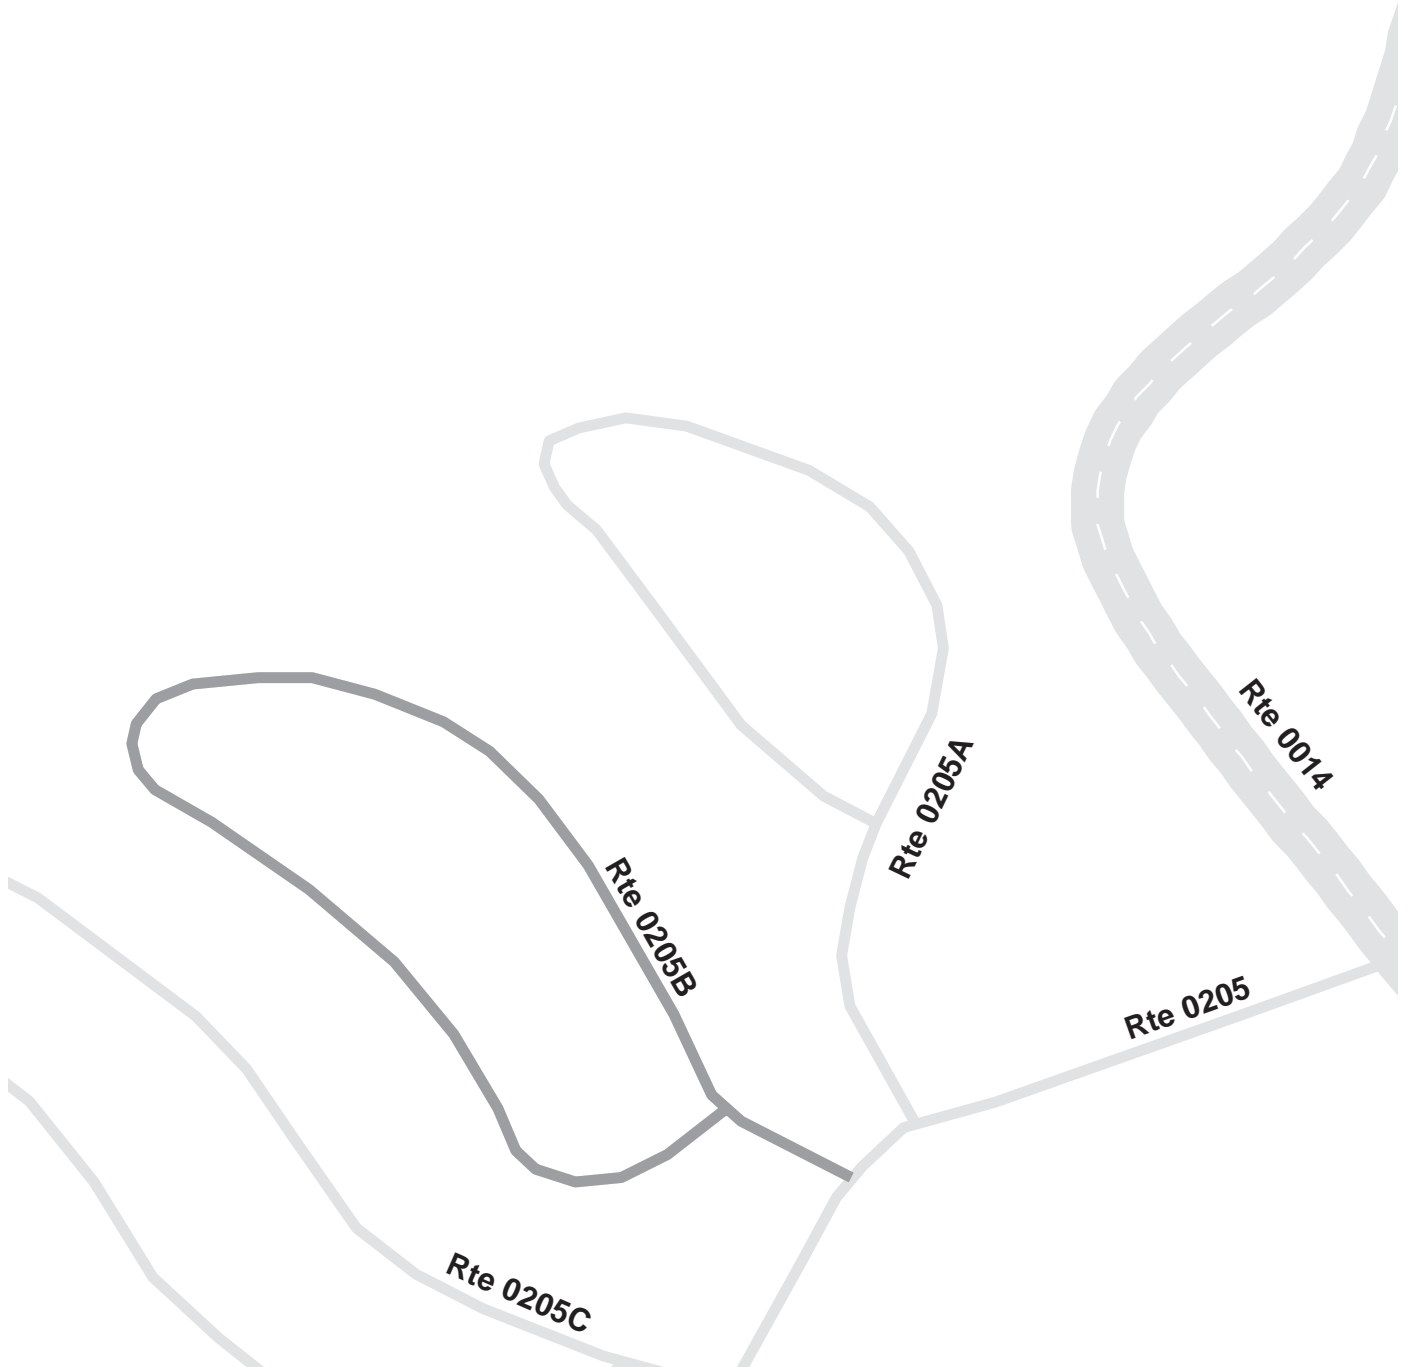
Mount Rainier National Park
Route 0205B
 Cougar Rock Campground Loop B
 From Route 0205

Route	Length (mi)	Width (ft)	Area (sq ft)	Lane Miles *	Condition / PCR	Surface Type
0205B	0.30	13.00	20592	0.35	GOOD / 90	AS

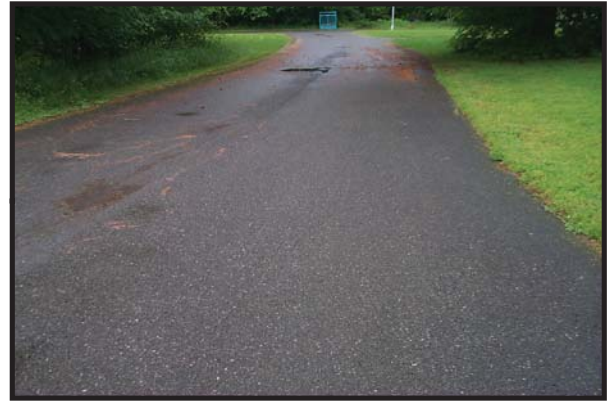
Mount Rainier National Park Route 0404

Route	Length (mi)	Width (ft)	Area (sq ft)	Lane Miles *	Condition / PCR	Surface Type
0404	0.10	0.00	6596	0.11	GOOD / 90	AS

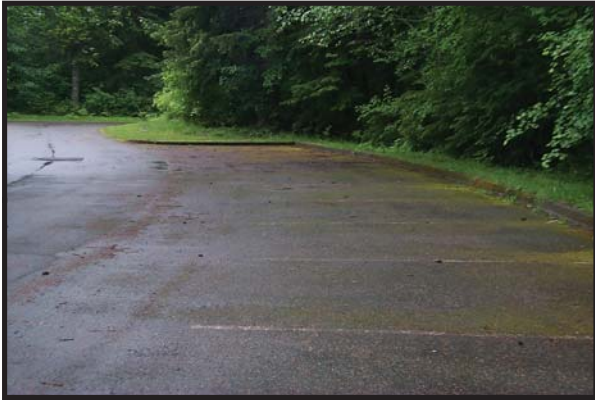
Route 0901

Route	Public / NonPublic	Date Visited	Area (sq ft)	Lane Miles *	Surface Type	Condition / PCR
0901	NonPublic	6/10/2001	6979	0.12	AS	POOR / 45

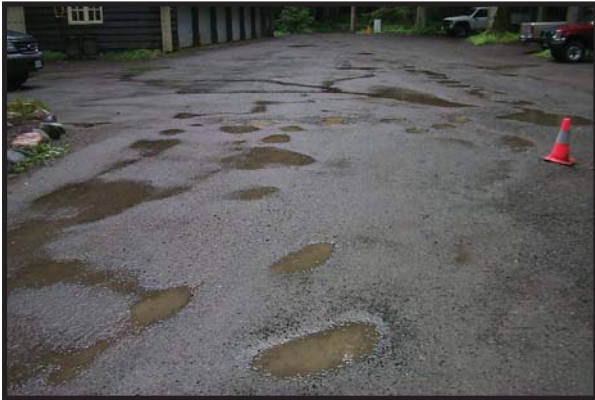
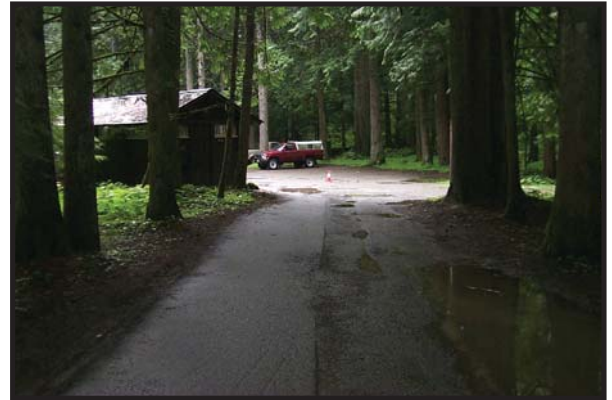
Route 0902

Route	Public / NonPublic	Date Visited	Area (sq ft)	Lane Miles *	Surface Type	Condition / PCR
0902	Public	6/10/2001	17750	0.31	AS	FAIR / 73

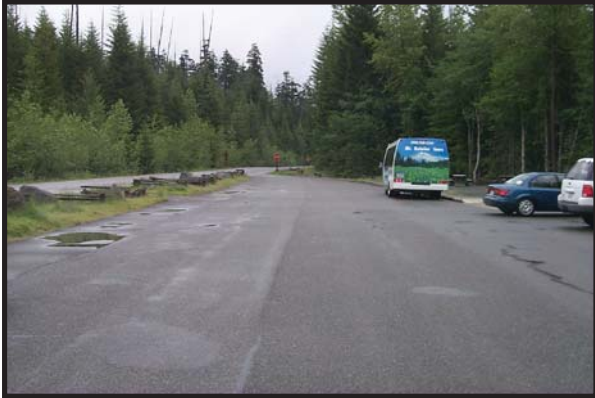
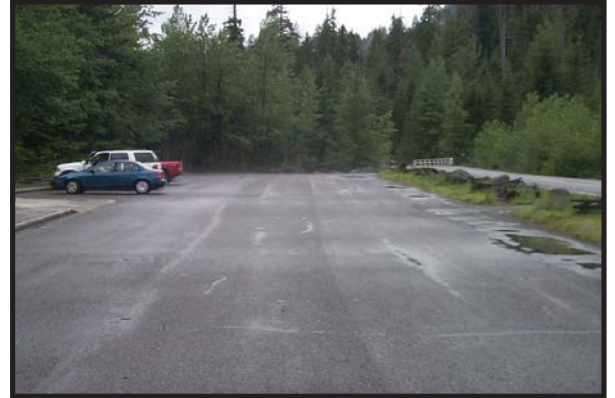
Route 0903A

Route	Public / NonPublic	Date Visited	Area (sq ft)	Lane Miles *	Surface Type	Condition / PCR
0903A	Public	6/10/2001	55688	0.96	AS	GOOD / 90

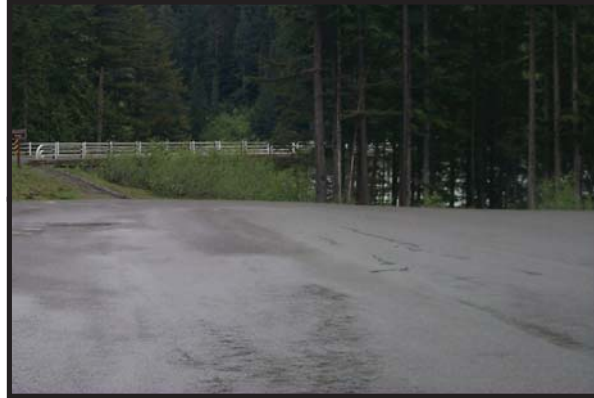
Route 0910B

Route	Public / NonPublic	Date Visited	Area (sq ft)	Lane Miles *	Surface Type	Condition / PCR
0910B	Public	6/8/2001	9783	0.17	AS	GOOD / 90

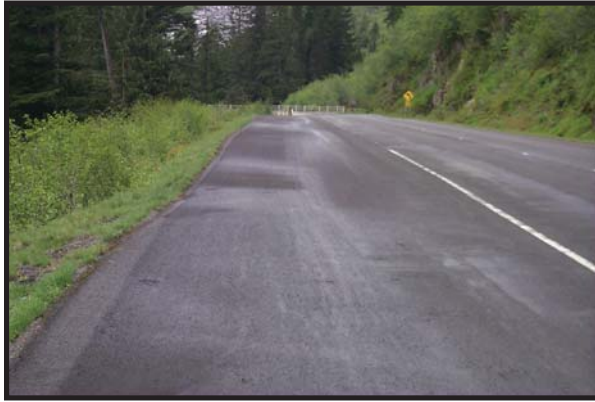
Route 0911

Route	Public / NonPublic	Date Visited	Area (sq ft)	Lane Miles *	Surface Type	Condition / PCR
0911	Public	6/8/2001	34816	0.60	AS	GOOD / 90

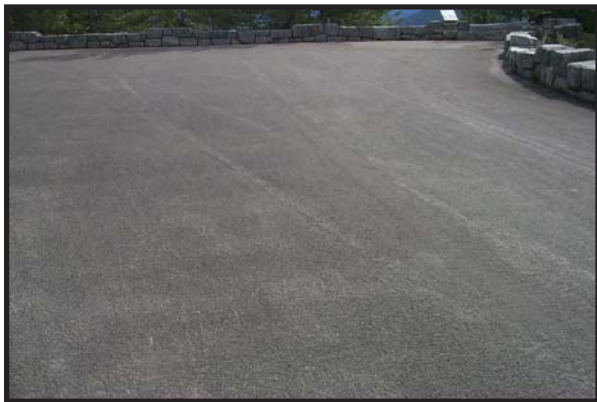
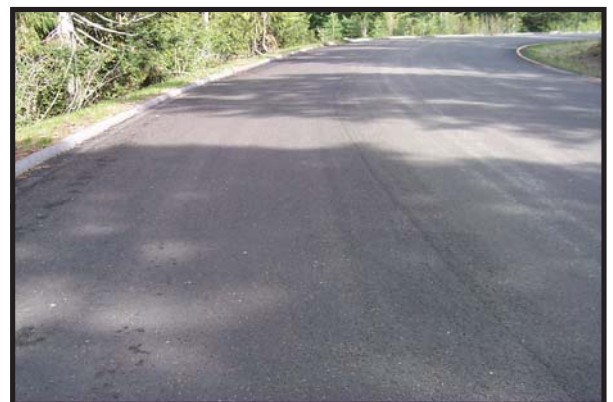
Route 0912

Route	Public / NonPublic	Date Visited	Area (sq ft)	Lane Miles *	Surface Type	Condition / PCR
0912	Public	6/9/2001	14682	0.25	AS	GOOD / 90

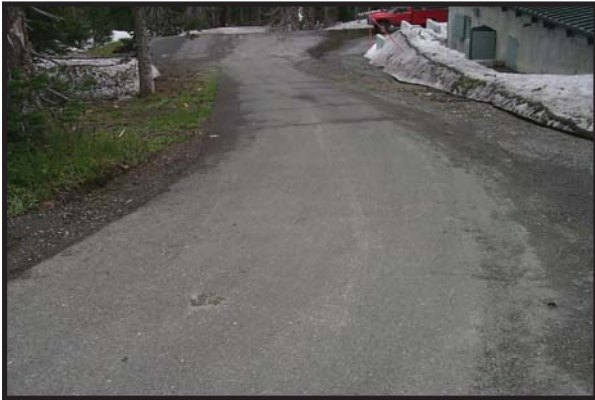
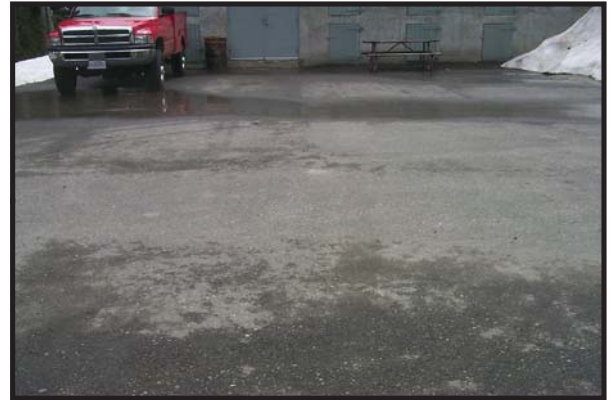
Route 0915

Route	Public / NonPublic	Date Visited	Area (sq ft)	Lane Miles *	Surface Type	Condition / PCR
0915	Public	6/9/2001	73481	1.27	AS	GOOD / 90

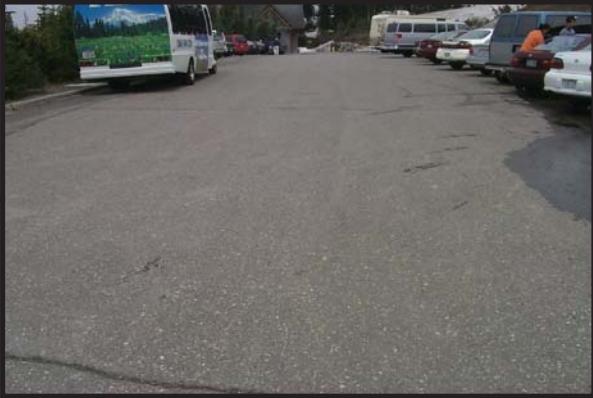
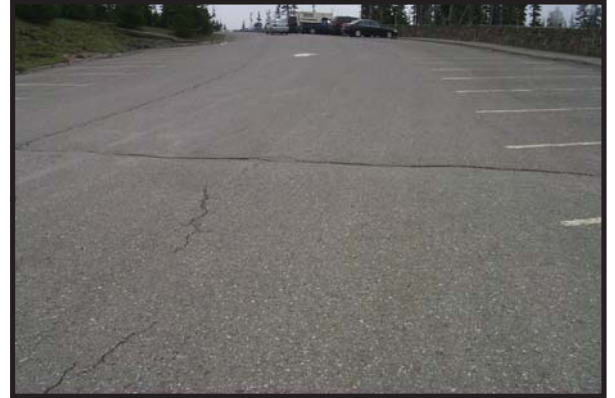
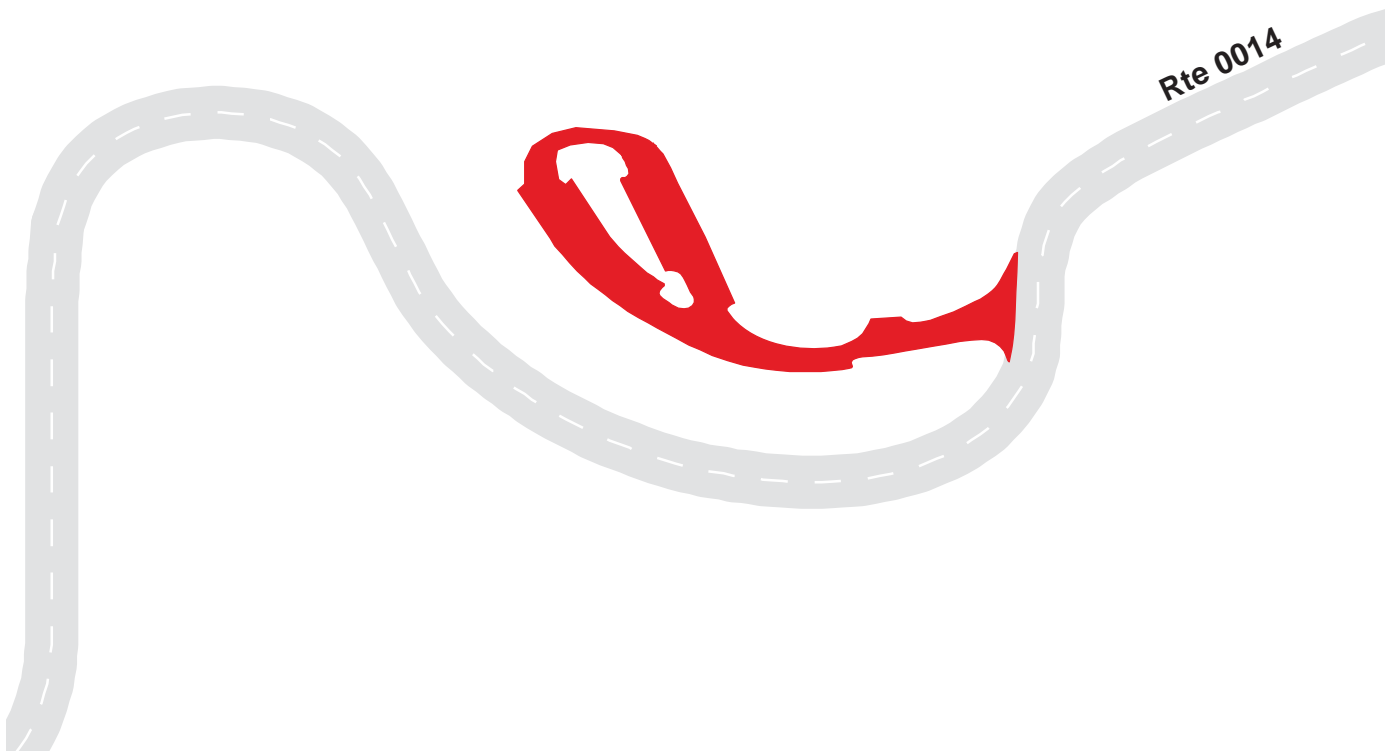
Route	Public / NonPublic	Date Visited	Area (sq ft)	Lane Miles *	Surface Type	Condition / PCR
0916	Public	6/9/2001	227677	3.92	AS	FAIR / 73

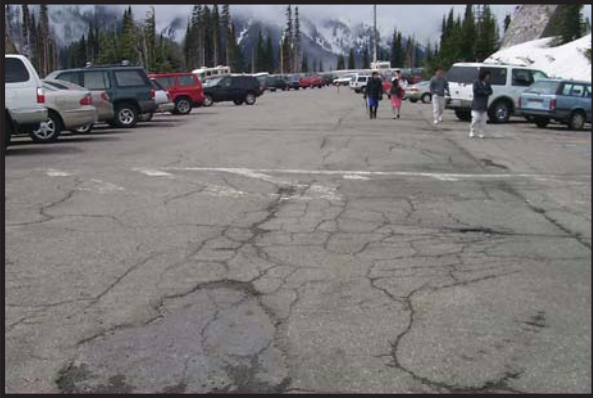
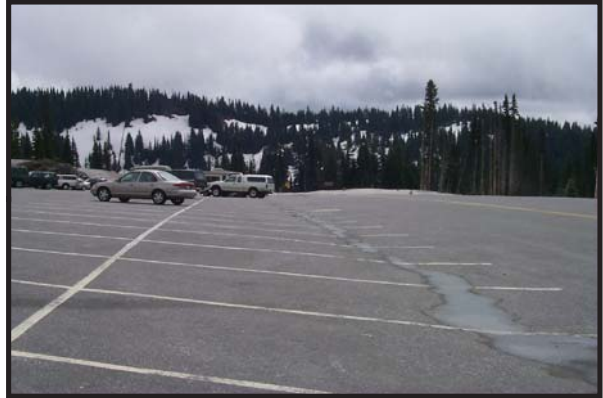
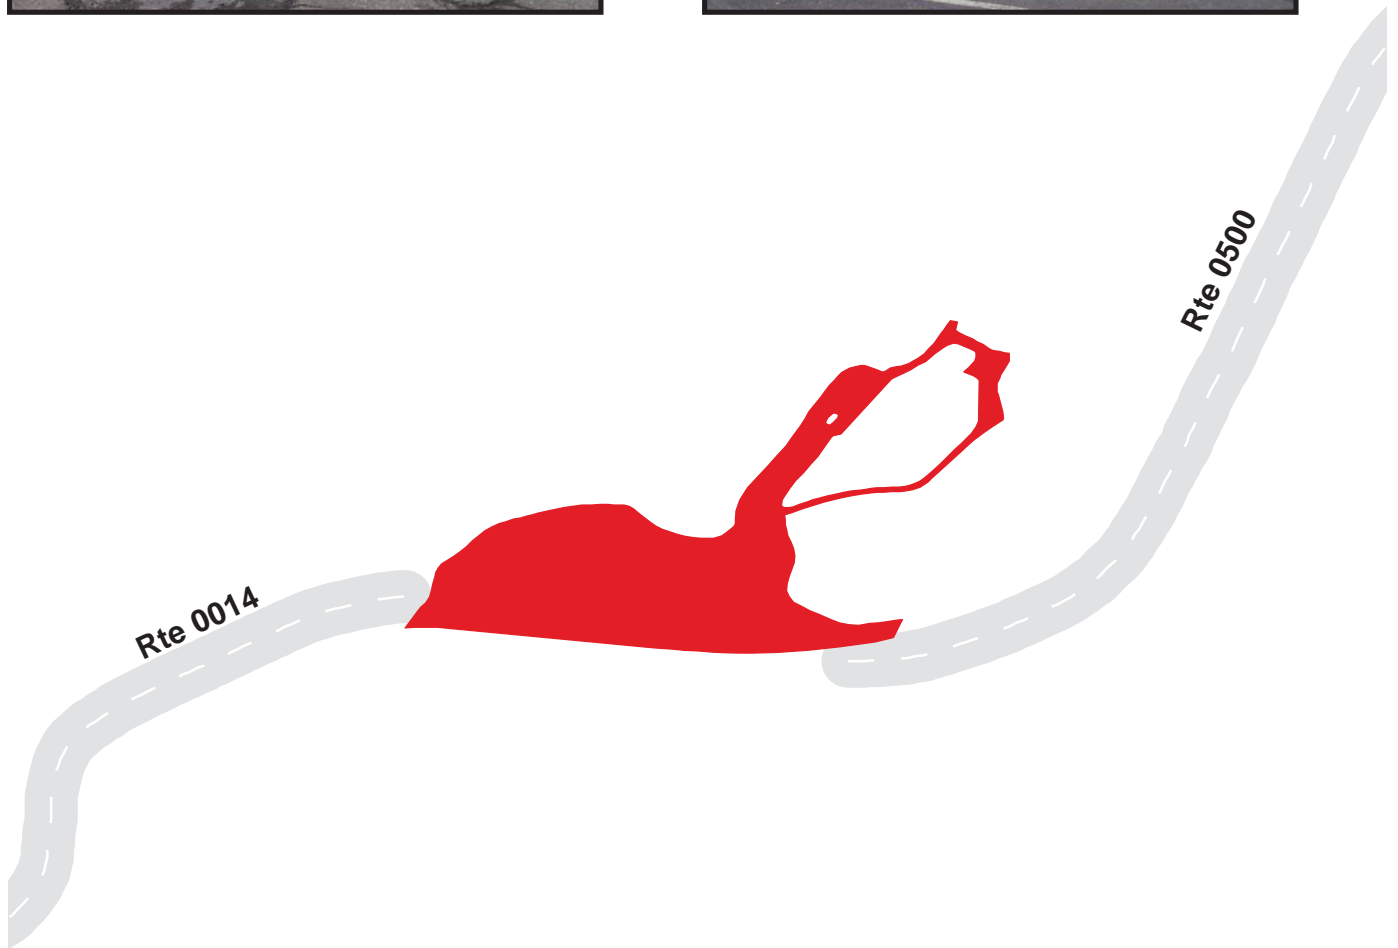
Route 0917

Route	Public / NonPublic	Date Visited	Area (sq ft)	Lane Miles *	Surface Type	Condition / PCR
0917	Public	6/9/2001	13408	0.23	AS	FAIR / 73

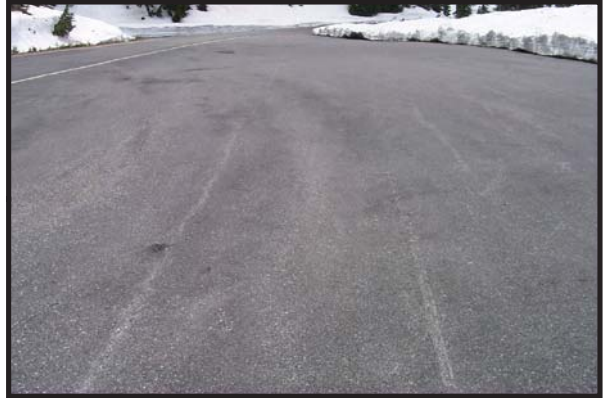
Route 0918

Route	Public / NonPublic	Date Visited	Area (sq ft)	Lane Miles *	Surface Type	Condition / PCR
0918	Public	6/8/2001	7707	0.13	AS	POOR / 45

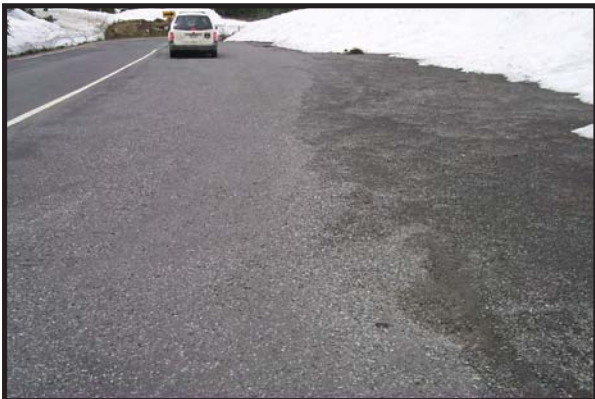
Route 0919

Route	Public / NonPublic	Date Visited	Area (sq ft)	Lane Miles *	Surface Type	Condition / PCR
0919	Public	6/9/2001	16136	0.28	AS	GOOD / 90

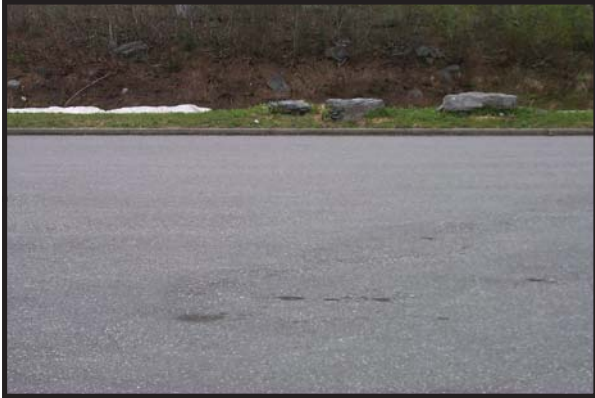
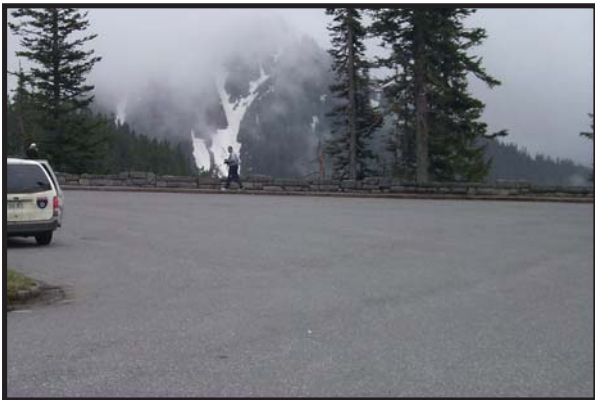
Route 0920A

Route	Public / NonPublic	Date Visited	Area (sq ft)	Lane Miles *	Surface Type	Condition / PCR
0920A	Public	6/9/2001	7889	0.14	AS	GOOD / 90

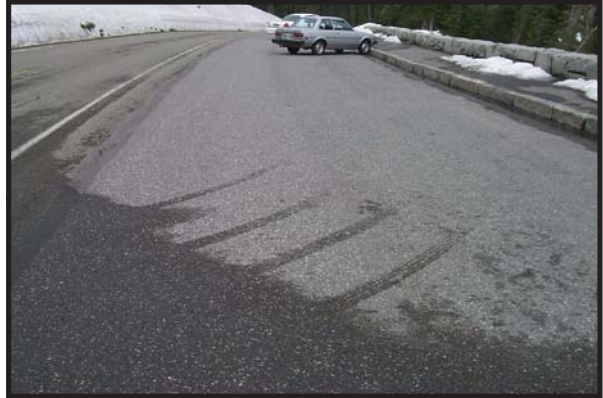
Route 0920B

Route	Public / NonPublic	Date Visited	Area (sq ft)	Lane Miles *	Surface Type	Condition / PCR
0920B	Public	6/9/2001	5805	0.10	AS	GOOD / 90

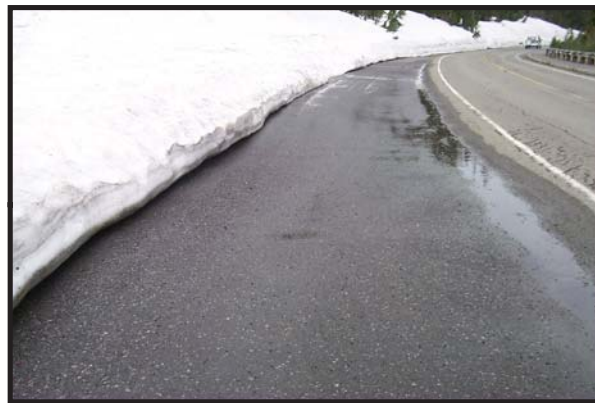
Route 0920C

Route	Public / NonPublic	Date Visited	Area (sq ft)	Lane Miles *	Surface Type	Condition / PCR
0920C	Public	6/9/2001	7145	0.12	AS	GOOD / 90

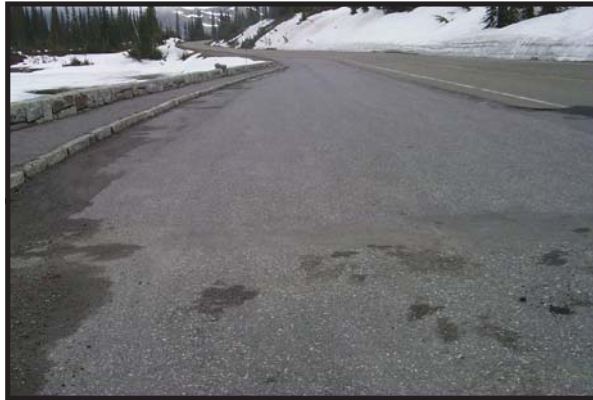
Route 0921

Route	Public / NonPublic	Date Visited	Area (sq ft)	Lane Miles *	Surface Type	Condition / PCR
0921	Public	6/9/2001	7300	0.13	AS	GOOD / 90

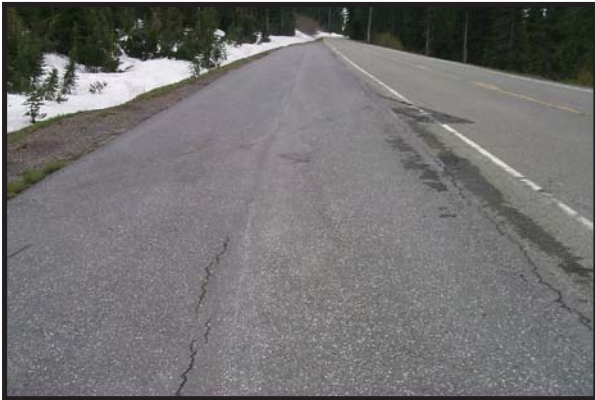
Route 0922

Route	Public / NonPublic	Date Visited	Area (sq ft)	Lane Miles *	Surface Type	Condition / PCR
0922	Public	6/9/2001	18799	0.32	AS	FAIR / 73

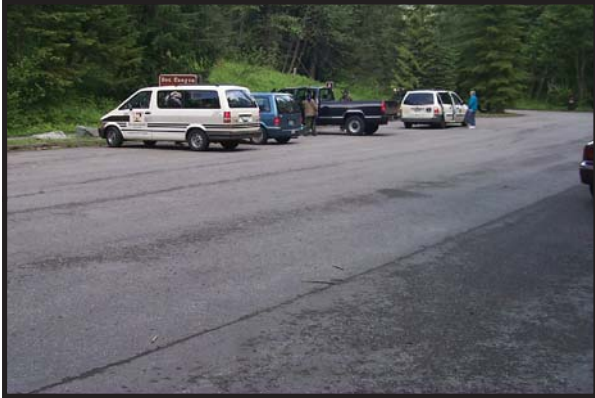
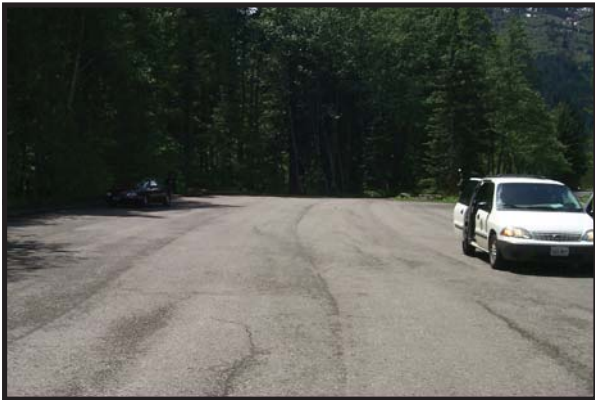
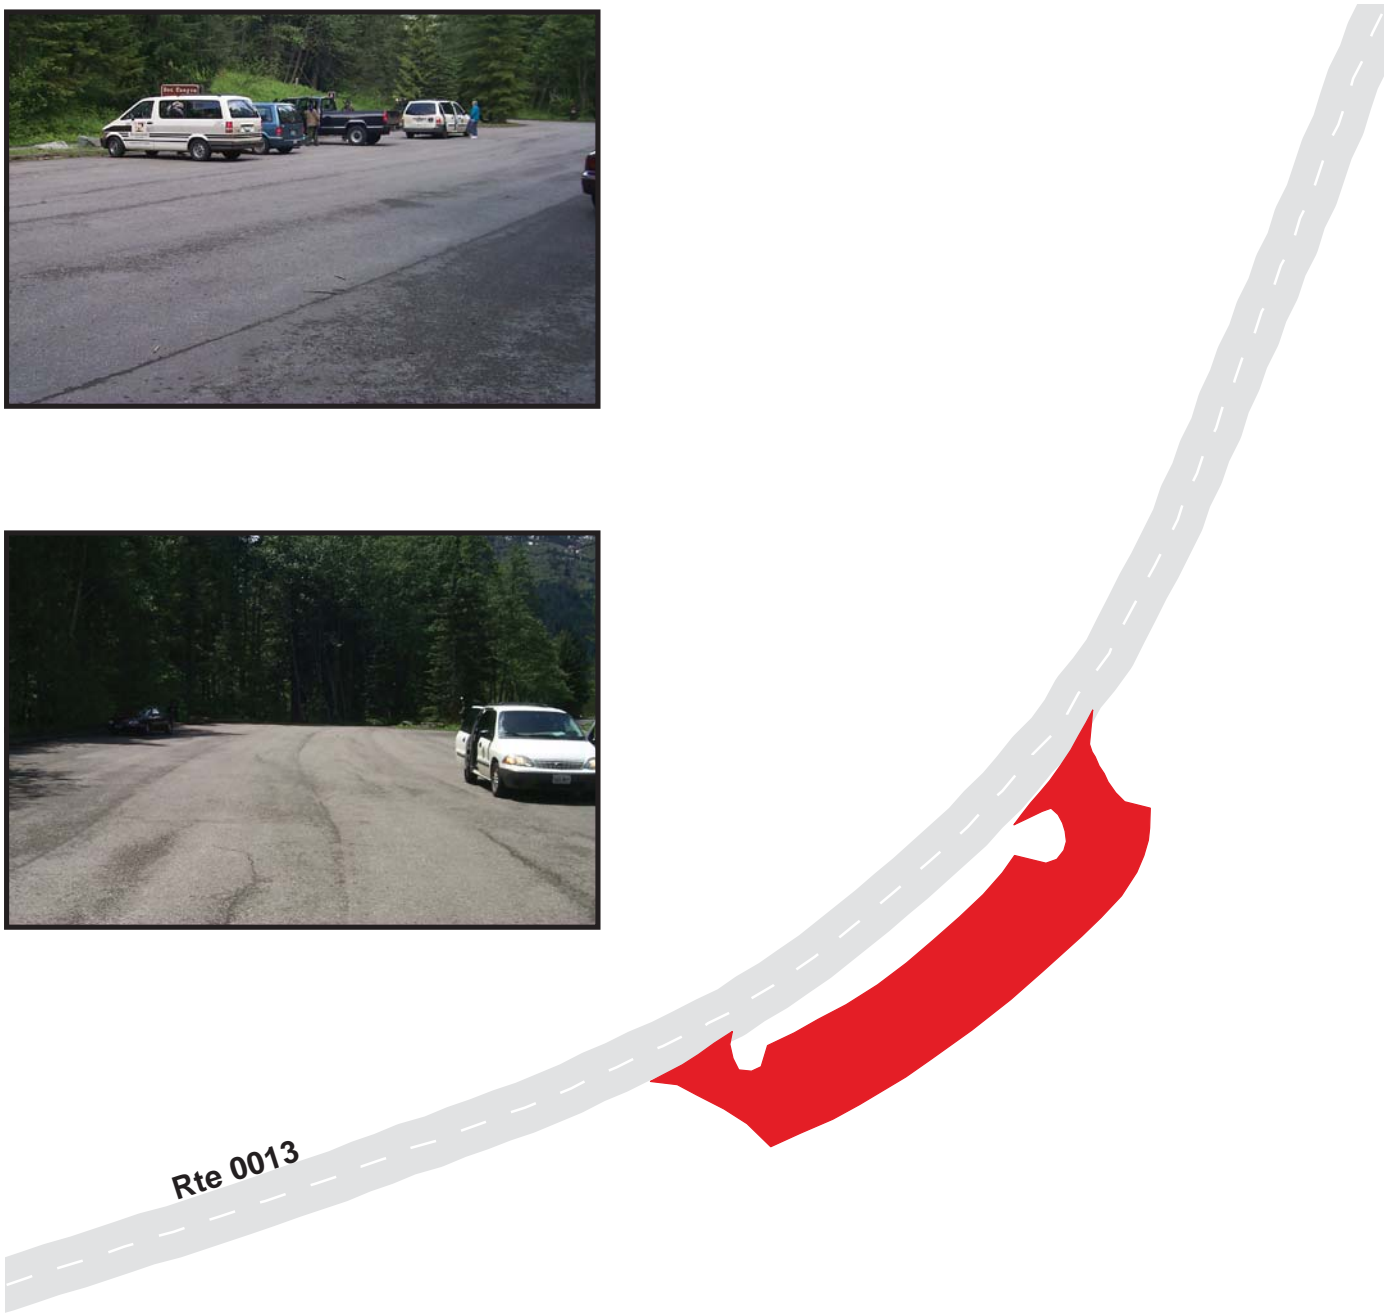
Route 0923

Route	Public / NonPublic	Date Visited	Area (sq ft)	Lane Miles *	Surface Type	Condition / PCR
0923	Public	6/9/2001	13852	0.24	AS	GOOD / 90

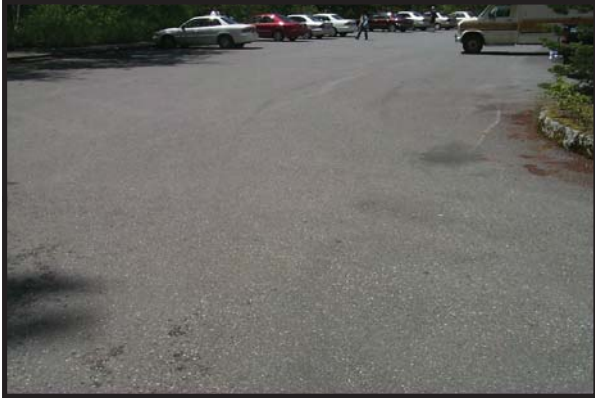
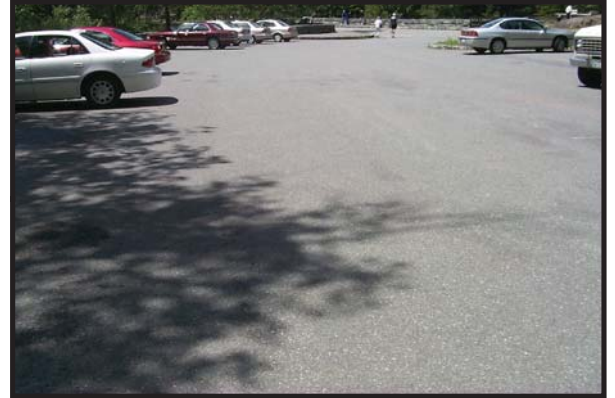
Route 0924

Route	Public / NonPublic	Date Visited	Area (sq ft)	Lane Miles *	Surface Type	Condition / PCR
0924	Public	6/9/2001	8885	0.15	AS	GOOD / 90

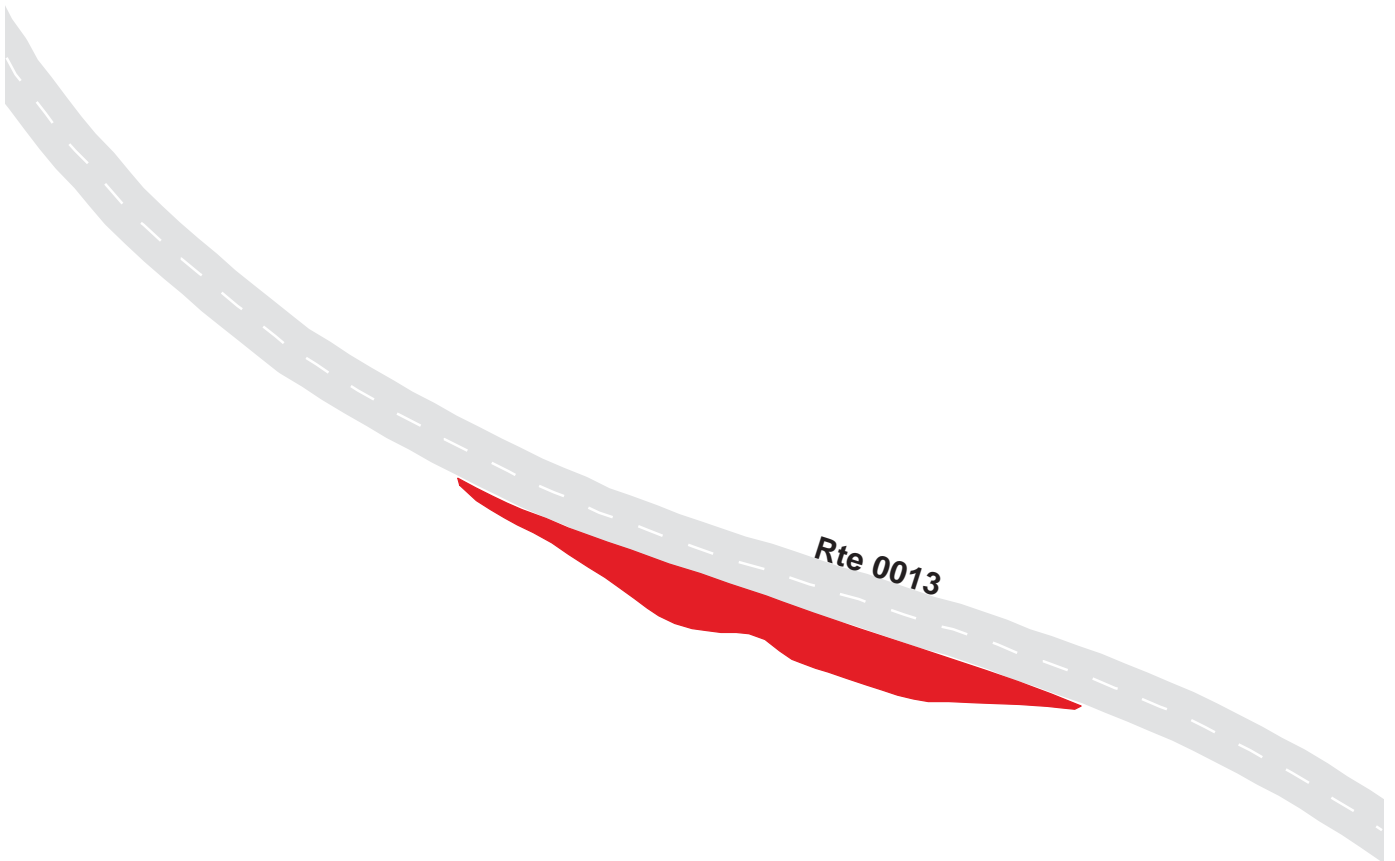
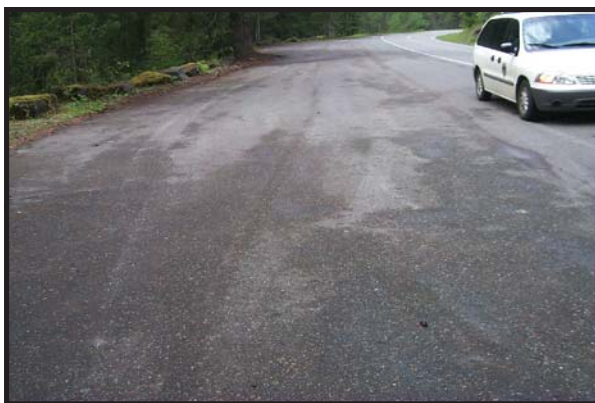
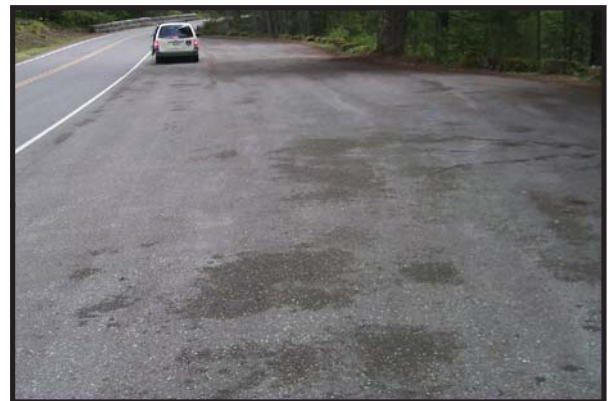
Route 0925

Route	Public / NonPublic	Date Visited	Area (sq ft)	Lane Miles *	Surface Type	Condition / PCR
0925	Public	6/9/2001	21038	0.36	AS	GOOD / 90

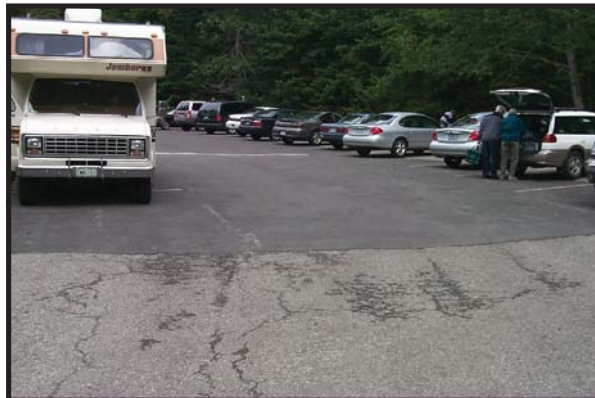
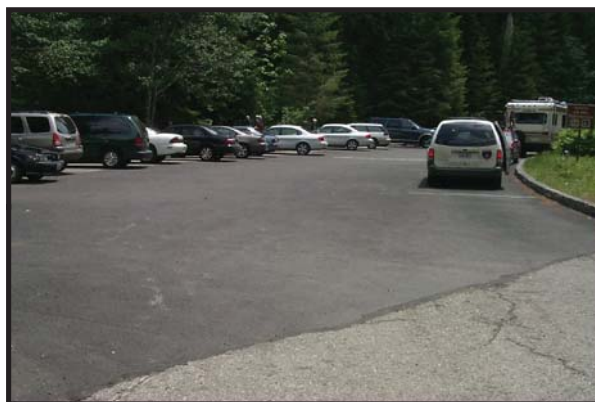
Route 0927

Route	Public / NonPublic	Date Visited	Area (sq ft)	Lane Miles *	Surface Type	Condition / PCR
0927	NonPublic	6/8/2001	82276	1.42	AS	GOOD / 90

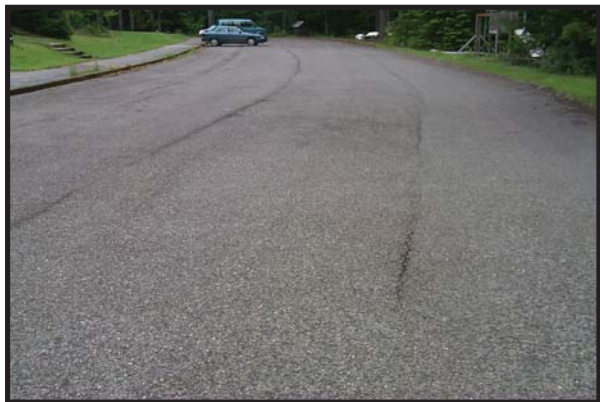
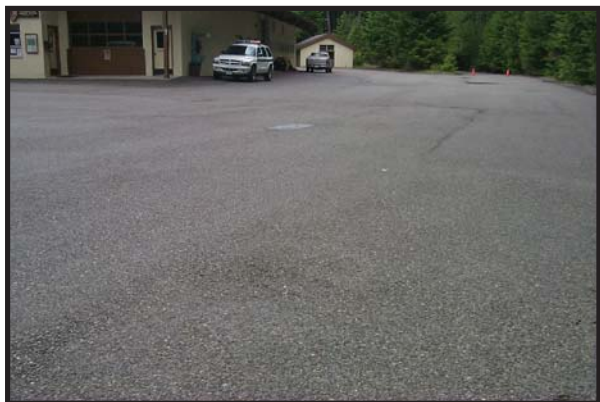
Route 0928

Route	Public / NonPublic	Date Visited	Area (sq ft)	Lane Miles *	Surface Type	Condition / PCR
0928	Public	6/8/2001	43561	0.75	AS	GOOD / 90

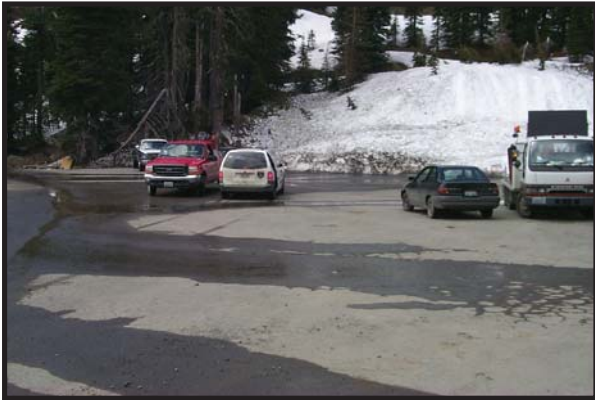
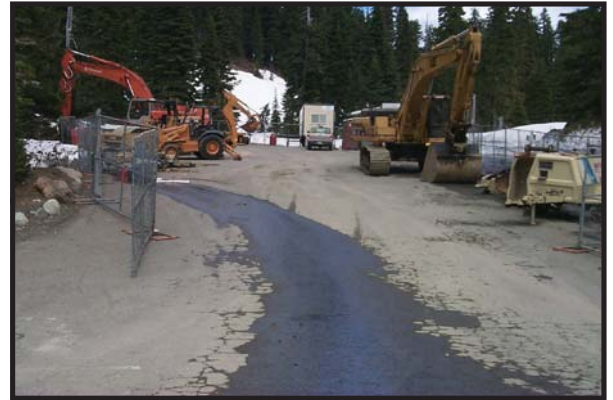
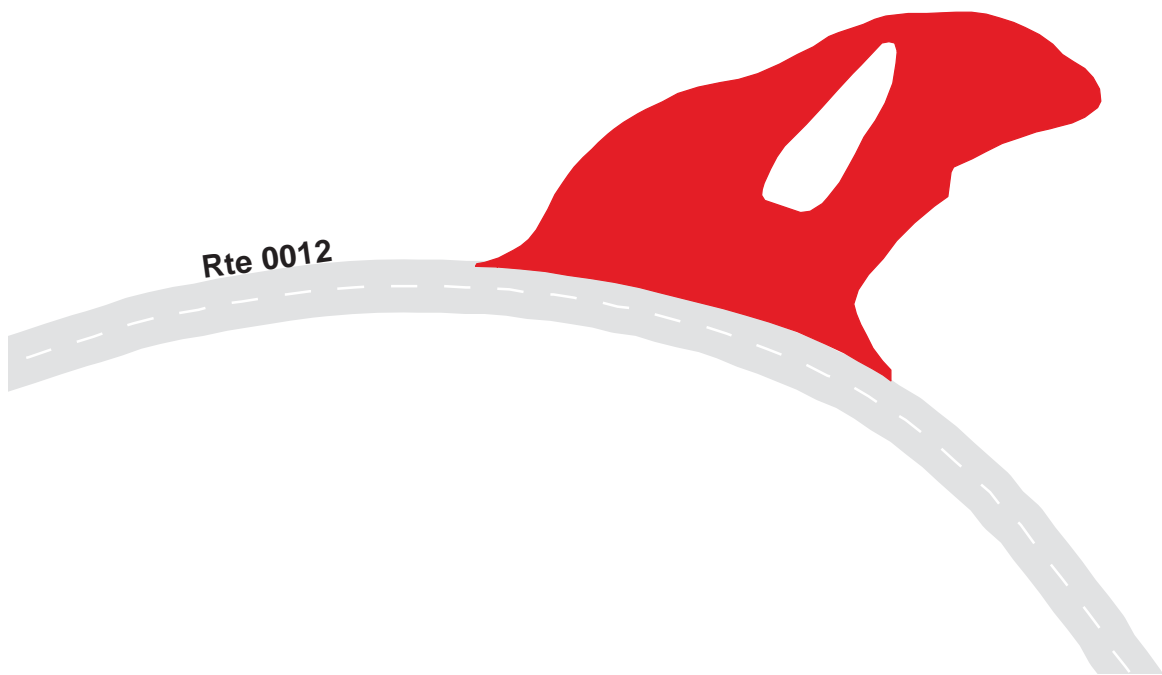
Route 0929

Route	Public / NonPublic	Date Visited	Area (sq ft)	Lane Miles *	Surface Type	Condition / PCR
0929	NonPublic	6/8/2001	19785	0.34	AS	POOR / 45

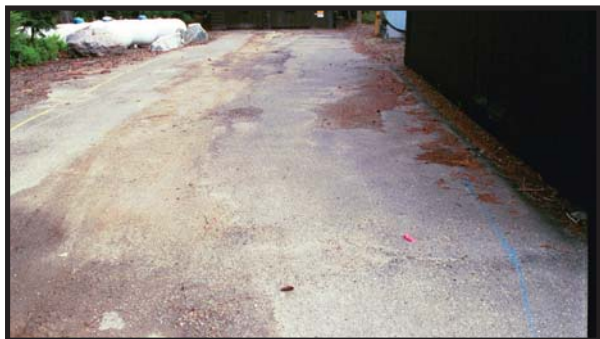
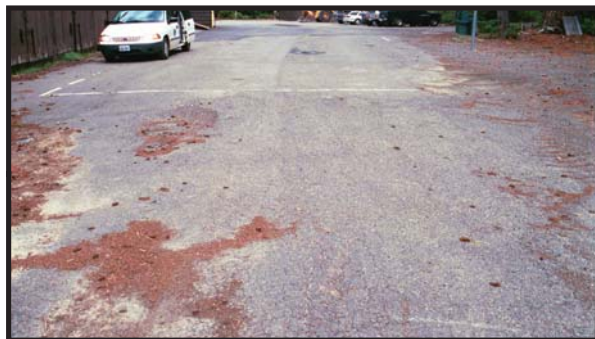
Route 0930A

Route	Public / NonPublic	Date Visited	Area (sq ft)	Lane Miles *	Surface Type	Condition / PCR
0930A	Public	6/8/2001	12503	0.22	AS	GOOD / 90

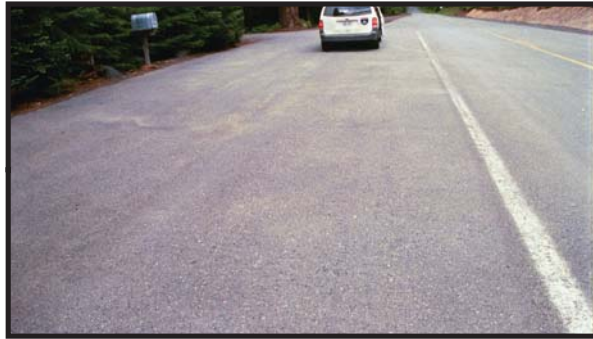
Route 0930B

Route	Public / NonPublic	Date Visited	Area (sq ft)	Lane Miles *	Surface Type	Condition / PCR
0930B	Public	6/8/2001	2223	0.04	AS	GOOD / 90

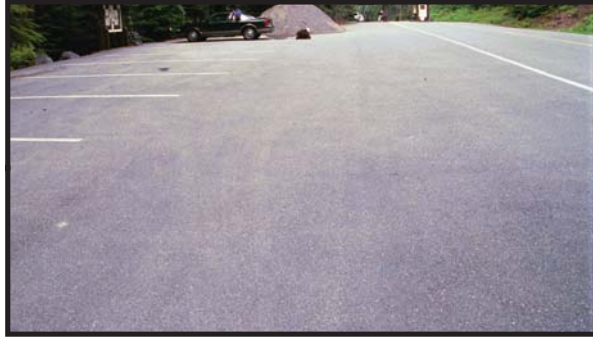
Route 0931

Route	Public / NonPublic	Date Visited	Area (sq ft)	Lane Miles *	Surface Type	Condition / PCR
0931	Public	6/8/2001	2608	0.04	AS	POOR / 45

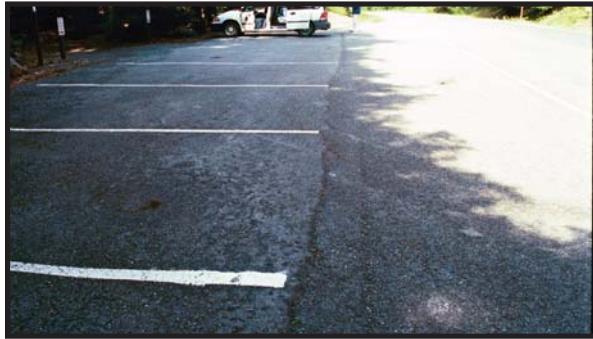
Route 0932

Route	Public / NonPublic	Date Visited	Area (sq ft)	Lane Miles *	Surface Type	Condition / PCR
0932	Public	6/8/2001	2195	0.04	AS	GOOD / 90

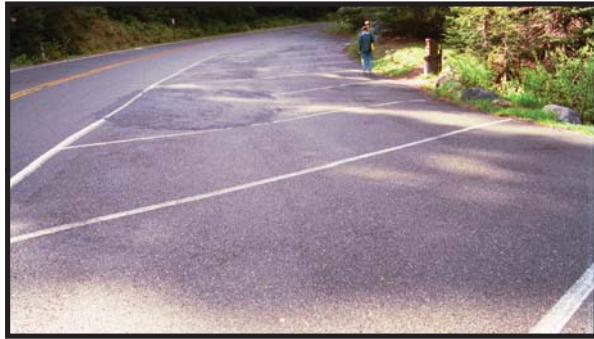
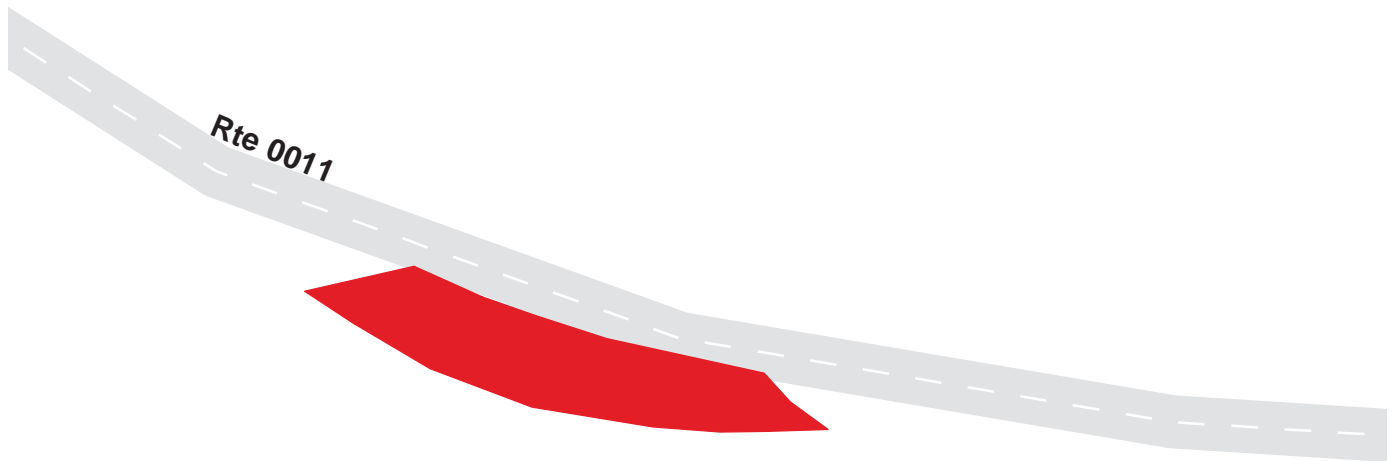
Route 0933

Route	Public / NonPublic	Date Visited	Area (sq ft)	Lane Miles *	Surface Type	Condition / PCR
0933	Public	6/8/2001	7422	0.13	AS	FAIR / 73

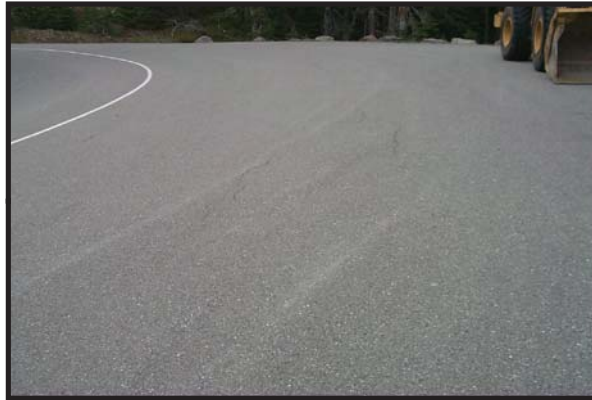
Mount Rainier National Park
Route 0934A
Sunrise Point Parking A
From Route 0011 at MP 12.75 on Left

Route	Public / NonPublic	Date Visited	Area (sq ft)	Lane Miles *	Surface Type	Condition / PCR
0934A	Public	6/10/2001	22333	0.38	AS	FAIR / 73

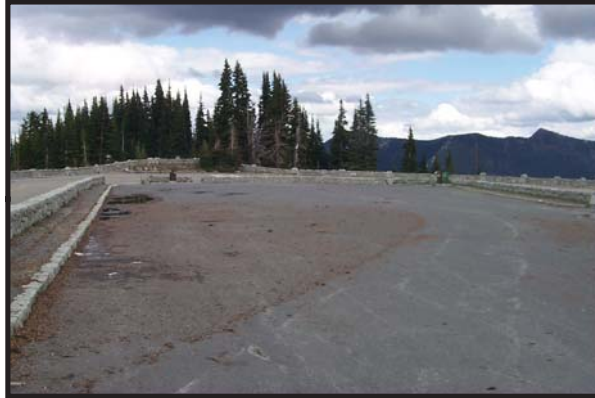
Route 0934B

Route	Public / NonPublic	Date Visited	Area (sq ft)	Lane Miles *	Surface Type	Condition / PCR
0934B	Public	6/10/2001	1870	0.03	AS	FAIR / 73

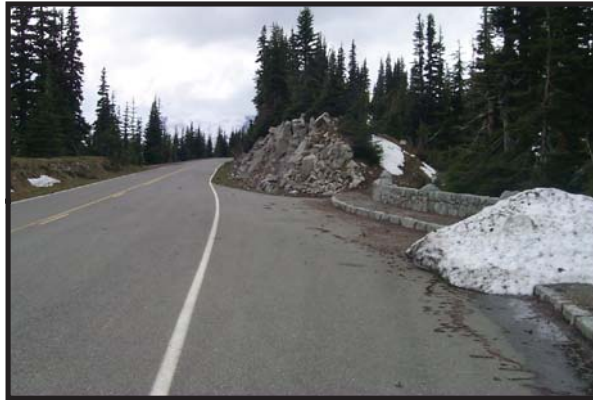
Route 0935

Route	Public / NonPublic	Date Visited	Area (sq ft)	Lane Miles *	Surface Type	Condition / PCR
0935	Public	6/10/2001	115525	1.99	AS	GOOD / 90

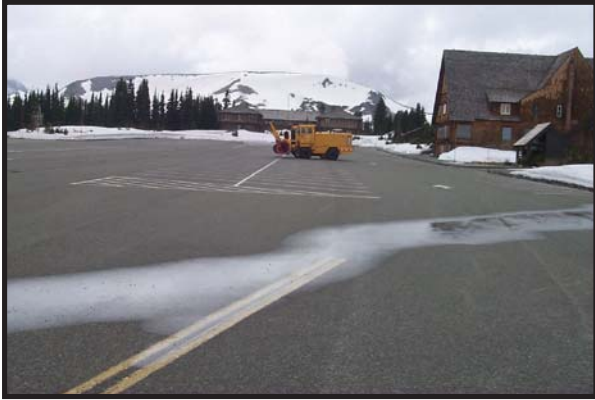
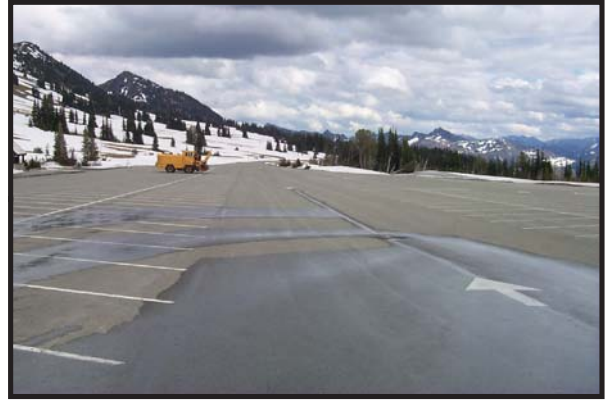
Route 0936

Route	Public / NonPublic	Date Visited	Area (sq ft)	Lane Miles *	Surface Type	Condition / PCR
0936	Public	6/9/2001	15425	0.27	AS	FAIR / 73

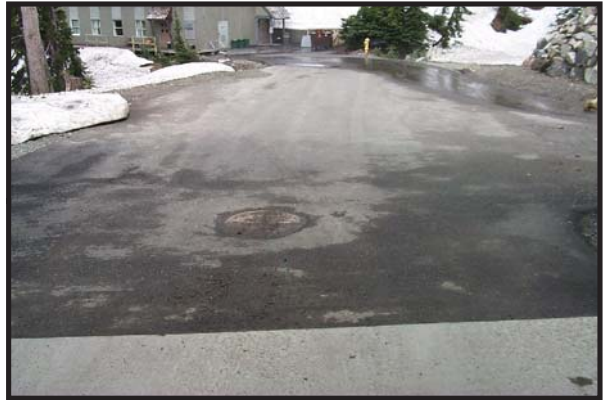
Route 0938

Route	Public / NonPublic	Date Visited	Area (sq ft)	Lane Miles *	Surface Type	Condition / PCR
0938	Public	6/9/2001	6908	0.12	AS	GOOD / 90
