The Road Inventory of Mount Rainier National Park MORA - 9450

Road Inventory Program

Prepared By:
Federal Highway Administration
Eastern Federal Lands Highway Division
Cycle 3

Mount Rainier National Park in Washington

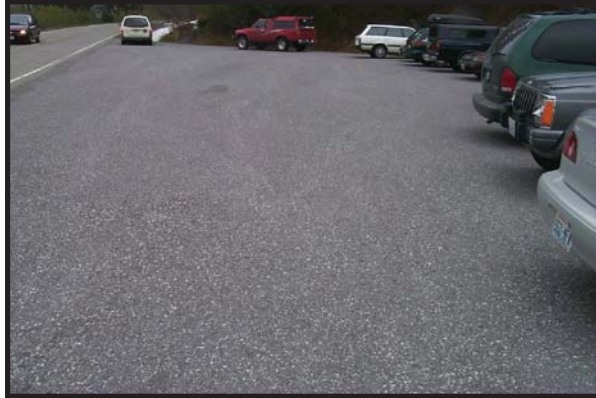
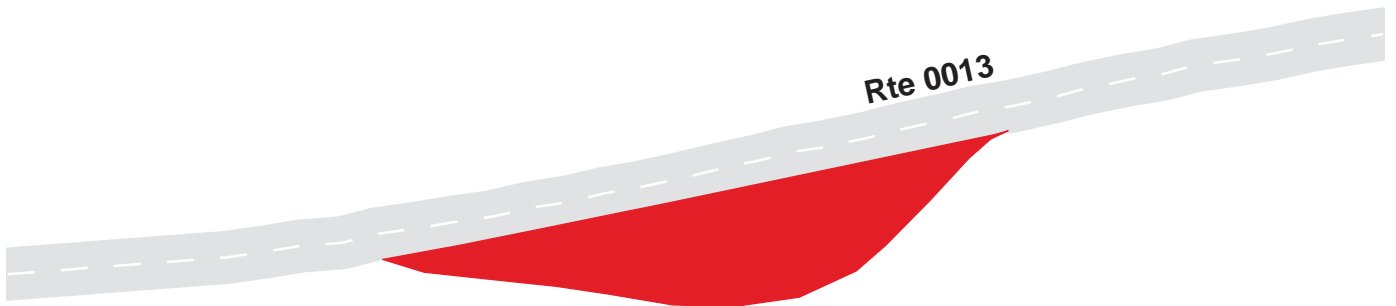
Route 0939

Route	Public / NonPublic	Date Visited	Area (sq ft)	Lane Miles *	Surface Type	Condition / PCR
0939	Public	6/9/2001	2342	0.04	AS	FAIR / 73

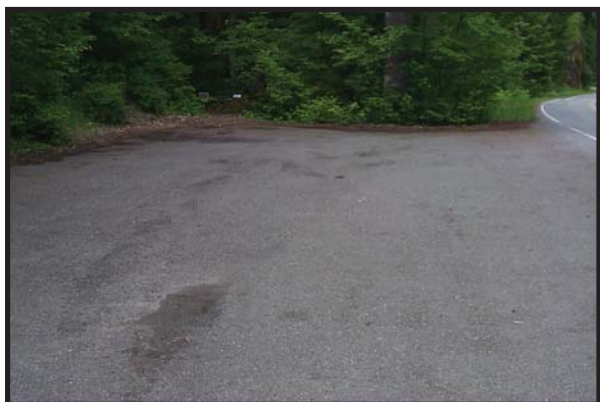
Route 0940A

Route	Public / NonPublic	Date Visited	Area (sq ft)	Lane Miles *	Surface Type	Condition / PCR
0940A	Public	6/10/2001	2517	0.04	AS	FAIR / 73

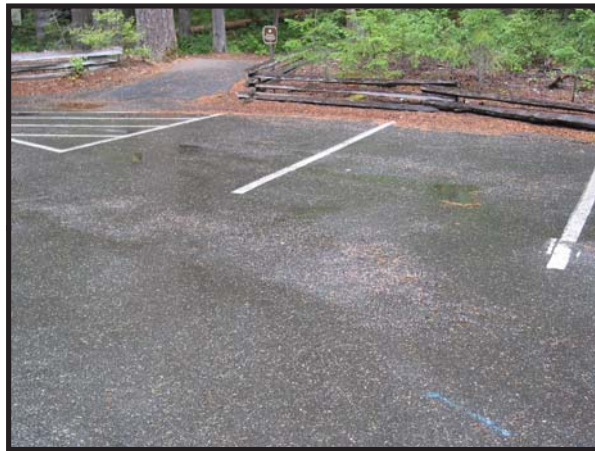
Route 0940C

Route	Public / NonPublic	Date Visited	Area (sq ft)	Lane Miles *	Surface Type	Condition / PCR
0940C	Public	6/10/2001	2625	0.05	AS	GOOD / 90

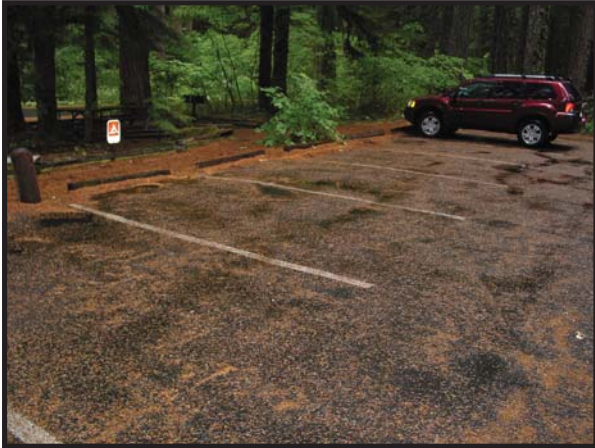
Route 0940D

Route	Public / NonPublic	Date Visited	Area (sq ft)	Lane Miles *	Surface Type	Condition / PCR
0940D	Public	6/10/2001	3724	0.06	AS	GOOD / 90

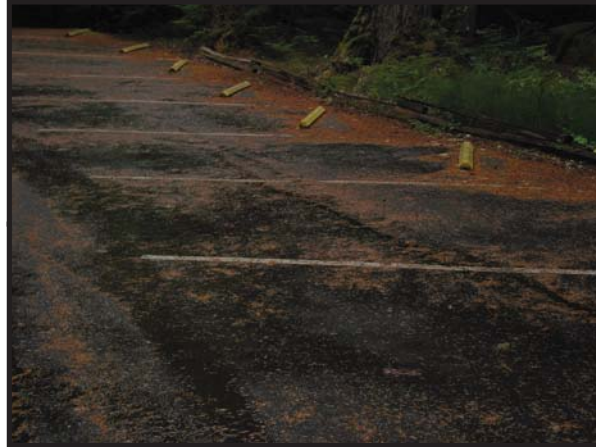
Route 0941A

Route	Public / NonPublic	Date Visited	Area (sq ft)	Lane Miles *	Surface Type	Condition / PCR
0941A	NonPublic	6/10/2001	3130	0.05	AS	GOOD / 90
