The Road Inventory of Morristown National Historical Park MORR - 1830

Prepared By:
Federal Highway Administration
Eastern Federal Lands Highway Division
Cycle 3

Morristown National Historical Park in New Jersey

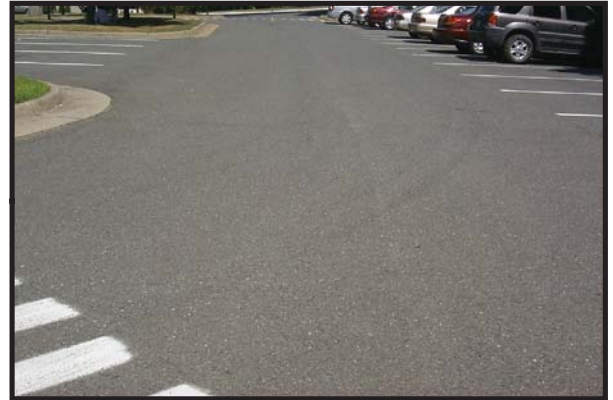
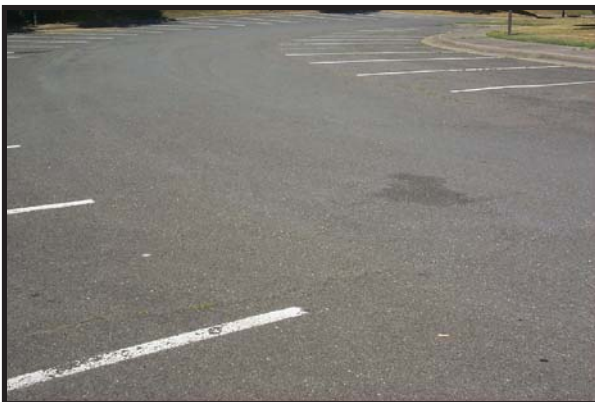
Route	Public / NonPublic	Date Visited	Area (sq ft)	Lane Miles *	Surface Type	Condition / PCR
0900	Public	8/8/2002	25242	0.43	AS	FAIR / 73

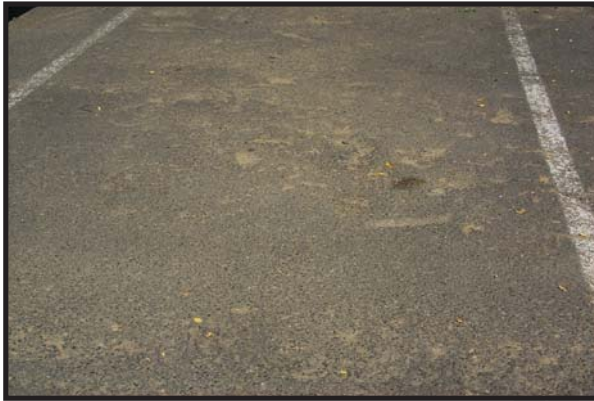
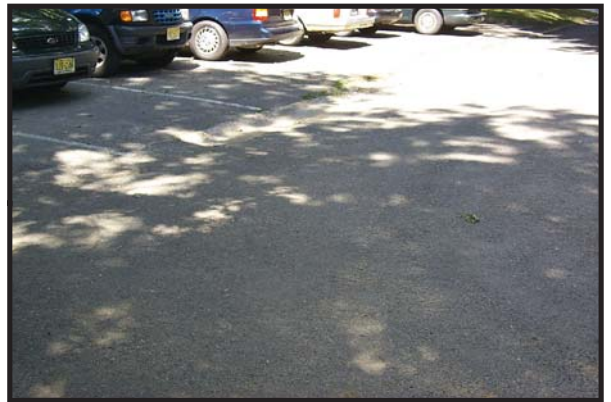
Route 0901

Route	Public / NonPublic	Date Visited	Area (sq ft)	Lane Miles *	Surface Type	Condition / PCR
0901	NonPublic	8/8/2002	6397	0.11	AS	POOR / 45

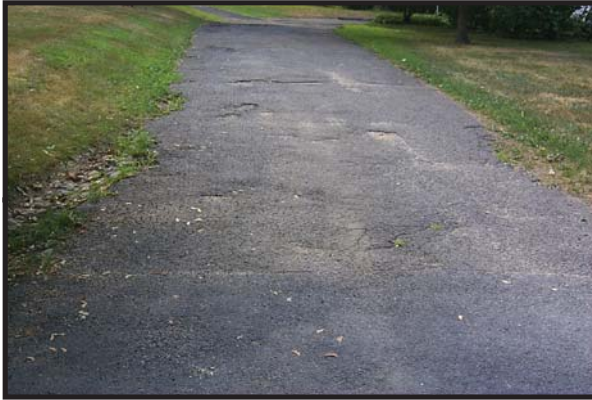
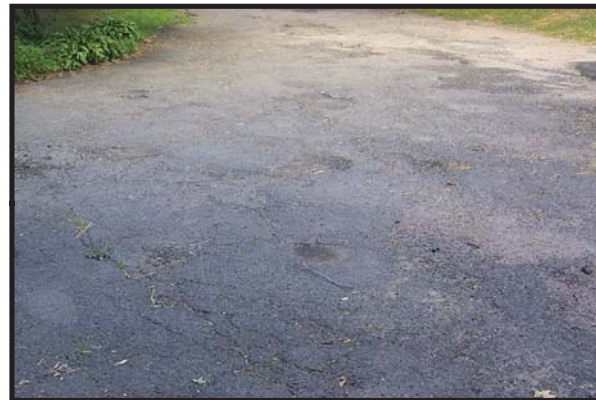
Route 0902

Route	Public / NonPublic	Date Visited	Area (sq ft)	Lane Miles *	Surface Type	Condition / PCR
0902	NonPublic	8/8/2002	2259	0.04	AS	POOR / 45

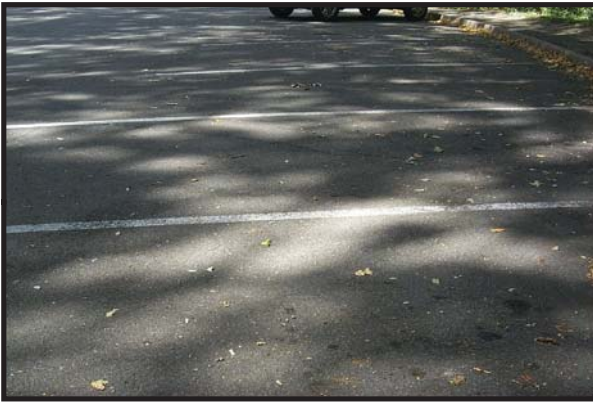
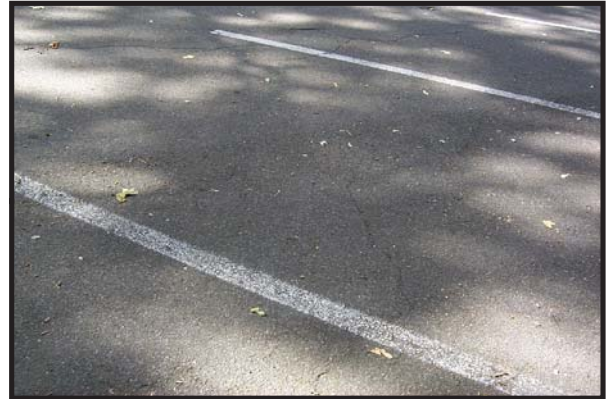
Route	Public / NonPublic	Date Visited	Area (sq ft)	Lane Miles *	Surface Type	Condition / PCR
0903	Public	8/8/2002	3072	0.05	AS	GOOD / 90

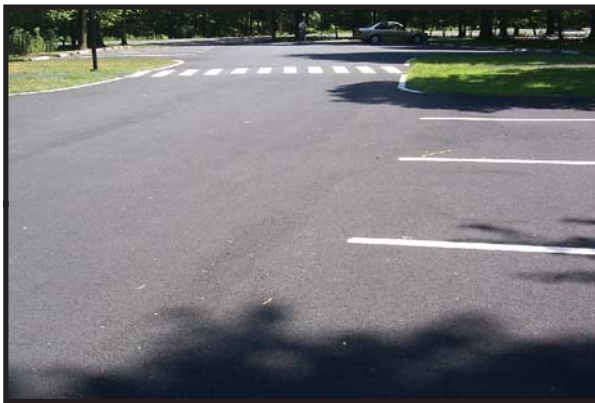
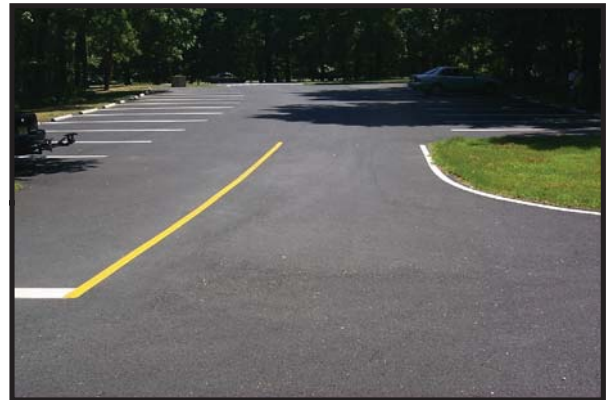
Route	Public / NonPublic	Date Visited	Area (sq ft)	Lane Miles *	Surface Type	Condition / PCR
0904A	Public	8/9/2002	18217	0.31	AS	EXCELLENT / 97

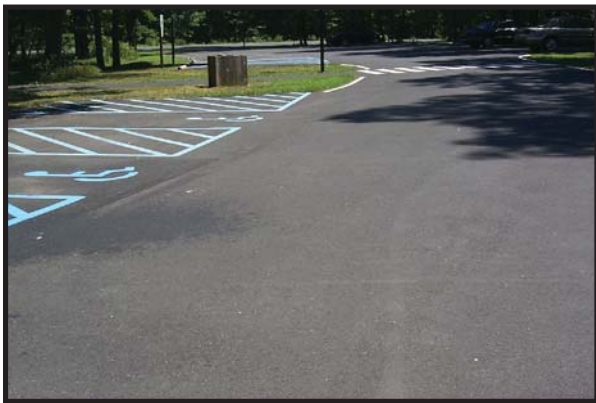
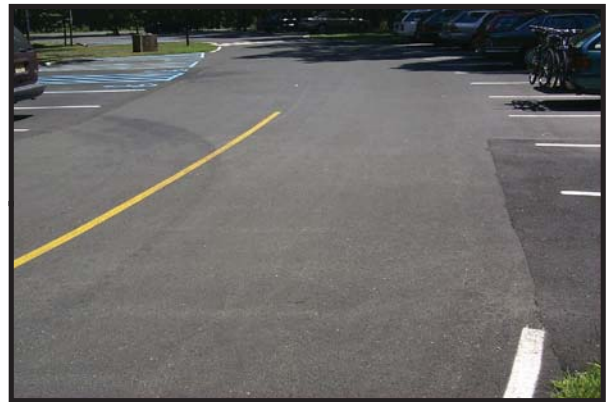
Route	Public / NonPublic	Date Visited	Area (sq ft)	Lane Miles *	Surface Type	Condition / PCR
0904B	Public	8/9/2002	19932	0.34	AS	EXCELLENT / 97

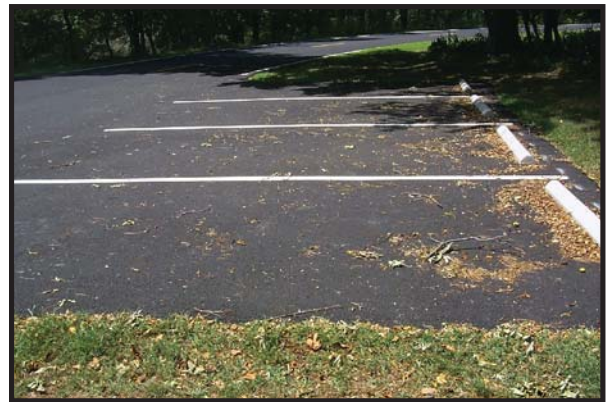
Route	Public / NonPublic	Date Visited	Area (sq ft)	Lane Miles *	Surface Type	Condition / PCR
0904C	Public	8/9/2002	928	0.02	AS	GOOD / 90

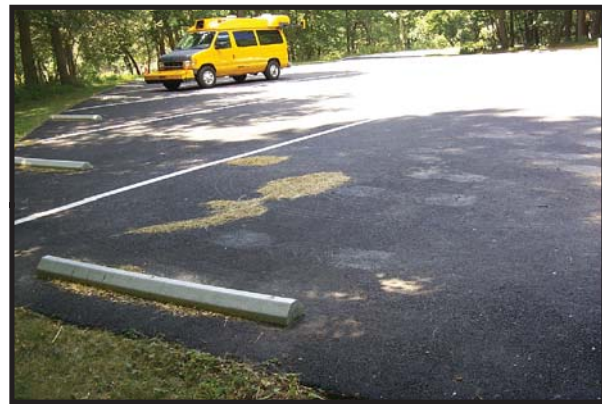
Route	Public / NonPublic	Date Visited	Area (sq ft)	Lane Miles *	Surface Type	Condition / PCR
0904D	Public	8/9/2002	4084	0.07	AS	GOOD / 90

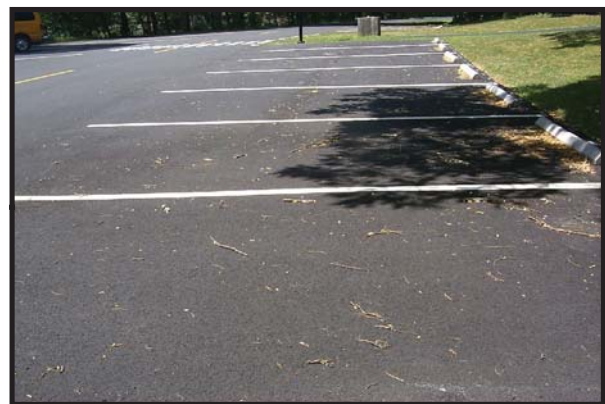
Route	Public / NonPublic	Date Visited	Area (sq ft)	Lane Miles *	Surface Type	Condition / PCR
0904E	Public	8/9/2002	1432	0.02	AS	GOOD / 90

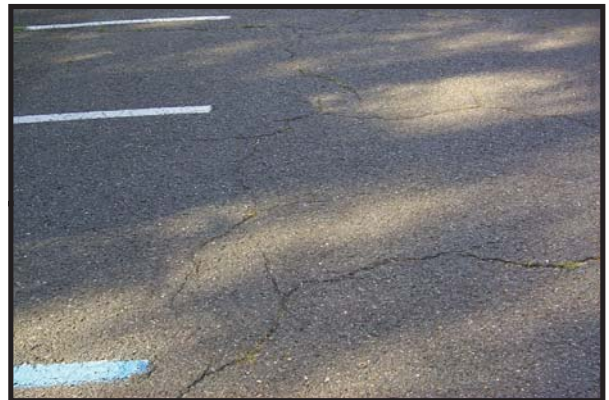
Route	Public / NonPublic	Date Visited	Area (sq ft)	Lane Miles *	Surface Type	Condition / PCR
0905	Public	8/9/2002	3433	0.06	AS	FAIR / 73

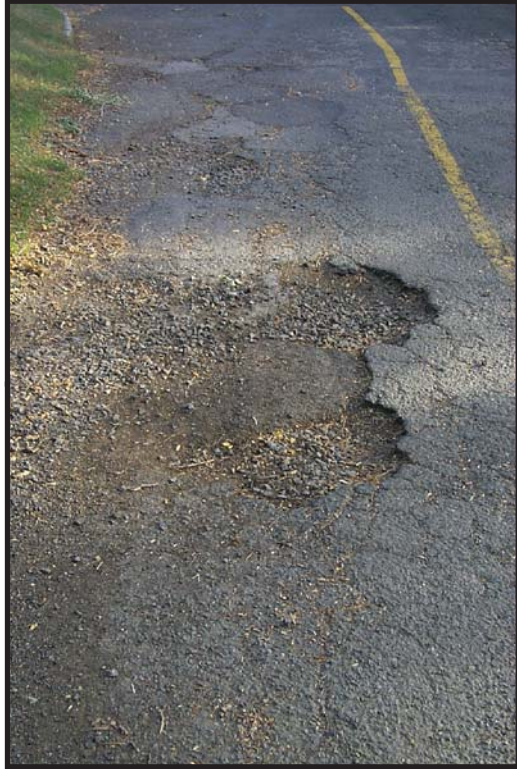
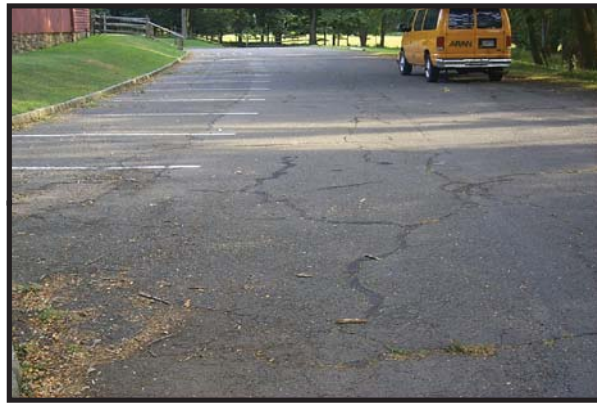
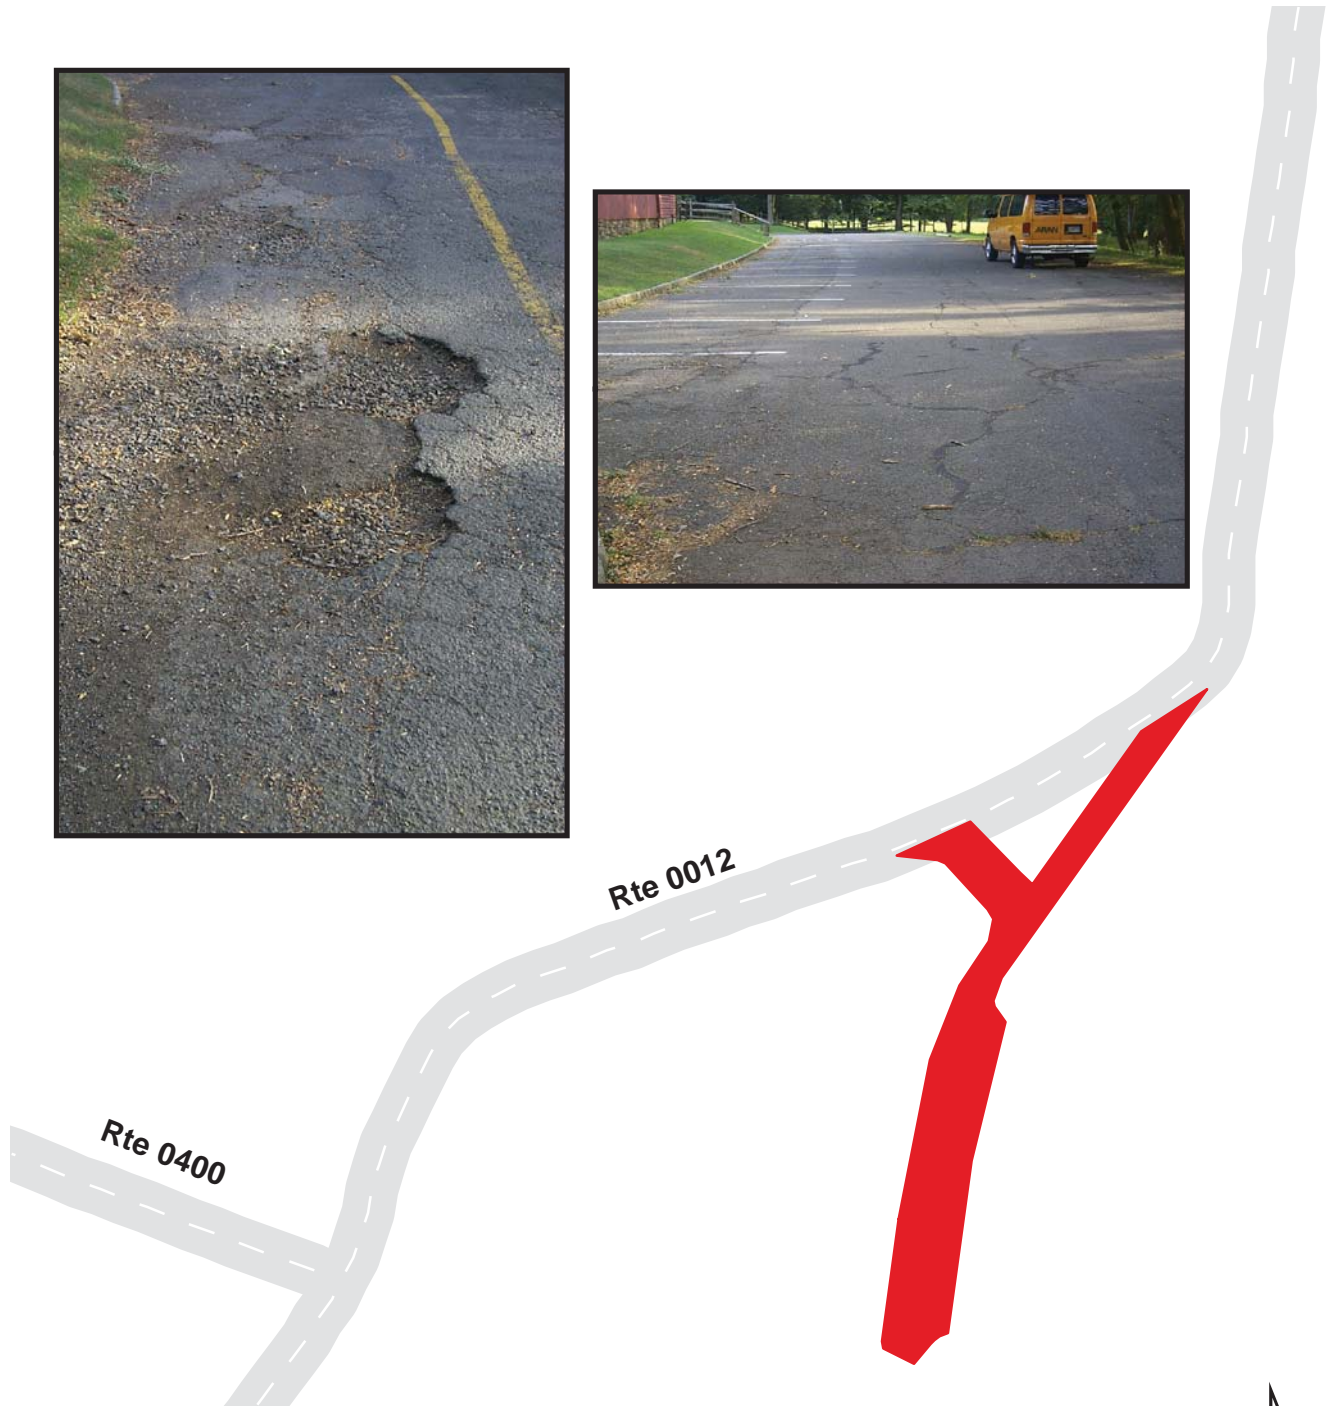
Route 0906

Route	Public / NonPublic	Date Visited	Area (sq ft)	Lane Miles *	Surface Type	Condition / PCR
0906	Public	8/9/2002	17093	0.29	AS	POOR / 45

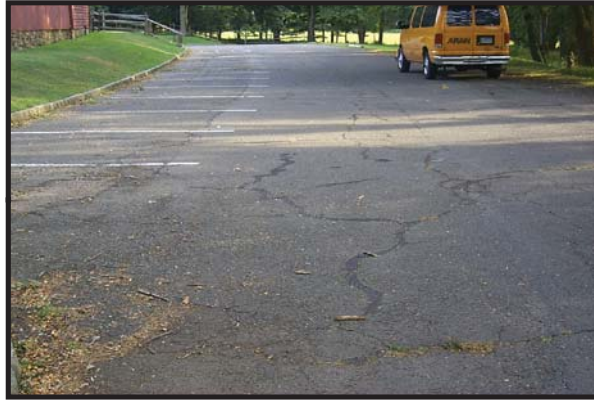
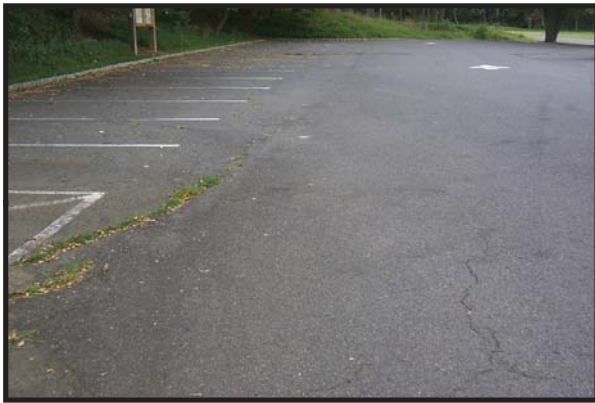
Route	Public / NonPublic	Date Visited	Area (sq ft)	Lane Miles *	Surface Type	Condition / PCR
0907	Public	8/9/2002	12643	0.22	AS	GOOD / 90

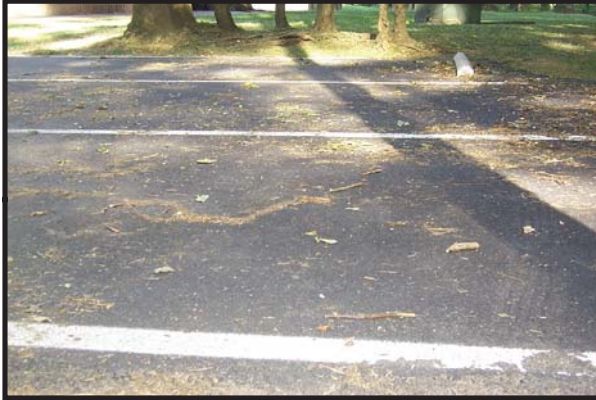
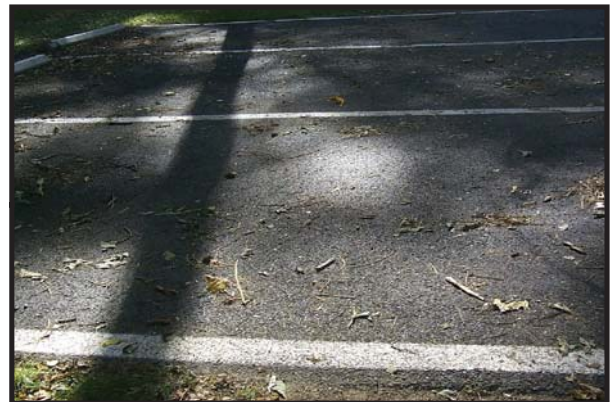
Route	Public / NonPublic	Date Visited	Area (sq ft)	Lane Miles *	Surface Type	Condition / PCR
0908	Public	8/9/2002	436	0.01	AS	GOOD / 90

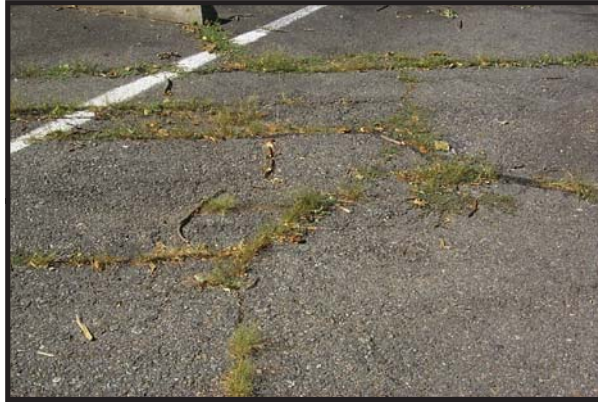
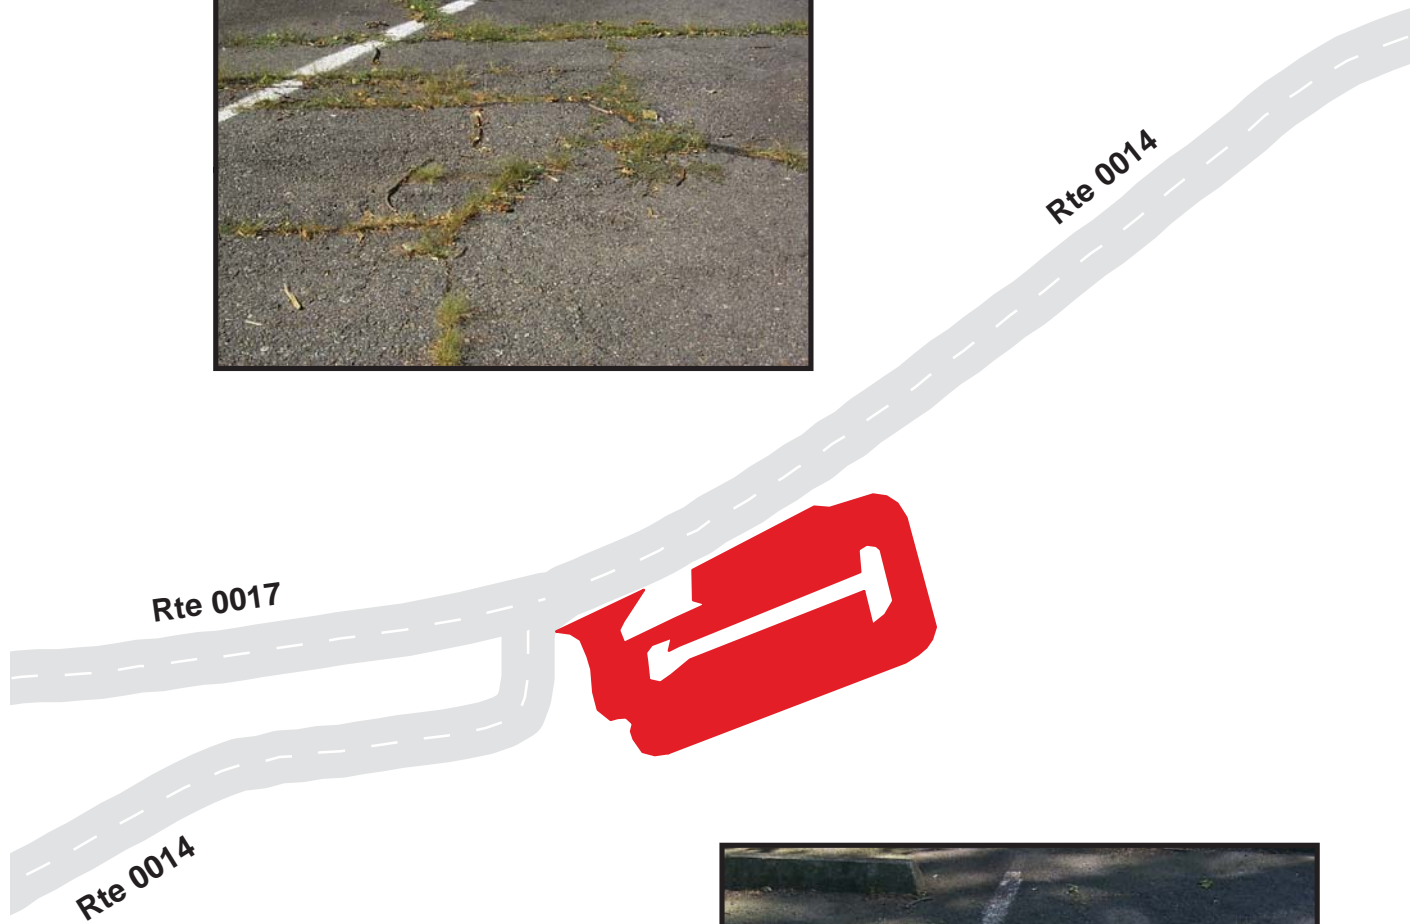
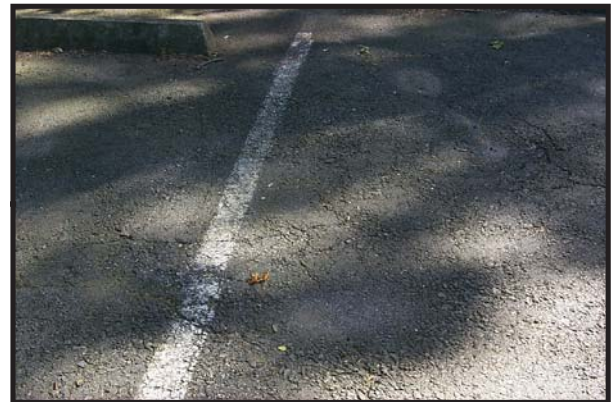
Route 0909

Route	Public / NonPublic	Date Visited	Area (sq ft)	Lane Miles *	Surface Type	Condition / PCR
0909	Public	8/9/2002	29080	0.50	AS	POOR / 45

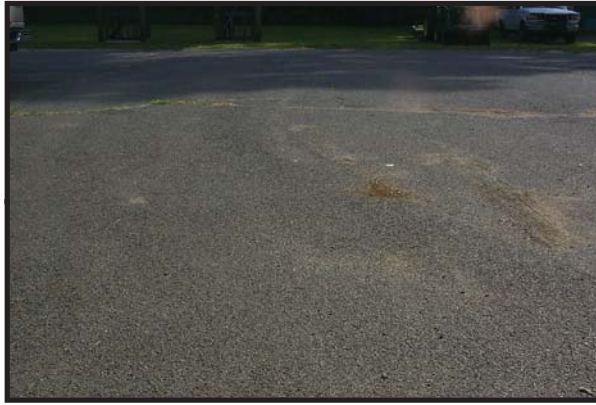
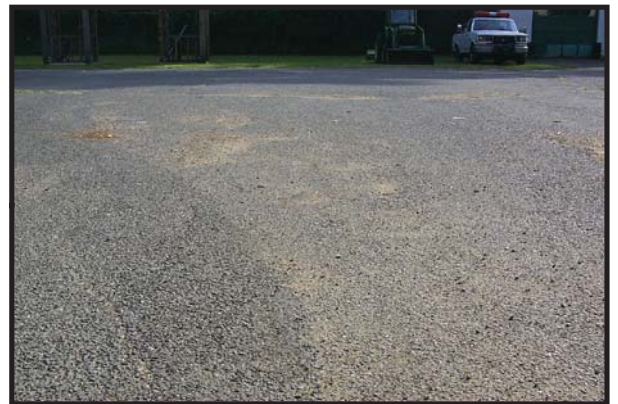
Route	Public / NonPublic	Date Visited	Area (sq ft)	Lane Miles *	Surface Type	Condition / PCR
0910	NonPublic	8/9/2002	17818	0.31	AS	GOOD / 90

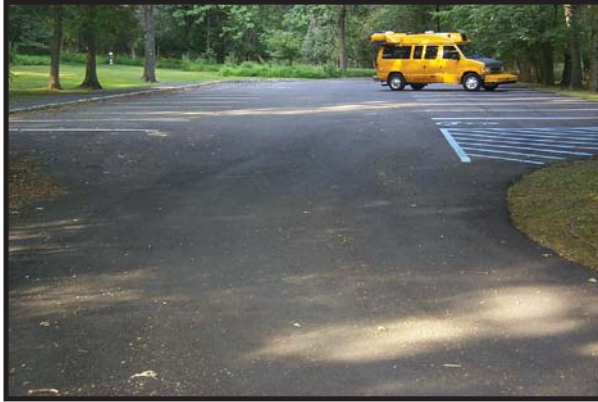
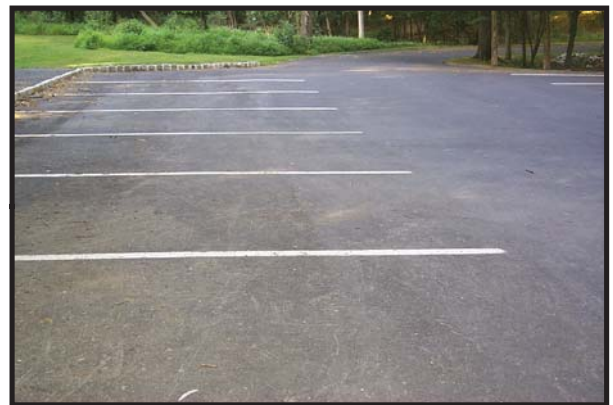
Route	Public / NonPublic	Date Visited	Area (sq ft)	Lane Miles *	Surface Type	Condition / PCR
0911	Public	8/9/2002	10524	0.18	AS	EXCELLENT / 97

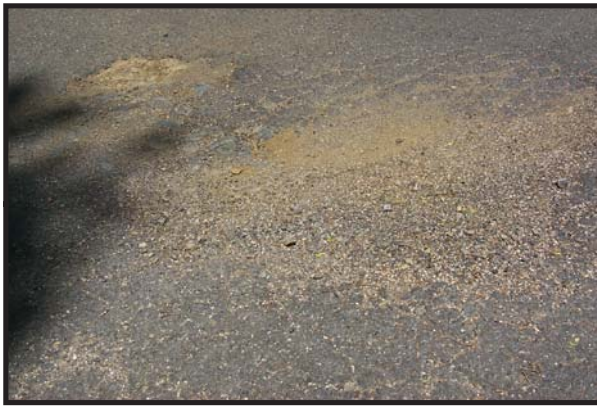
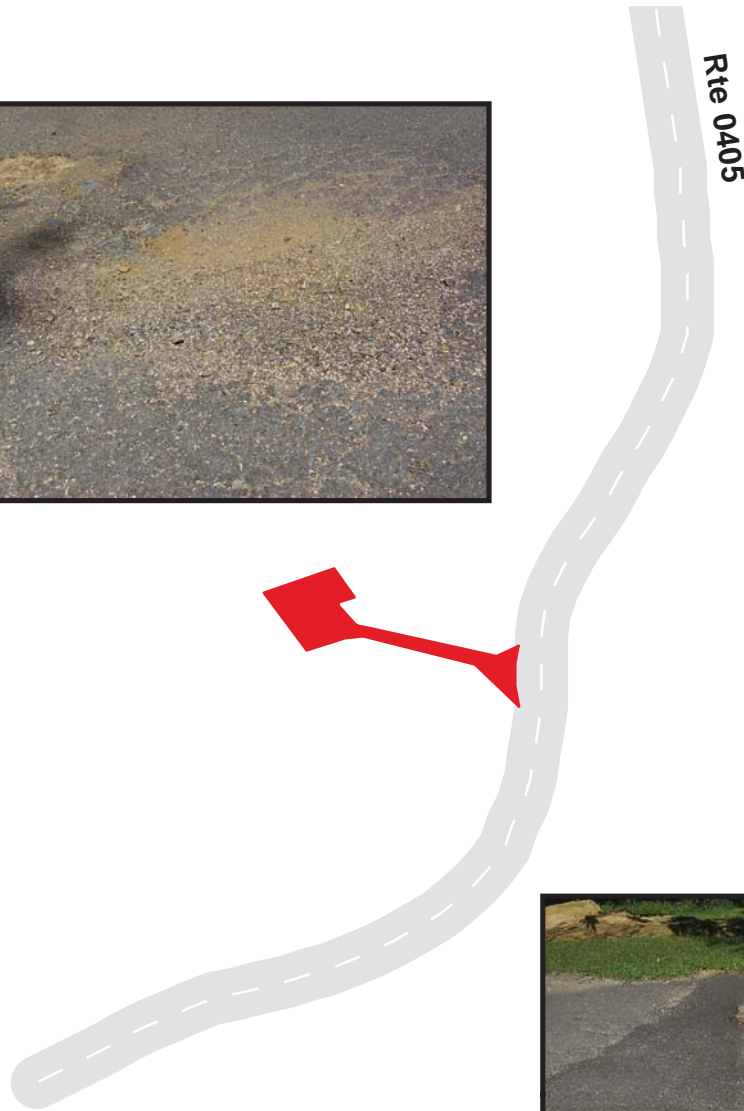
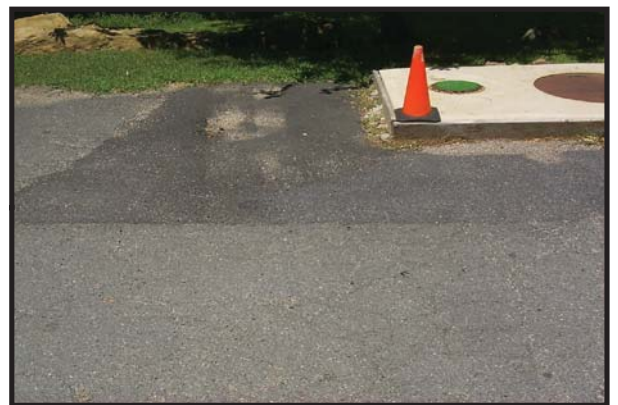
Route 0912

Route	Public / NonPublic	Date Visited	Area (sq ft)	Lane Miles *	Surface Type	Condition / PCR
0912	NonPublic	8/9/2002	3151	0.05	AS	POOR / 45

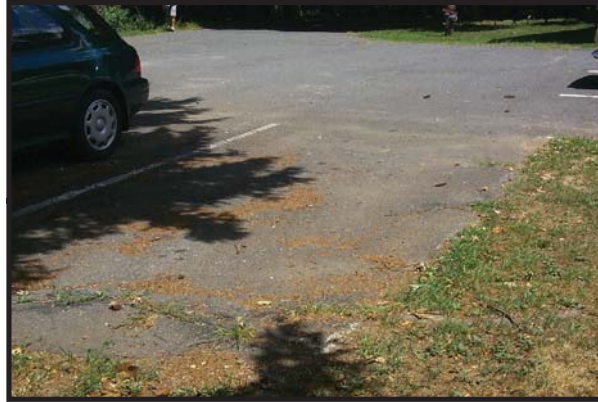
Route	Public / NonPublic	Date Visited	Area (sq ft)	Lane Miles *	Surface Type	Condition / PCR
0914	NonPublic	8/9/2002	2756	0.05	AS	FAIR / 73
