The Road Inventory of Mount Rushmore National Memorial MORU – 1500

Road Inventory Program

Prepared By:
Federal Highway Administration
Eastern Federal Lands Highway Division
Cycle 3

Mount Rushmore National Memorial in South Dakota

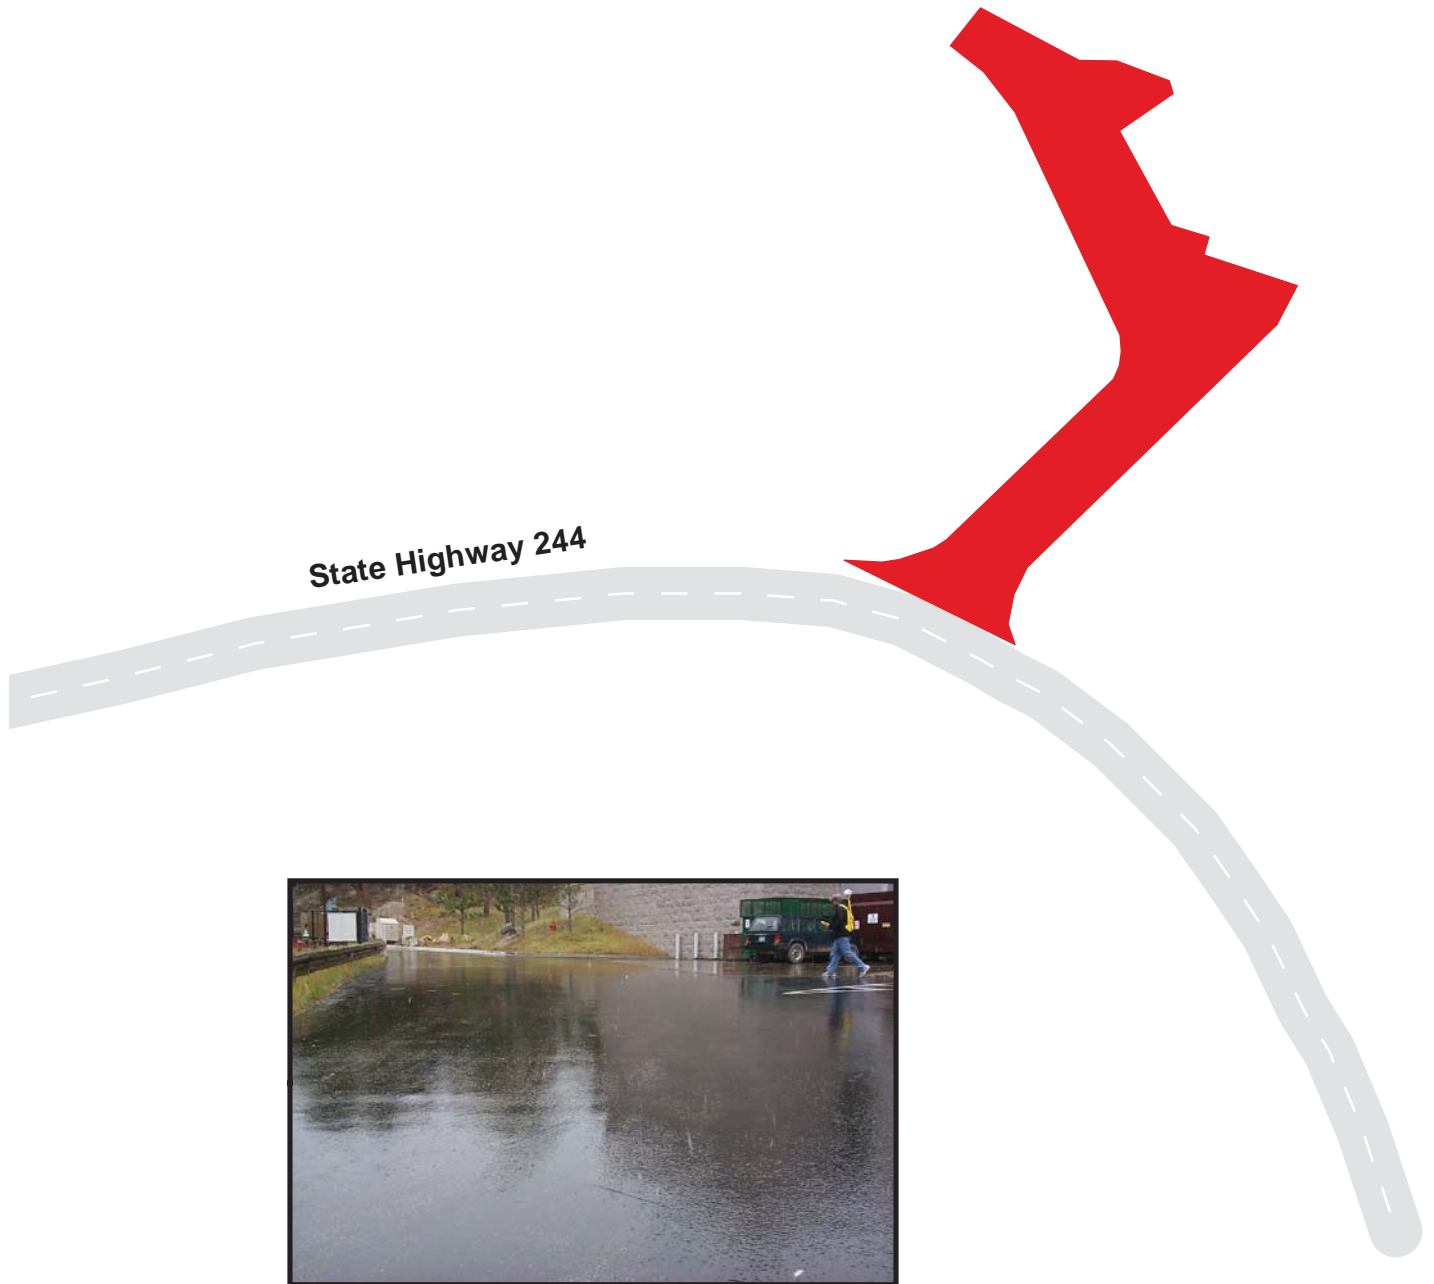
Route 0901

Route	Public / NonPublic	Date Visited	Area (sq ft)	Lane Miles *	Surface Type	Condition / PCR
0901	NonPublic	10/13/2001	8491	0.15	AS	EXCELLENT / 97

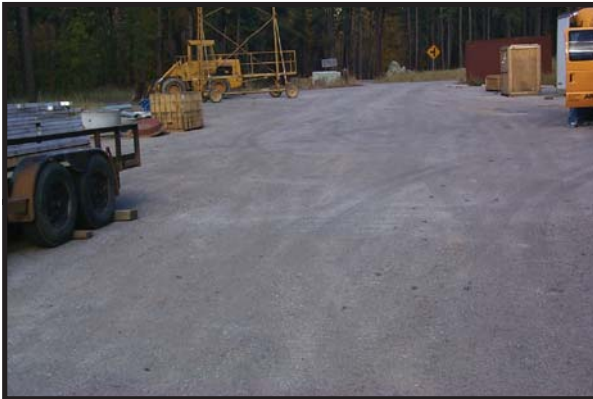
Route 0905

Route	Public / NonPublic	Date Visited	Area (sq ft)	Lane Miles *	Surface Type	Condition / PCR
0905	NonPublic	10/13/2001	12970	0.22	AS	GOOD / 90

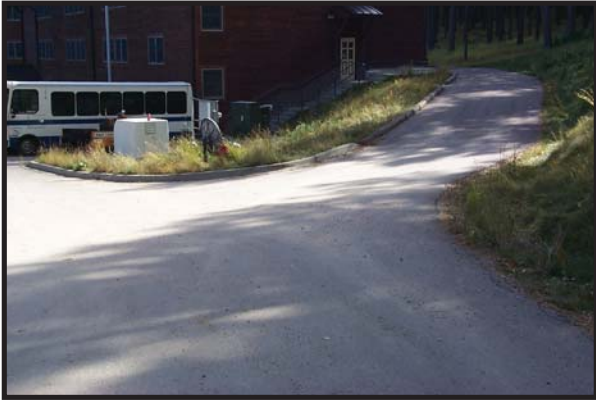
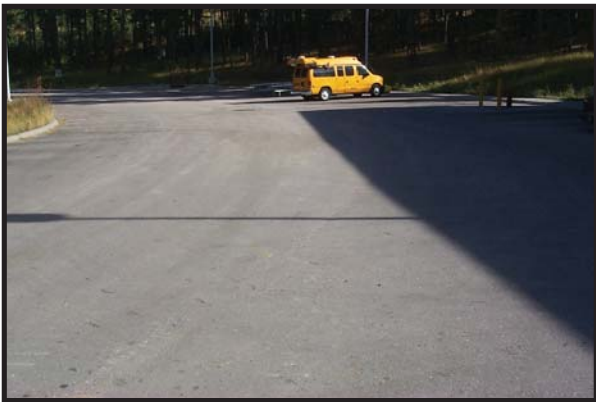
Route 0906

Route	Public / NonPublic	Date Visited	Area (sq ft)	Lane Miles *	Surface Type	Condition / PCR
0906	NonPublic	10/13/2001	28396	0.49	AS	GOOD / 90

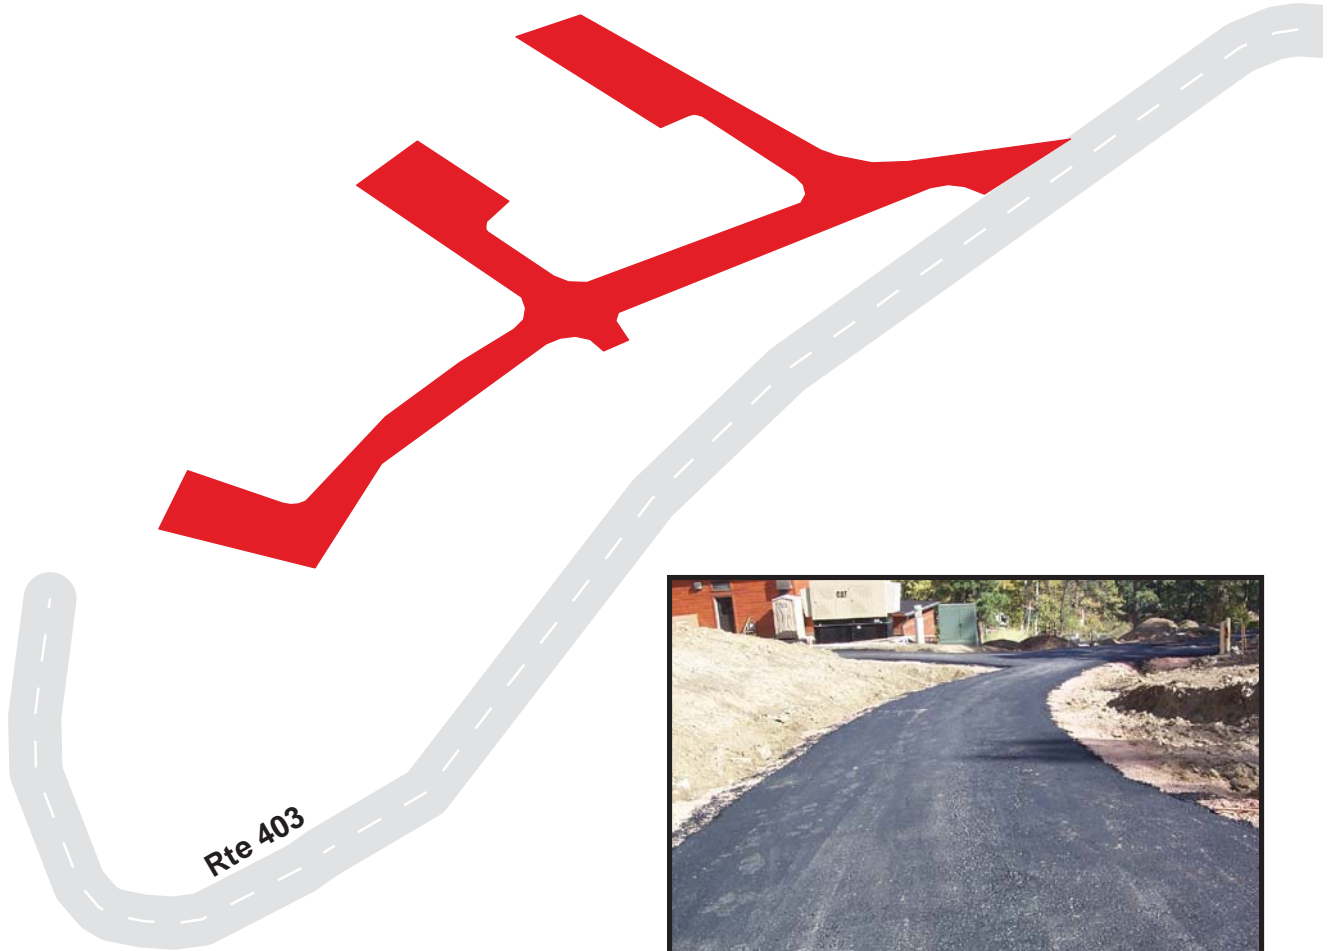
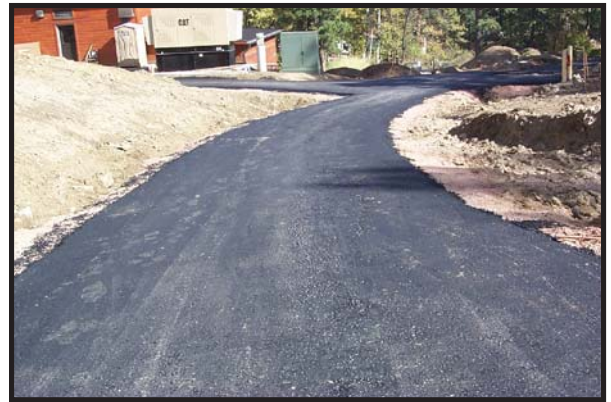
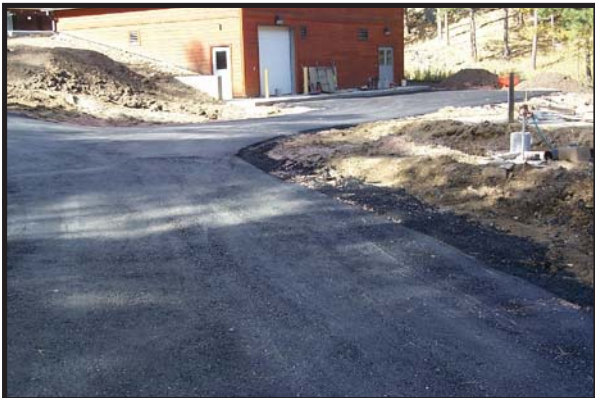
Route 0907

Route	Public / NonPublic	Date Visited	Area (sq ft)	Lane Miles *	Surface Type	Condition / PCR
0907	NonPublic	10/13/2001	7956	0.14	AS	EXCELLENT / 97

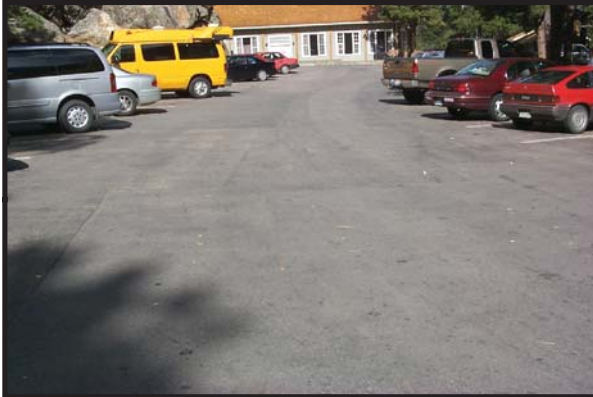
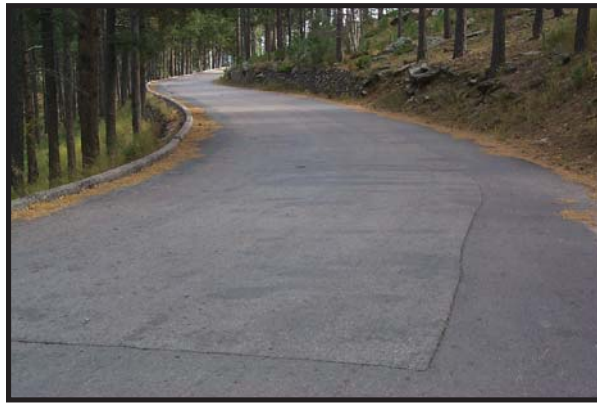
Route 0908

Route	Public / NonPublic	Date Visited	Area (sq ft)	Lane Miles *	Surface Type	Condition / PCR
0908	Public	10/13/2001	26522	0.46	AS	POOR / 45

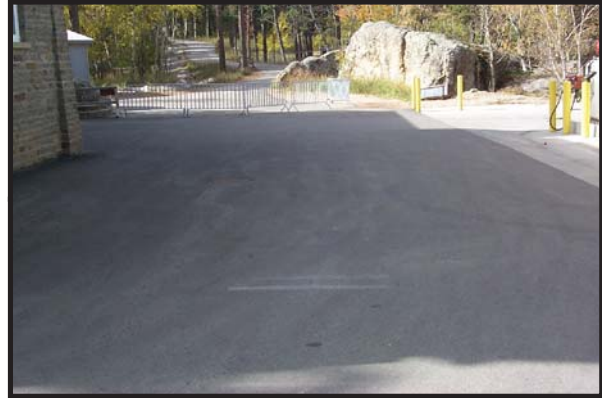
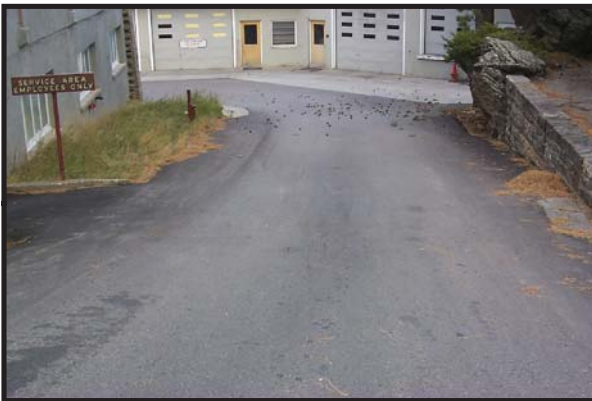
Route 0909

Route	Public / NonPublic	Date Visited	Area (sq ft)	Lane Miles *	Surface Type	Condition / PCR
0909	NonPublic	10/13/2001	10329	0.18	AS	EXCELLENT / 97
