# The Road Inventory of Muir Woods National Monument MUWO - 8180

## Road Inventory Program

Prepared By:  
Federal Highway Administration  
Eastern Federal Lands Highway Division  
Cycle 3

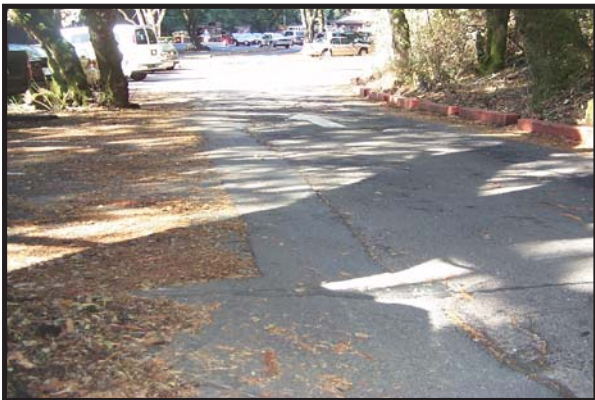
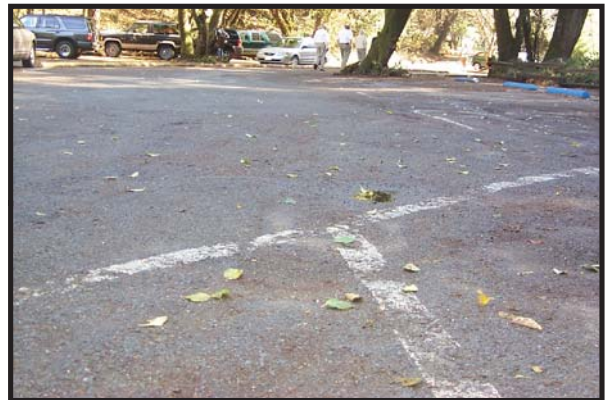
## Route 0900

MUIR WOODS PARKING  
From Muir Woods Road

Route	Public / NonPublic	Date Visited	Area (sq ft)	Lane Miles *	Surface Type	Condition / PCR
0900	Public	11/2/2001	52397	0.90	AS	FAIR / 73

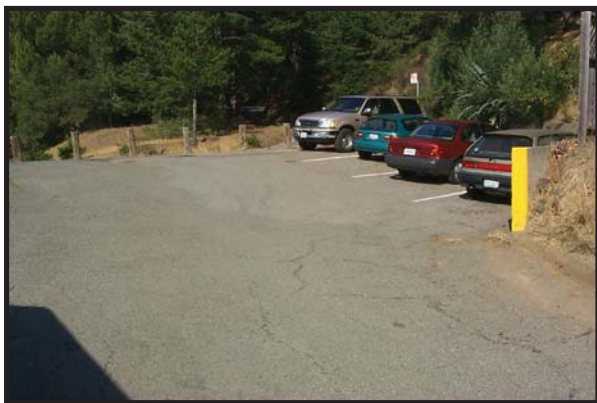
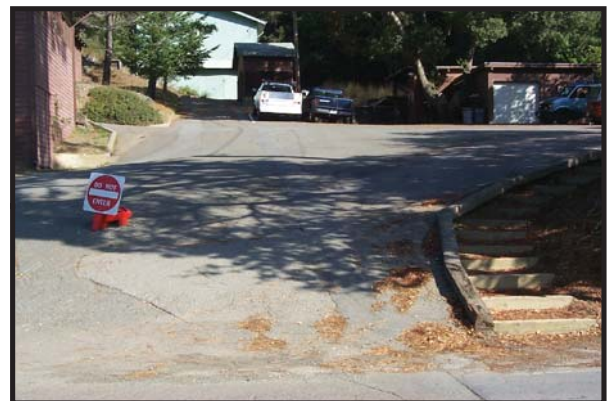
## Route 0901

### MUIR WOODS OLD INN PARKING

Route	Public / NonPublic	Date Visited	Area (sq ft)	Lane Miles *	Surface Type	Condition / PCR
0901	NonPublic	11/2/2001	13805	0.24	AS	FAIR / 73

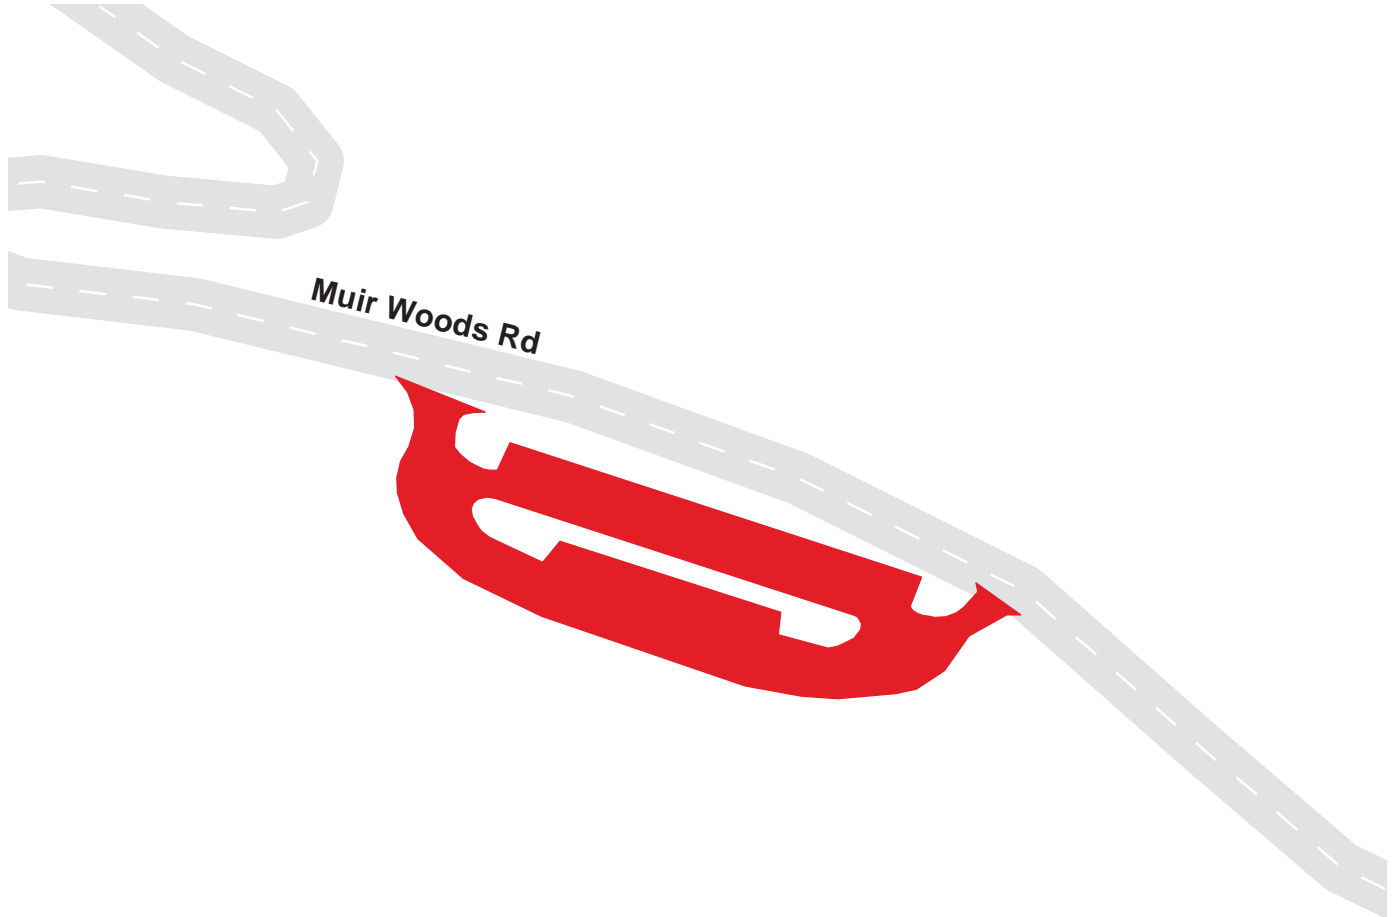
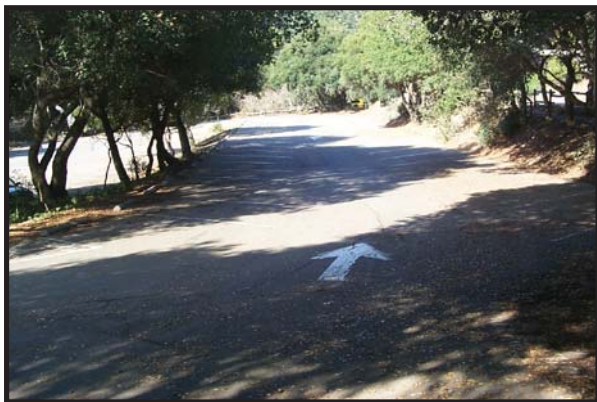
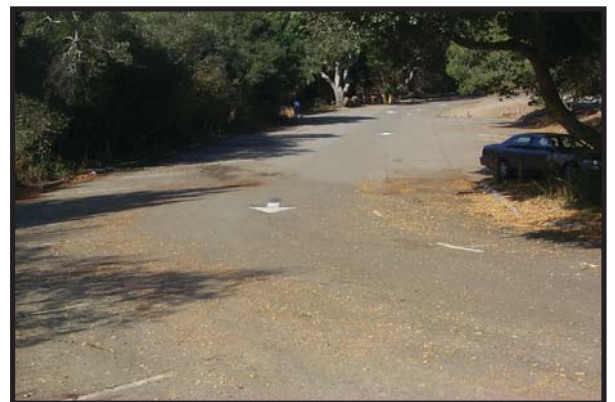
## Route 0902

### MUIR WOODS LOWER ANNEX PARKING

Route	Public / NonPublic	Date Visited	Area (sq ft)	Lane Miles *	Surface Type	Condition / PCR
0902	Public	11/2/2001	33795	0.58	AS	GOOD / 90

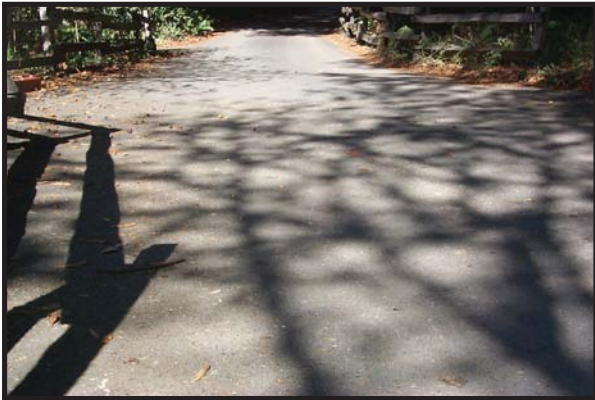
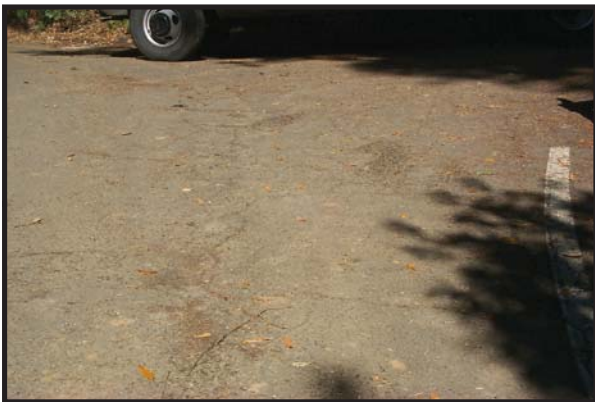
## Route 0903

MUIR WOODS ARAMARK-NPS ADMINISTRATIVE PARKING

Route	Public / NonPublic	Date Visited	Area (sq ft)	Lane Miles *	Surface Type	Condition / PCR
0903	NonPublic	11/2/2001	13418	0.23	NC	GOOD / 90

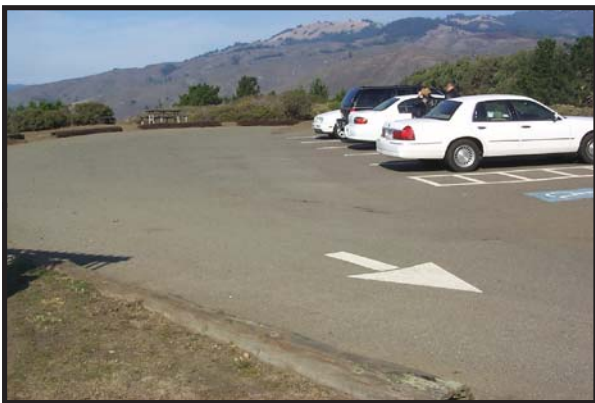
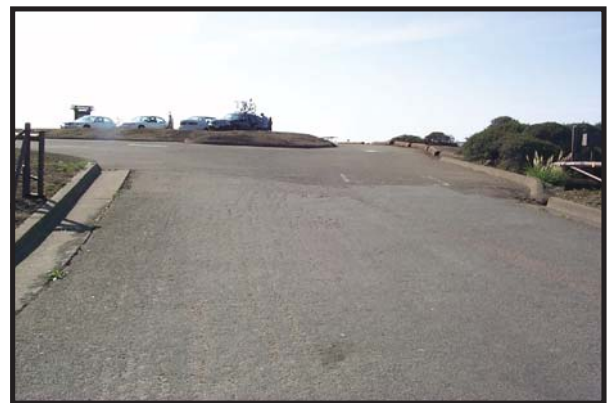
## Route 0922

MUIR BEACH OVERLOOK

Route	Public / NonPublic	Date Visited	Area (sq ft)	Lane Miles *	Surface Type	Condition / PCR
0922	Public	11/2/2001	16262	0.28	AS	GOOD / 90
