The Road Inventory of Natural Bridges National Monument NABR – 1349

Road Inventory Program

Prepared By:
Federal Highway Administration
Eastern Federal Lands Highway Division
Cycle 3

Natural Bridges National Monument in Utah

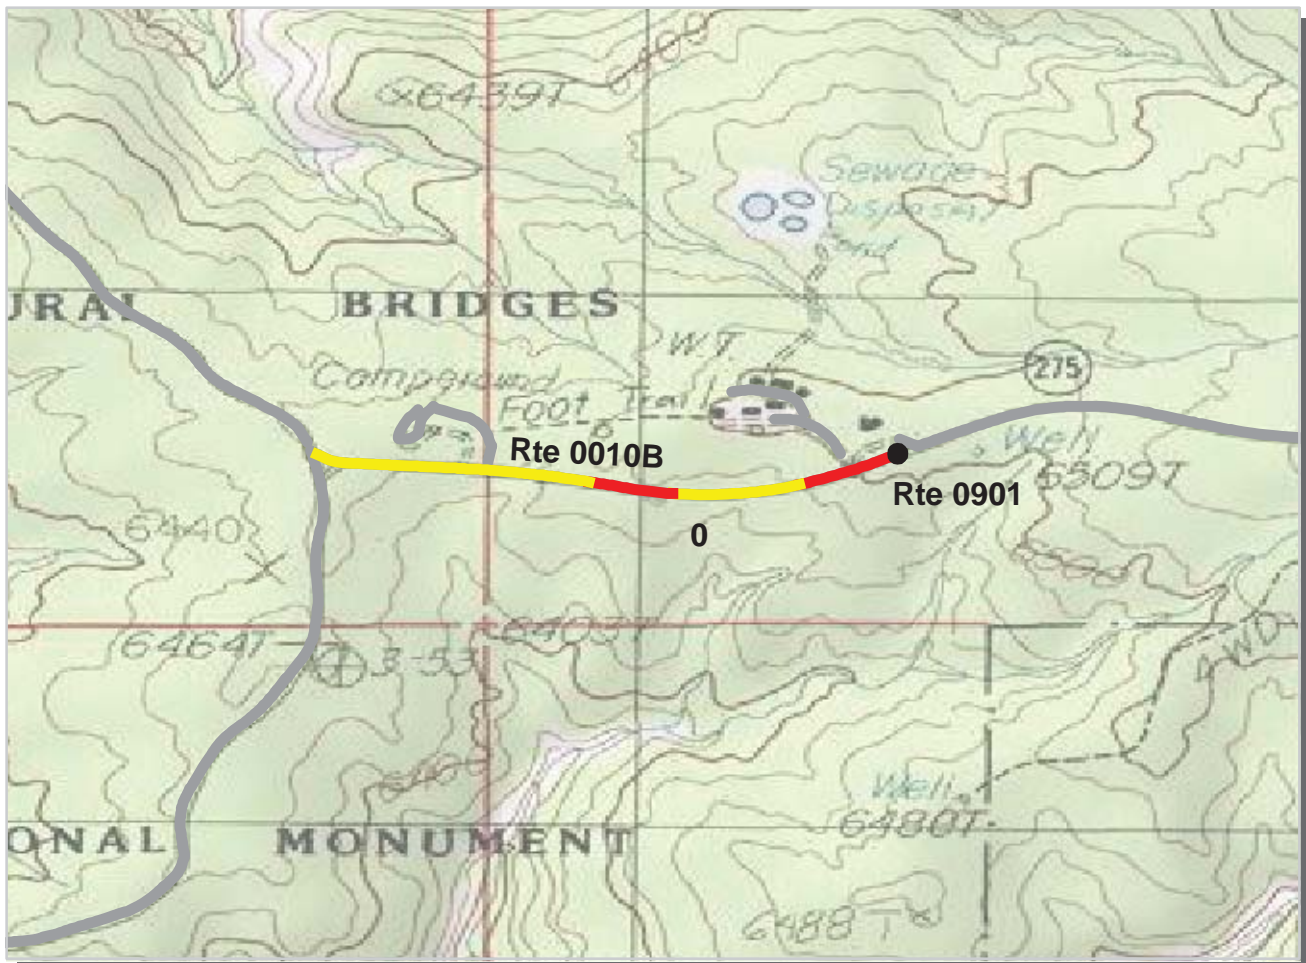
ROUTE: 0010B Entrance Road **TOTAL LENGTH: 0.58 Miles**

Section Number	0				
Section Length (mi)	0.58				
AADT	**				
SADT	**				
ADT Date	**				
Cross Section Information					
Number of Lanes	2				
Paved Width (ft)	21				
Lane Width (ft)	11				
Shoulder Width (ft)	0				
Roadway Condition Information					
PCR (Pavement Condition Rating)	64				
RCI (Roughness Condition Index)	58				
SCR (Surface Condition Rating)	69				
Alligator Cracking Index	100				
Rutting Index	74				
Patching Index	100				
Transverse Cracking Index	96				
Longitudinal Cracking Index	98				
Shoulder Condition Rating	N/A				
Drainage Condition Rating	GOOD

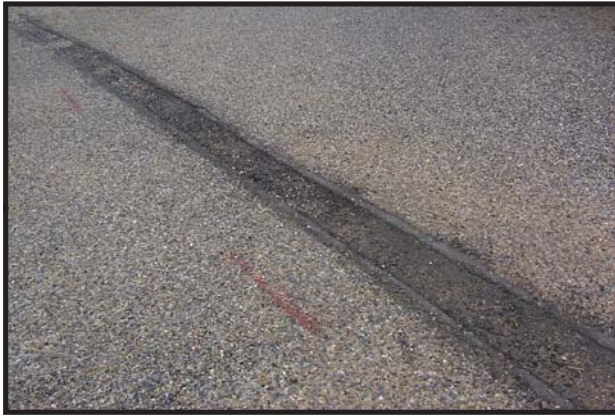
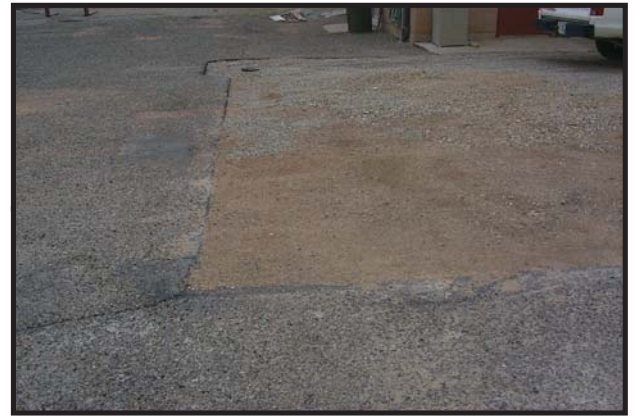
Route 0902

Route	Public / NonPublic	Date Visited	Area (sq ft)	Lane Miles *	Surface Type	Condition / PCR
0902	NonPublic	4/22/2003	16505	0.28	OC	FAIR / 73

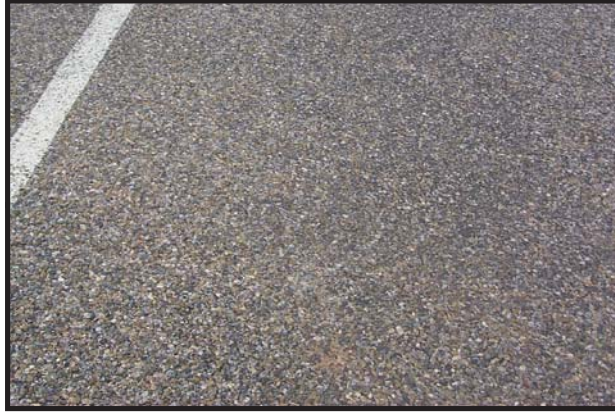
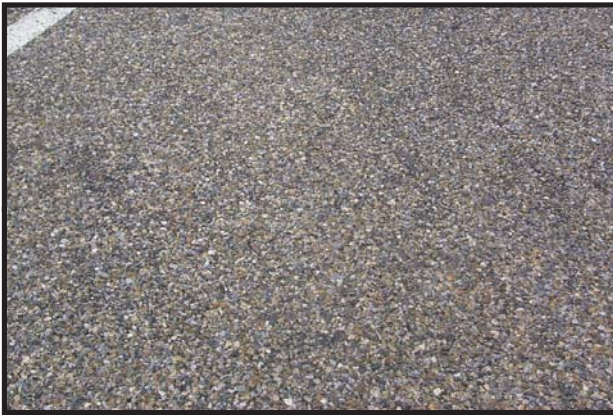
Route 0904

Route	Public / NonPublic	Date Visited	Area (sq ft)	Lane Miles *	Surface Type	Condition / PCR
0904	Public	4/22/2003	7571	0.13	NC	GOOD / 90

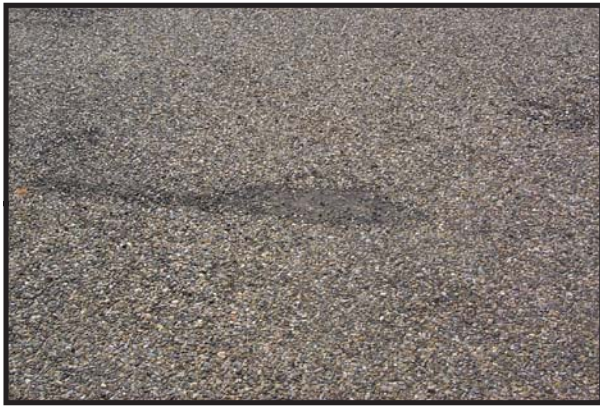
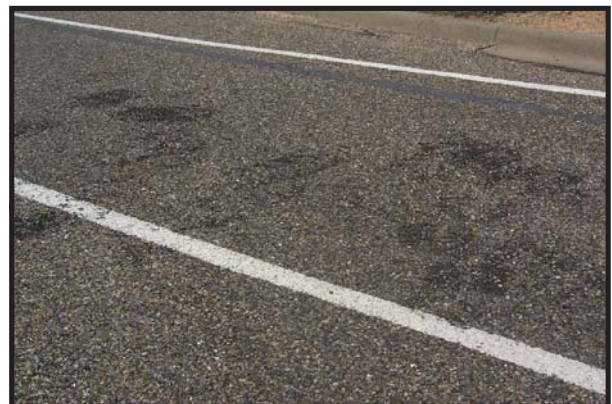
Route 0905

Route	Public / NonPublic	Date Visited	Area (sq ft)	Lane Miles *	Surface Type	Condition / PCR
0905	Public	4/22/2003	3366	0.06	OC	GOOD / 90

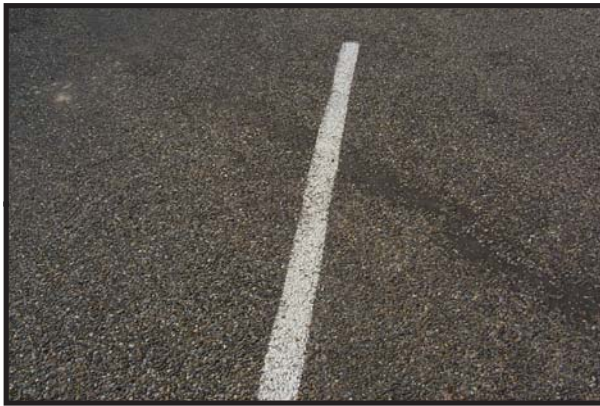
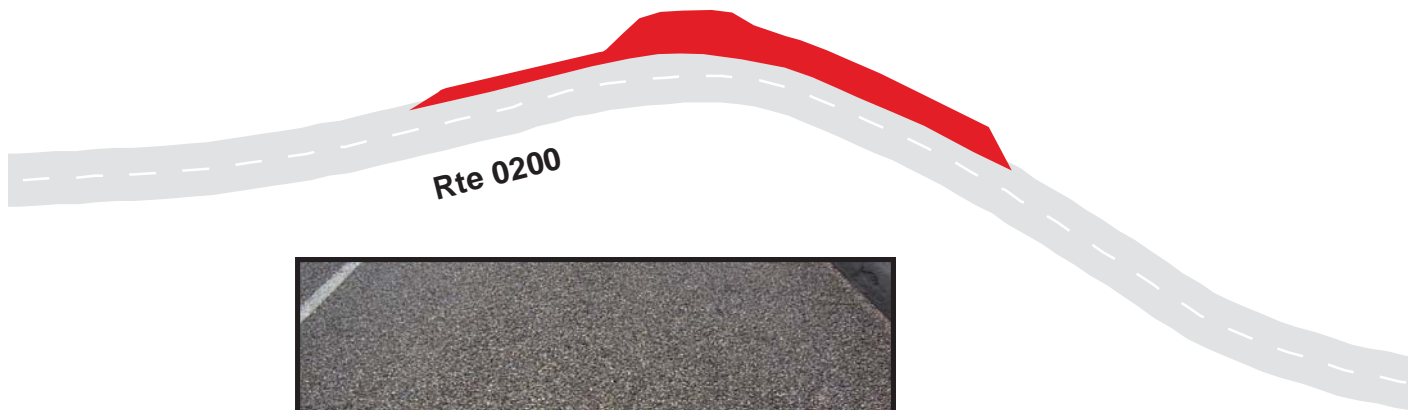
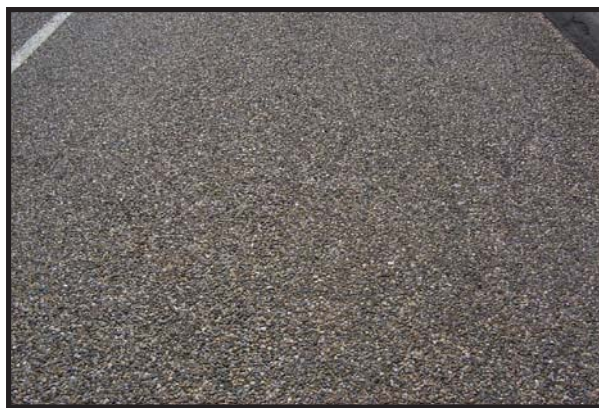
Route 0906

Route	Public / NonPublic	Date Visited	Area (sq ft)	Lane Miles *	Surface Type	Condition / PCR
0906	Public	4/22/2003	11558	0.20	OC	GOOD / 90

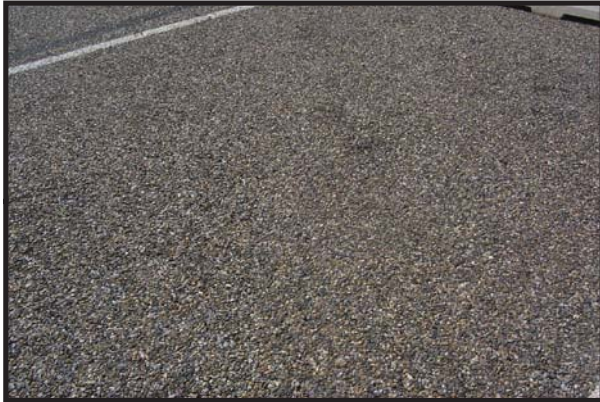
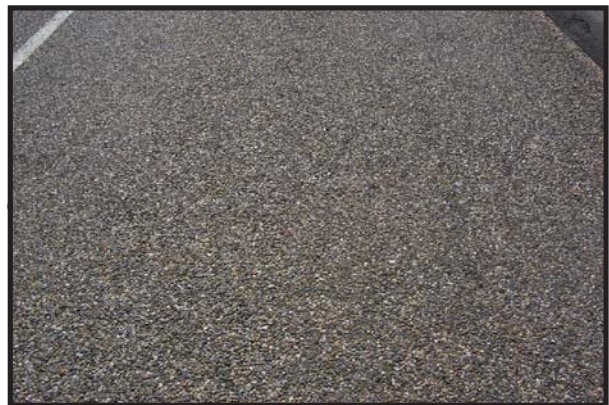
Route 0907

Route	Public / NonPublic	Date Visited	Area (sq ft)	Lane Miles *	Surface Type	Condition / PCR
0907	Public	4/22/2003	9079	0.16	OC	GOOD / 90

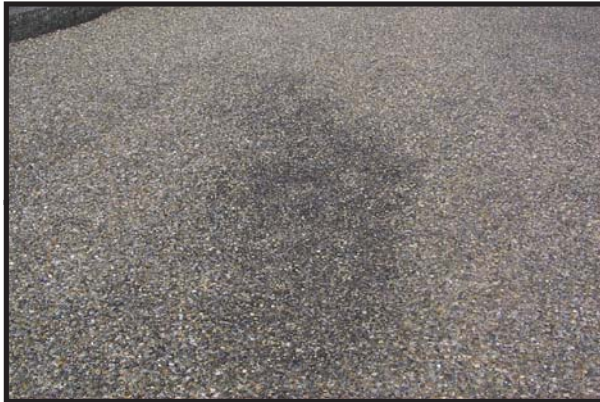
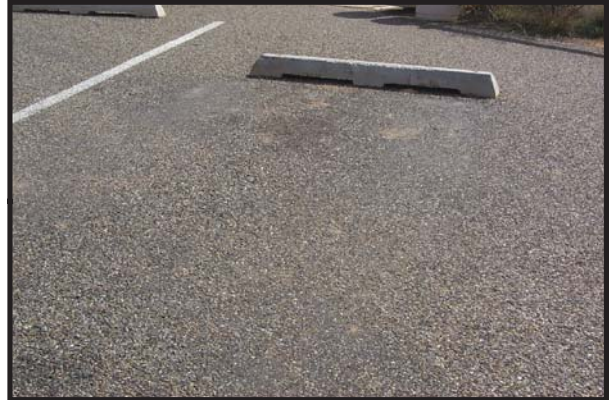
Route 0908

Route	Public / NonPublic	Date Visited	Area (sq ft)	Lane Miles *	Surface Type	Condition / PCR
0908	Public	4/22/2003	12167	0.21	OC	GOOD / 90

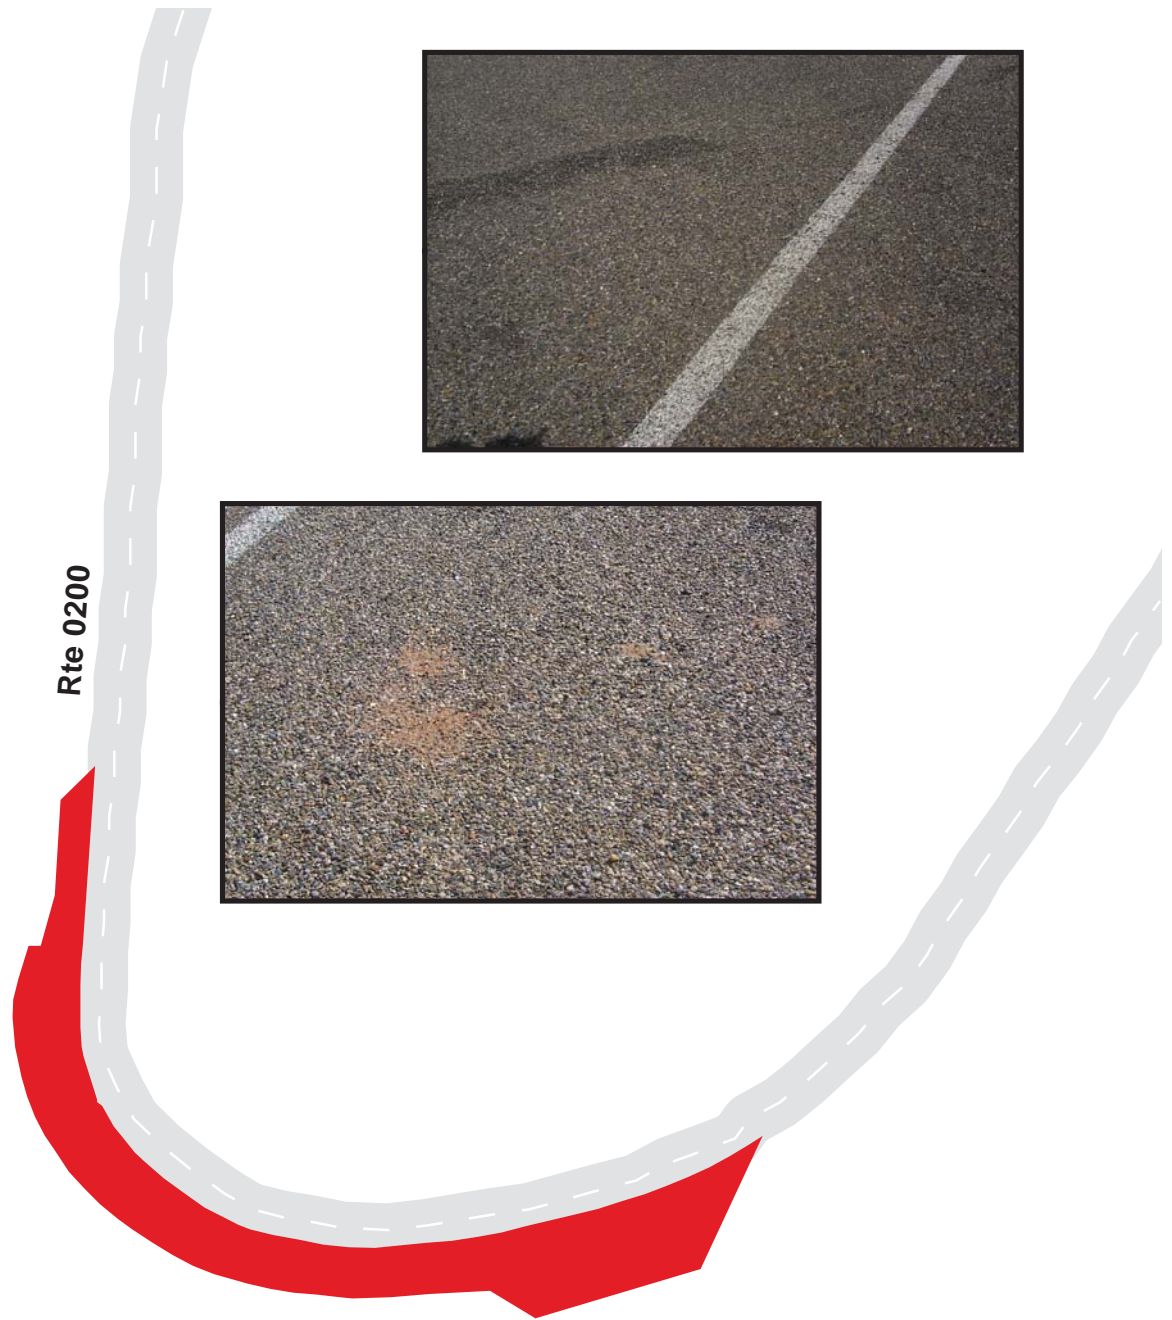
Route 0909

Route	Public / NonPublic	Date Visited	Area (sq ft)	Lane Miles *	Surface Type	Condition / PCR
0909	Public	4/22/2003	14471	0.25	NC	GOOD / 90

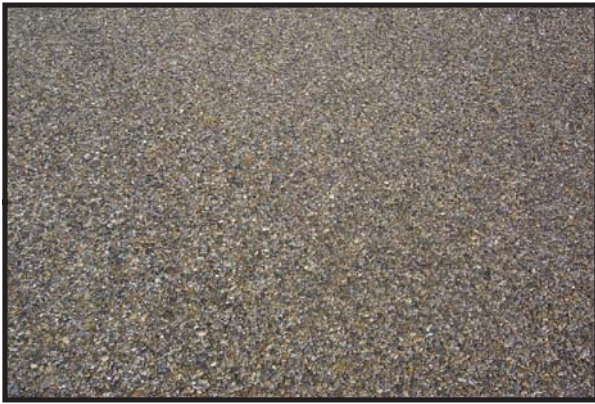
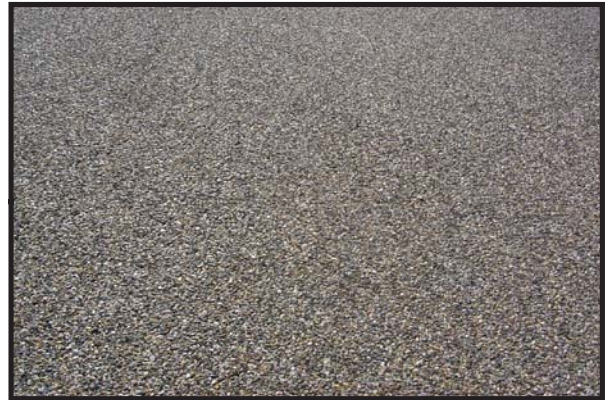
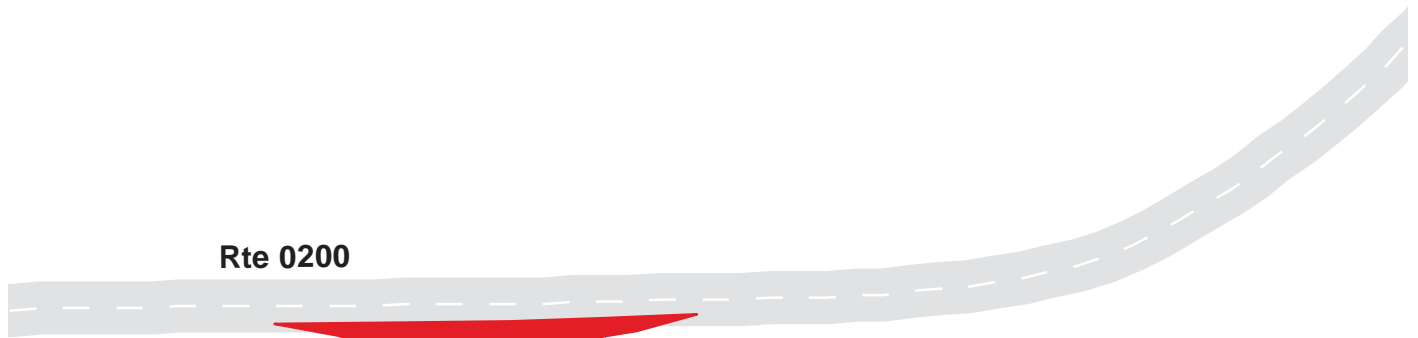
Route 0910

Route	Public / NonPublic	Date Visited	Area (sq ft)	Lane Miles *	Surface Type	Condition / PCR
0910	Public	4/22/2003	2408	0.04	NC	GOOD / 90

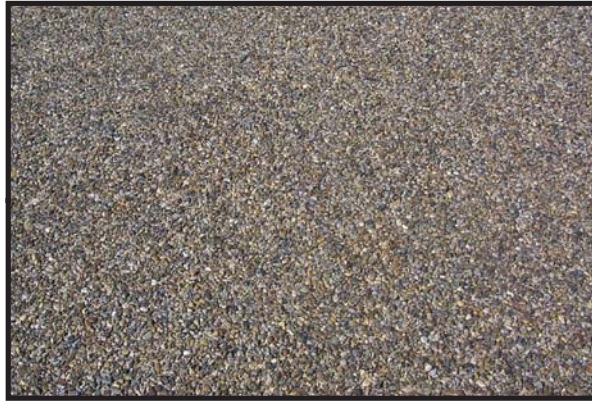
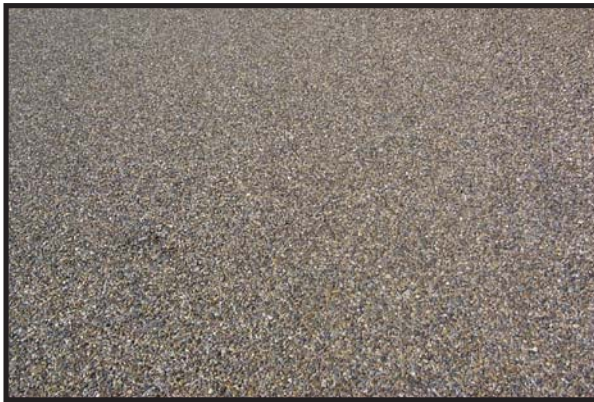
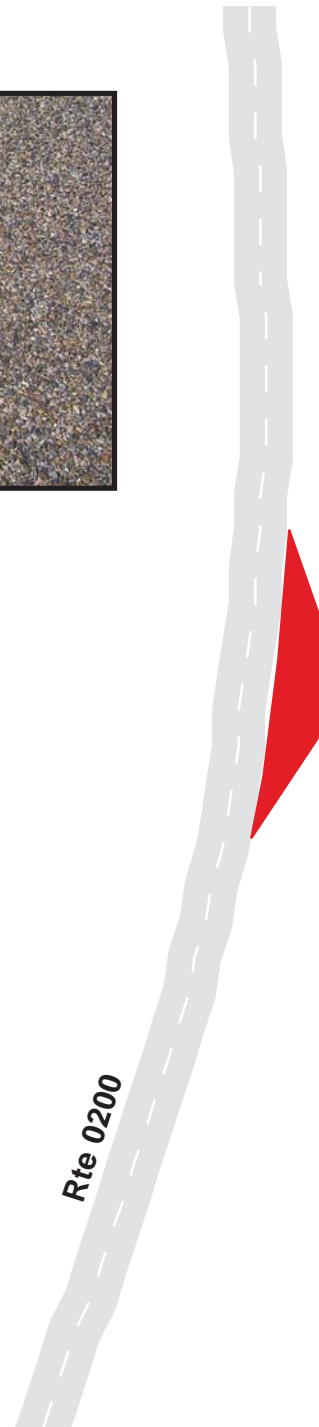
Route 0911

Route	Public / NonPublic	Date Visited	Area (sq ft)	Lane Miles *	Surface Type	Condition / PCR
0911	Public	4/22/2003	1974	0.03	NC	GOOD / 90
