The Road Inventory of National Capital Parks-East NACE - 3500

Road Inventory Program

Prepared By:
Federal Highway Administration
Eastern Federal Lands Highway Division
Cycle 3

National Capital Parks-East in Washington DC

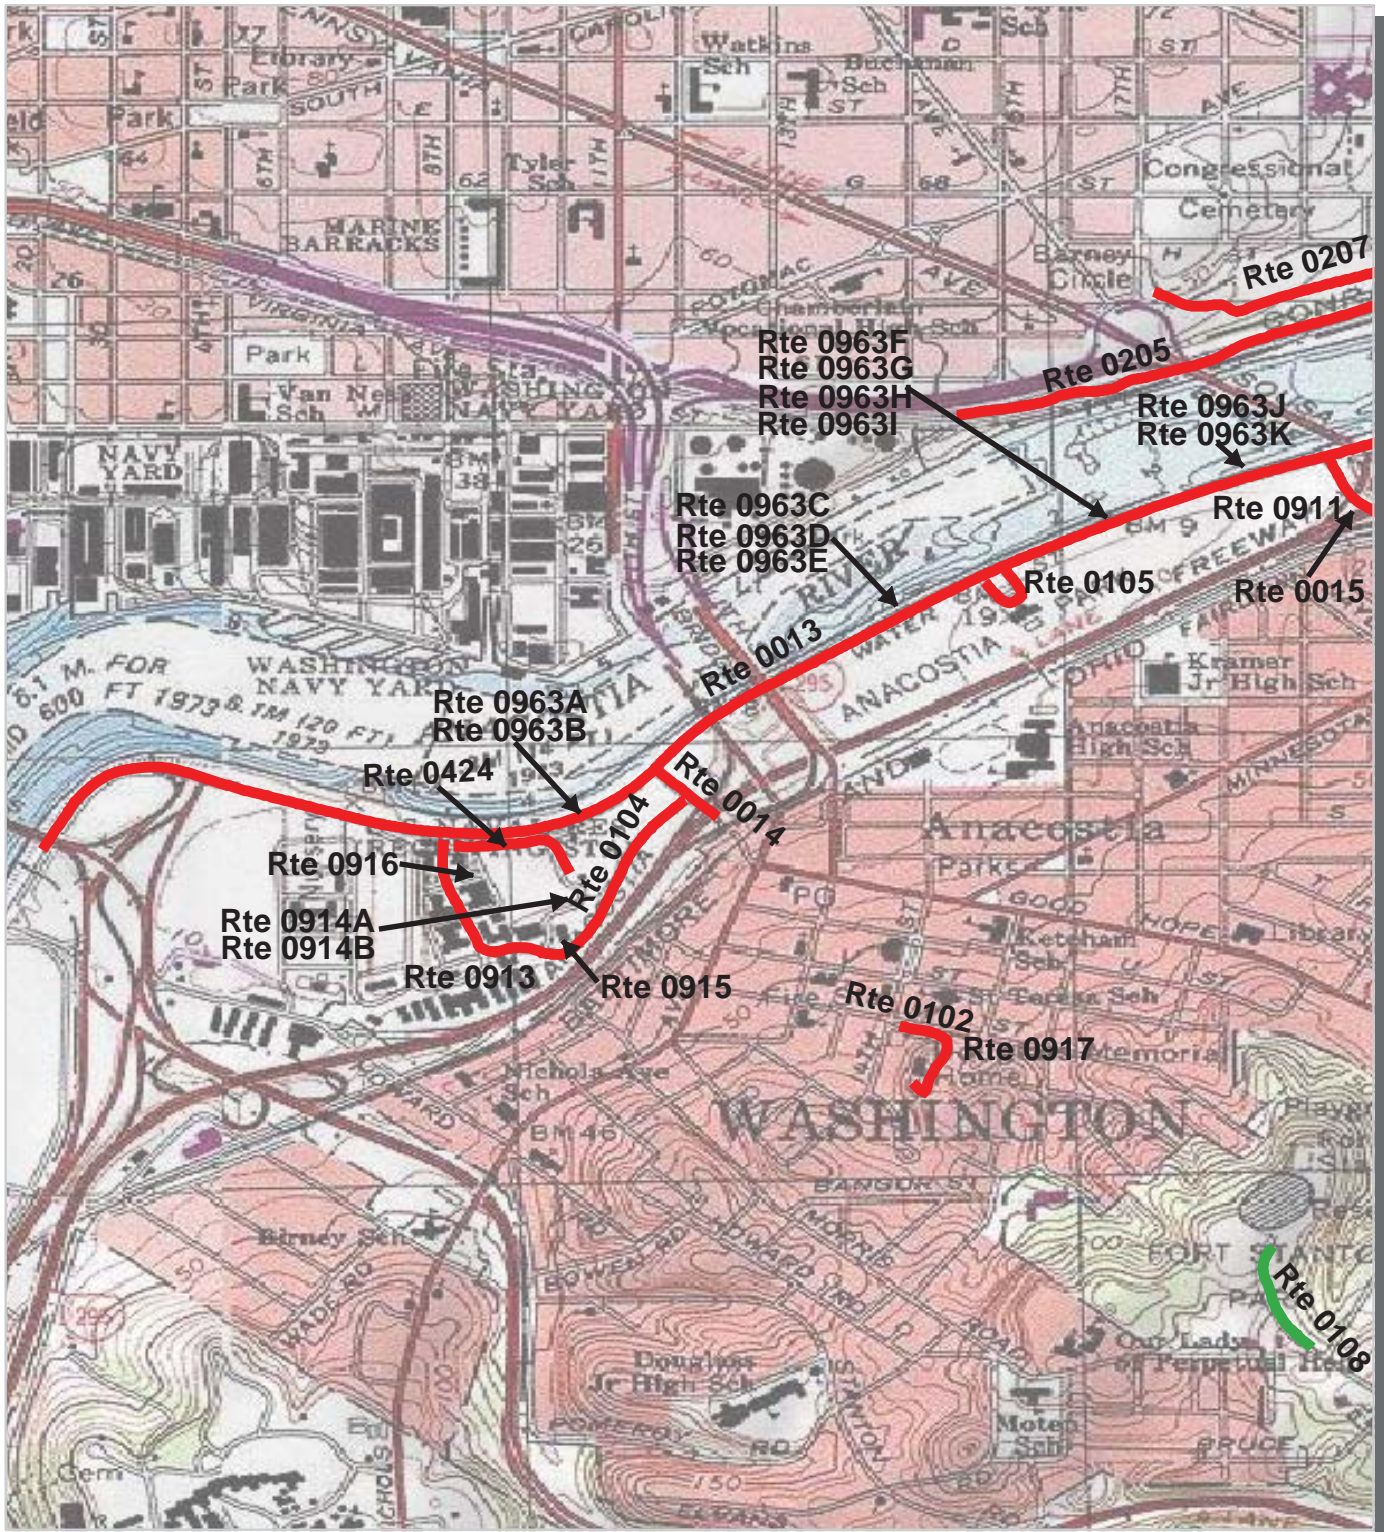
National Capital Parks-East Route Condition Area Map 2 PCR - Mile by Mile

| PCR | Poor | Fair | Good | Excellent |
| | (<=60) | (61 - 84) | (85 - 94) | (95 - 100) |

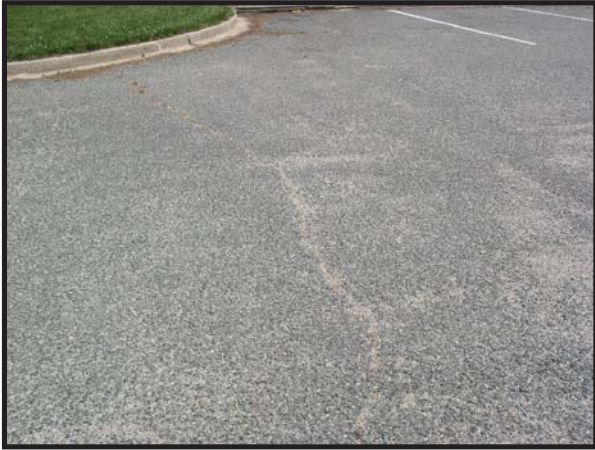
National Capital Parks-East
Route 0902
 KENILWORTH AQUATIC GARDENS MAINTENANCE AREA
 FROM ROUTE 0401

| Route | Public / NonPublic | Date Visited | Area (sq ft) | Lane Miles * | Surface Type | Condition / PCR |
|---|---|---|---|---|---|---|
| 0902 | NonPublic | 6/23/2004 | 634 | 0.01 | AS | POOR / 45 |

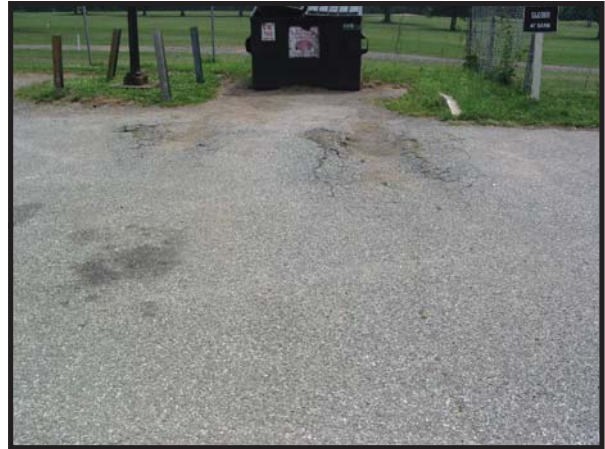
National Capital Parks-East
Route 0906
 KENILWORTH MAINTENANCE YARD
 FROM ROUTE 0402

| Route | Public / NonPublic | Date Visited | Area (sq ft) | Lane Miles * | Surface Type | Condition / PCR |
|---|---|---|---|---|---|---|
| 0906 | NonPublic | 6/23/2004 | 47065 | 0.81 | AS | POOR / 45 |

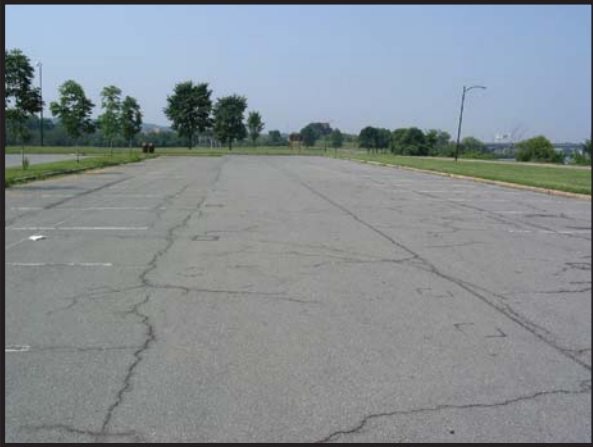
National Capital Parks-East
Route 0908
 ANACOSTIA BOAT RAMP PARKING
 FROM ROUTE 0013

| Route | Public / NonPublic | Date Visited | Area (sq ft) | Lane Miles * | Surface Type | Condition / PCR |
|---|---|---|---|---|---|---|
| 0908 | Public | 6/9/2004 | 54087 | 0.93 | AS | GOOD / 90 |

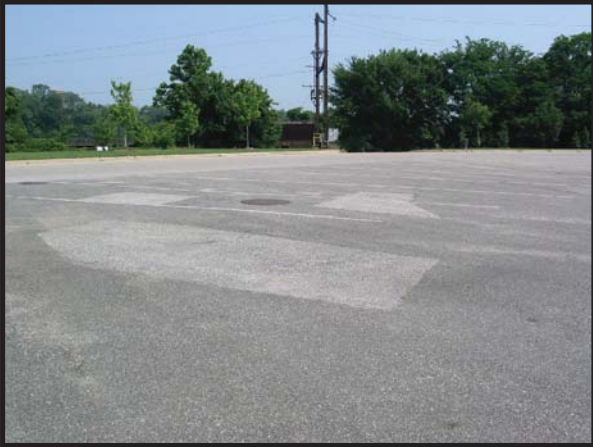
National Capital Parks-East
Route 0909
 ANACOSTIA SKATE PARK PARKING
 FROM ROUTE 0016

| Route | Public / NonPublic | Date Visited | Area (sq ft) | Lane Miles * | Surface Type | Condition / PCR |
|---|---|---|---|---|---|---|
| 0909 | Public | 6/9/2004 | 100285 | 1.73 | AS | POOR / 45 |

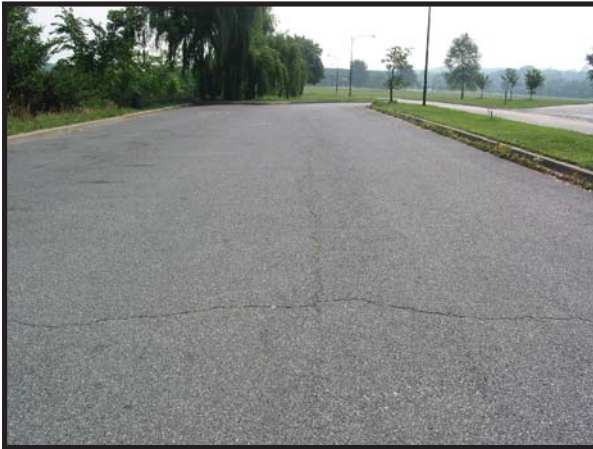
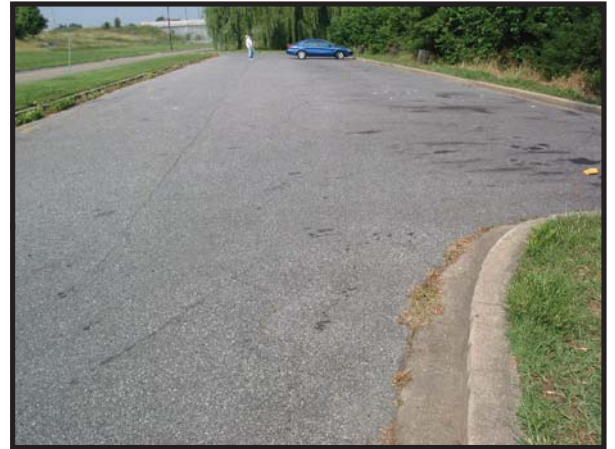
National Capital Parks-East
Route 0911
 ANACOSTIA PLAYGROUND PARKING
 FROM ROUTE 0015

| Route | Public / NonPublic | Date Visited | Area (sq ft) | Lane Miles * | Surface Type | Condition / PCR |
|---|---|---|---|---|---|---|
| 0911 | Public | 5/20/2004 | 12255 | 0.21 | AS | FAIR / 73 |

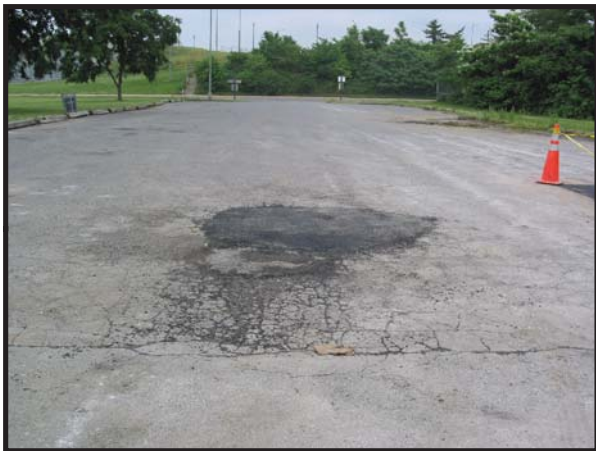
National Capital Parks-East
Route 0913
 NACE PARK HEADQUARTERS PARKING
 FROM ROUTE 0104

| Route | Public / NonPublic | Date Visited | Area (sq ft) | Lane Miles * | Surface Type | Condition / PCR |
|---|---|---|---|---|---|---|
| 0913 | NonPublic | 5/20/2004 | 32310 | 0.56 | AS | FAIR / 73 |

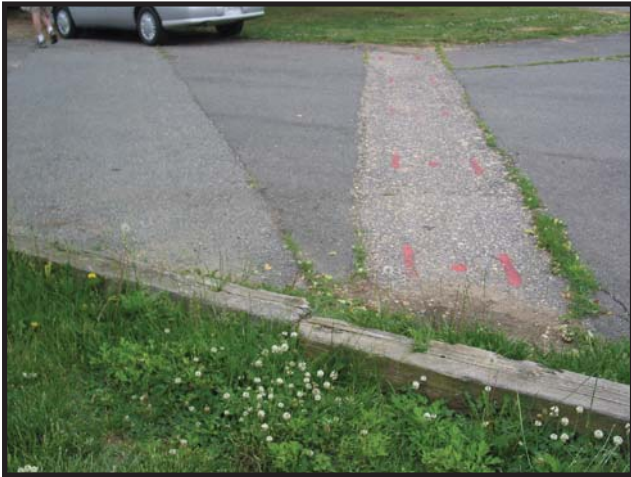
National Capital Parks-East
Route 0916
 U.S. PARK POLICE OFFICE PARKING
 FROM ROUTE 0104

| Route | Public / NonPublic | Date Visited | Area (sq ft) | Lane Miles * | Surface Type | Condition / PCR |
|---|---|---|---|---|---|---|
| 0916 | NonPublic | 5/20/2004 | 53939 | 0.93 | AS | GOOD / 90 |

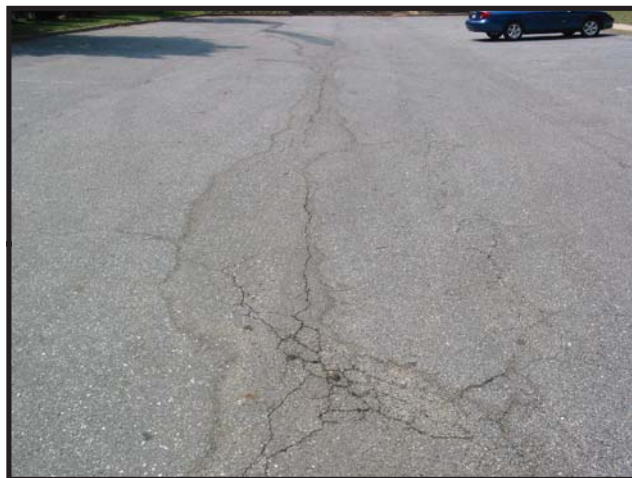
National Capital Parks-East
Route 0918
 FT. DUPONT MAINTENANCE YARD PARKING
 FROM ROUTE 0117

| Route | Public / NonPublic | Date Visited | Area (sq ft) | Lane Miles * | Surface Type | Condition / PCR |
|---|---|---|---|---|---|---|
| 0918 | NonPublic | 6/9/2004 | 8853 | 0.15 | AS | FAIR / 73 |

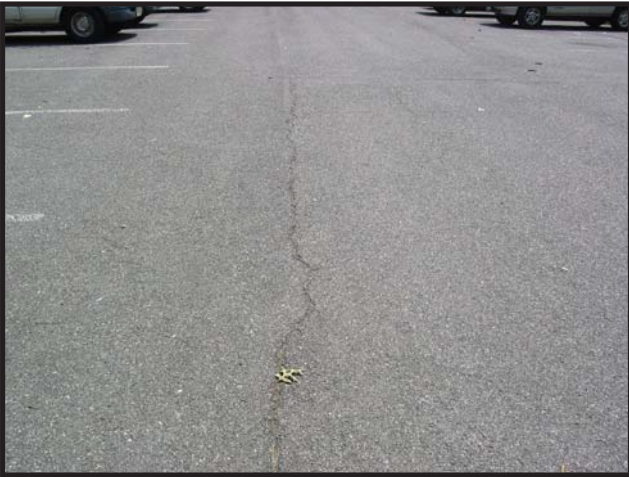
National Capital Parks-East
Route 0919A
 FT. DUPONT MAINTENANCE AREA A
 FROM ROUTE 0406

| Route | Public / NonPublic | Date Visited | Area (sq ft) | Lane Miles * | Surface Type | Condition / PCR |
|---|---|---|---|---|---|---|
| 0919A | NonPublic | 6/17/2004 | 17854 | 0.31 | AS | FAIR / 73 |

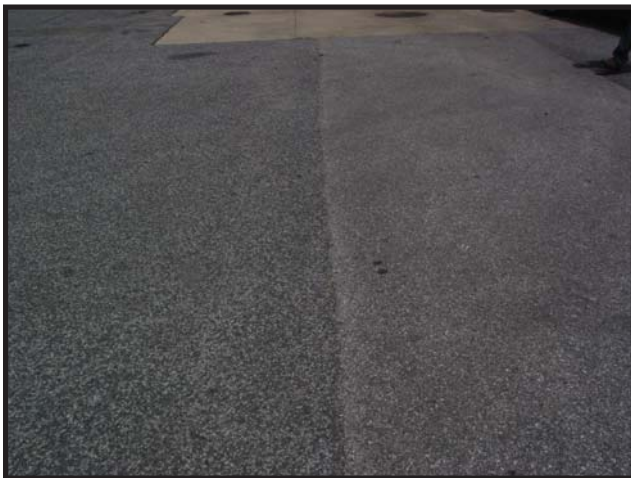
National Capital Parks-East
Route 0919B
FT. DUPONT MAINTENANCE AREA B
FROM ROUTE 0117

| Route | Public / NonPublic | Date Visited | Area (sq ft) | Lane Miles * | Surface Type | Condition / PCR |
|---|---|---|---|---|---|---|
| 0919B | NonPublic | 6/17/2004 | 4736 | 0.08 | AS | FAIR / 73 |

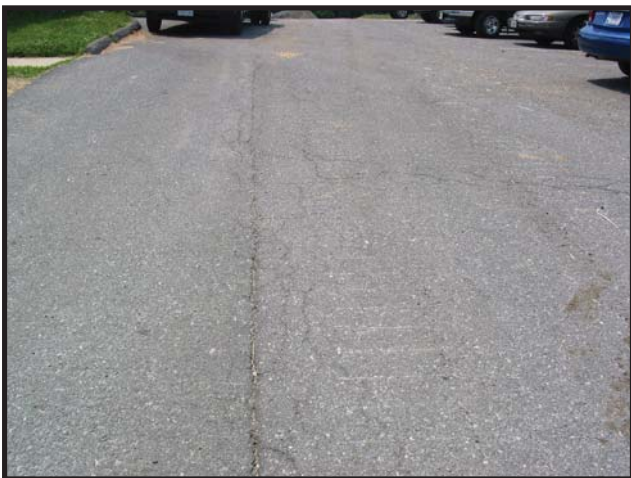
National Capital Parks-East
Route 0921
FT. DUPONT ICE SKATING RINK PARKING
FROM ELY PLACE

| Route | Public / NonPublic | Date Visited | Area (sq ft) | Lane Miles * | Surface Type | Condition / PCR |
|---|---|---|---|---|---|---|
| 0921 | Public | 6/9/2004 | 76726 | 1.32 | AS | GOOD / 90 |

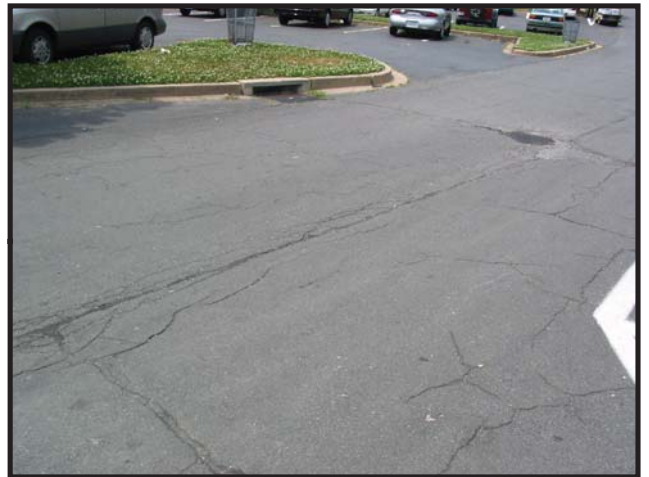
National Capital Parks-East
Route 0926
 RFK STADIUM NORTH PARKING
 FROM EAST CAPITAL STREET NE

| Route | Public / NonPublic | Date Visited | Area (sq ft) | Lane Miles * | Surface Type | Condition / PCR |
|---|---|---|---|---|---|---|
| 0926 | Public | 5/4/2004 | 107413 | 1.85 | OC | GOOD / 90 |

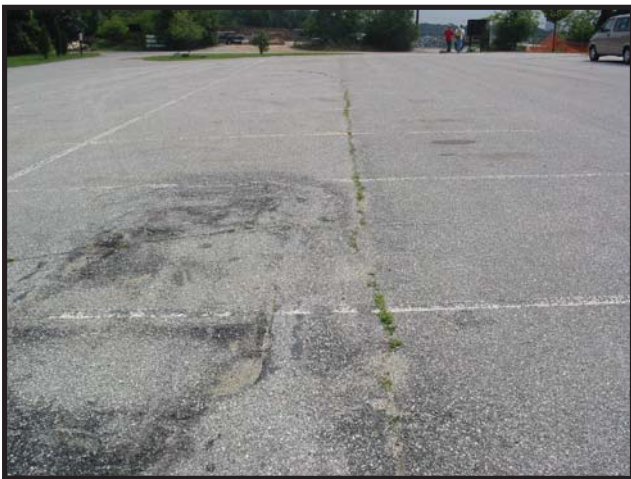
National Capital Parks-East
Route 0956
 MARSHALL HALL BOAT RAMP PARKING
 FROM ROUTE 0124

| Route | Public / NonPublic | Date Visited | Area (sq ft) | Lane Miles * | Surface Type | Condition / PCR |
|---|---|---|---|---|---|---|
| 0956 | Public | 6/7/2004 | 47593 | 0.82 | AS | GOOD / 90 |

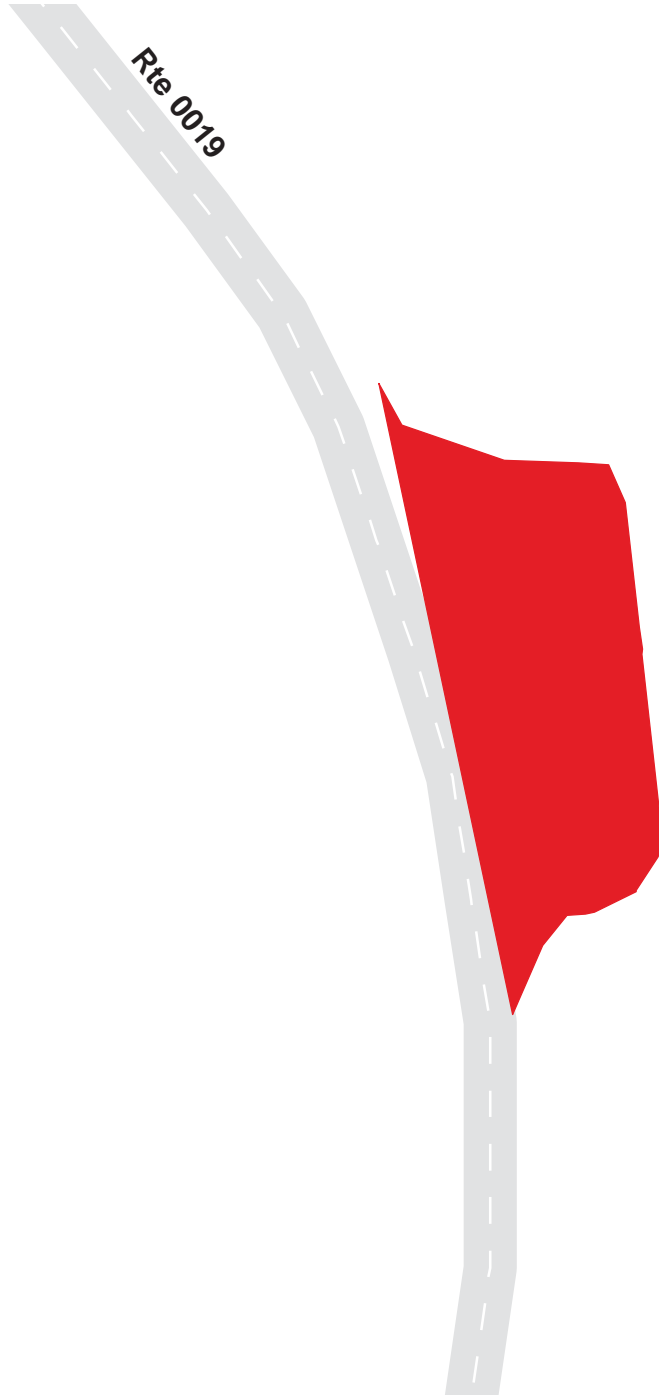
National Capital Parks-East
Route 0958C
 RIDGE PICNIC AREA PARKING C
 FROM ROUTE 0019

| Route | Public / NonPublic | Date Visited | Area (sq ft) | Lane Miles * | Surface Type | Condition / PCR |
|---|---|---|---|---|---|---|
| 0958C | Public | 6/17/2004 | 2583 | 0.04 | AS | FAIR / 73 |

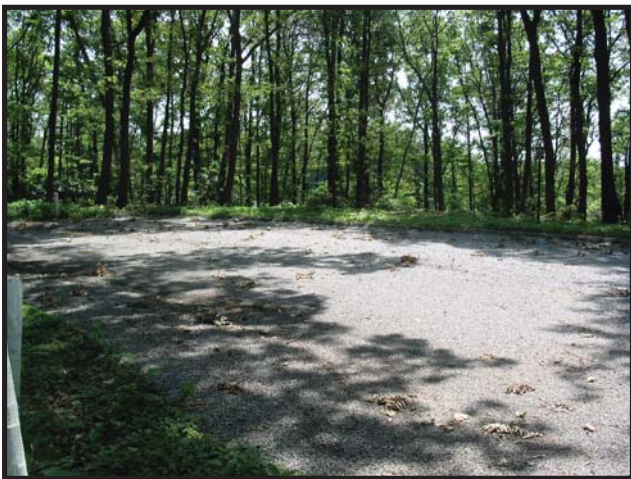
National Capital Parks-East
Route 0958D
RIDGE PICNIC AREA PARKING D
FROM ROUTE 0019

| Route | Public / NonPublic | Date Visited | Area (sq ft) | Lane Miles * | Surface Type | Condition / PCR |
|---|---|---|---|---|---|---|
| 0958D | Public | 6/17/2004 | 529 | 0.01 | AS | FAIR / 73 |

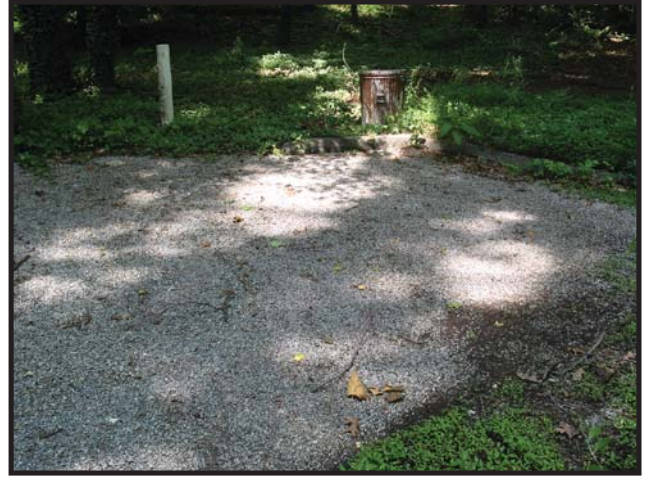
National Capital Parks-East
Route 0958G
 RIDGE PICNIC AREA PARKING G
 FROM ROUTE 0019

| Route | Public / NonPublic | Date Visited | Area (sq ft) | Lane Miles * | Surface Type | Condition / PCR |
|---|---|---|---|---|---|---|
| 0958G | Public | 6/17/2004 | 303 | 0.01 | AS | FAIR / 73 |

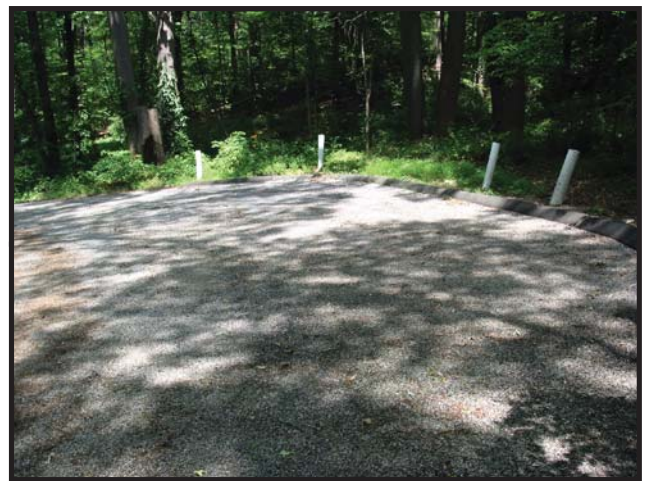
National Capital Parks-East
Route 0958H
 RIDGE PICNIC AREA PARKING H
 FROM ROUTE 0019

| Route | Public / NonPublic | Date Visited | Area (sq ft) | Lane Miles * | Surface Type | Condition / PCR |
|---|---|---|---|---|---|---|
| 0958H | Public | 6/17/2004 | 2471 | 0.04 | AS | FAIR / 73 |

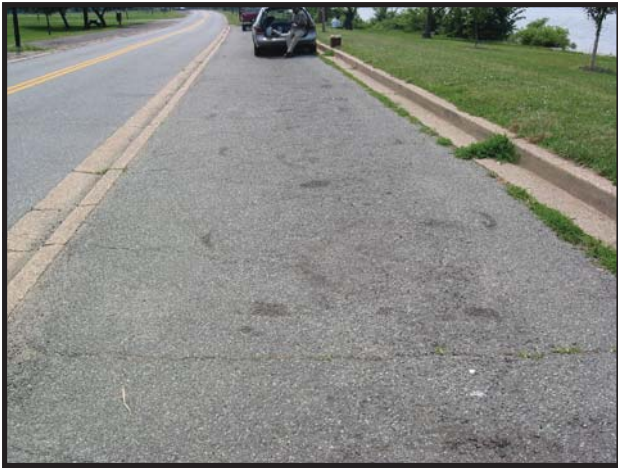
| Route | Public / NonPublic | Date Visited | Area (sq ft) | Lane Miles * | Surface Type | Condition / PCR |
|---|---|---|---|---|---|---|
| 0963F | Public | 6/7/2004 | 2602 | 0.04 | AS | FAIR / 73 |

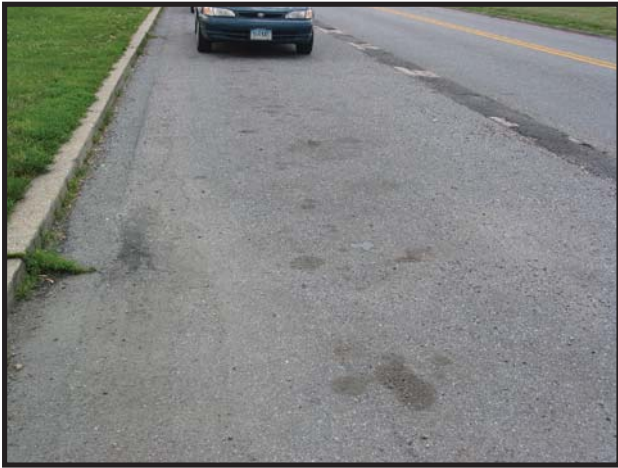
Route 0963G

| Route | Public / NonPublic | Date Visited | Area (sq ft) | Lane Miles * | Surface Type | Condition / PCR |
|---|---|---|---|---|---|---|
| 0963G | Public | 6/7/2004 | 1512 | 0.03 | AS | GOOD / 90 |

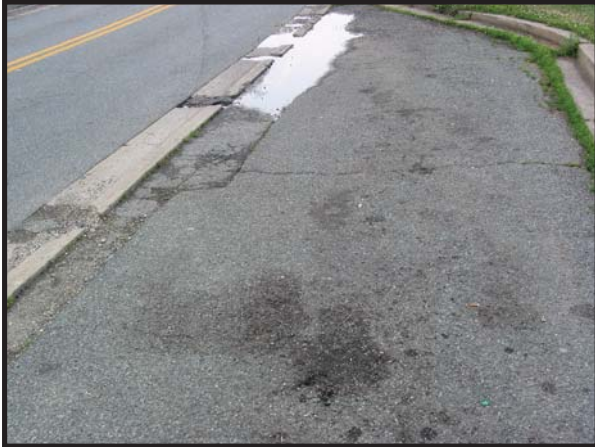
Route 0963H

| Route | Public / NonPublic | Date Visited | Area (sq ft) | Lane Miles * | Surface Type | Condition / PCR |
|---|---|---|---|---|---|---|
| 0963H | Public | 6/7/2004 | 2040 | 0.04 | AS | POOR / 45 |

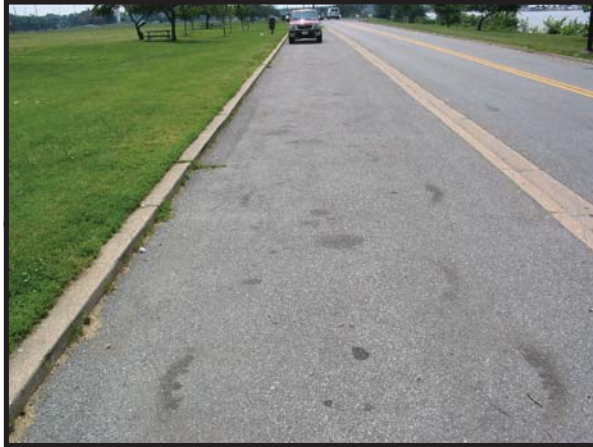
Route 0963I

| Route | Public / NonPublic | Date Visited | Area (sq ft) | Lane Miles * | Surface Type | Condition / PCR |
|---|---|---|---|---|---|---|
| 0963I | Public | 6/7/2004 | 2634 | 0.05 | AS | GOOD / 90 |

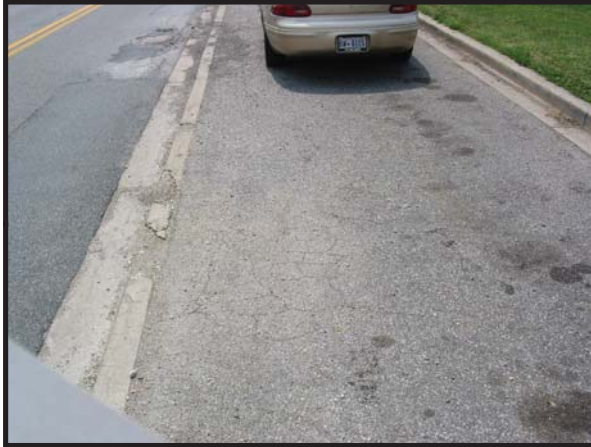
| Route | Public / NonPublic | Date Visited | Area (sq ft) | Lane Miles * | Surface Type | Condition / PCR |
|---|---|---|---|---|---|---|
| 0963K | Public | 6/7/2004 | 1830 | 0.03 | AS | POOR / 45 |

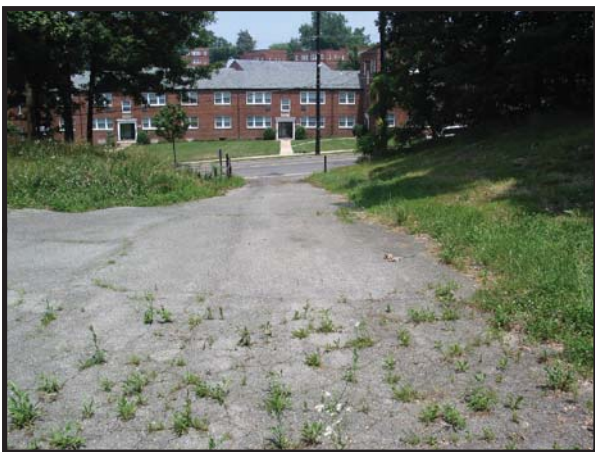
National Capital Parks-East
Route 0976A
 SEAFARERS YACHT CLUB PARKING A
 FROM ROUTE 0205

| Route | Public / NonPublic | Date Visited | Area (sq ft) | Lane Miles * | Surface Type | Condition / PCR |
|---|---|---|---|---|---|---|
| 0976A | NonPublic | 6/17/2004 | 2205 | 0.04 | AS | GOOD / 90 |

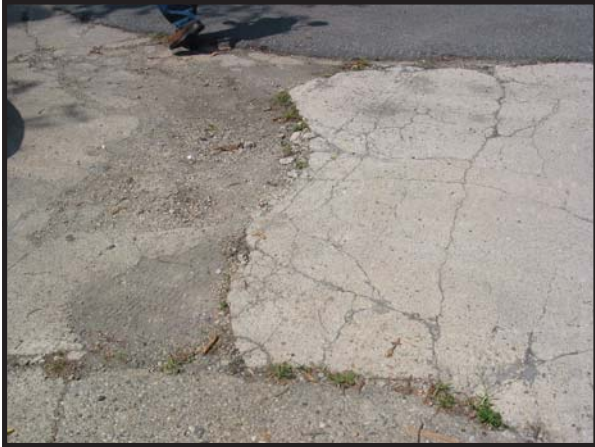
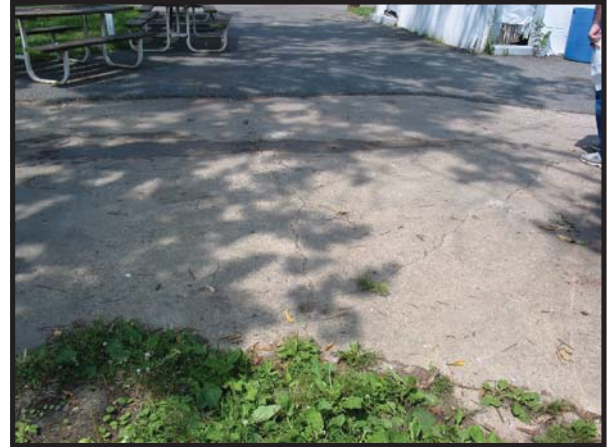
National Capital Parks-East
Route 0976B
 SEAFARERS YACHT CLUB PARKING B
 FROM ROUTE 0205

| Route | Public / NonPublic | Date Visited | Area (sq ft) | Lane Miles * | Surface Type | Condition / PCR |
|---|---|---|---|---|---|---|
| 0976B | NonPublic | 6/17/2004 | 1667 | 0.03 | CO | FAIR / 73 |

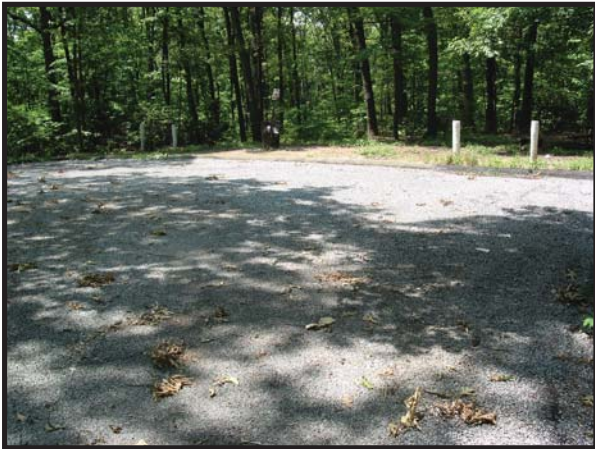
Route 0980

| Route | Public / NonPublic | Date Visited | Area (sq ft) | Lane Miles * | Surface Type | Condition / PCR |
|---|---|---|---|---|---|---|
| 0980 | Public | 6/17/2004 | 1298 | 0.02 | AS | POOR / 45 |
