**The Road Inventory  
of  
Natchez National Historical Park  
NATC - 5565**

**Road Inventory Program**

Prepared By:  
Federal Highway Administration  
Eastern Federal Lands Highway Division  
Cycle 3

# Natchez National Historical Park in Mississippi

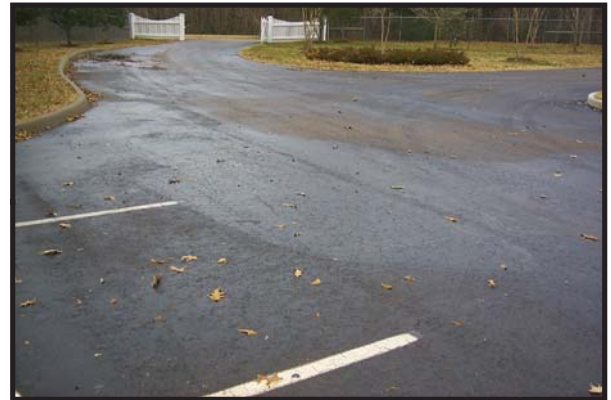
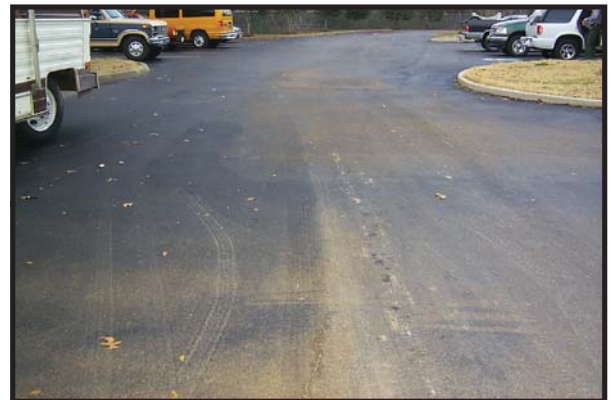
## Route 0901

Melrose Mansion Maintenance Parking  
From Melrose Parkway

Route	Public / NonPublic	Date Visited	Area (sq ft)	Lane Miles *	Surface Type	Condition / PCR
0901	NonPublic	1/24/2002	28228	0.49	AS	FAIR / 73
