The Road Inventory of Navajo National Monument NAVA - 7430

Prepared By:
Federal Highway Administration
Eastern Federal Lands Highway Division
Cycle 3

Navajo National Monument in Arizona

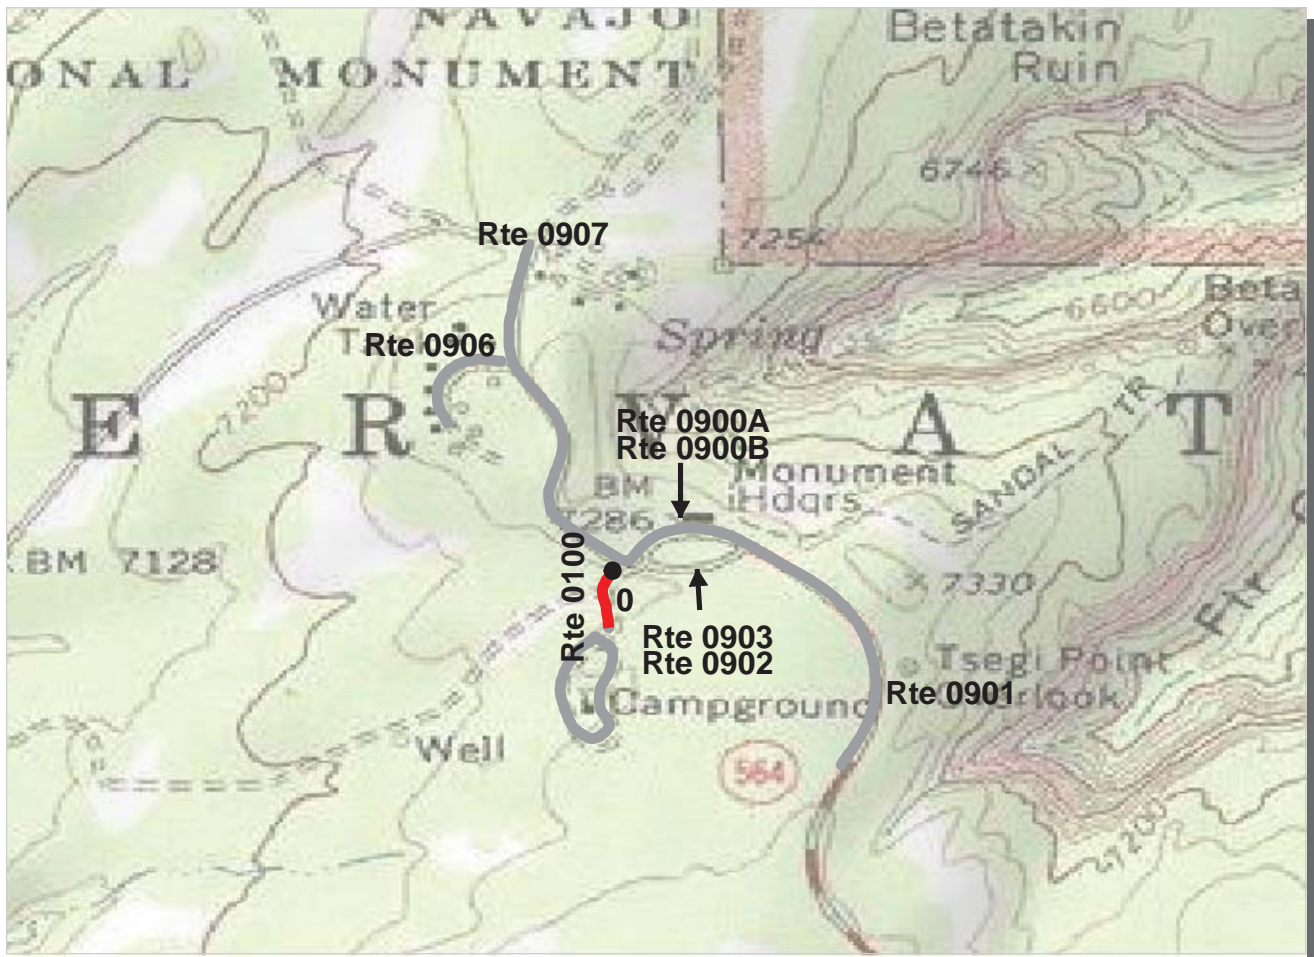
ROUTE: 0100 CAMPGROUND LOOP ACCESS ROAD **TOTAL LENGTH: 0.08 Miles**

Section Number	0				
Section Length (mi)	0.08				
AADT	**				
SADT	**				
ADT Date	**				
Cross Section Information					
Number of Lanes	2				
Paved Width (ft)	19				
Lane Width (ft)	9				
Shoulder Width (ft)	0				
Roadway Condition Information					
PCR (Pavement Condition Rating)	57				
RCI (Roughness Condition Index)	50				
SCR (Surface Condition Rating)	53				
Alligator Cracking Index	100				
Rutting Index	85				
Patching Index	93				
Transverse Cracking Index	81				
Longitudinal Cracking Index	92				
Shoulder Condition Rating	N/A				
Drainage Condition Rating	GOOD

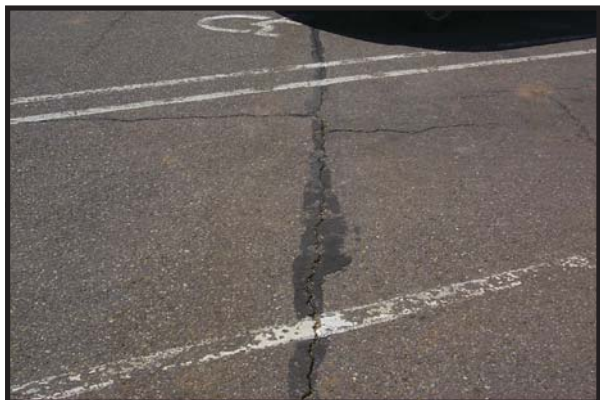
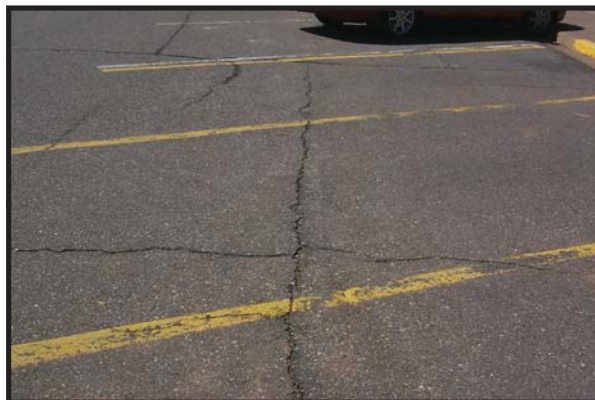
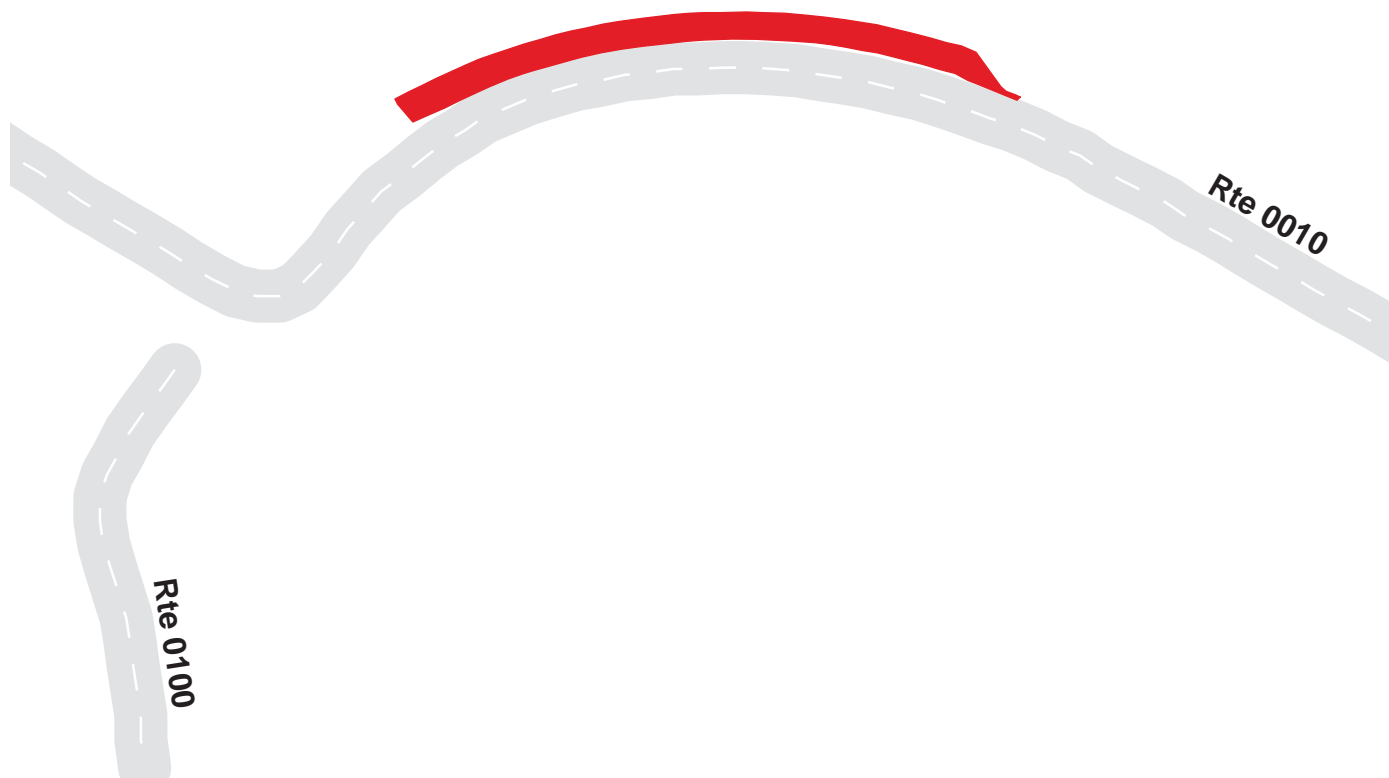
Route	Public / NonPublic	Date Visited	Area (sq ft)	Lane Miles *	Surface Type	Condition / PCR
0900A	Public	4/4/2003	7537	0.13	AS	FAIR / 73

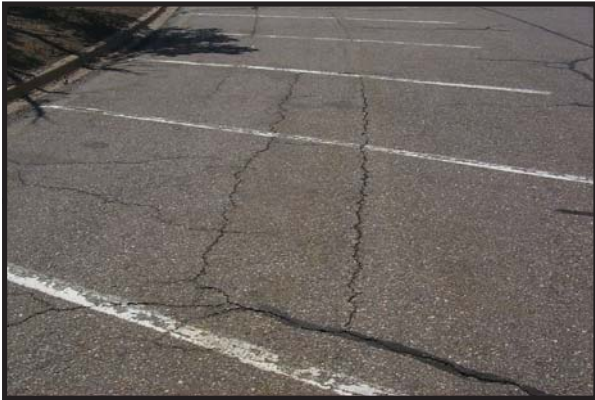
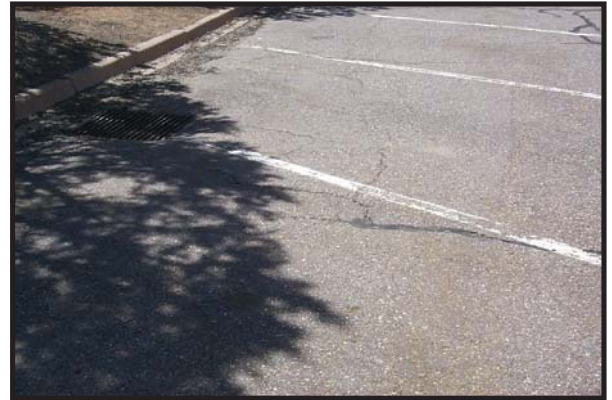
Route 0900B

Route	Public / NonPublic	Date Visited	Area (sq ft)	Lane Miles *	Surface Type	Condition / PCR
0900B	Public	4/4/2003	6087	0.10	AS	FAIR / 73

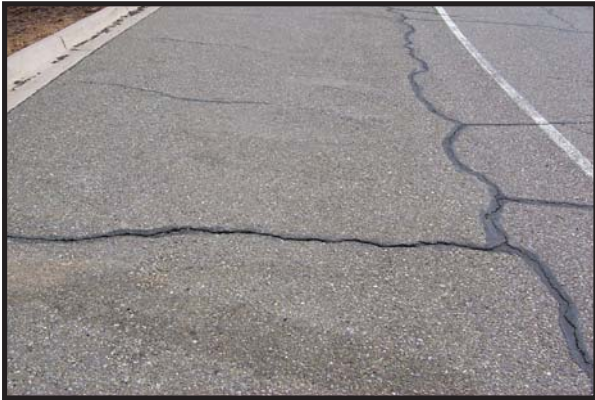
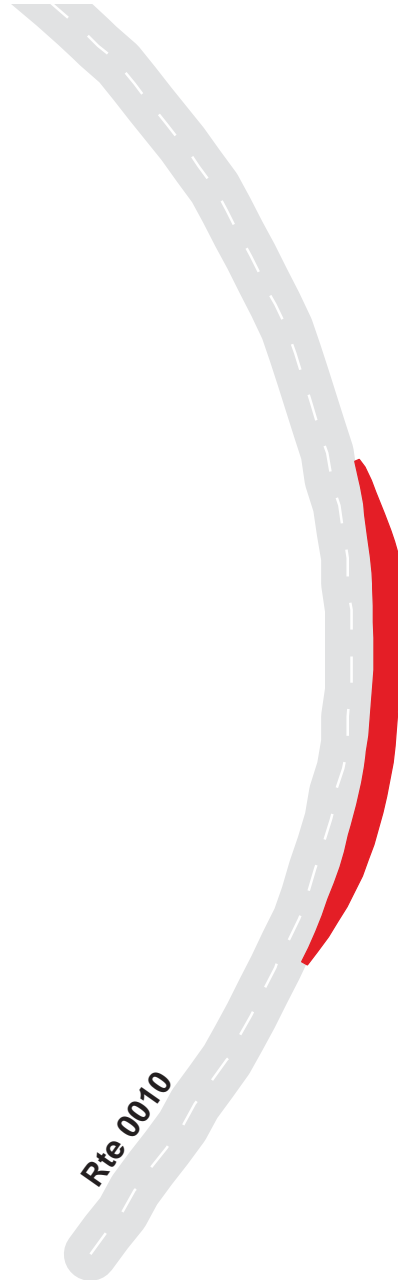
Route 0901

Route	Public / NonPublic	Date Visited	Area (sq ft)	Lane Miles *	Surface Type	Condition / PCR
0901	Public	4/4/2003	4763	0.08	AS	FAIR / 73

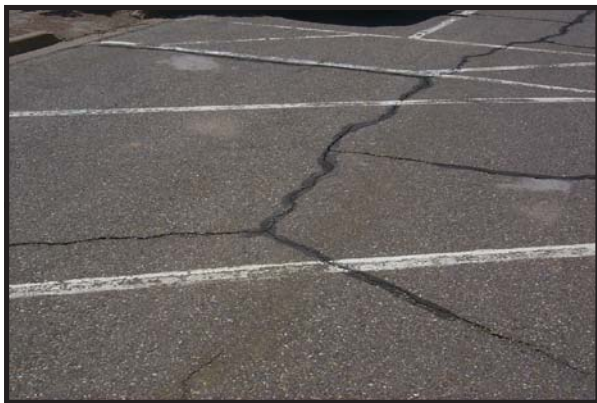
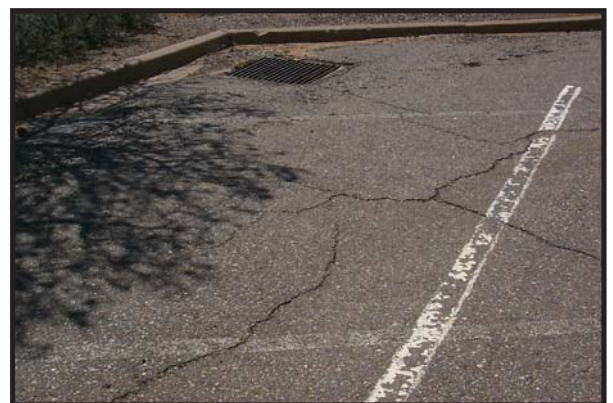
Route 0902

Route	Public / NonPublic	Date Visited	Area (sq ft)	Lane Miles *	Surface Type	Condition / PCR
0902	Public	4/4/2003	3712	0.06	AS	FAIR / 73

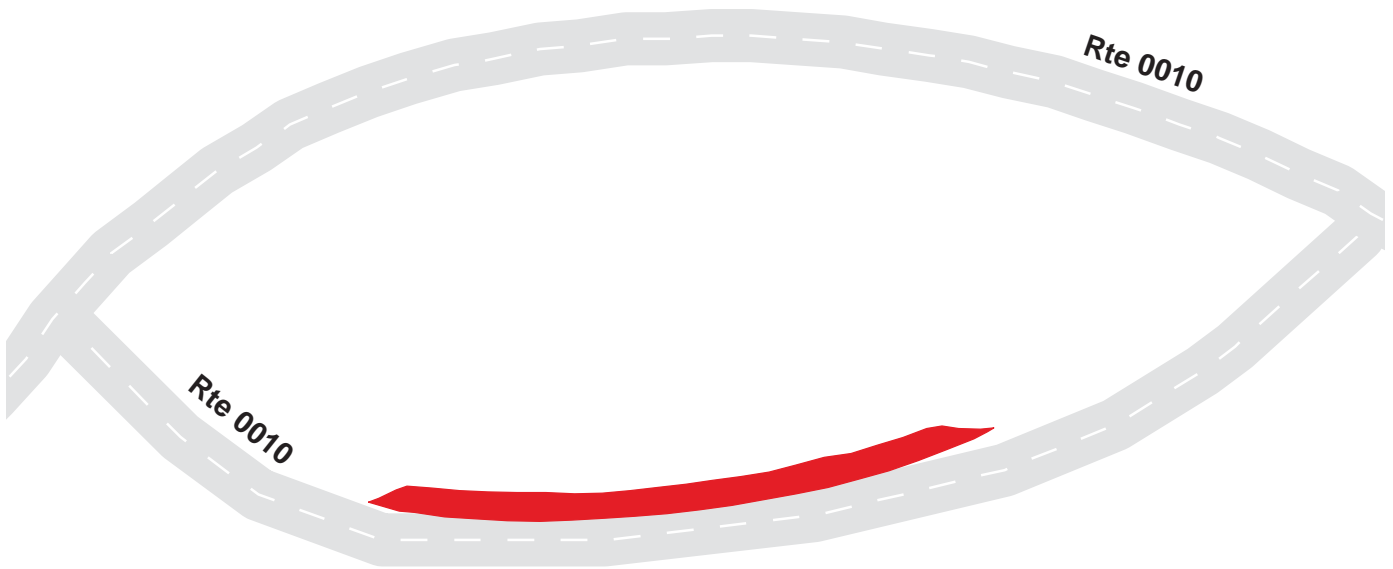
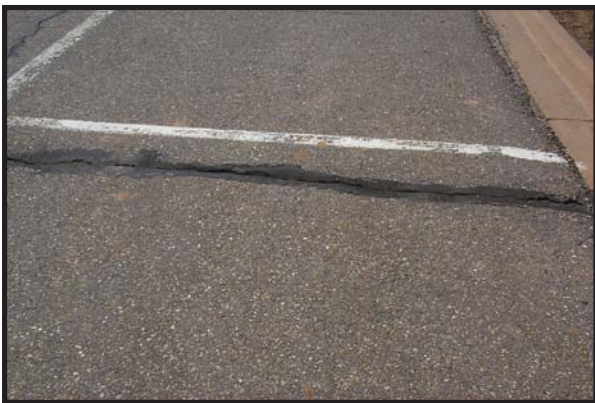
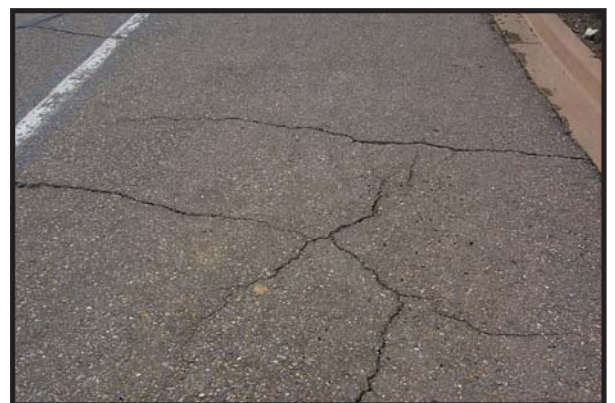
Route 0903

Route	Public / NonPublic	Date Visited	Area (sq ft)	Lane Miles *	Surface Type	Condition / PCR
0903	Public	4/4/2003	2268	0.04	AS	FAIR / 73

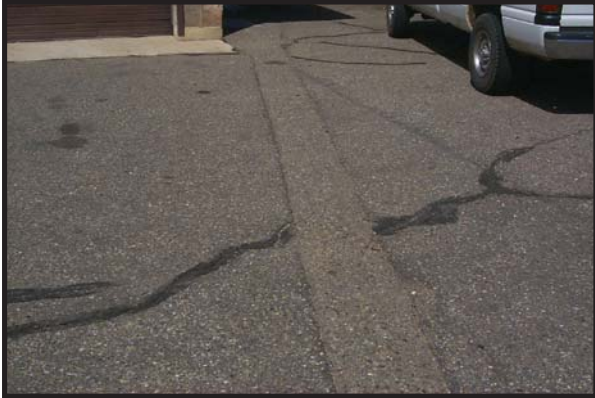
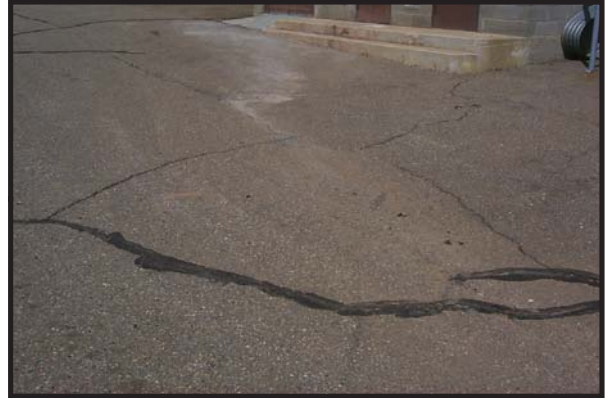
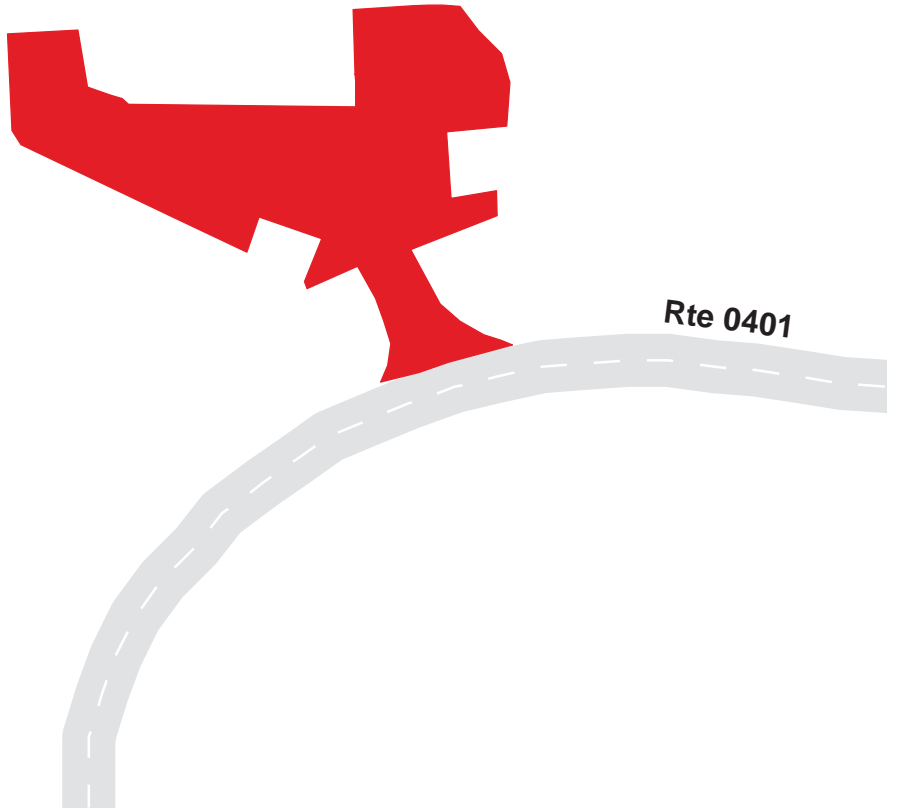
Route 0906

Route	Public / NonPublic	Date Visited	Area (sq ft)	Lane Miles *	Surface Type	Condition / PCR
0906	NonPublic	4/4/2003	11410	0.20	AS	POOR / 45

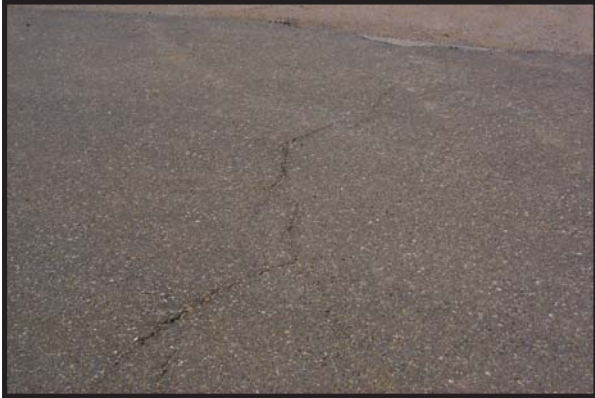
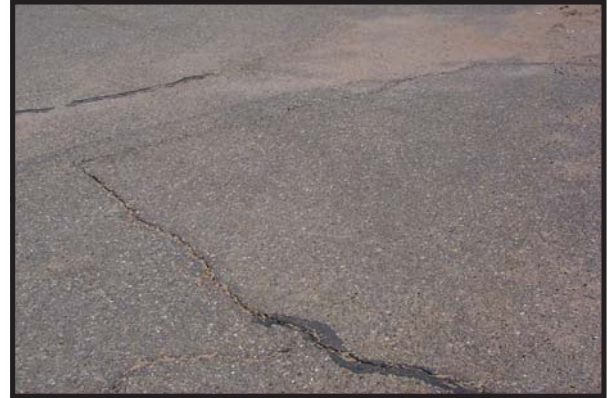
Route 0907

Route	Public / NonPublic	Date Visited	Area (sq ft)	Lane Miles *	Surface Type	Condition / PCR
0907	Public	4/4/2003	3748	0.06	AS	FAIR / 73
