The Road Inventory of Nez Perce National Historical Park NEPE - 9371

Road Inventory Program

Prepared By:
Federal Highway Administration
Eastern Federal Lands Highway Division
Cycle 3

Nez Perce National Historical Park in Idaho

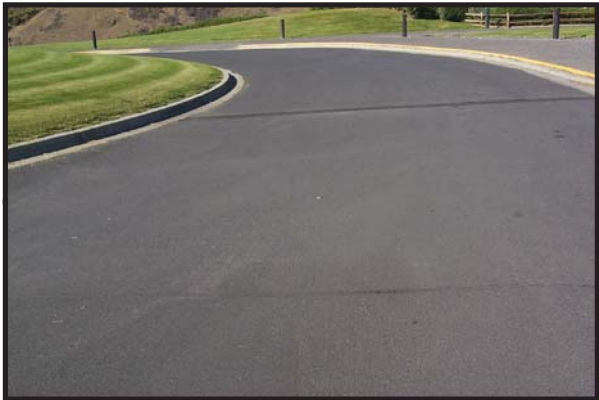
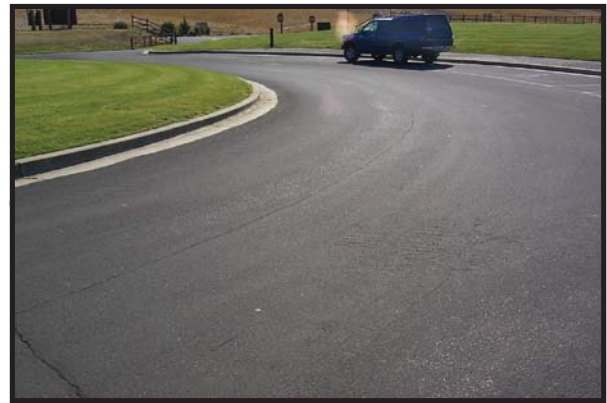
Route	Public / NonPublic	Date Visited	Area (sq ft)	Lane Miles *	Surface Type	Condition / PCR
0900A	Public	10/7/2002	11685	0.20	AS	GOOD / 90

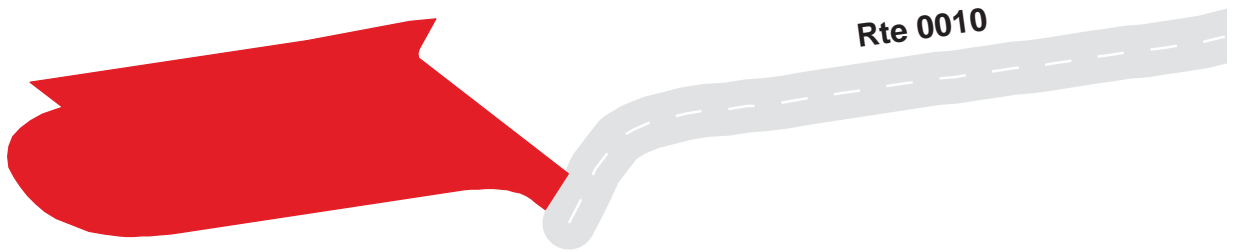
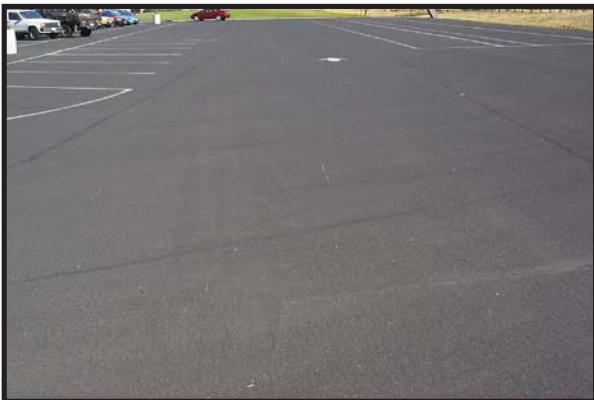
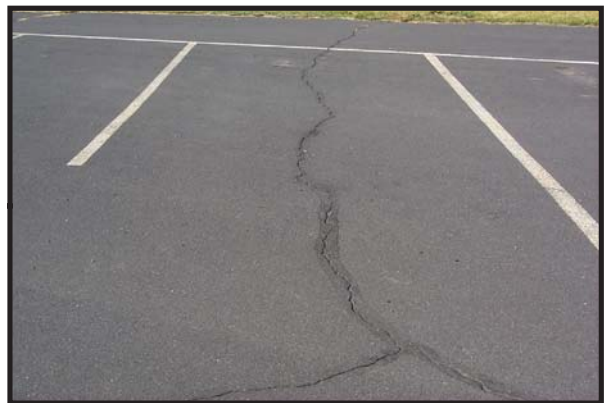
Route 0900B

Route	Public / NonPublic	Date Visited	Area (sq ft)	Lane Miles *	Surface Type	Condition / PCR
0900B	Public	10/7/2002	48497	0.84	AS	GOOD / 90

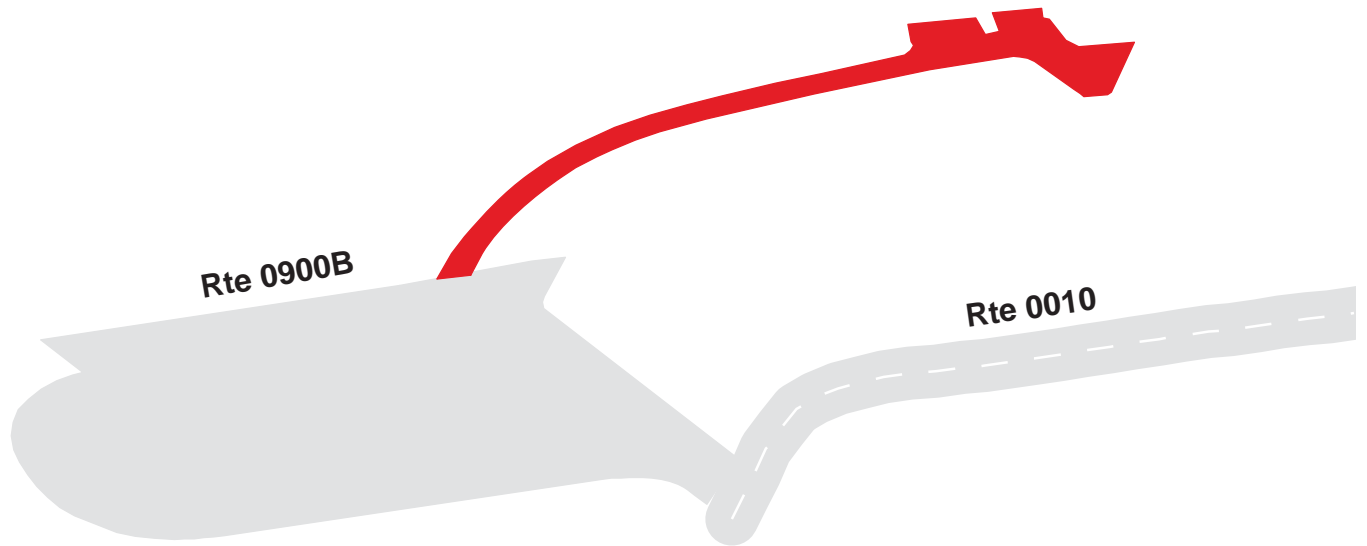
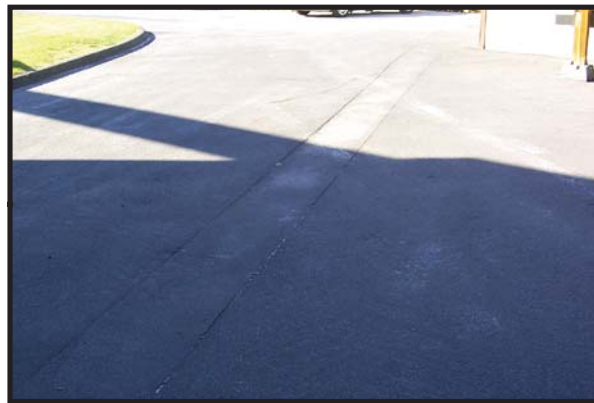
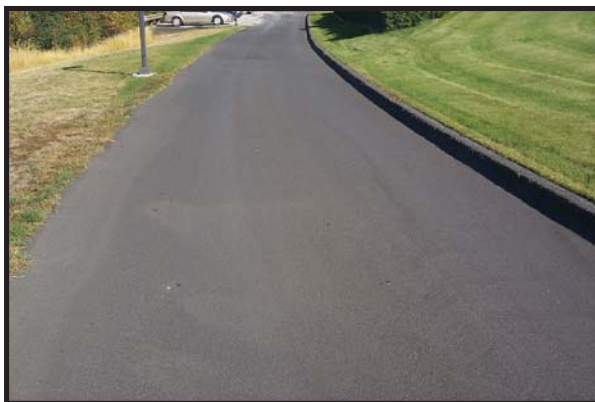
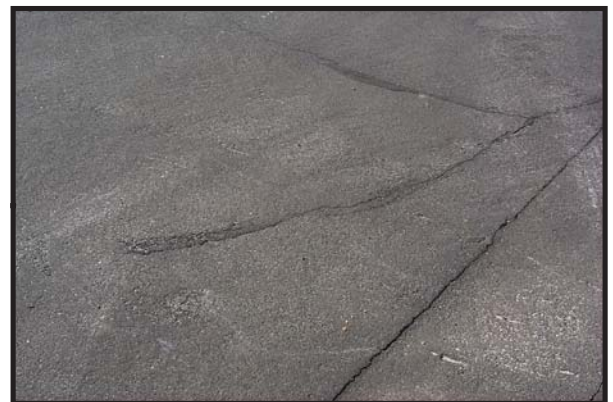
Route 0901

Route	Public / NonPublic	Date Visited	Area (sq ft)	Lane Miles *	Surface Type	Condition / PCR
0901	NonPublic	10/7/2022	7619	0.13	AS	GOOD / 90

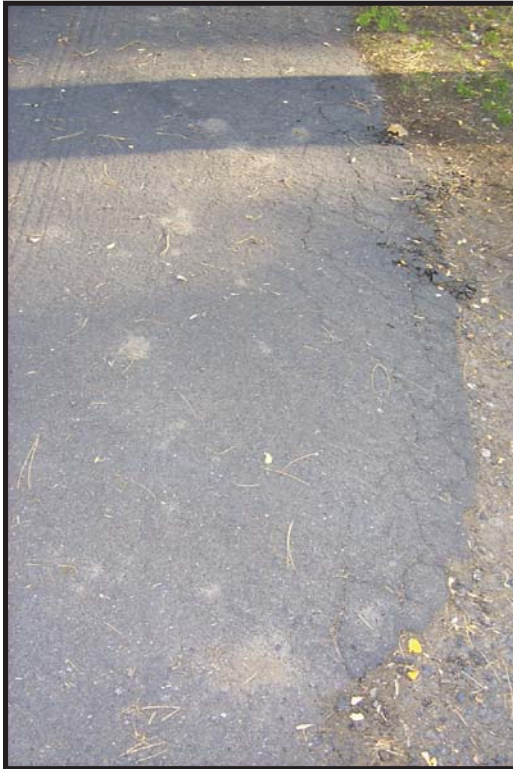
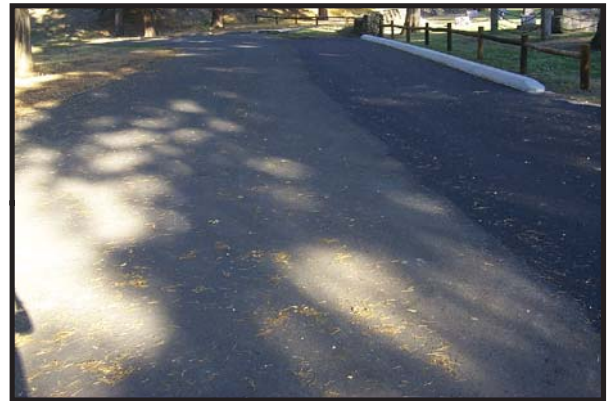
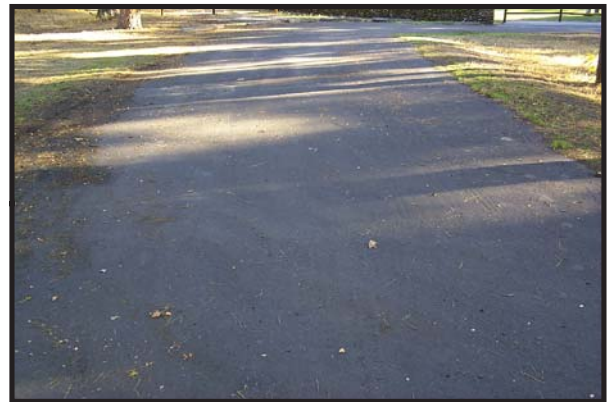
Route 0902

Route	Public / NonPublic	Date Visited	Area (sq ft)	Lane Miles *	Surface Type	Condition / PCR
0902	Public	10/7/2002	3721	0.06	AS	GOOD / 90

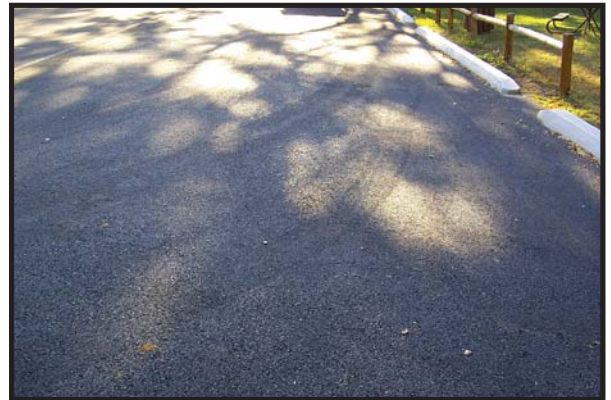
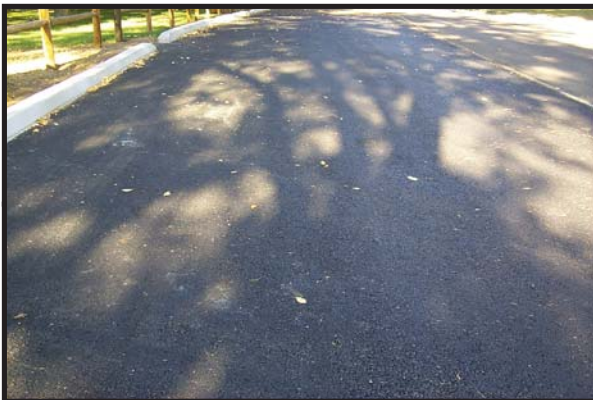
Route 0904A

Route	Public / NonPublic	Date Visited	Area (sq ft)	Lane Miles *	Surface Type	Condition / PCR
0904A	Public	10/7/2002	4860	0.08	AS	EXCELLENT / 97

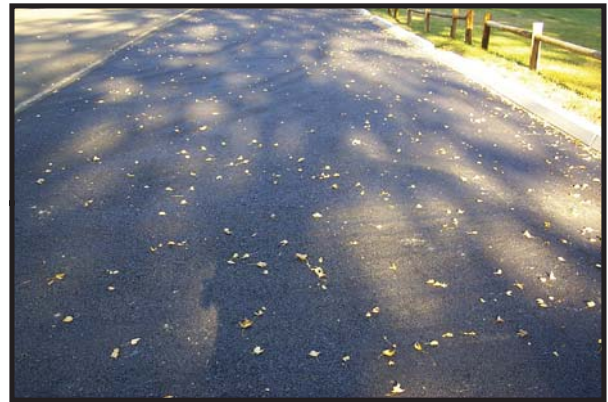
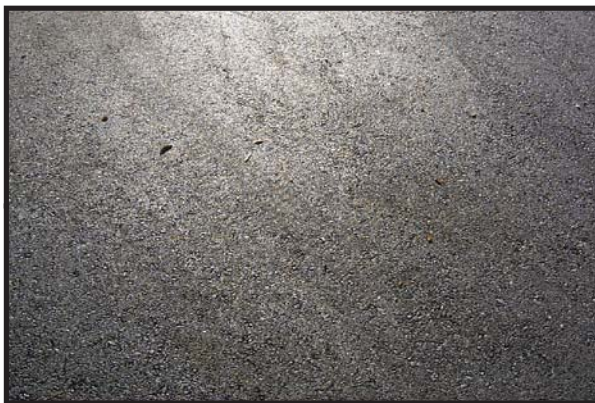
Route 0904B

Route	Public / NonPublic	Date Visited	Area (sq ft)	Lane Miles *	Surface Type	Condition / PCR
0904B	Public	10/7/2002	2819	0.05	AS	EXCELLENT / 97

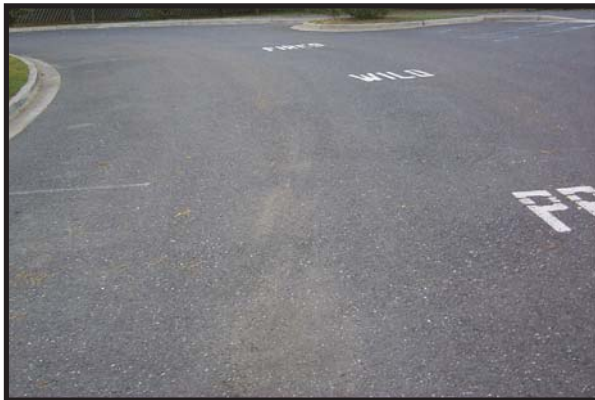
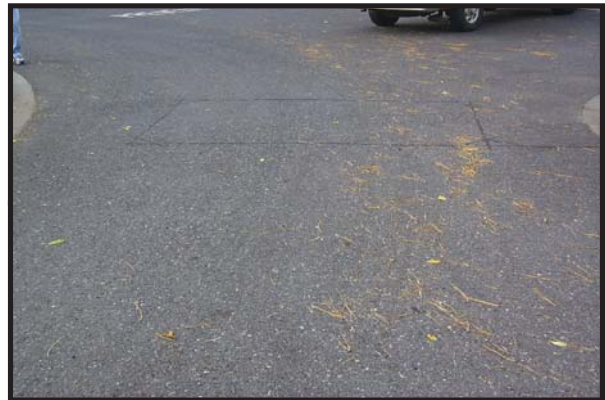
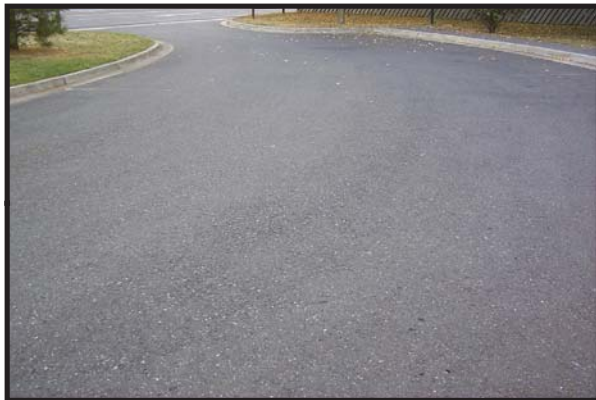
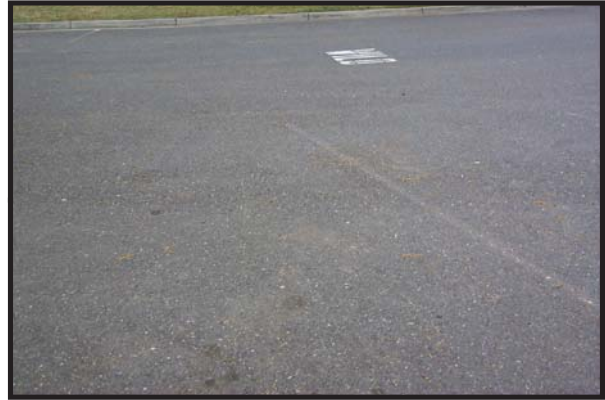
Route 0905

Route	Public / NonPublic	Date Visited	Area (sq ft)	Lane Miles *	Surface Type	Condition / PCR
0905	Public	10/7/2002	7986	0.14	AS	GOOD / 90

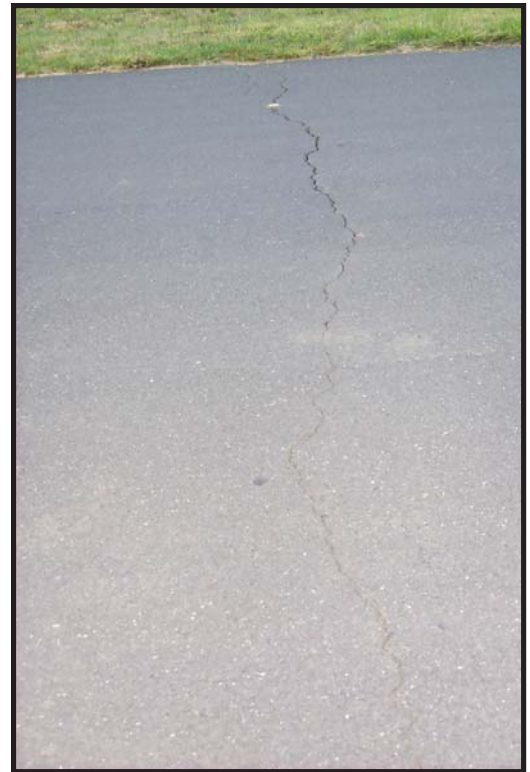
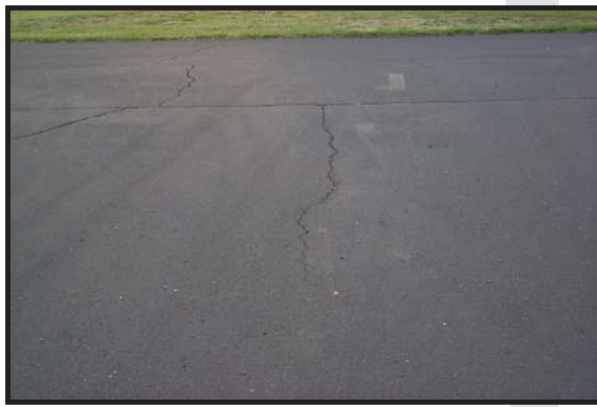
Route 0906

Route	Public / NonPublic	Date Visited	Area (sq ft)	Lane Miles *	Surface Type	Condition / PCR
0906	Public	10/7/2002	19219	0.33	AS	GOOD / 90
