The Road Inventory of New River Gorge National River NERI - 4780

Road Inventory Program

Prepared By:
Federal Highway Administration
Eastern Federal Lands Highway Division
Cycle 3

New River Gorge National River in West Virginia

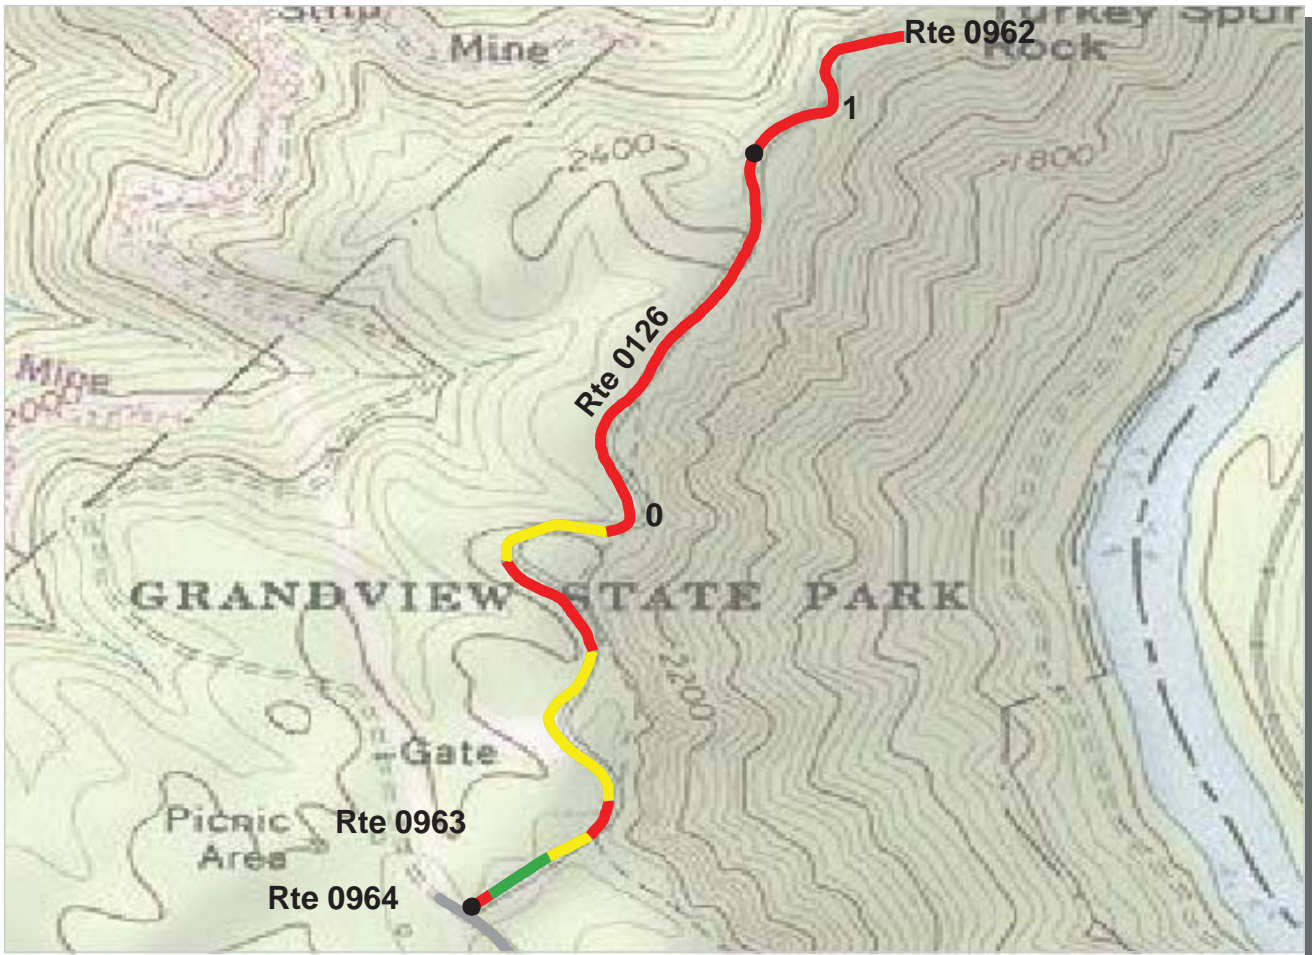
ROUTE: 0126 TURKEY SPUR ROAD **TOTAL LENGTH: 1.21 Miles**

Section Number	0	1			
Section Length (mi)	1.00	0.21			
AADT	**				
SADT	**				
ADT Date	**				
Cross Section Information					
Number of Lanes	2	2			
Paved Width (ft)	16	16			
Lane Width (ft)	8	8			
Shoulder Width (ft)	4	5			
Roadway Condition Information					
PCR (Pavement Condition Rating)	60	29			
RCI (Roughness Condition Index)	66	43			
SCR (Surface Condition Rating)	56	22			
Alligator Cracking Index	96	76			
Rutting Index	61	40			
Patching Index	100	99			
Transverse Cracking Index	99	99			
Longitudinal Cracking Index	99	97			
Shoulder Condition Rating	GOOD	GOOD			
Drainage Condition Rating	GOOD	GOOD

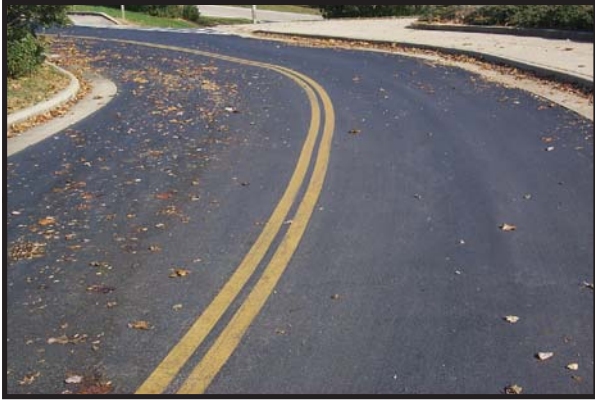
Route	Public / NonPublic	Date Visited	Area (sq ft)	Lane Miles *	Surface Type	Condition / PCR
0906	Public	11/14/2002	90173	1.55	AS	GOOD / 90

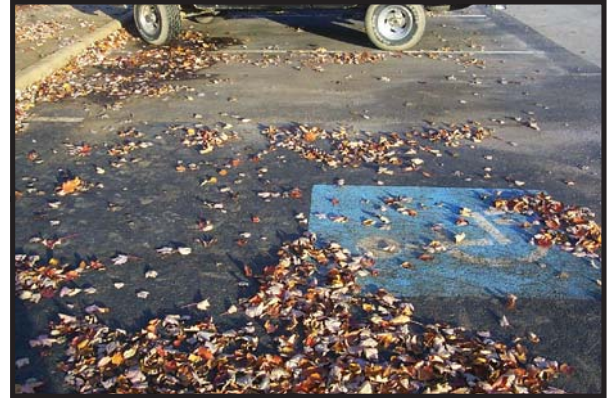
Route 0919B

Route	Public / NonPublic	Date Visited	Area (sq ft)	Lane Miles *	Surface Type	Condition / PCR
0919B	Public	11/15/2002	1306	0.02	AS	GOOD / 90

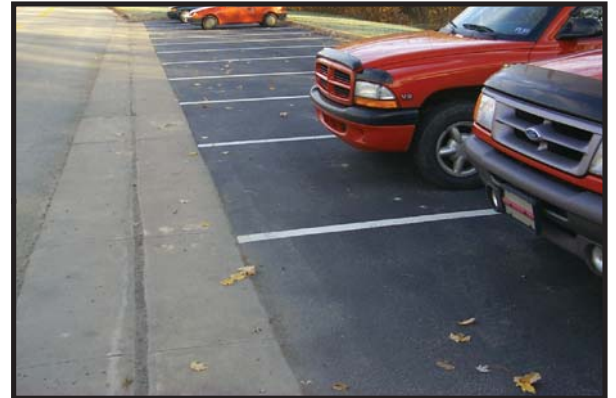
New River Gorge National River
Route 0920
 HEADQUARTERS MAINTENANCE AREA
 From Main Street

Route	Public / NonPublic	Date Visited	Area (sq ft)	Lane Miles *	Surface Type	Condition / PCR
0920	NonPublic	11/15/2002	10685	0.18	AS	FAIR / 73

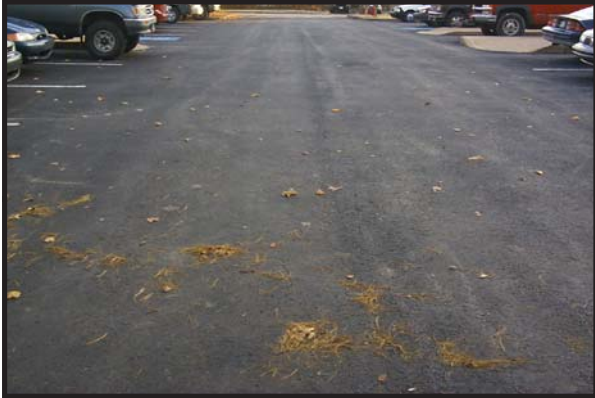
Route 0923

Route	Public / NonPublic	Date Visited	Area (sq ft)	Lane Miles *	Surface Type	Condition / PCR
0923	Public	11/15/2002	4549	0.08	AS	GOOD / 90

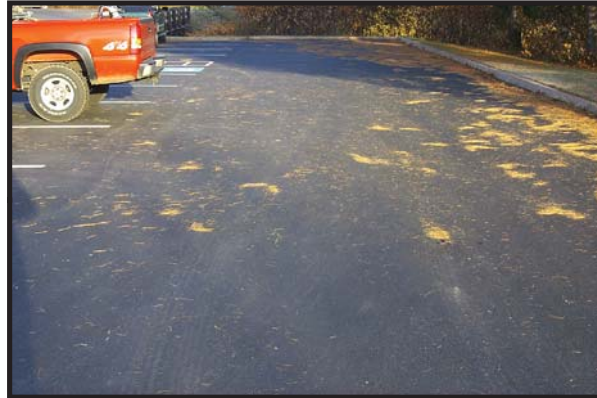
Route 0926

Route	Public / NonPublic	Date Visited	Area (sq ft)	Lane Miles *	Surface Type	Condition / PCR
0926	Public	11/15/2002	3641	0.06	AS	GOOD / 90

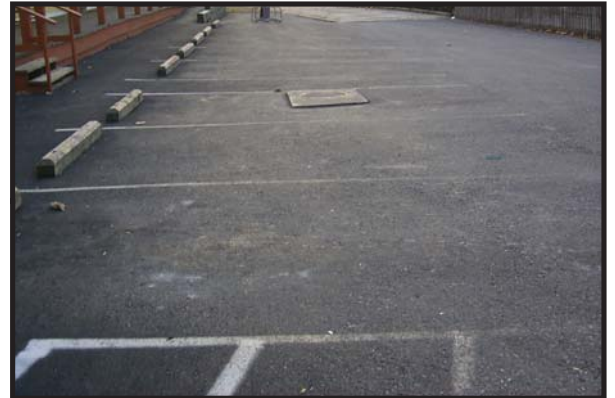
Route 0947

Route	Public / NonPublic	Date Visited	Area (sq ft)	Lane Miles *	Surface Type	Condition / PCR
0947	NonPublic	11/15/2002	12857	0.22	AS	GOOD / 90

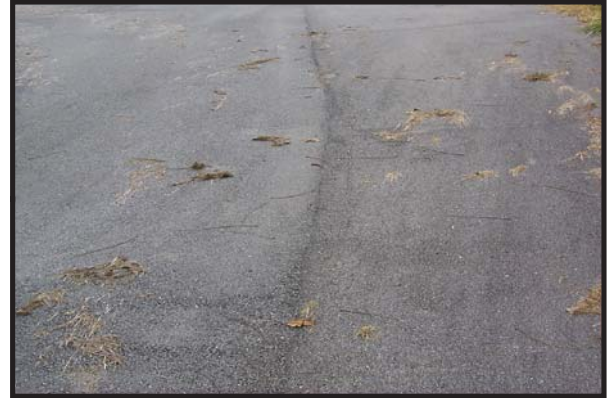
Route 0958

Route	Public / NonPublic	Date Visited	Area (sq ft)	Lane Miles *	Surface Type	Condition / PCR
0958	Public	11/15/2002	11386	0.20	AS	GOOD / 90

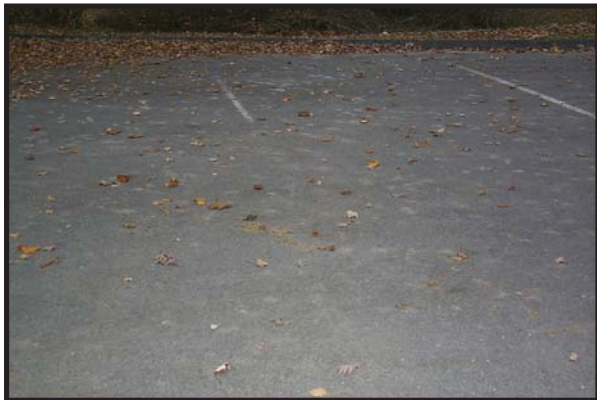
New River Gorge National River Route 0959

Route	Public / NonPublic	Date Visited	Area (sq ft)	Lane Miles *	Surface Type	Condition / PCR
0959	NonPublic	11/15/2002	8907	0.15	AS	POOR / 45

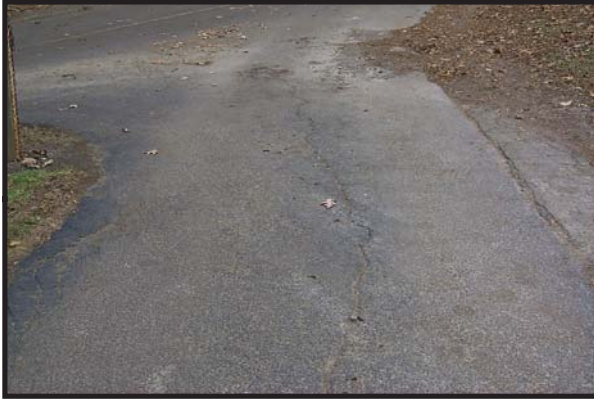
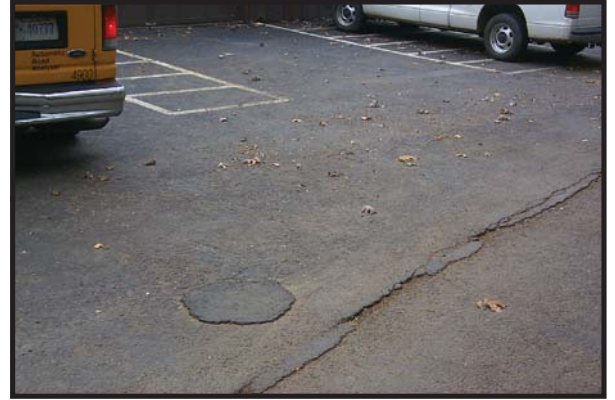
OPERATIONAL COMPOUND PARKING From Route 0010

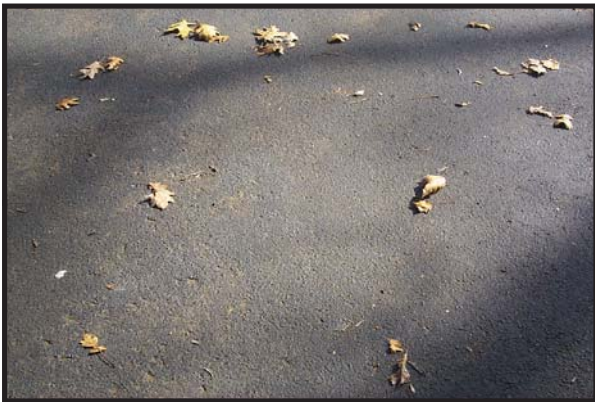
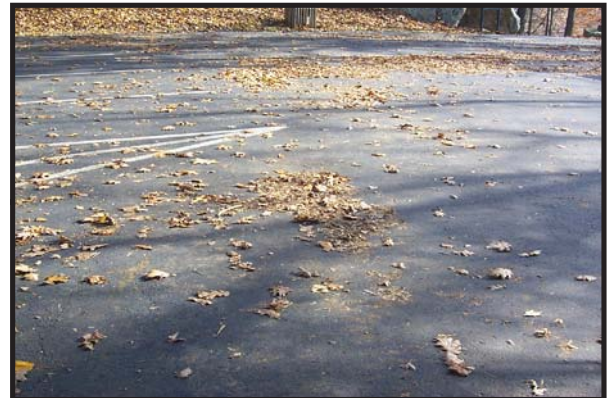
Route 0963

Route	Public / NonPublic	Date Visited	Area (sq ft)	Lane Miles *	Surface Type	Condition / PCR
0963	Public	11/15/2002	28307	0.49	AS	GOOD / 90

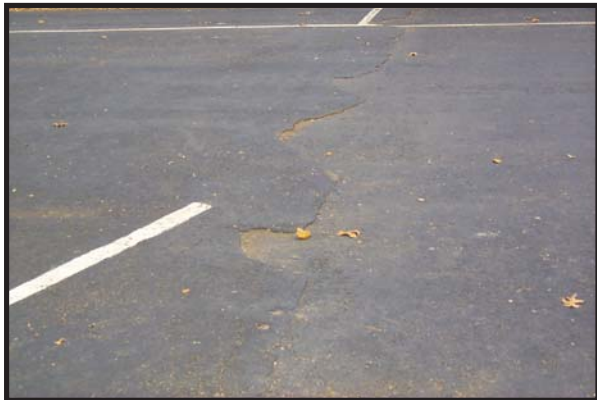
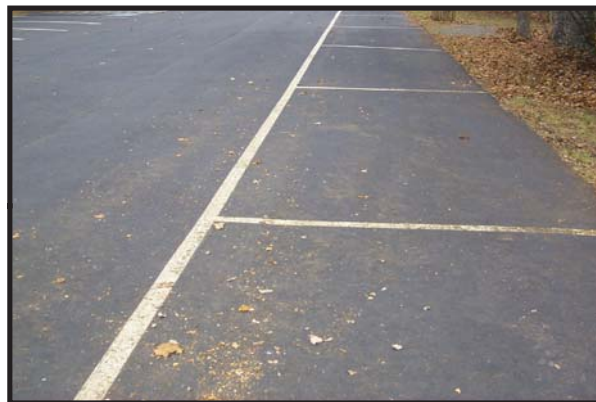
Route 0964

Route	Public / NonPublic	Date Visited	Area (sq ft)	Lane Miles *	Surface Type	Condition / PCR
0964	Public	11/15/2002	17176	0.30	AS	GOOD / 90

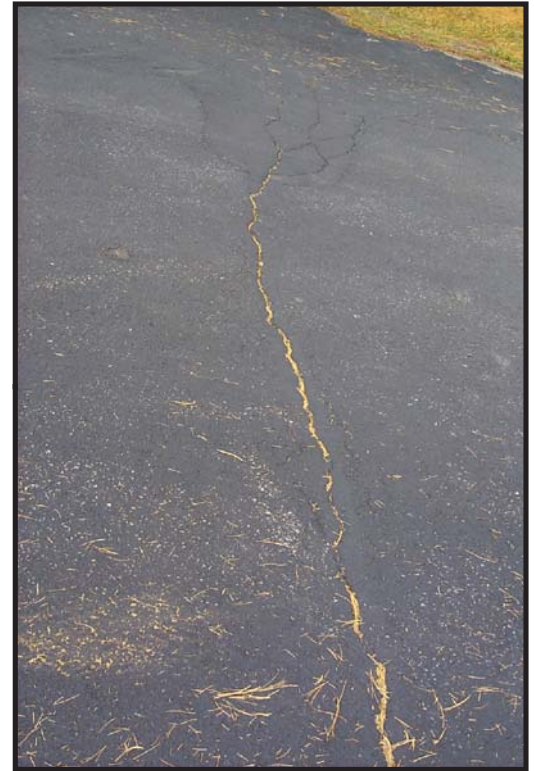
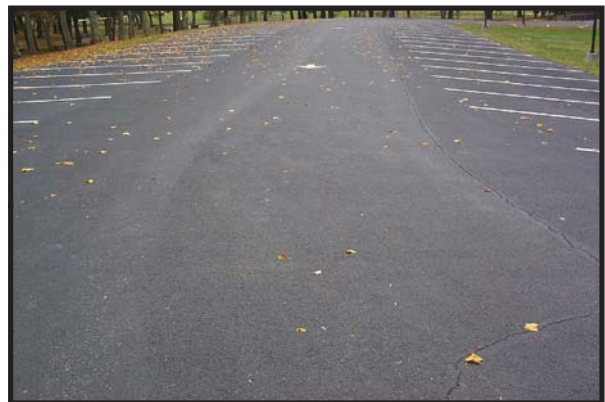
Route 0967A

Route	Public / NonPublic	Date Visited	Area (sq ft)	Lane Miles *	Surface Type	Condition / PCR
0967A	Public	11/15/2002	4835	0.08	AS	GOOD / 90

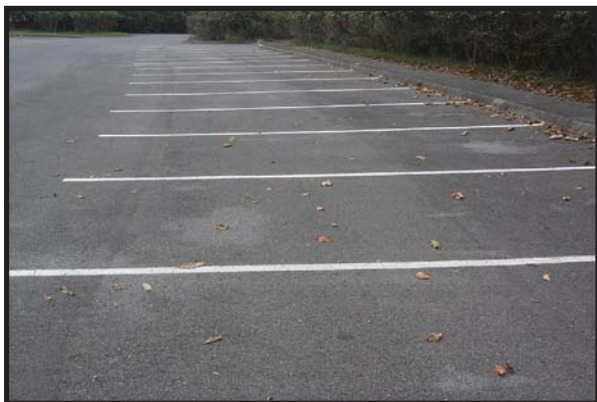
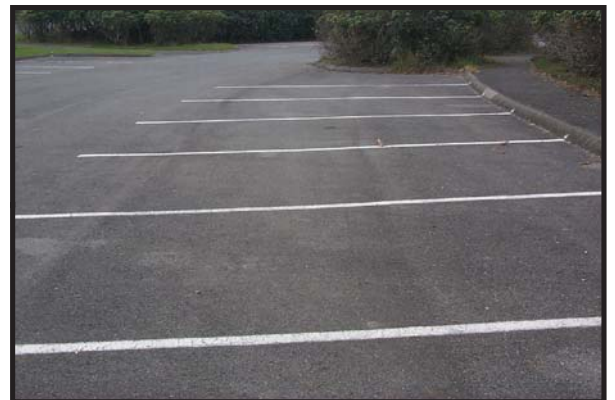
Route 0967B

Route	Public / NonPublic	Date Visited	Area (sq ft)	Lane Miles *	Surface Type	Condition / PCR
0967B	Public	11/15/2002	6848	0.12	AS	GOOD / 90

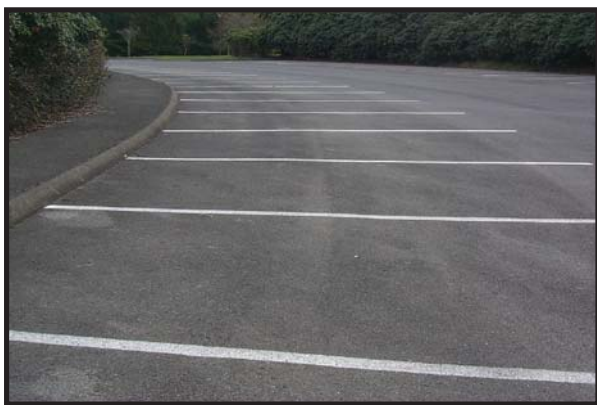
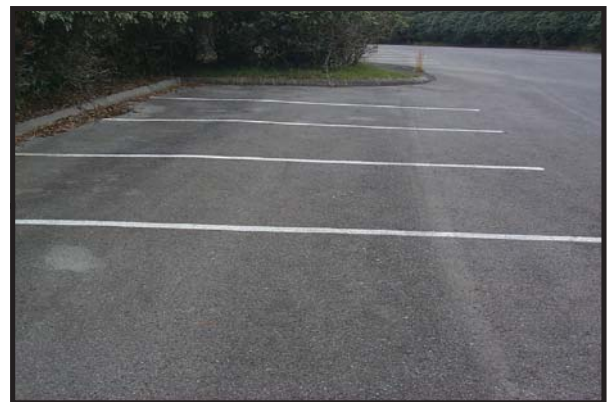
Route 0967C

Route	Public / NonPublic	Date Visited	Area (sq ft)	Lane Miles *	Surface Type	Condition / PCR
0967C	Public	11/15/2002	7183	0.12	AS	GOOD / 90

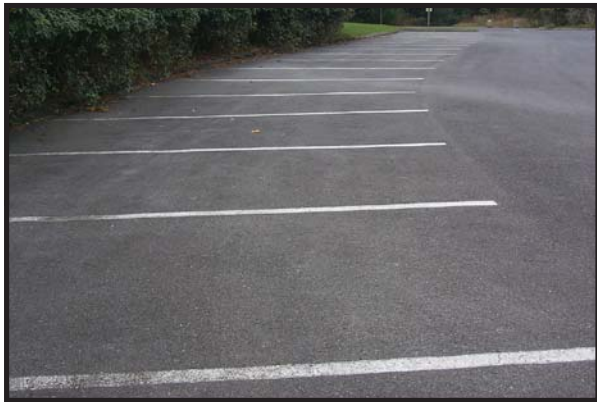
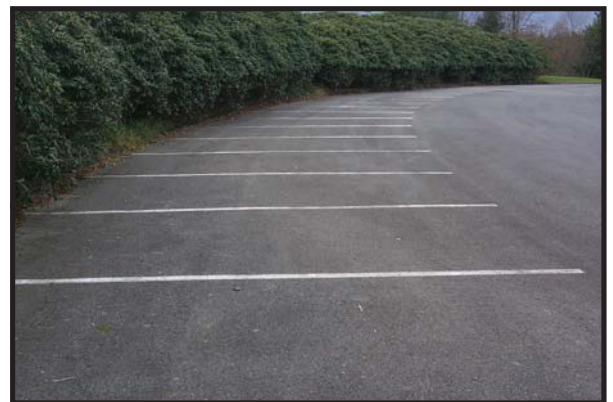
Route 0967D

Route	Public / NonPublic	Date Visited	Area (sq ft)	Lane Miles *	Surface Type	Condition / PCR
0967D	Public	11/15/2002	5389	0.09	AS	GOOD / 90

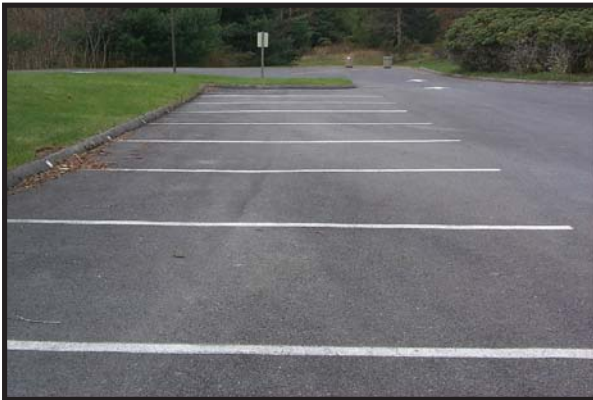
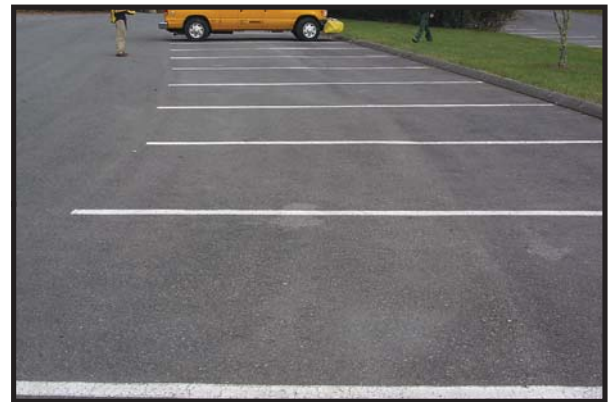
Route 0967E

Route	Public / NonPublic	Date Visited	Area (sq ft)	Lane Miles *	Surface Type	Condition / PCR
0967E	Public	11/15/2002	11730	0.20	AS	GOOD / 90

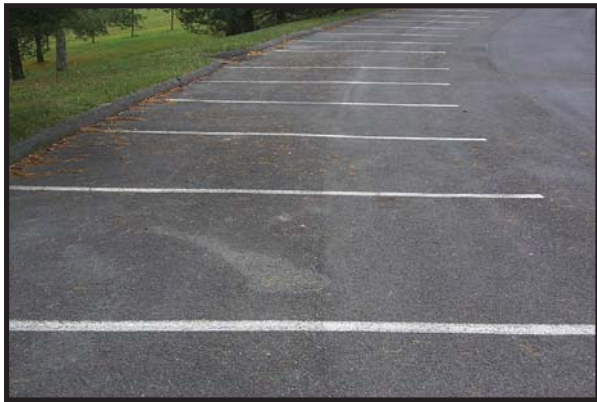
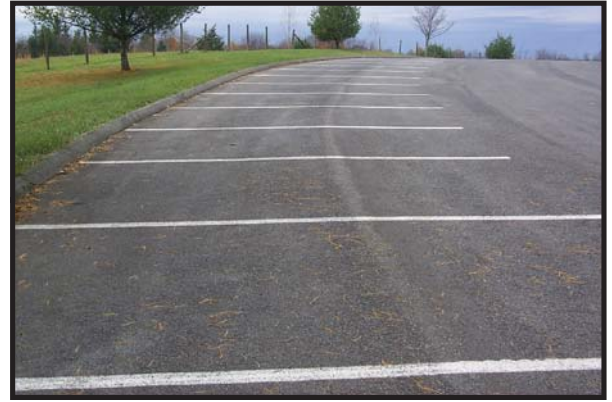
Route 0967F

Route	Public / NonPublic	Date Visited	Area (sq ft)	Lane Miles *	Surface Type	Condition / PCR
0967F	Public	11/15/2002	5915	0.10	AS	GOOD / 90

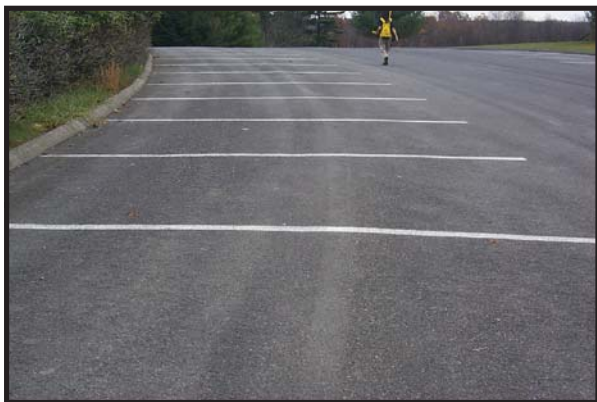
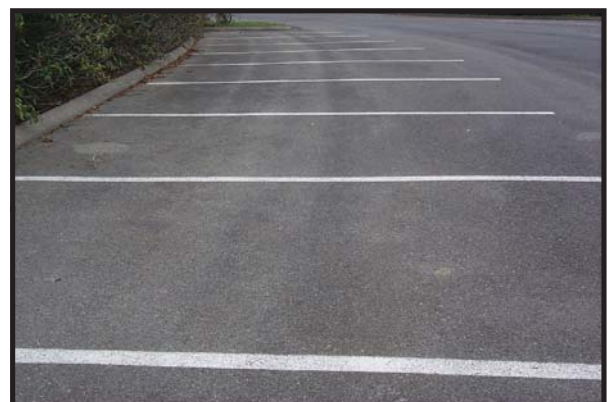
Route 0967G

Route	Public / NonPublic	Date Visited	Area (sq ft)	Lane Miles *	Surface Type	Condition / PCR
0967G	Public	11/15/2002	4851	0.08	AS	GOOD / 90

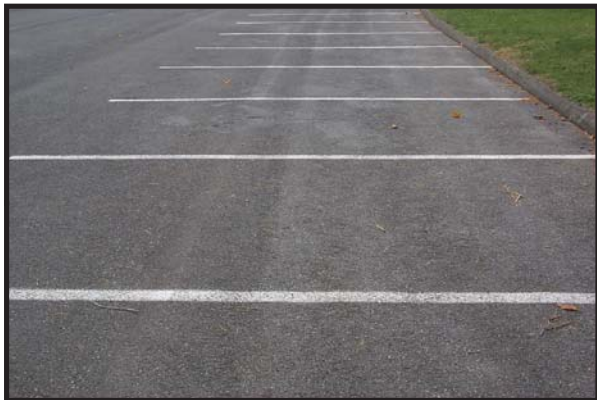
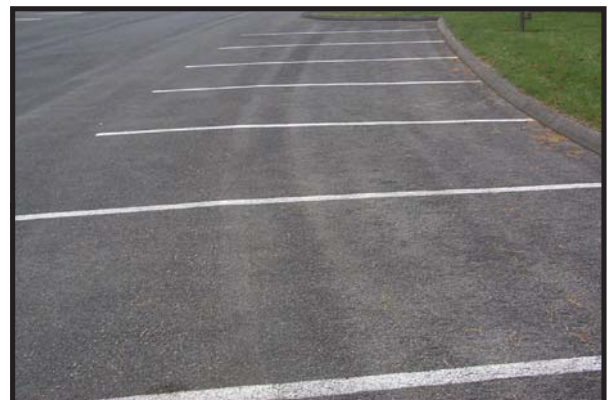
New River Gorge National River
Route 0968
 SANDSTONE VISITOR CENTER PARKING
 From State Route 20

Route	Public / NonPublic	Date Visited	Area (sq ft)	Lane Miles *	Surface Type	Condition / PCR
0968	Public	11/15/2002	63738	1.10	AS	NC / -1
