The Road Inventory of Ninety Six National Historic Site NISI - 5610

Road Inventory Program

Prepared By:
Federal Highway Administration
Eastern Federal Lands Highway Division
Cycle 3

Ninety Six National Historic Site in South Carolina

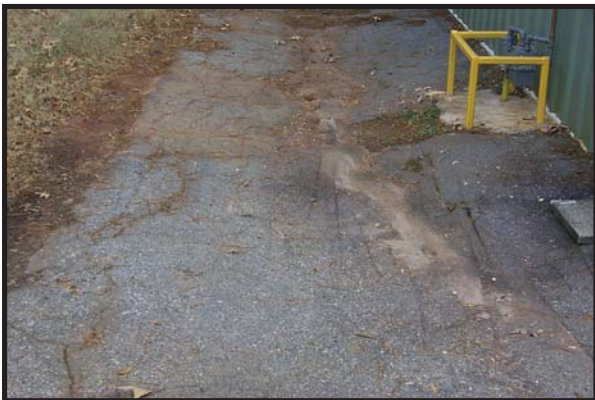
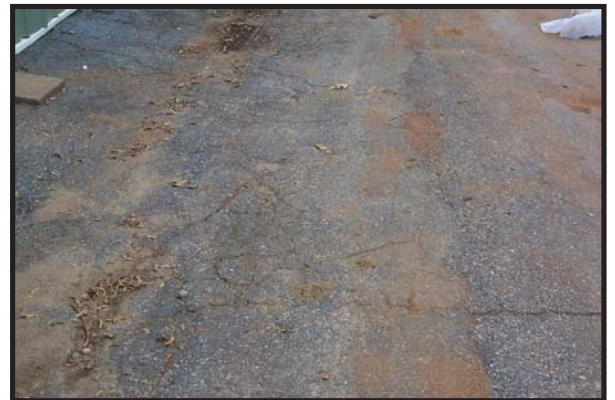
Route 0901

Route	Public / NonPublic	Date Visited	Area (sq ft)	Lane Miles *	Surface Type	Condition / PCR
0901	NonPublic	12/9/2002	4341	0.07	AS	POOR / 45
