# The Road Inventory of North Cascades National Park NOCA - 9470

## Road Inventory Program

Prepared By:  
Federal Highway Administration  
Eastern Federal Lands Highway Division  
Cycle 3

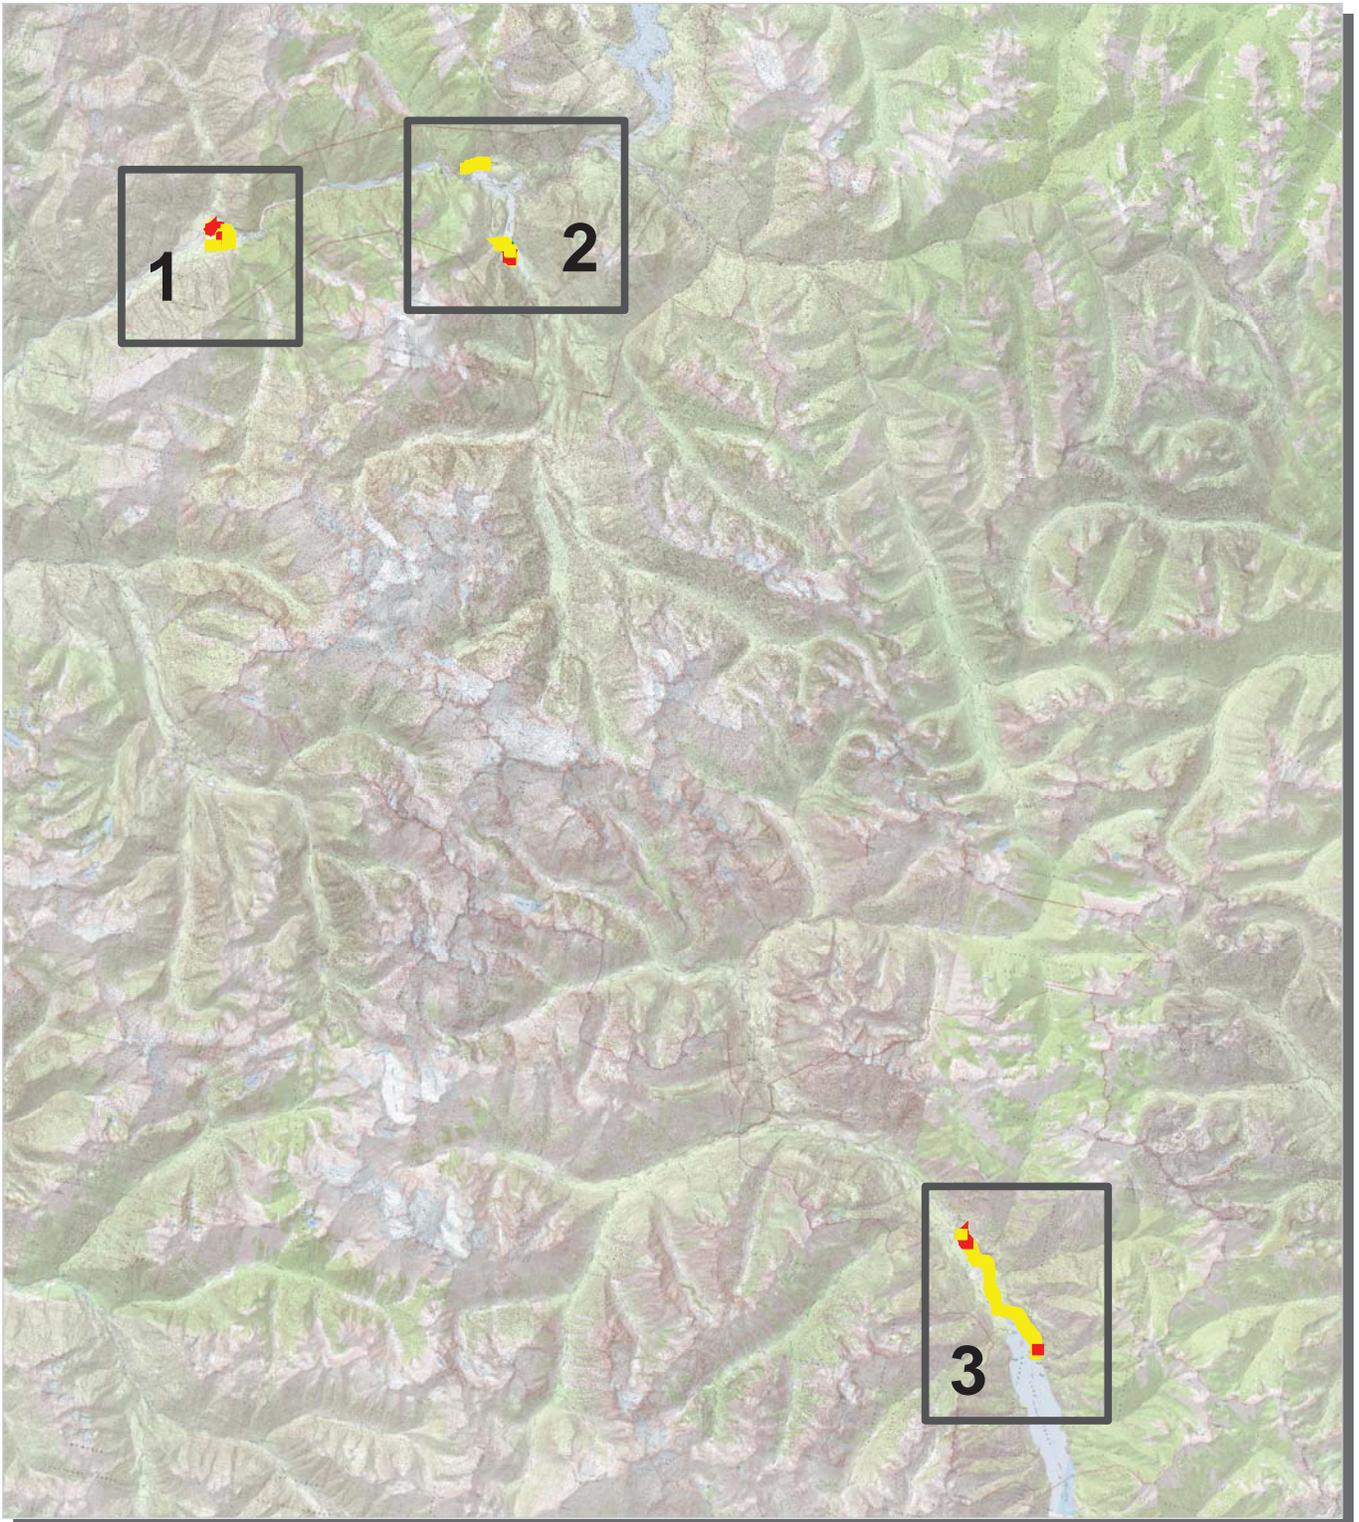
# North Cascades National Park Route Condition Key Map PCR - Mile by Mile

PCR	Poor	Fair	Good	Excellent
	( $\leq 60$ )	(61 - 84)	(85 - 94)	(95 - 100)

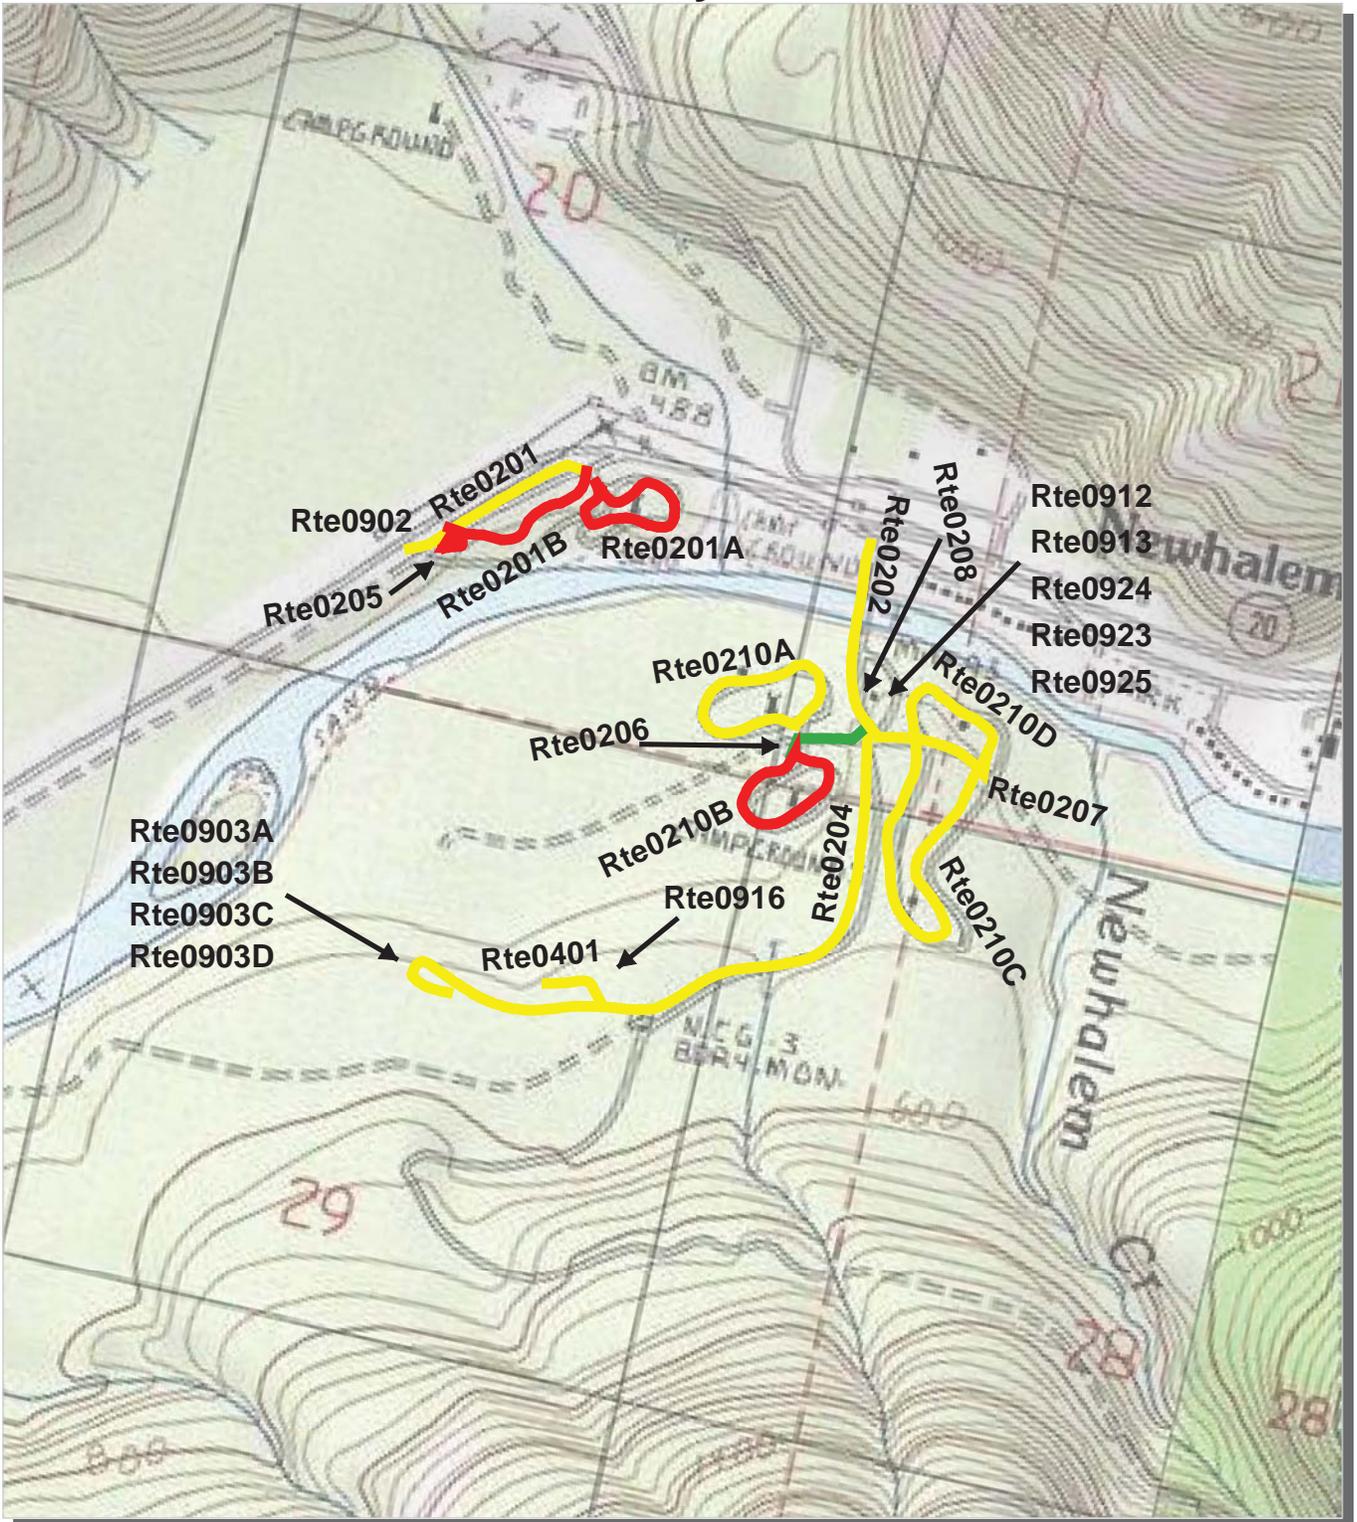
# North Cascades National Park Route Condition Area Map 1 PCR - Mile by Mile

PCR	Poor	Fair	Good	Excellent
	(≤60)	(61 - 84)	(85 - 94)	(95 - 100)

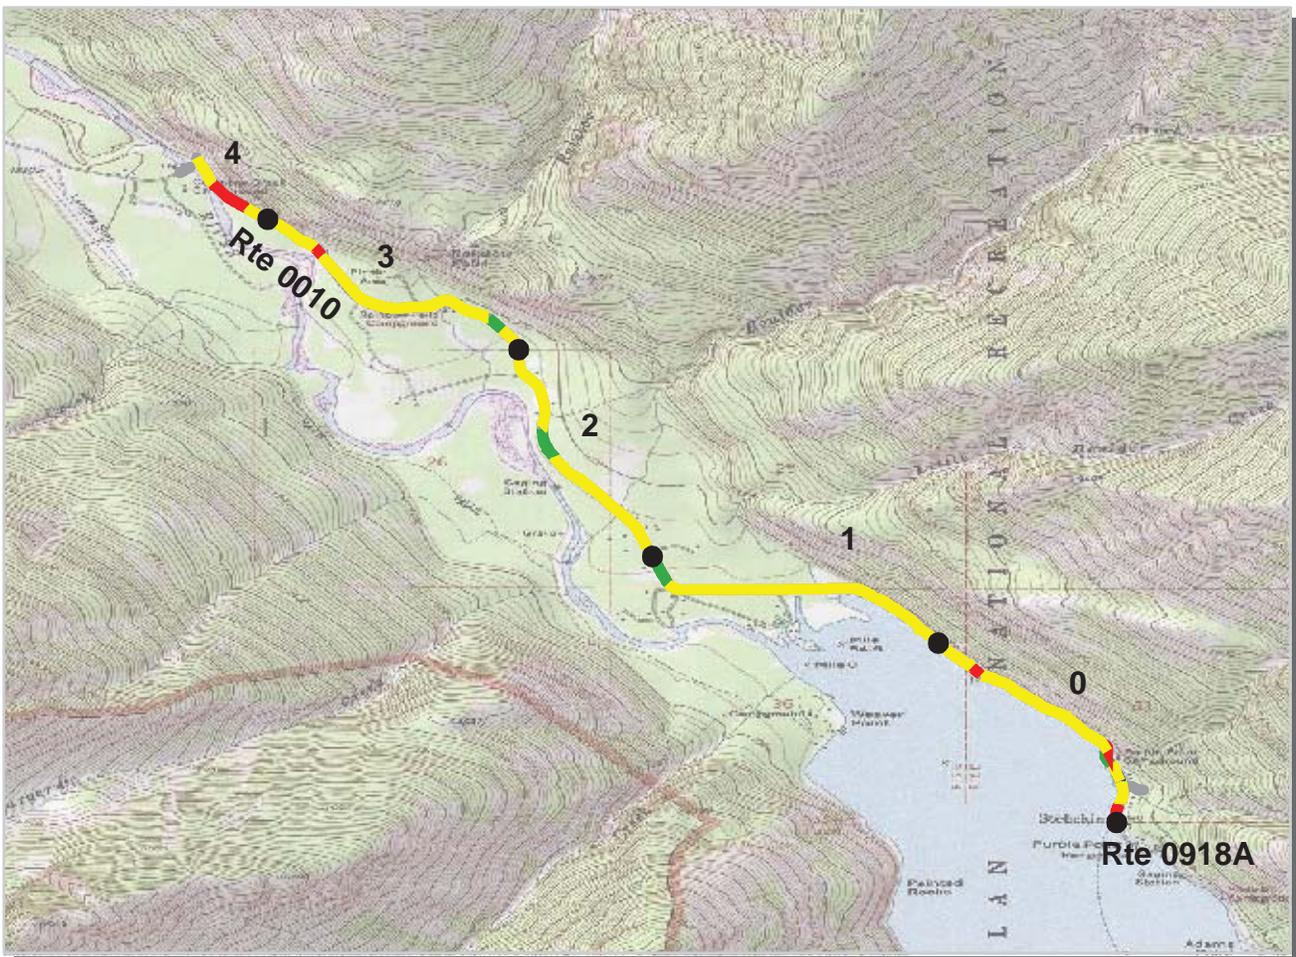
ROUTE: 0010 Stehekin Valley Road

Section Number	0	1	2	3	4
Section Length (mi)	1.00	1.00	1.00	1.00	0.35
AADT	**				
SADT	**				
ADT Date	**				
<b>Cross Section Information</b>					
Number of Lanes	2	2	2	2	2
Paved Width (ft)	16	16	16	17	19
Lane Width (ft)	8	8	8	8	9
Shoulder Width (ft)	0	0	0	0	0
<b>Roadway Condition Information</b>					
PCR (Pavement Condition Rating)	72	76	79	72	57
RCI (Roughness Condition Index)	59	63	75	74	56
SCR (Surface Condition Rating)	77	85	82	70	57
Alligator Cracking Index	100	100	99	100	100
Rutting Index	78	85	83	71	73
Patching Index	99	99	99	99	84
Transverse Cracking Index	100	99	99	99	99
Longitudinal Cracking Index	99	99	99	99	99
Shoulder Condition Rating	N/A	N/A	N/A	N/A	N/A
Drainage Condition Rating	GOOD	GOOD	GOOD	GOOD	GOOD

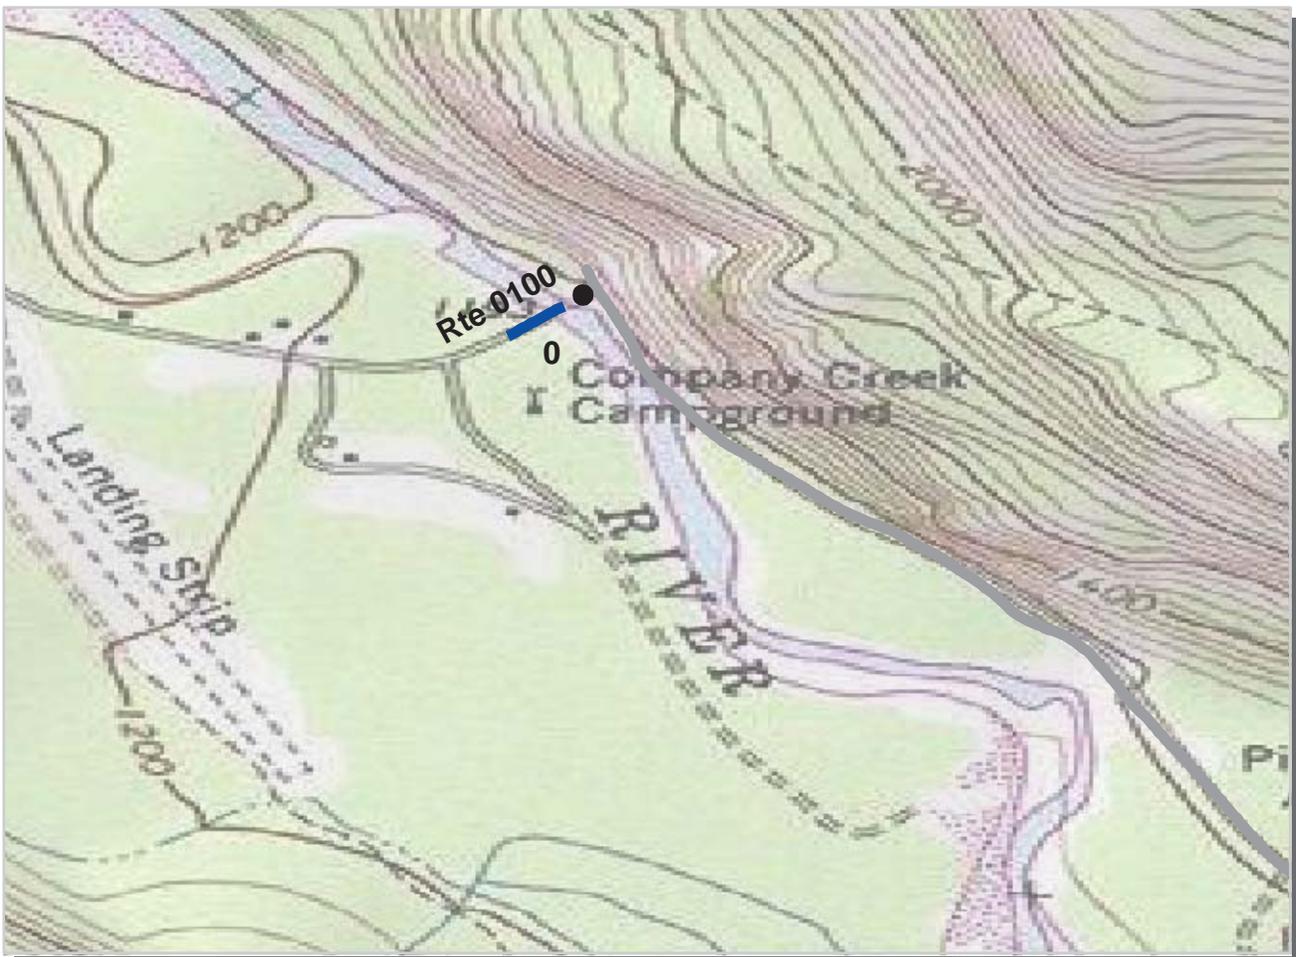
**ROUTE: 0100 Company Creek Road** **TOTAL LENGTH: 0.07 Miles**

Section Number	0				
Section Length (mi)	0.07				
AADT	**				
SADT	**				
ADT Date	**				
<b>Cross Section Information</b>					
Number of Lanes	1				
Paved Width (ft)	15				
Lane Width (ft)	15				
Shoulder Width (ft)	0				
<b>Roadway Condition Information</b>					
PCR (Pavement Condition Rating)	78				
RCI (Roughness Condition Index)	17				
SCR (Surface Condition Rating)	85				
Alligator Cracking Index	100				
Rutting Index	85				
Patching Index	100				
Transverse Cracking Index	100				
Longitudinal Cracking Index	100				
Shoulder Condition Rating	N/A				
Drainage Condition Rating	GOOD

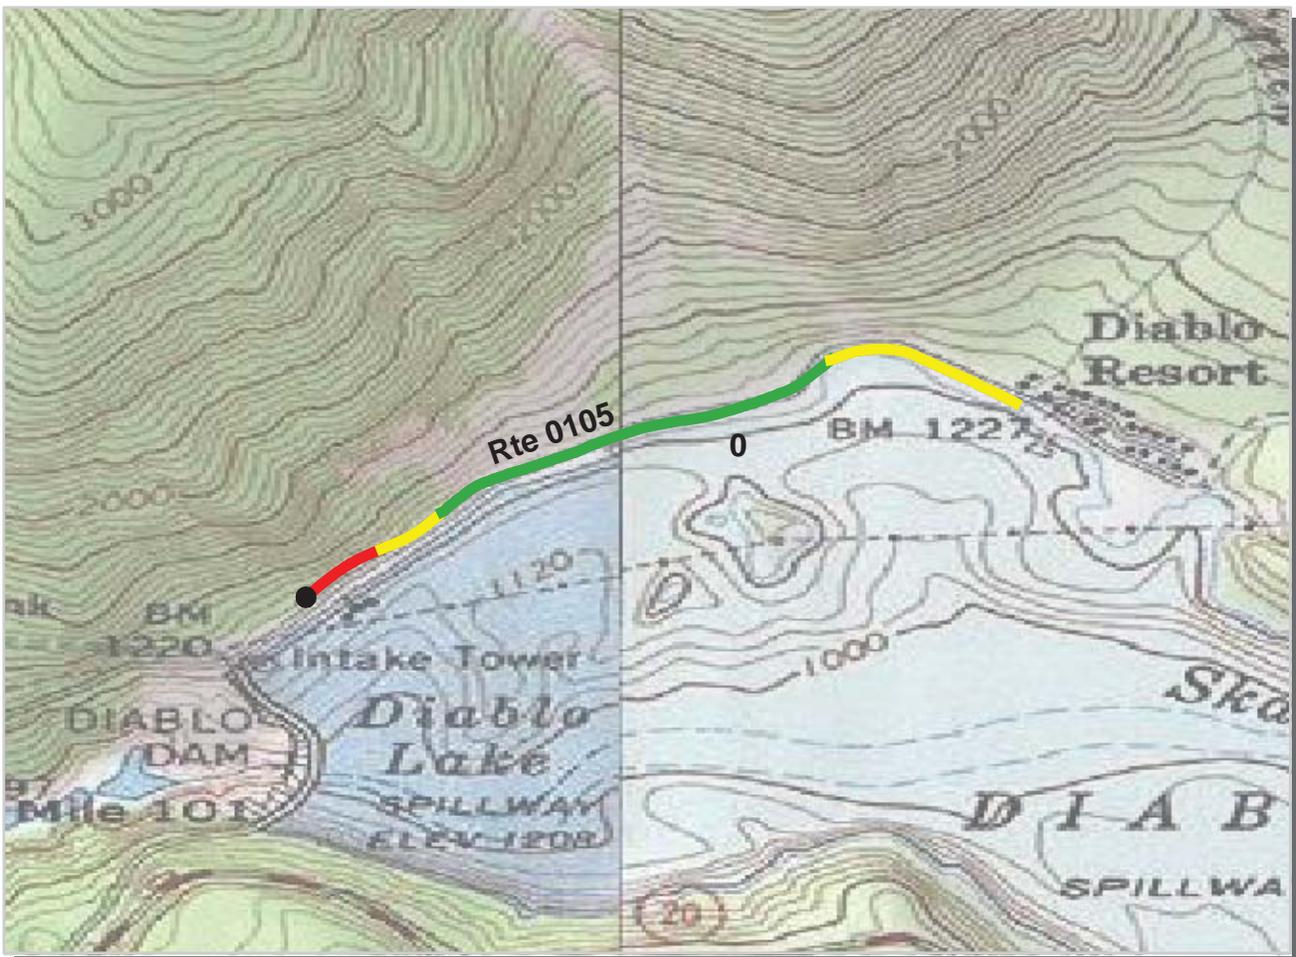
ROUTE: 0105 Environmental Learning Center Access Road

Section Number	0				
Section Length (mi)	0.66				
AADT	**				
SADT	**				
ADT Date	**				
<b>Cross Section Information</b>					
Number of Lanes	2				
Paved Width (ft)	18				
Lane Width (ft)	9				
Shoulder Width (ft)	0				
<b>Roadway Condition Information</b>					
PCR (Pavement Condition Rating)	76				
RCI (Roughness Condition Index)	89				
SCR (Surface Condition Rating)	69				
Alligator Cracking Index	98				
Rutting Index	75				
Patching Index	99				
Transverse Cracking Index	97				
Longitudinal Cracking Index	98				
Shoulder Condition Rating	N/A				
Drainage Condition Rating	GOOD

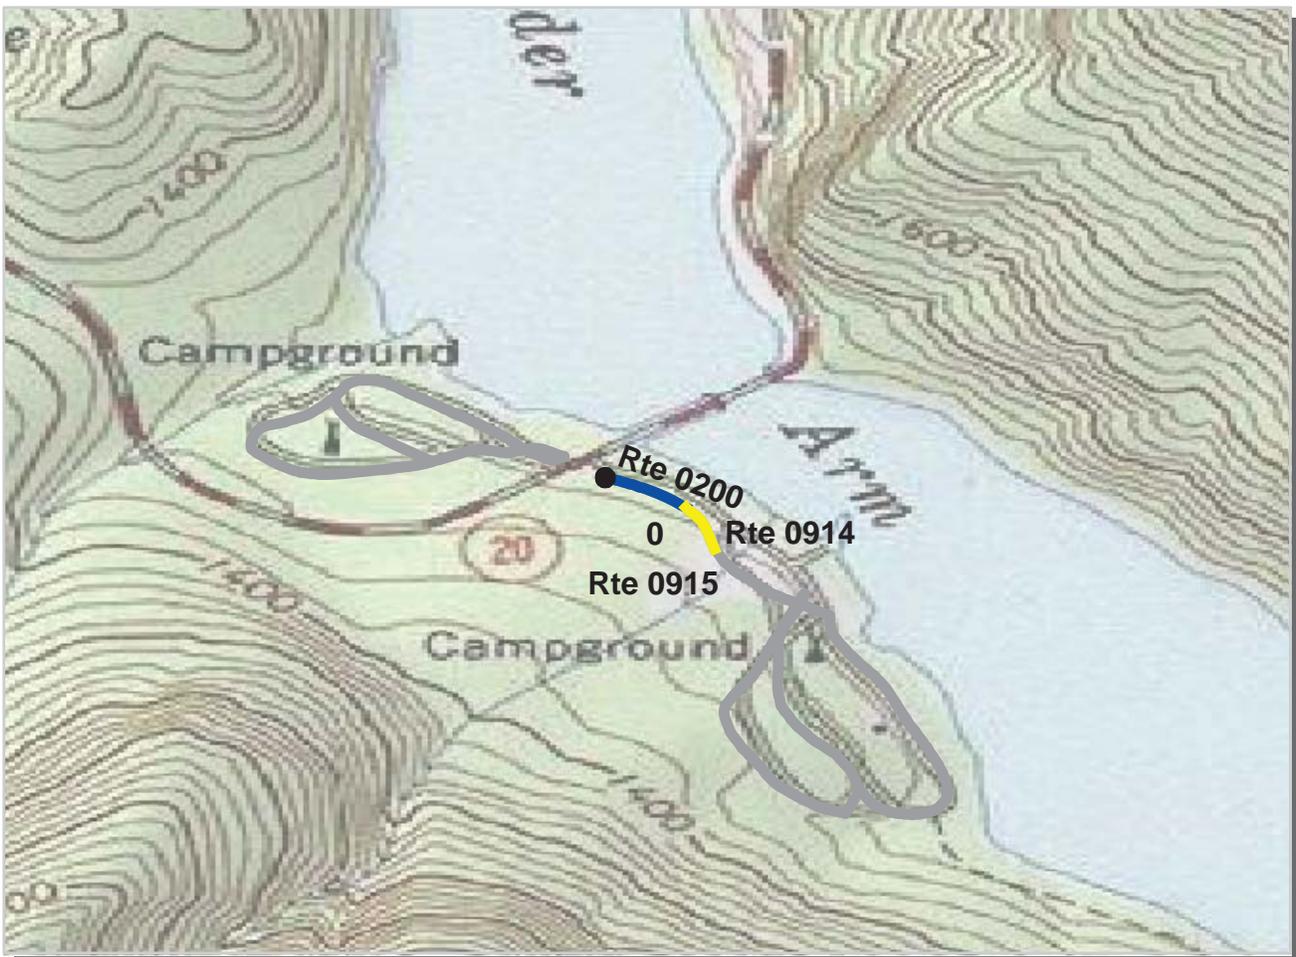
**ROUTE: 0200 Colonial Creek Campground Access South** **TOTAL LENGTH: 0.11 Miles**

Section Number	0				
Section Length (mi)	0.11				
AADT	**				
SADT	**				
ADT Date	**				
<b>Cross Section Information</b>					
Number of Lanes	2				
Paved Width (ft)	22				
Lane Width (ft)	11				
Shoulder Width (ft)	0				
<b>Roadway Condition Information</b>					
PCR (Pavement Condition Rating)	85				
RCI (Roughness Condition Index)	76				
SCR (Surface Condition Rating)	87				
Alligator Cracking Index	100				
Rutting Index	87				
Patching Index	100				
Transverse Cracking Index	100				
Longitudinal Cracking Index	100				
Shoulder Condition Rating	N/A				
Drainage Condition Rating	GOOD

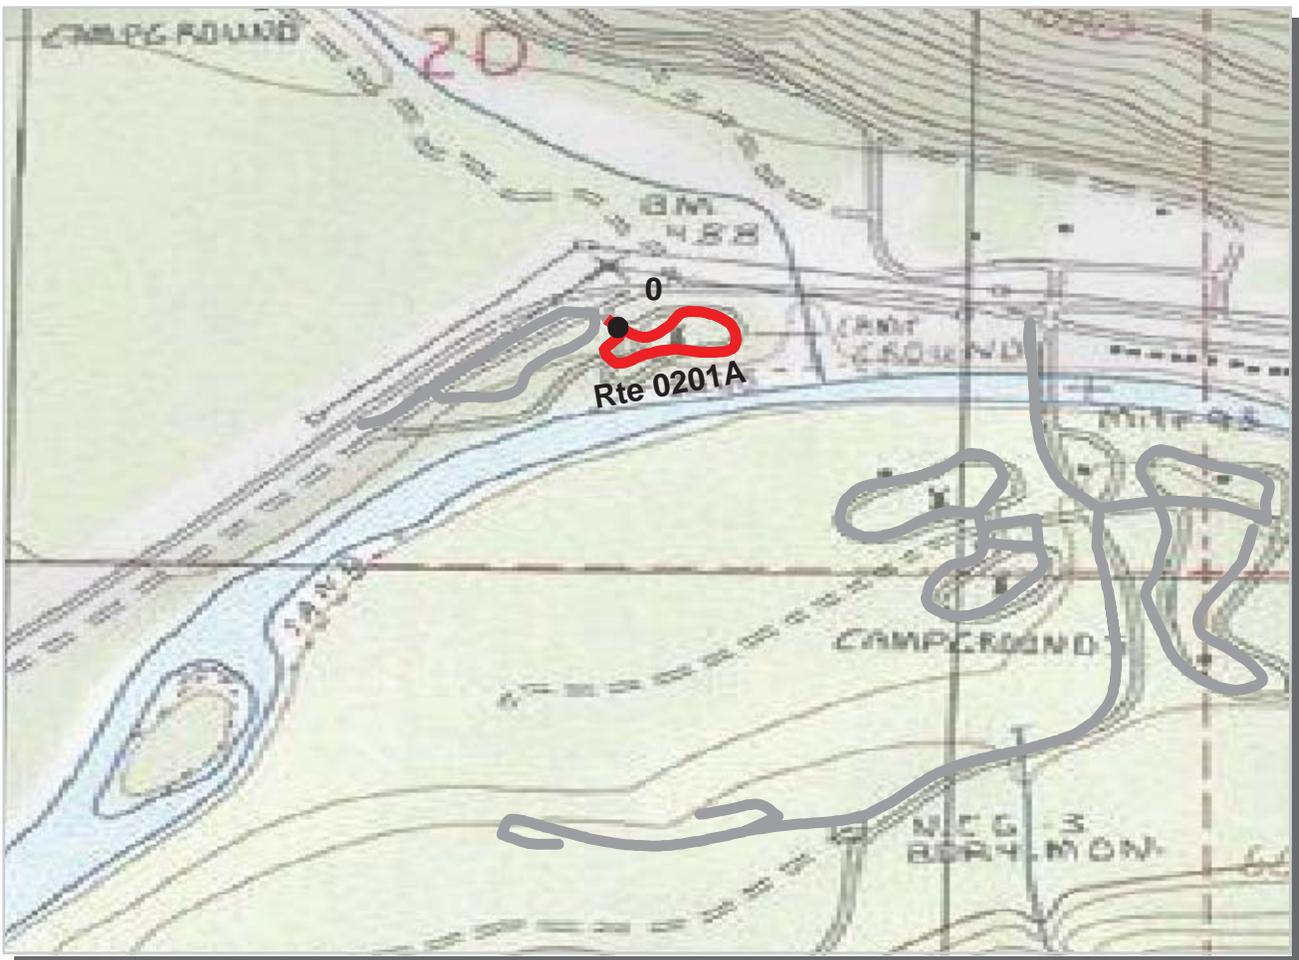
**ROUTE: 0201A Goodell Creek Campground Loop A** **TOTAL LENGTH: 0.27 Miles**

Section Number	0				
Section Length (mi)	0.27				
AADT	**				
SADT	**				
ADT Date	**				
<b>Cross Section Information</b>					
Number of Lanes	1				
Paved Width (ft)	12				
Lane Width (ft)	12				
Shoulder Width (ft)	0				
<b>Roadway Condition Information</b>					
PCR (Pavement Condition Rating)	43				
RCI (Roughness Condition Index)	NC				
SCR (Surface Condition Rating)	43				
Alligator Cracking Index	100				
Rutting Index	43				
Patching Index	100				
Transverse Cracking Index	100				
Longitudinal Cracking Index	100				
Shoulder Condition Rating	N/A				
Drainage Condition Rating	GOOD

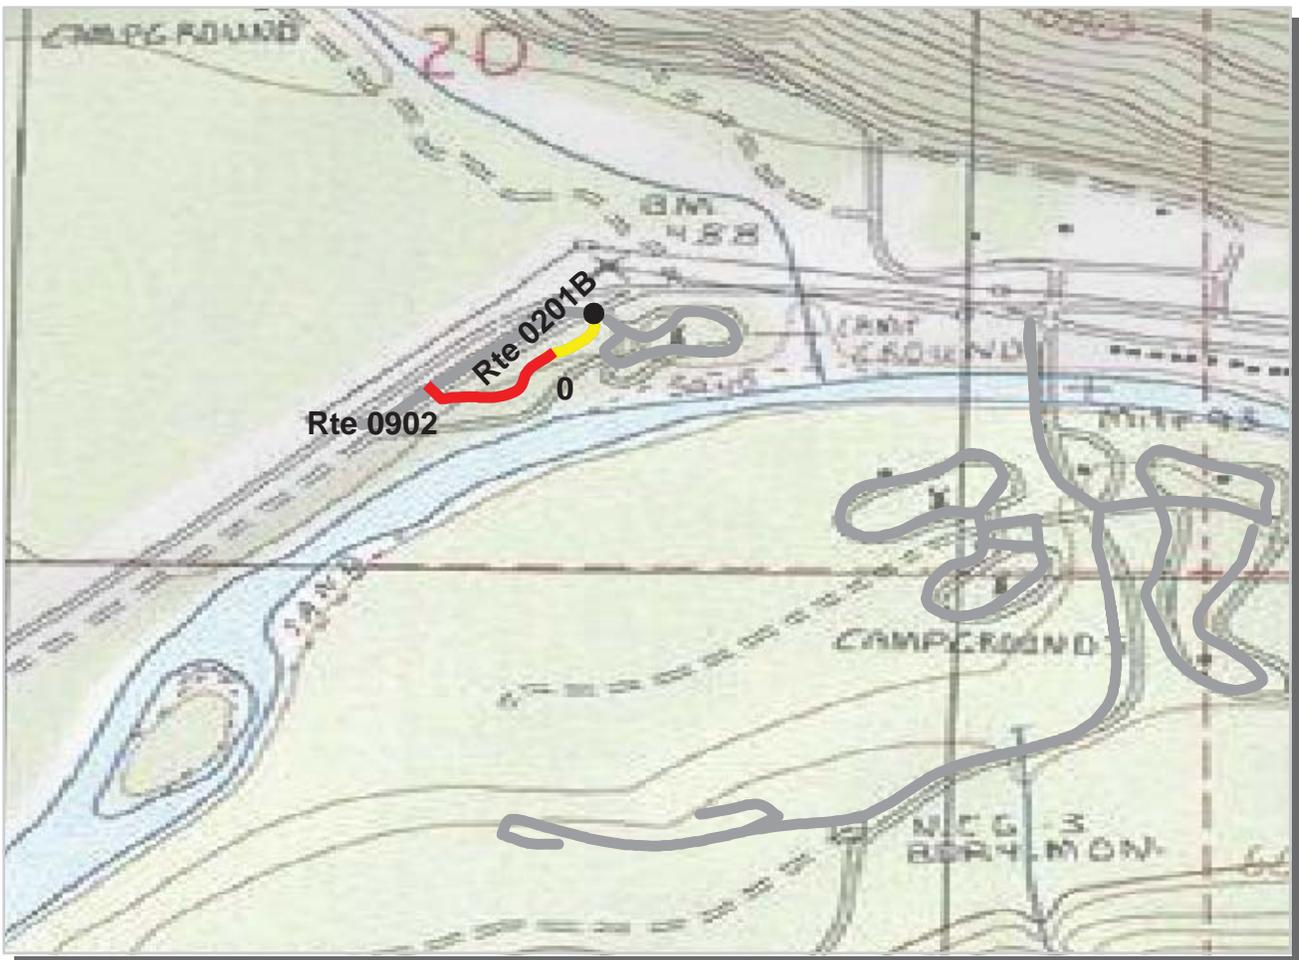
**ROUTE: 0201B Goodell Creek Campground Loop B** **TOTAL LENGTH: 0.18 Miles**

Section Number	0				
Section Length (mi)	0.18				
AADT	**				
SADT	**				
ADT Date	**				
<b>Cross Section Information</b>					
Number of Lanes	1				
Paved Width (ft)	12				
Lane Width (ft)	12				
Shoulder Width (ft)	0				
<b>Roadway Condition Information</b>					
PCR (Pavement Condition Rating)	51				
RCI (Roughness Condition Index)	NC				
SCR (Surface Condition Rating)	51				
Alligator Cracking Index	100				
Rutting Index	51				
Patching Index	100				
Transverse Cracking Index	100				
Longitudinal Cracking Index	100				
Shoulder Condition Rating	N/A				
Drainage Condition Rating	GOOD

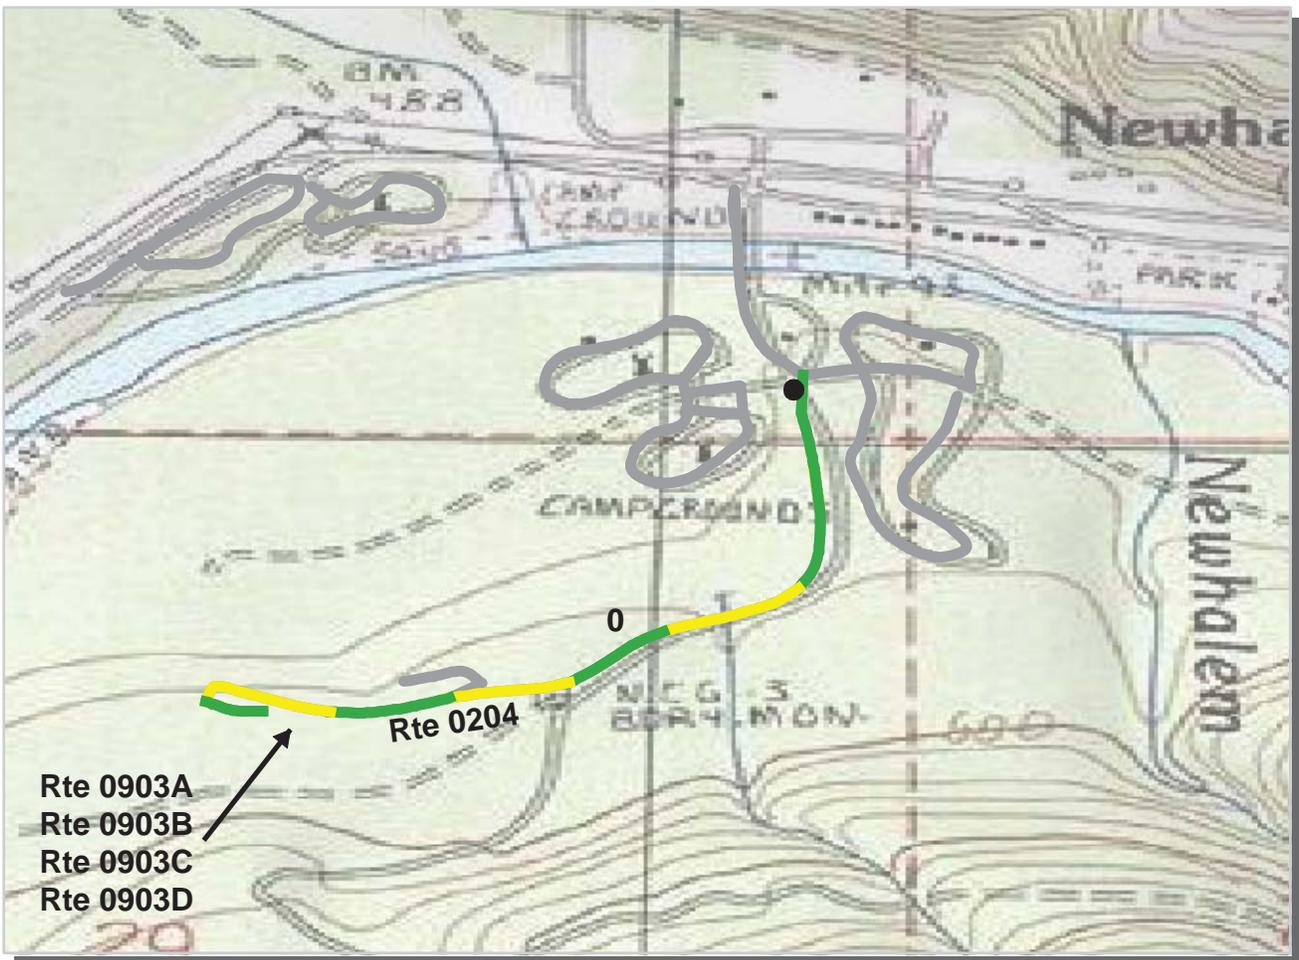
**ROUTE: 0204 North Cascades Visitor Center Access Road** **TOTAL LENGTH: 0.70 Miles**

Section Number	0				
Section Length (mi)	0.70				
AADT	**				
SADT	**				
ADT Date	**				
<b>Cross Section Information</b>					
Number of Lanes	2				
Paved Width (ft)	21				
Lane Width (ft)	10				
Shoulder Width (ft)	0				
<b>Roadway Condition Information</b>					
PCR (Pavement Condition Rating)	81				
RCI (Roughness Condition Index)	65				
SCR (Surface Condition Rating)	88				
Alligator Cracking Index	100				
Rutting Index	89				
Patching Index	99				
Transverse Cracking Index	99				
Longitudinal Cracking Index	99				
Shoulder Condition Rating	N/A				
Drainage Condition Rating	GOOD

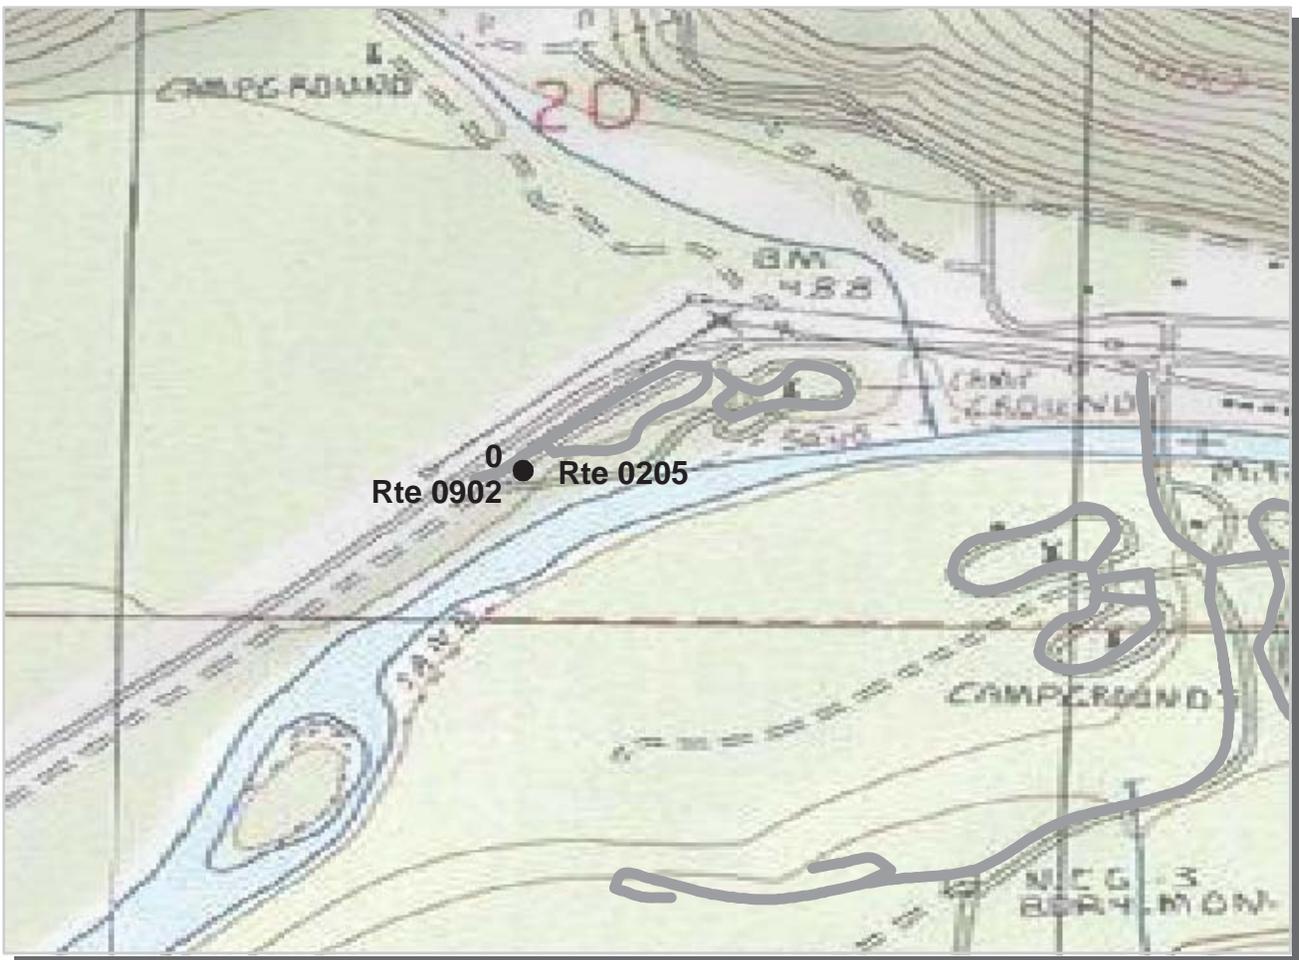
**ROUTE: 0205 Raft Launch Loop** **TOTAL LENGTH: 0.05 Miles**

Section Number	0				
Section Length (mi)	0.05				
AADT	**				
SADT	**				
ADT Date	**				
<b>Cross Section Information</b>					
Number of Lanes	1				
Paved Width (ft)	10				
Lane Width (ft)	10				
Shoulder Width (ft)	0				
<b>Roadway Condition Information</b>					
PCR (Pavement Condition Rating)	60				
RCI (Roughness Condition Index)	NC				
SCR (Surface Condition Rating)	60				
Alligator Cracking Index	100				
Rutting Index	61				
Patching Index	100				
Transverse Cracking Index	99				
Longitudinal Cracking Index	100				
Shoulder Condition Rating	N/A				
Drainage Condition Rating	GOOD

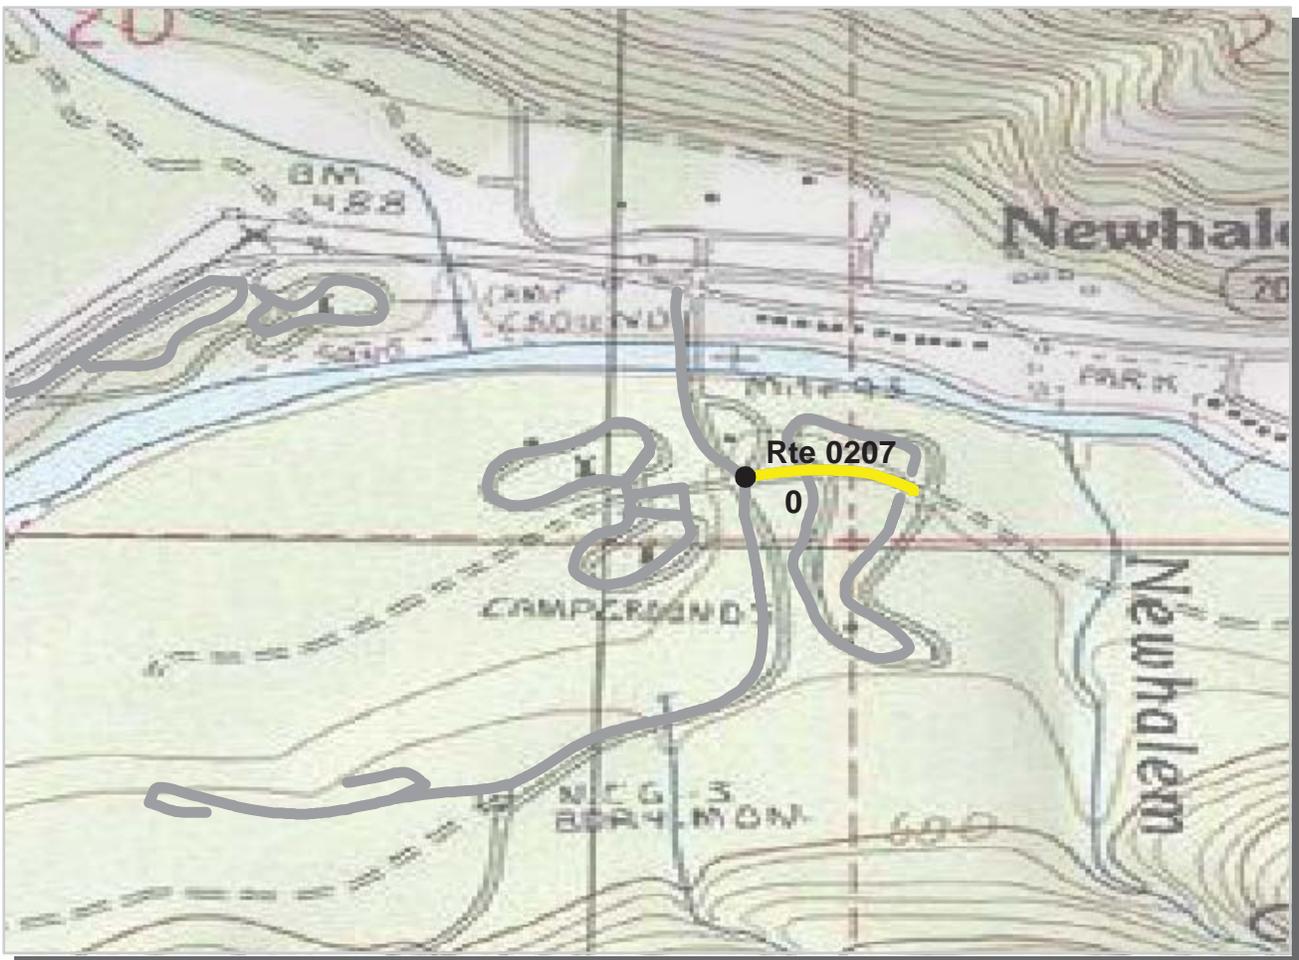
**ROUTE: 0207 Newhalem Creek Campground Access To Loops C & D** **TOTAL LENGTH: 0.13 Miles**

Section Number	0				
Section Length (mi)	0.13				
AADT	**				
SADT	**				
ADT Date	**				
<b>Cross Section Information</b>					
Number of Lanes	2				
Paved Width (ft)	20				
Lane Width (ft)	10				
Shoulder Width (ft)	4				
<b>Roadway Condition Information</b>					
PCR (Pavement Condition Rating)	67				
RCI (Roughness Condition Index)	61				
SCR (Surface Condition Rating)	70				
Alligator Cracking Index	100				
Rutting Index	71				
Patching Index	100				
Transverse Cracking Index	99				
Longitudinal Cracking Index	99				
Shoulder Condition Rating	GOOD				
Drainage Condition Rating	GOOD

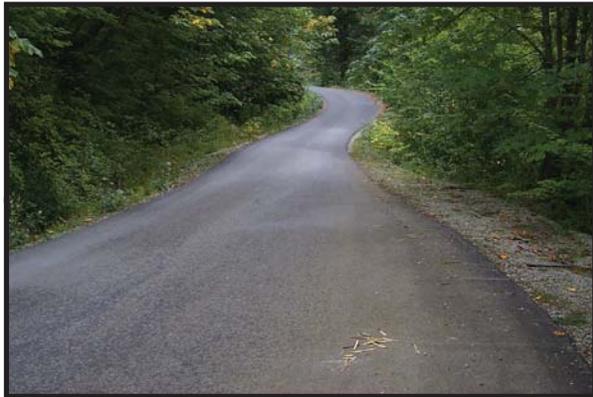
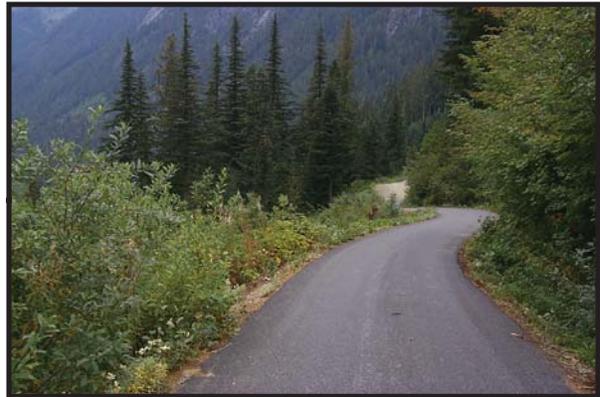
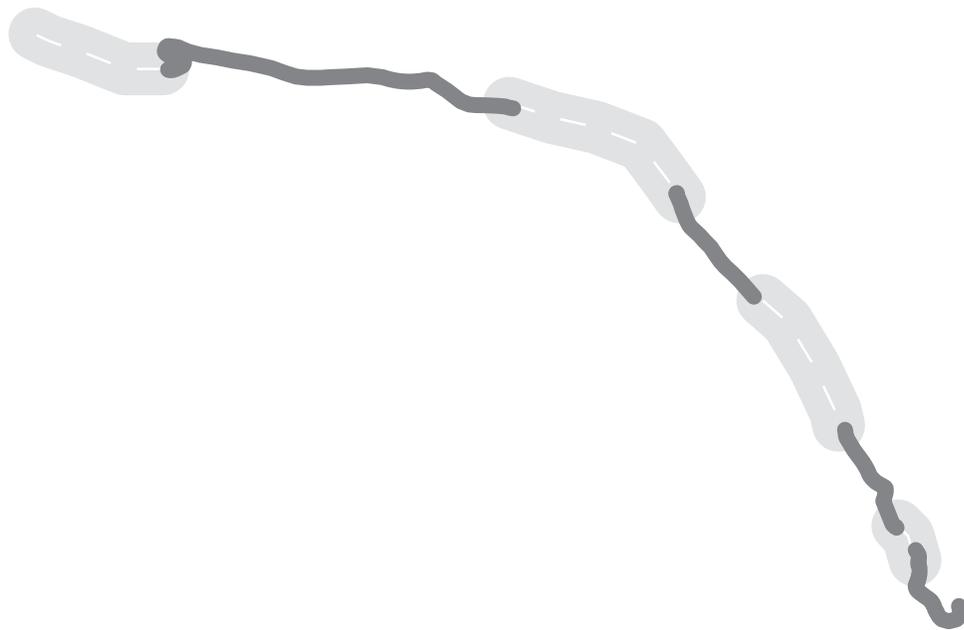
## Route 0900A

Route	Public / NonPublic	Date Visited	Area (sq ft)	Lane Miles *	Surface Type	Condition / PCR
0900A	NonPublic	9/25/2002	59671	1.03	AS	FAIR / 73

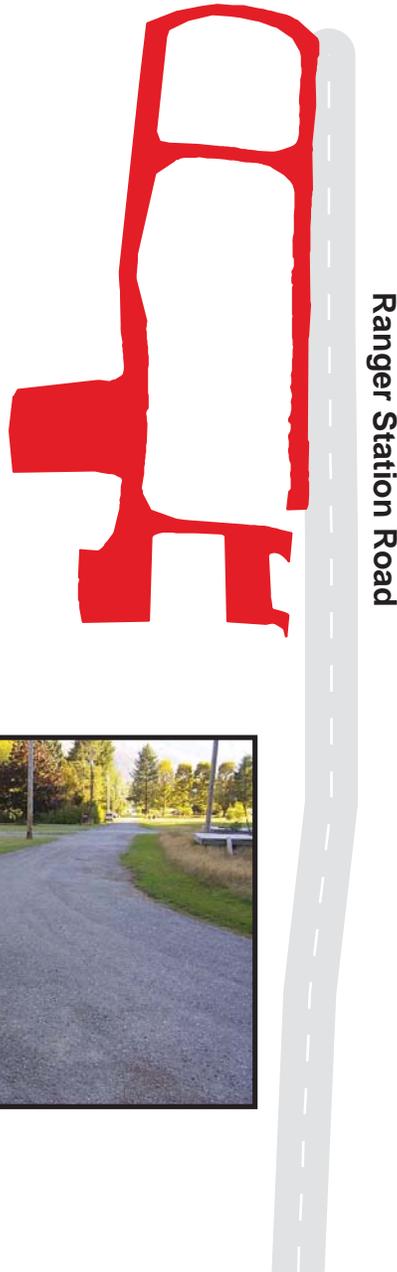
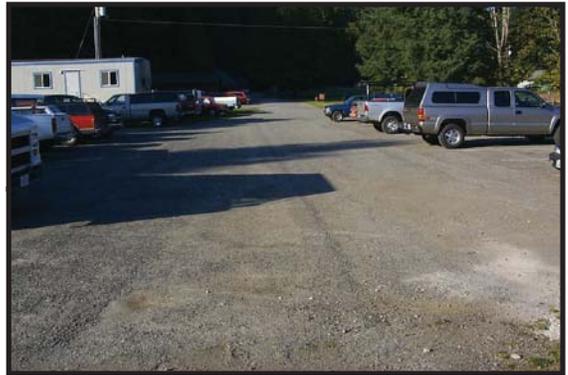
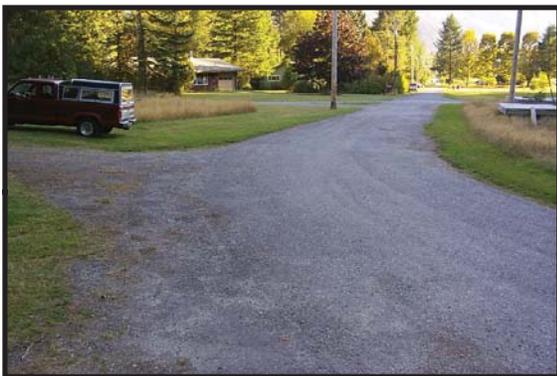
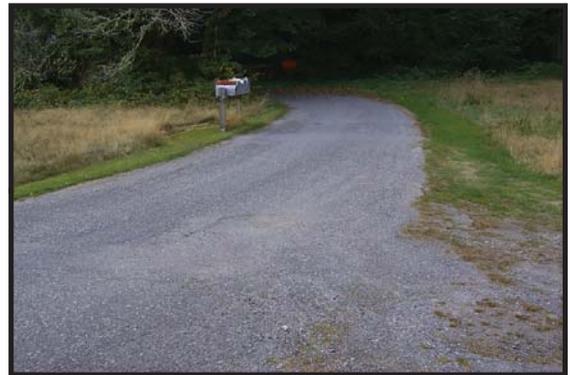
## Route 0900B

Route	Public / NonPublic	Date Visited	Area (sq ft)	Lane Miles *	Surface Type	Condition / PCR
0900B	NonPublic	9/25/2002	11939	0.21	AS	FAIR / 73

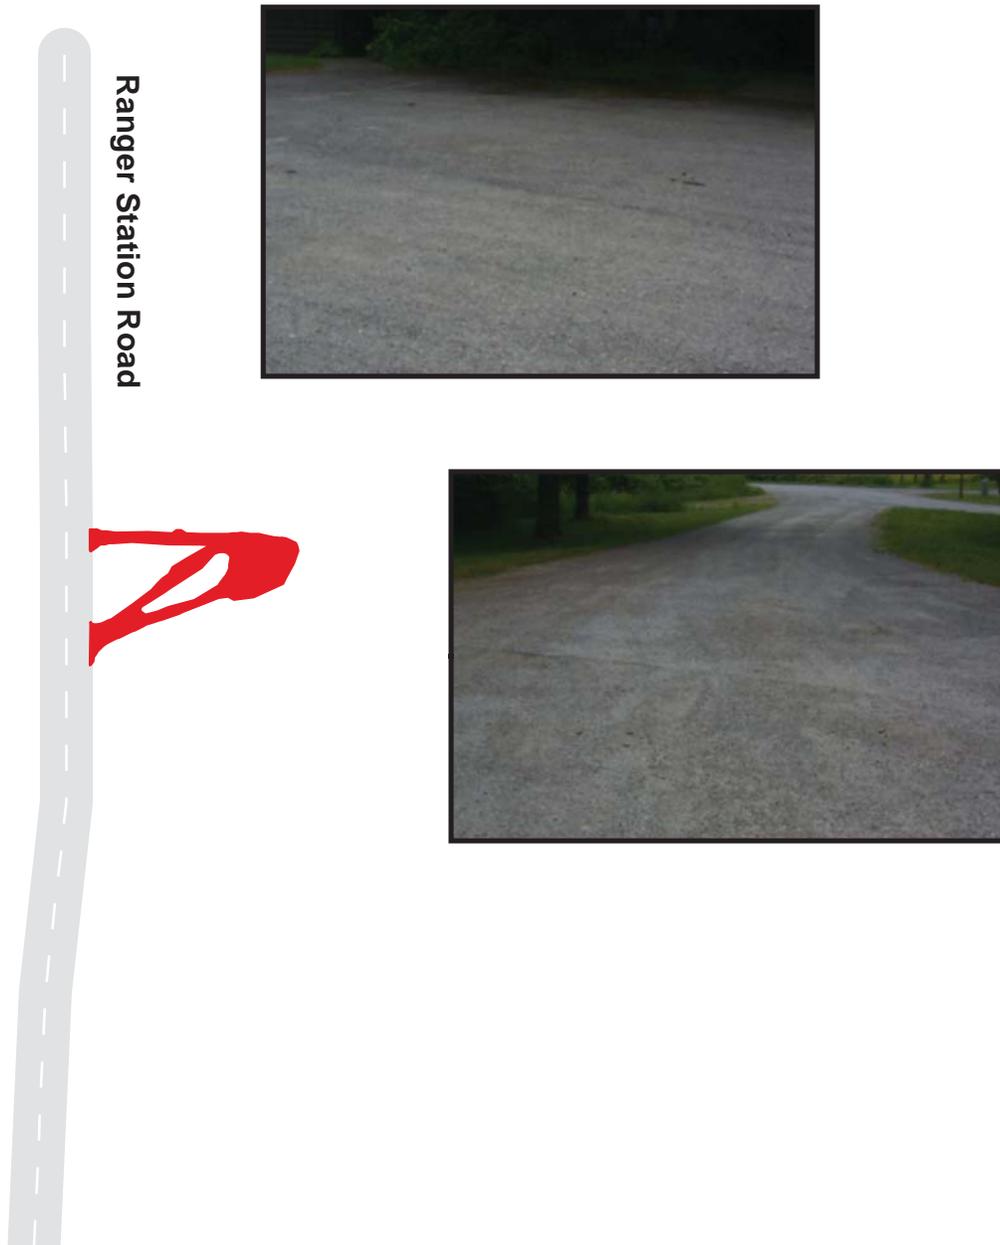
## Route 0901

Route	Public / NonPublic	Date Visited	Area (sq ft)	Lane Miles *	Surface Type	Condition / PCR
0901	Public	9/25/2002	5708	0.10	AS	EXCELLENT / 97

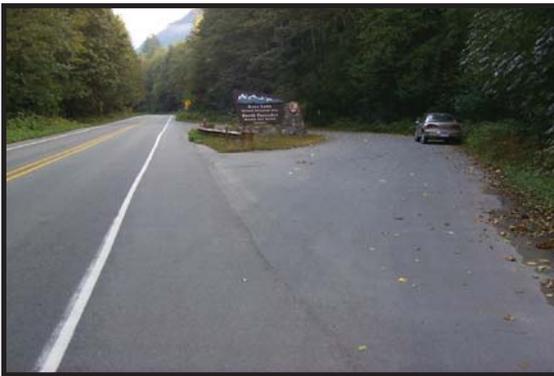
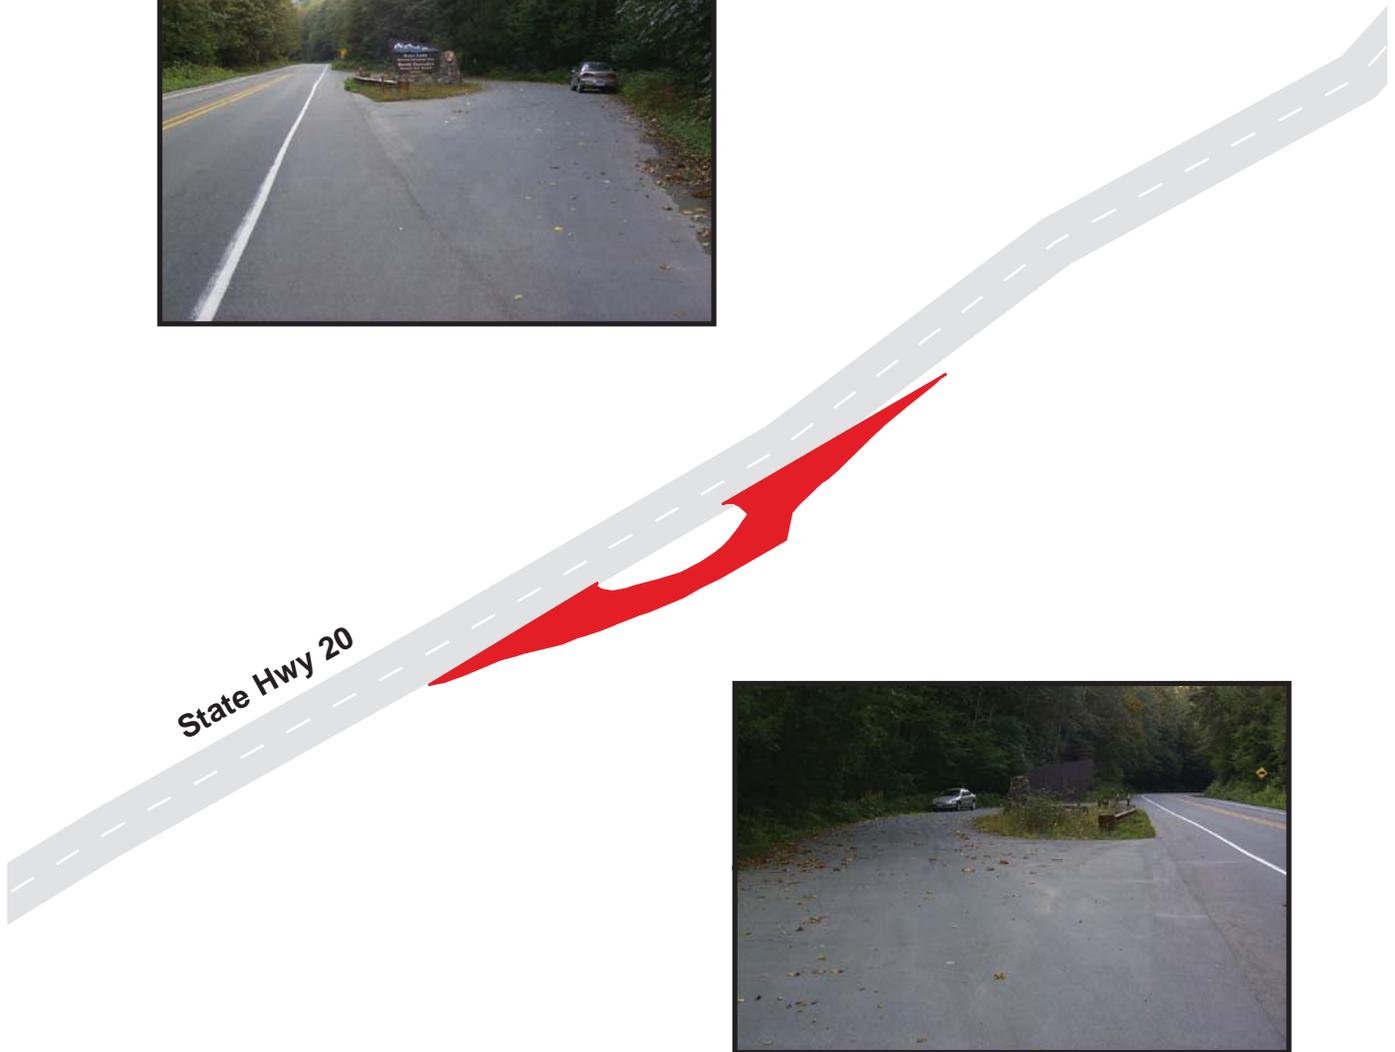
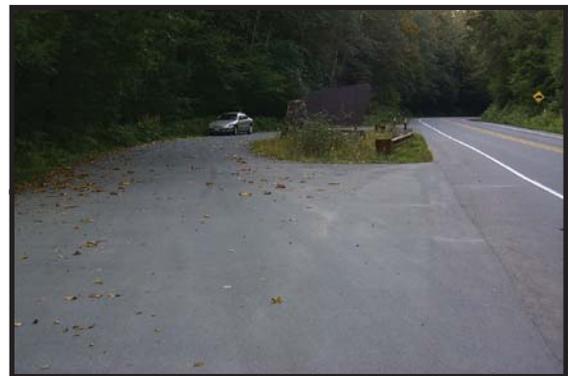
## Route 0902

Route	Public / NonPublic	Date Visited	Area (sq ft)	Lane Miles *	Surface Type	Condition / PCR
0902	Public	9/25/2002	2327	0.04	AS	GOOD / 90

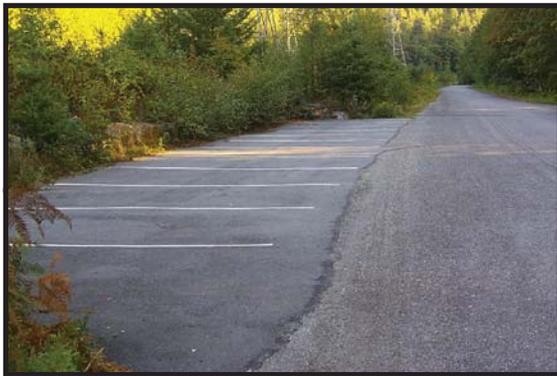
## Route 0903A

Route	Public / NonPublic	Date Visited	Area (sq ft)	Lane Miles *	Surface Type	Condition / PCR
0903A	Public	9/25/2002	4570	0.08	AS	EXCELLENT / 97

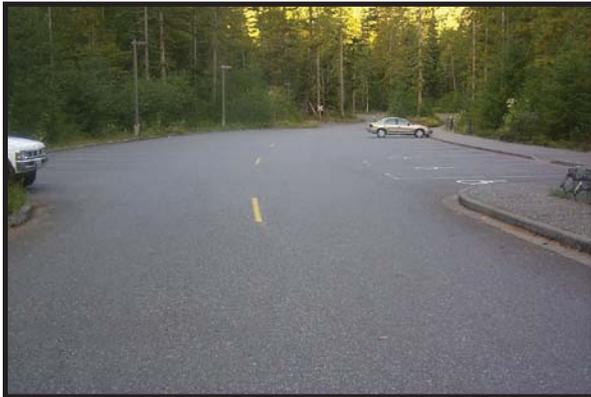
## Route 0903B

Route	Public / NonPublic	Date Visited	Area (sq ft)	Lane Miles *	Surface Type	Condition / PCR
0903B	Public	9/25/2002	4668	0.08	AS	EXCELLENT / 97
