# The Road Inventory of North Cascades National Park NOCA - 9470

## Road Inventory Program

Prepared By:  
Federal Highway Administration  
Eastern Federal Lands Highway Division  
Cycle 3

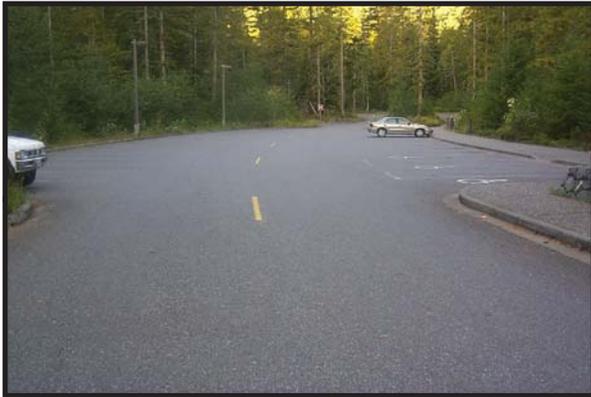
## Route 0903C

Route	Public / NonPublic	Date Visited	Area (sq ft)	Lane Miles *	Surface Type	Condition / PCR
0903C	Public	9/25/2002	2715	0.05	AS	EXCELLENT / 97

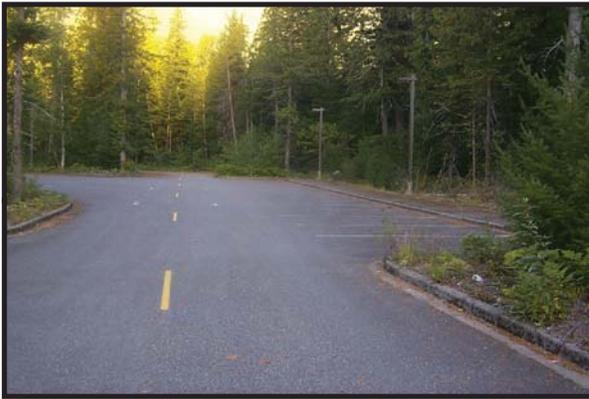
## Route 0903D

Route	Public / NonPublic	Date Visited	Area (sq ft)	Lane Miles *	Surface Type	Condition / PCR
0903D	Public	9/25/2002	8178	0.14	AS	EXCELLENT / 97

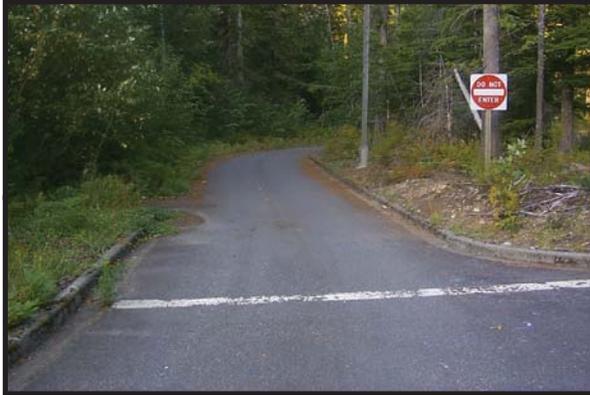
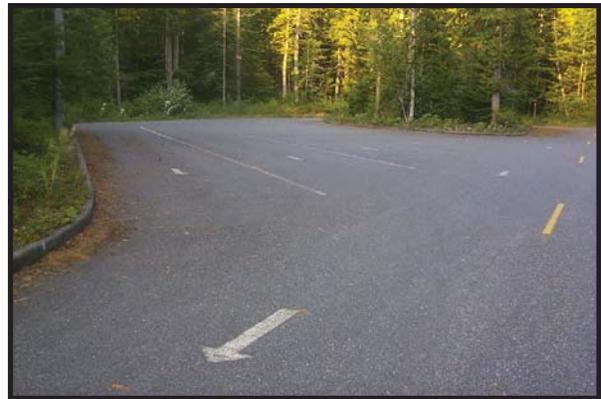
## Route 0904

Route	Public / NonPublic	Date Visited	Area (sq ft)	Lane Miles *	Surface Type	Condition / PCR
0904	Public	9/25/2002	28842	0.50	AS	GOOD / 90

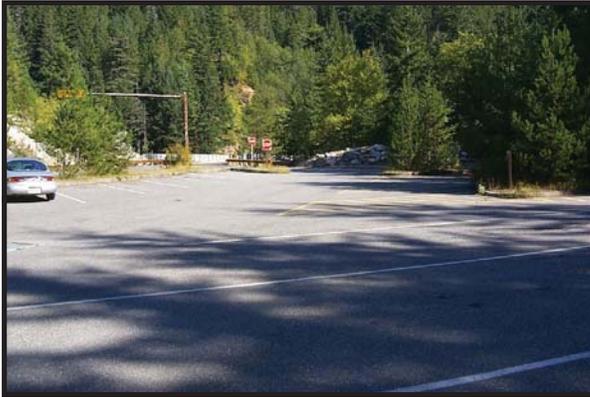
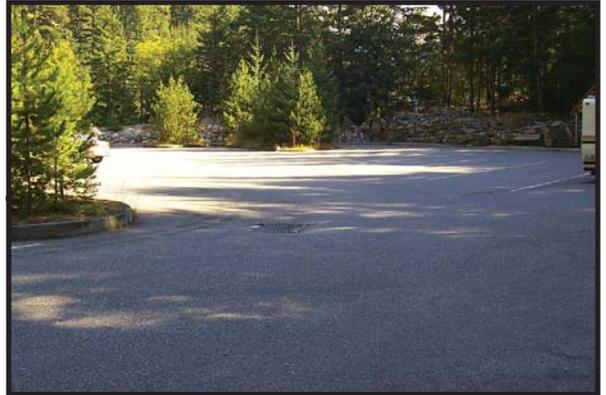
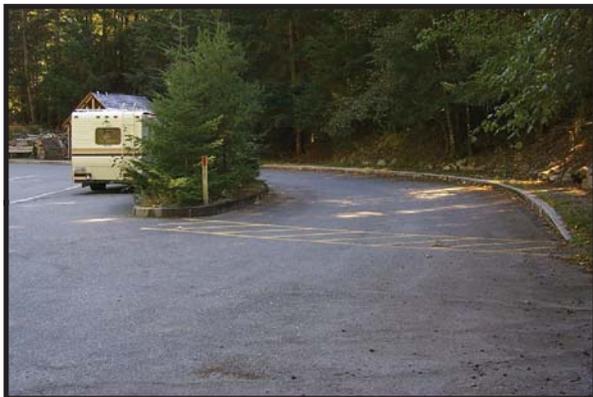
## Route 0905

Route	Public / NonPublic	Date Visited	Area (sq ft)	Lane Miles *	Surface Type	Condition / PCR
0905	Public	9/25/2002	12545	0.22	AS	EXCELLENT / 97

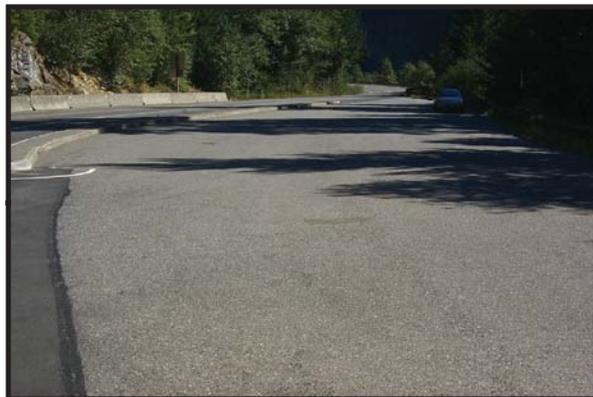
## Route 0906

Route	Public / NonPublic	Date Visited	Area (sq ft)	Lane Miles *	Surface Type	Condition / PCR
0906	Public	9/25/2002	58071	1.00	AS	FAIR / 73

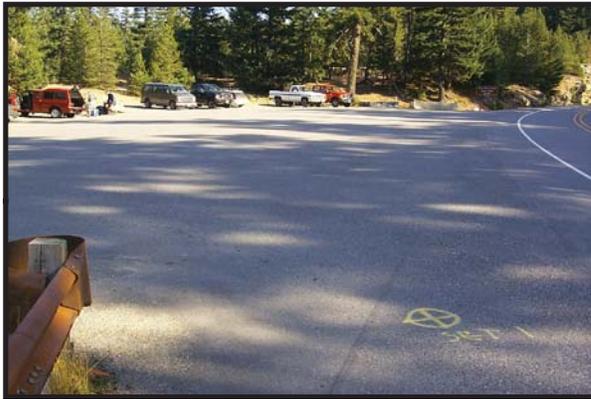
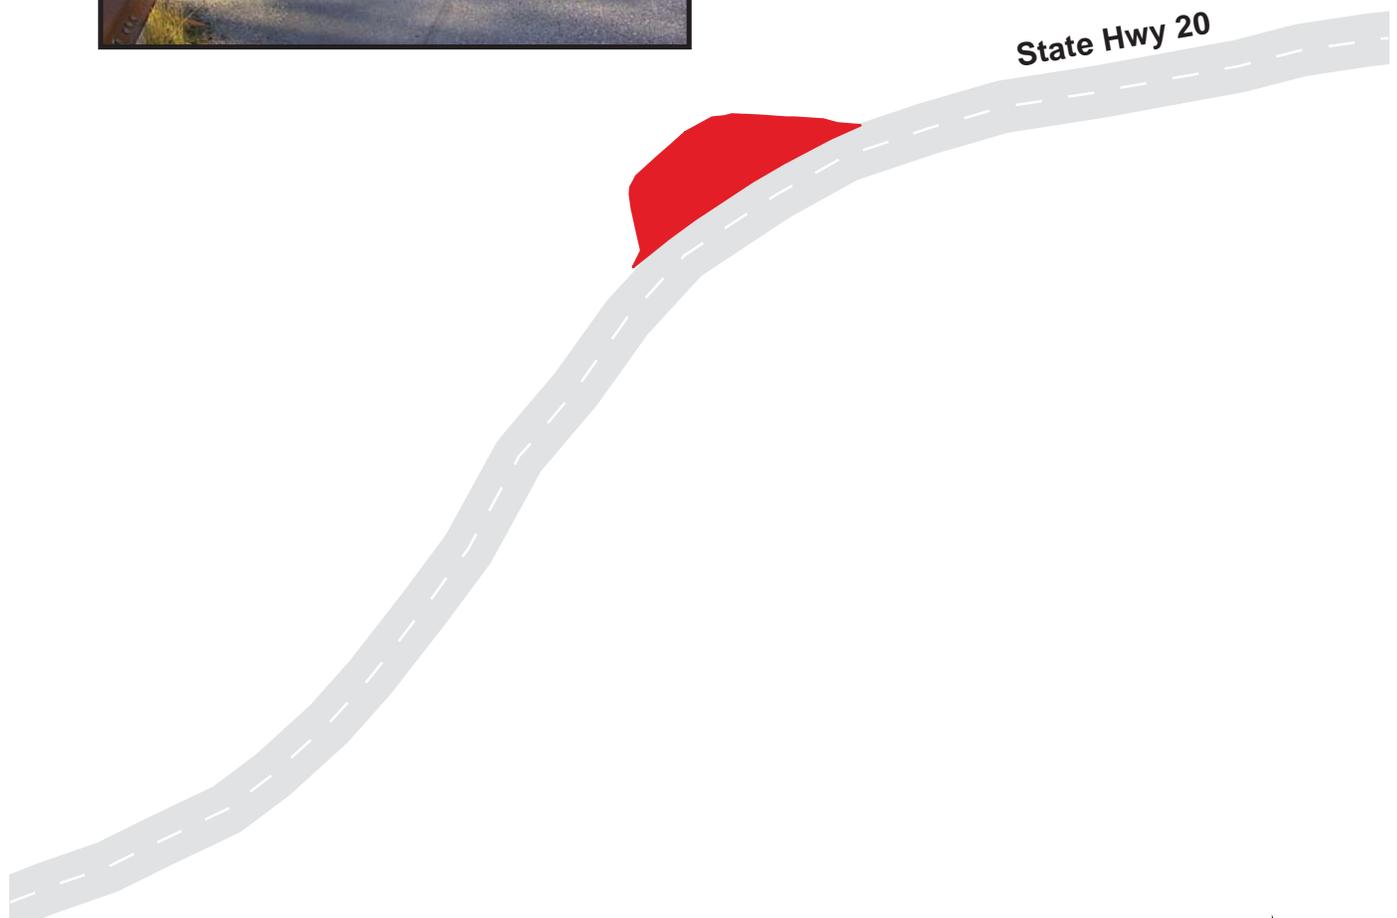
## Route 0909

Route	Public / NonPublic	Date Visited	Area (sq ft)	Lane Miles *	Surface Type	Condition / PCR
0909	Public	9/25/2002	9726	0.17	AS	GOOD / 90

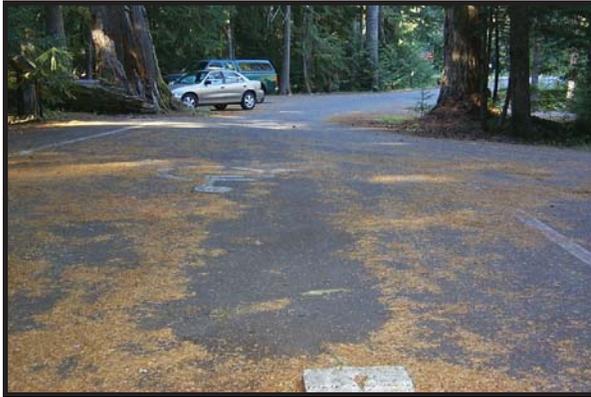
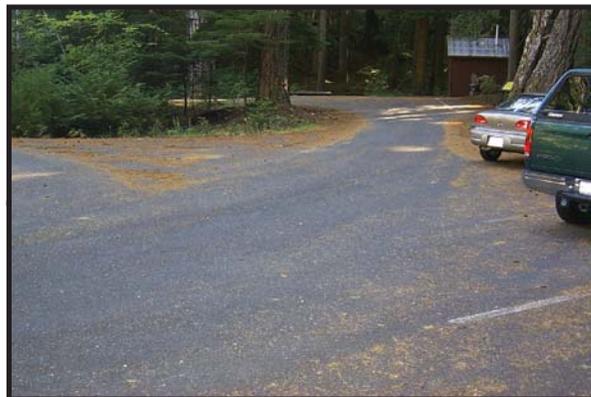
## Route 0910A

Route	Public / NonPublic	Date Visited	Area (sq ft)	Lane Miles *	Surface Type	Condition / PCR
0910A	Public	9/25/2002	9586	0.17	AS	EXCELLENT / 97

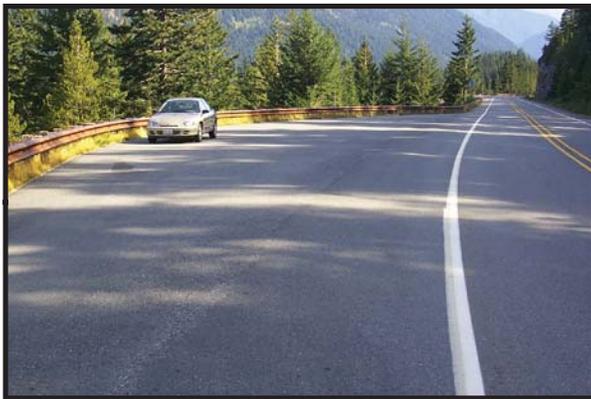
## Route 0910B

Route	Public / NonPublic	Date Visited	Area (sq ft)	Lane Miles *	Surface Type	Condition / PCR
0910B	Public	9/25/2002	4684	0.08	AS	EXCELLENT / 97

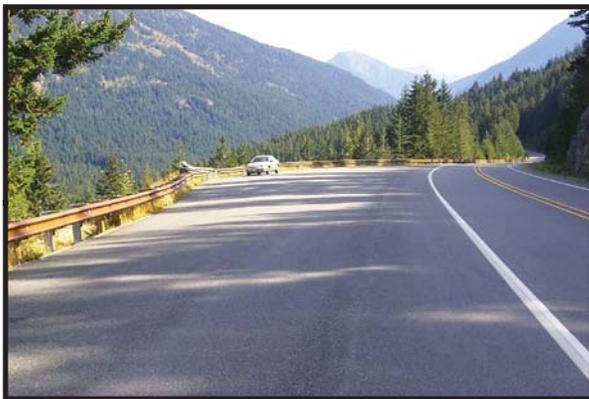
## Route 0912

Route	Public / NonPublic	Date Visited	Area (sq ft)	Lane Miles *	Surface Type	Condition / PCR
0912	Public	9/25/2002	901	0.02	AS	EXCELLENT / 97
