# The Road Inventory of Obed Wild and Scenic River OBRI - 5640

Prepared By:  
Federal Highway Administration  
Eastern Federal Lands Highway Division  
Cycle 3

# Obed Wild and Scenic River in Tennessee

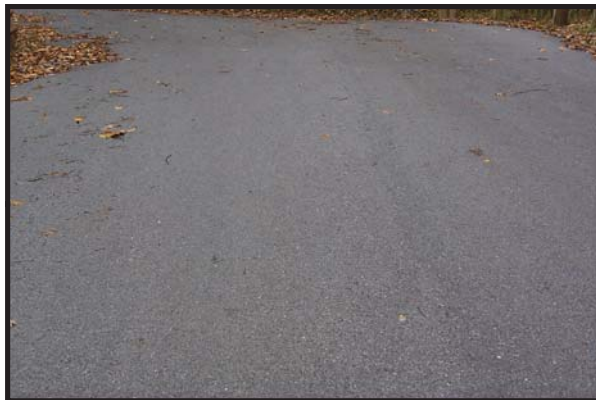
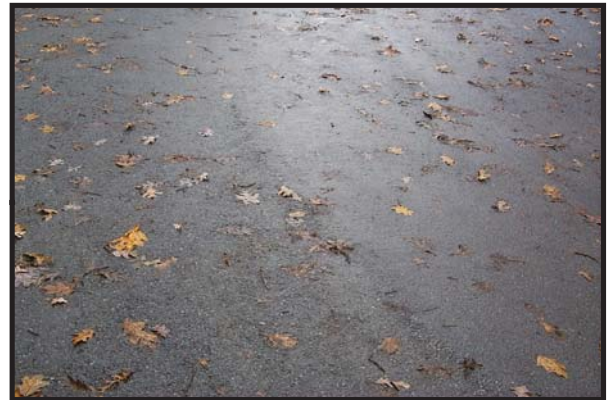
## Route 0900

Nemo Picnic Area Parking  
From Catoosa Road

Route	Public / NonPublic	Date Visited	Area (sq ft)	Lane Miles *	Surface Type	Condition / PCR
0900	Public	11/19/2002	31423	0.54	AS	GOOD / 90

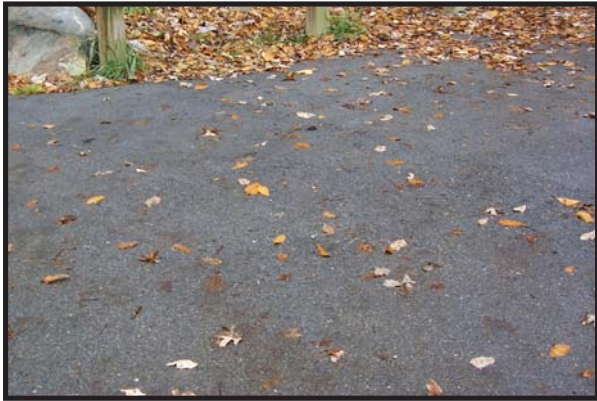
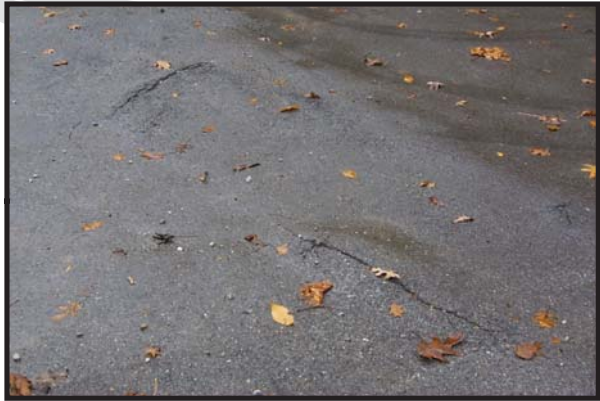
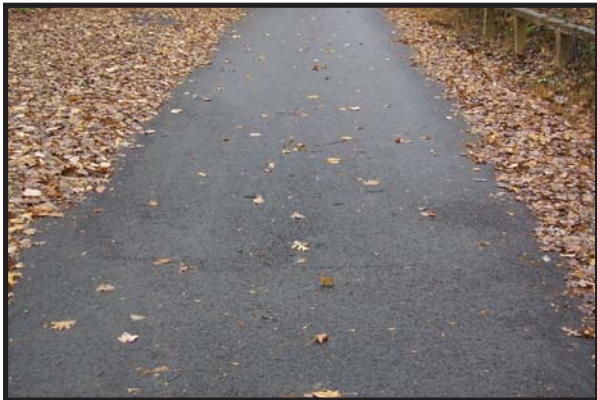
# Obed Wild and Scenic River Route 0901

Rock Creek Campground Parking  
From Route 0100

Route	Public / NonPublic	Date Visited	Area (sq ft)	Lane Miles *	Surface Type	Condition / PCR
0901	Public	11/19/2002	18407	0.32	AS	GOOD / 90

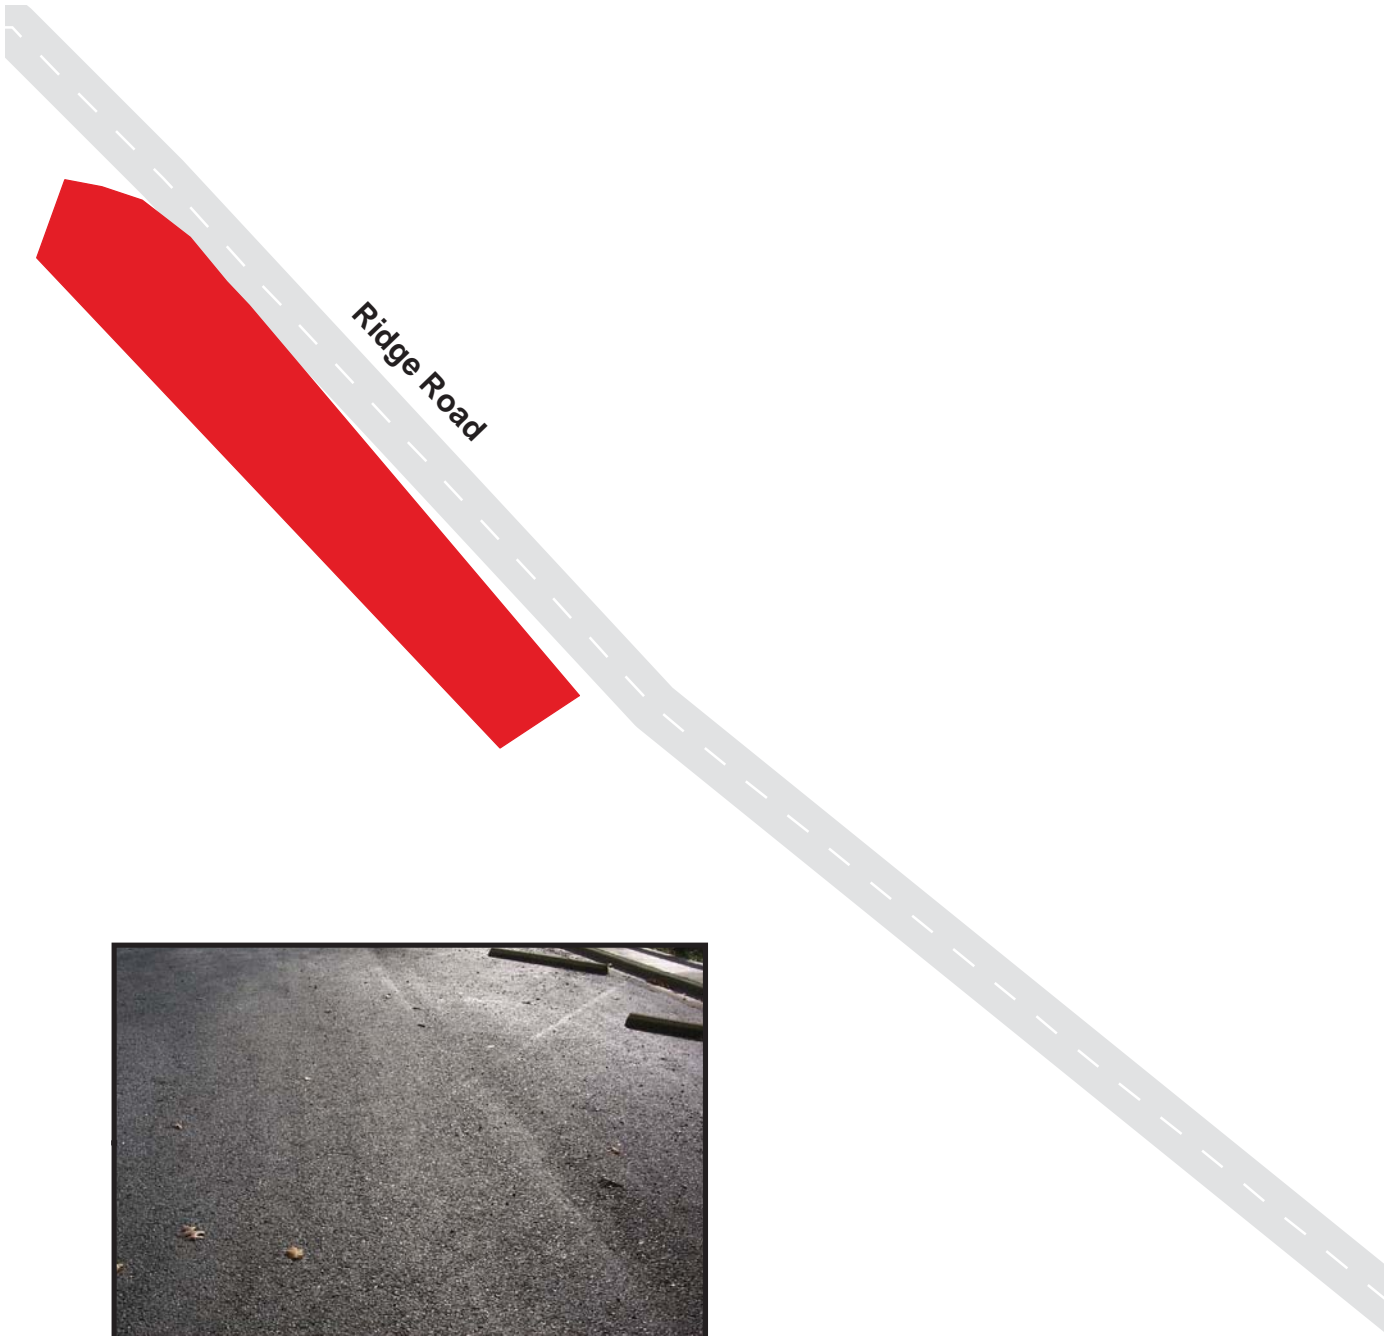
## Route 0902B

Lilly Bridge Parking Area B  
From Ridge Road

Route	Public / NonPublic	Date Visited	Area (sq ft)	Lane Miles *	Surface Type	Condition / PCR
0902B	Public	11/19/2002	3436	0.06	AS	GOOD / 90
