The Road Inventory of Ocmulgee National Monument OCMU - 5620

Road Inventory Program

Prepared By:
Federal Highway Administration
Eastern Federal Lands Highway Division
Cycle 3

Ocmulgee National Monument in Georgia

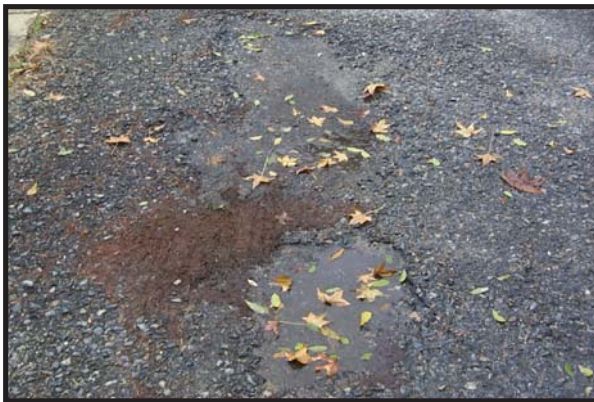
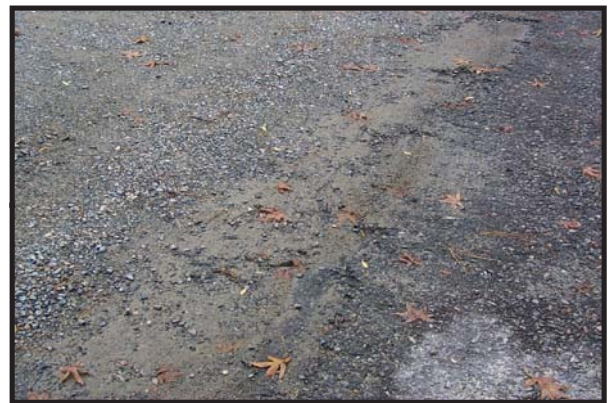
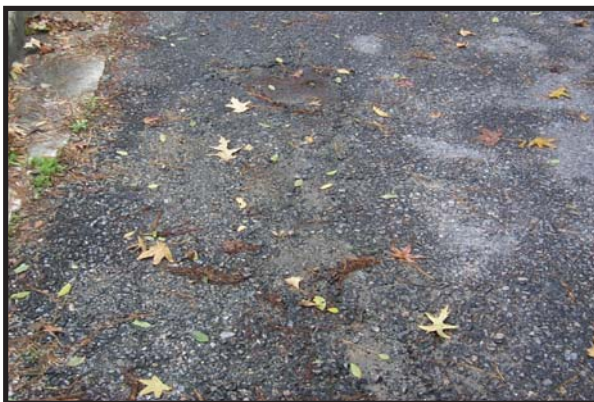
Route 0900

Route	Public / NonPublic	Date Visited	Area (sq ft)	Lane Miles *	Surface Type	Condition / PCR
0900	NonPublic	12/14/2002	10916	0.19	AS	POOR / 45

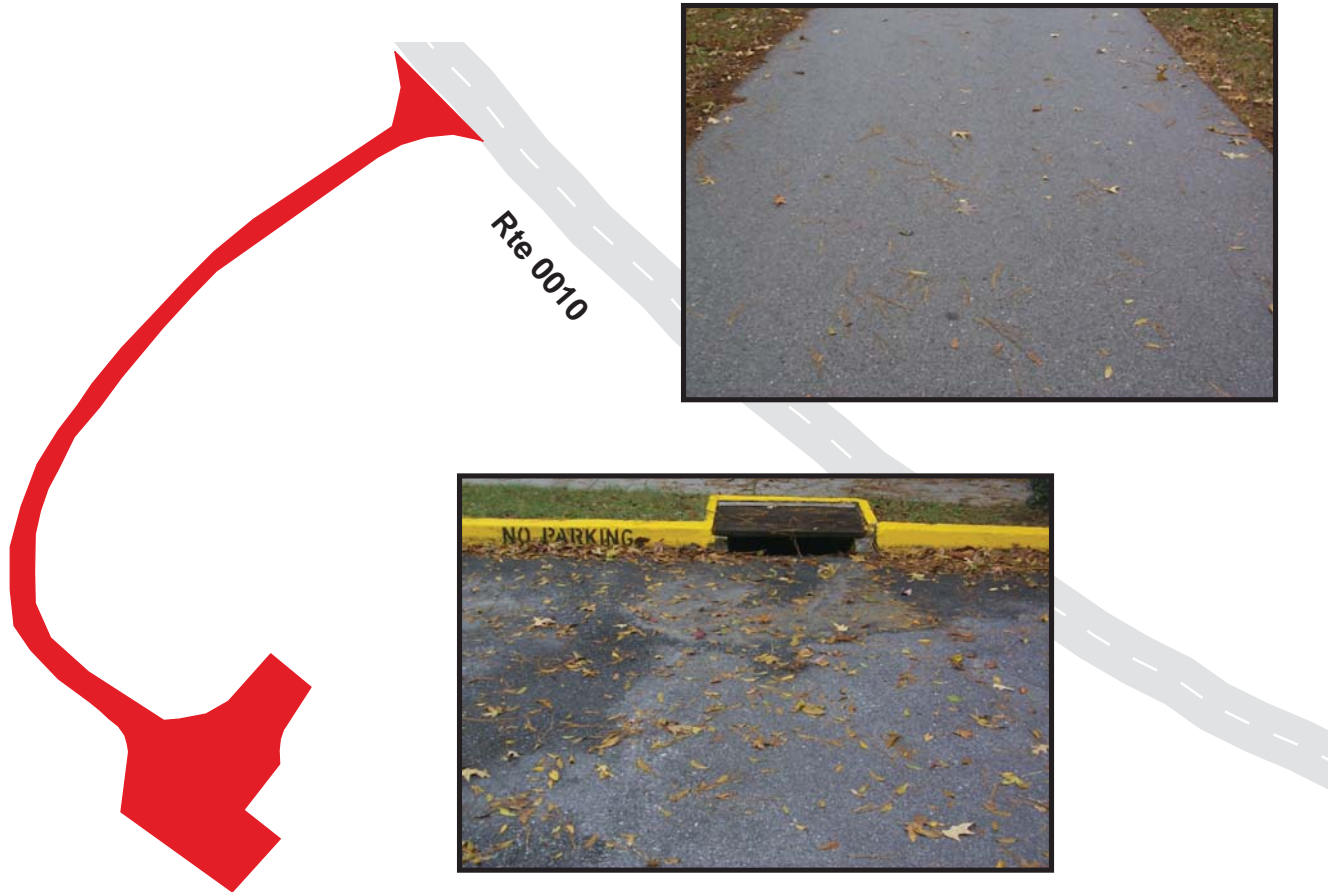
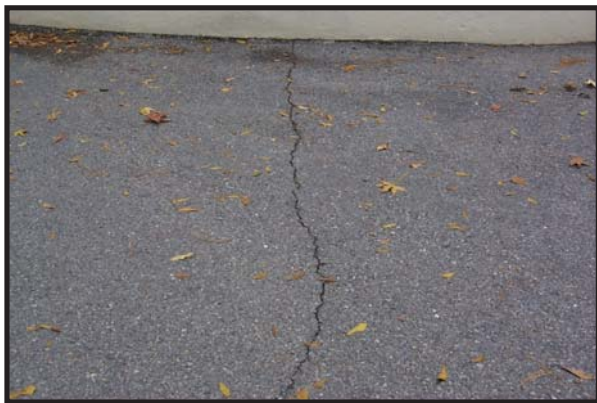
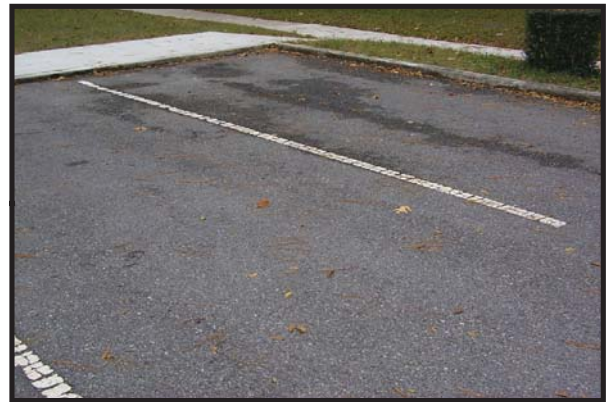
Route 0901

Route	Public / NonPublic	Date Visited	Area (sq ft)	Lane Miles *	Surface Type	Condition / PCR
0901	NonPublic	12/14/2002	5654	0.10	AS	GOOD / 90

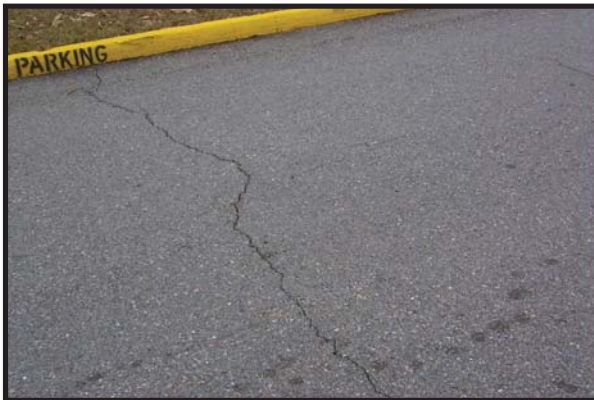
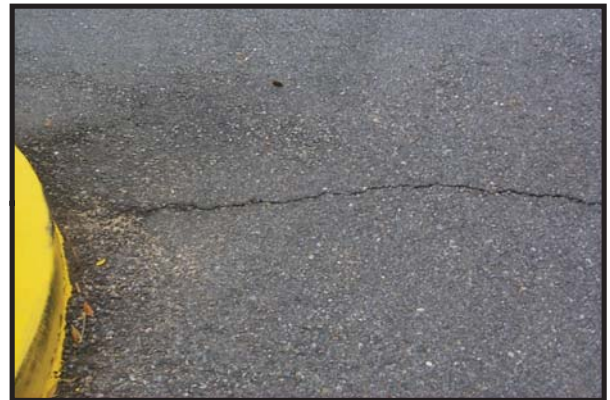
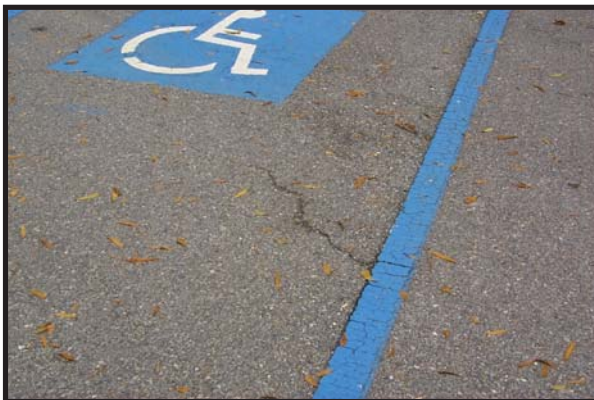
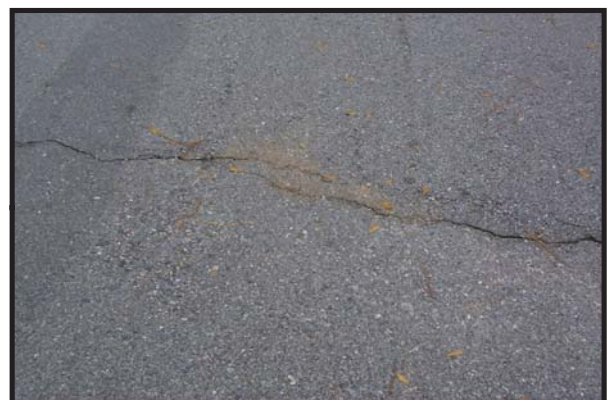
Route 0902

Route	Public / NonPublic	Date Visited	Area (sq ft)	Lane Miles *	Surface Type	Condition / PCR
0902	Public	12/14/2002	34466	0.59	AS	FAIR / 73

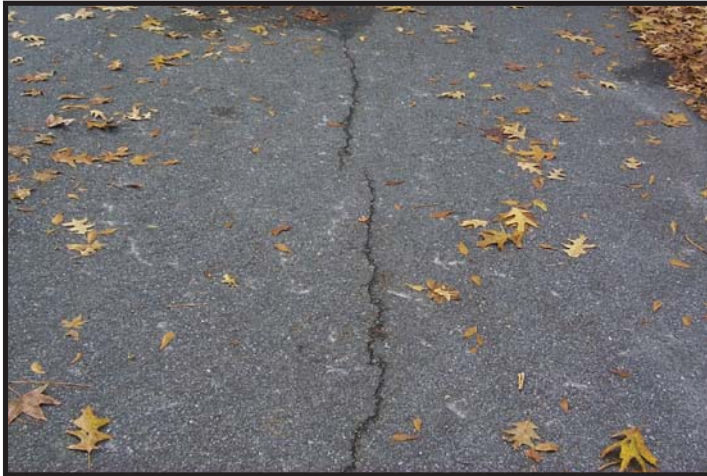
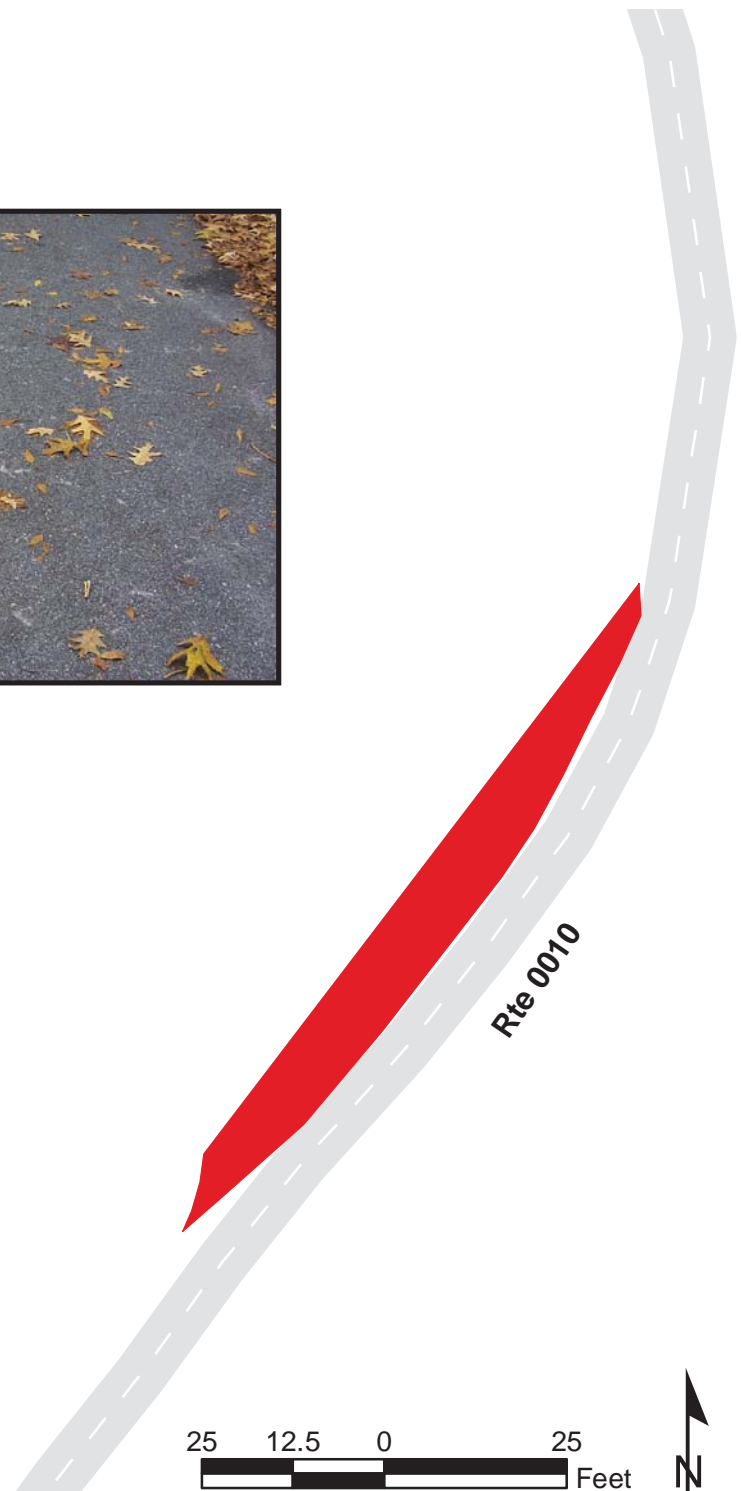
Route 0903

Route	Public / NonPublic	Date Visited	Area (sq ft)	Lane Miles *	Surface Type	Condition / PCR
0903	Public	12/14/2002	656	0.01	AS	GOOD / 90

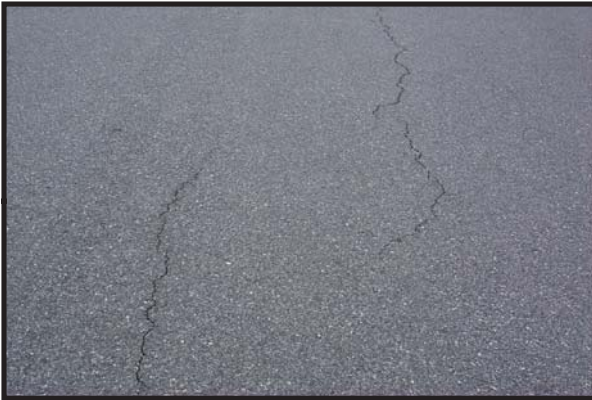
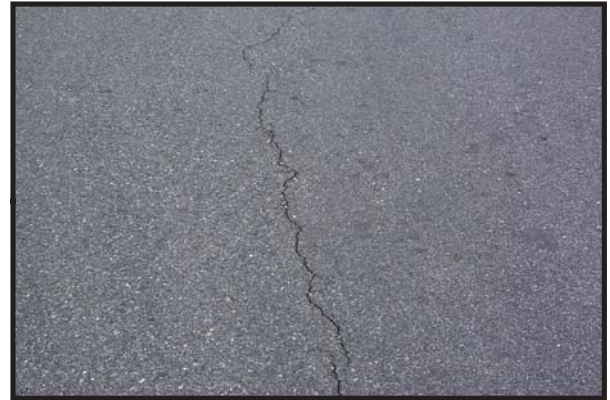
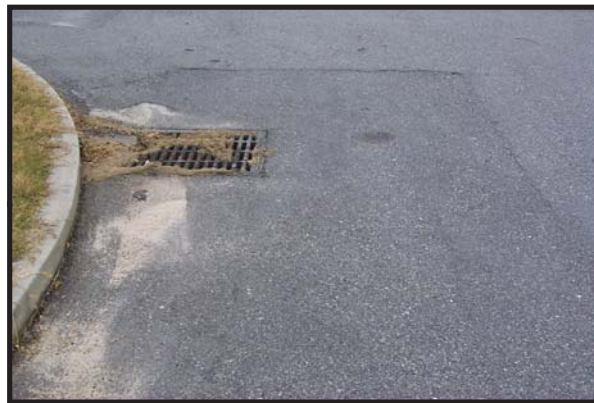
Route 0904

Route	Public / NonPublic	Date Visited	Area (sq ft)	Lane Miles *	Surface Type	Condition / PCR
0904	Public	12/14/2002	21848	0.38	AS	GOOD / 90

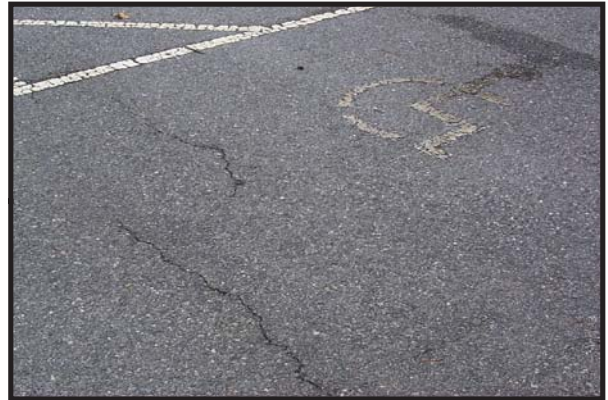
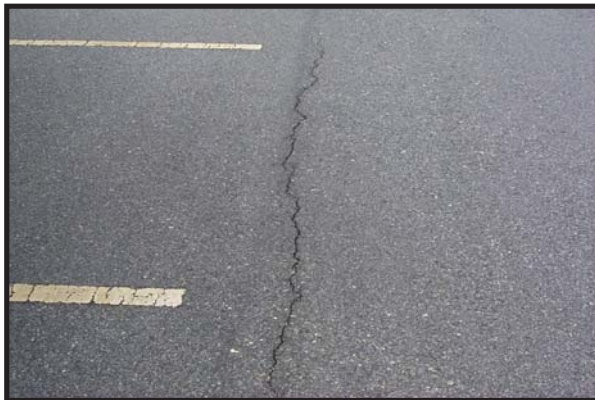
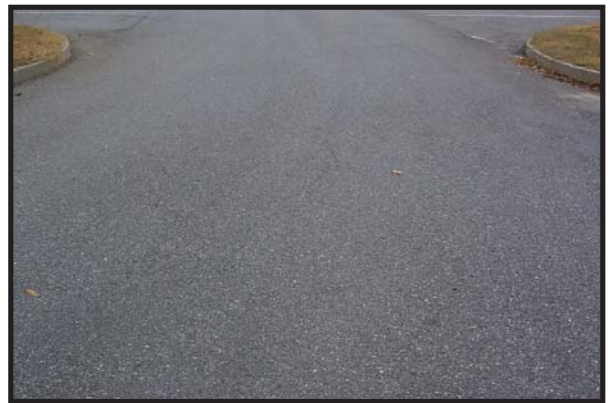
Route 0905

Route	Public / NonPublic	Date Visited	Area (sq ft)	Lane Miles *	Surface Type	Condition / PCR
0905	Public	12/14/2002	26461	0.46	AS	GOOD / 90
