The Road Inventory of Olympic National Park OLYM – 9500

Road Inventory Program

Prepared By:
Federal Highway Administration
Eastern Federal Lands Highway Division
Cycle 3

Olympic National Park in Washington

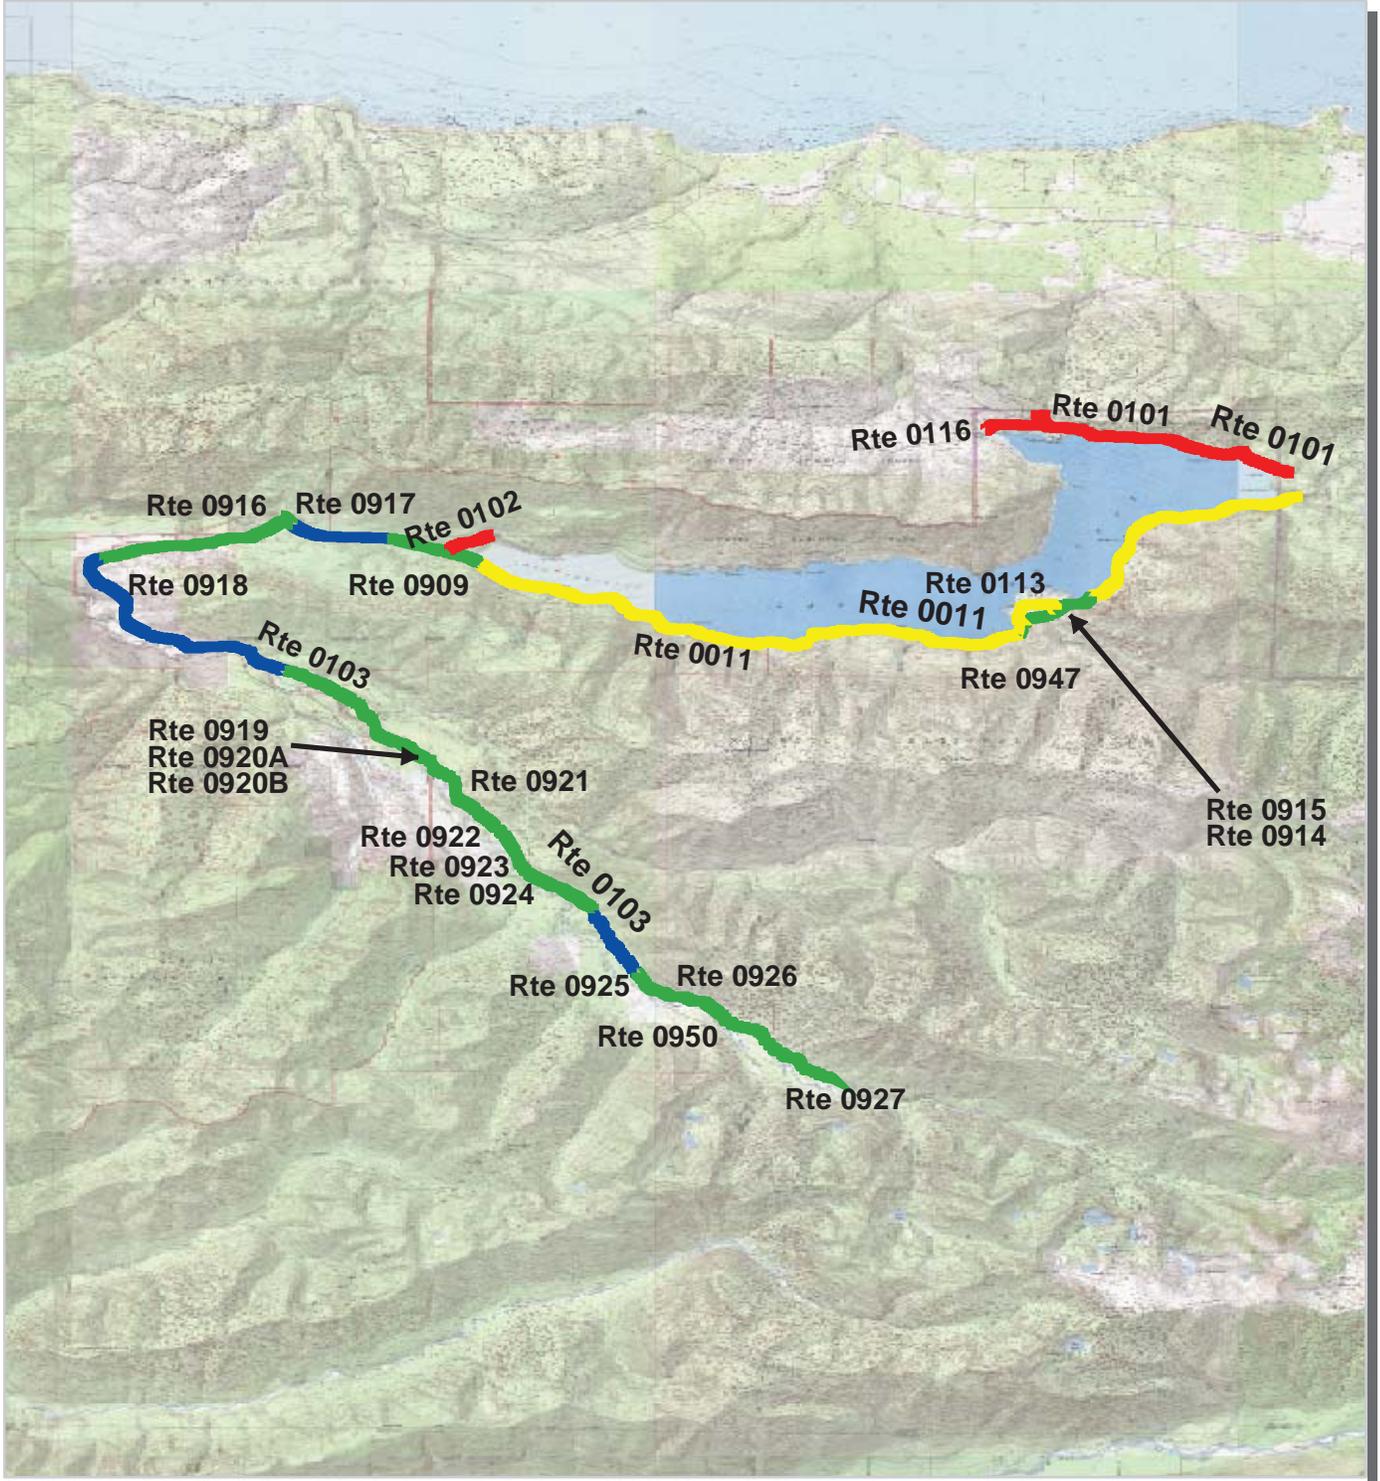
Olympic National Park Route Condition Area Map 3 PCR - Mile by Mile

PCR	Poor		Fair		Good		Excellent	
	(<=60)		(61 - 84)		(85 - 94)		(95 - 100)

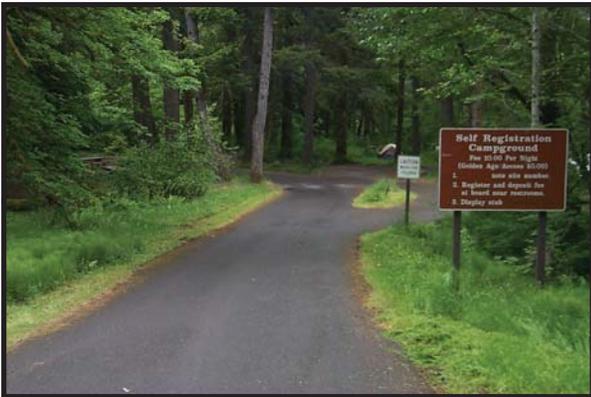
OLYMPIC NATIONAL PARK
Route 0202
 ELWHA CAMPGROUND
 FROM SOUTH ROUTE 0100 AT MP 1.0

Route	Length (mi)	Width (ft)	Area (sq ft)	Lane Miles *	Condition / PCR	Surface Type
0202	0.22	0.00	12907	0.22	FAIR / 73	AS

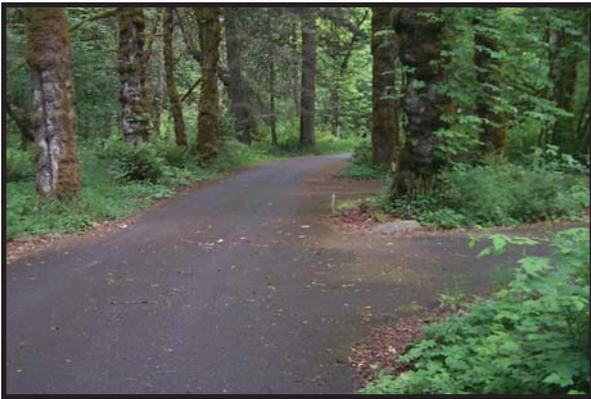
Route 0204

Route	Length (mi)	Width (ft)	Area (sq ft)	Lane Miles *	Condition / PCR	Surface Type
0204	1.05	0.00	61111	1.05	FAIR / 73	AS

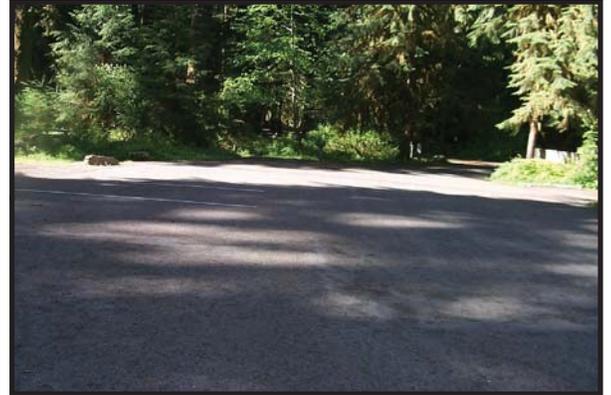
Route 0206B

Route	Length (mi)	Width (ft)	Area (sq ft)	Lane Miles *	Condition / PCR	Surface Type
0206B	0.71	0.00	18704	0.32	GOOD / 90	AS

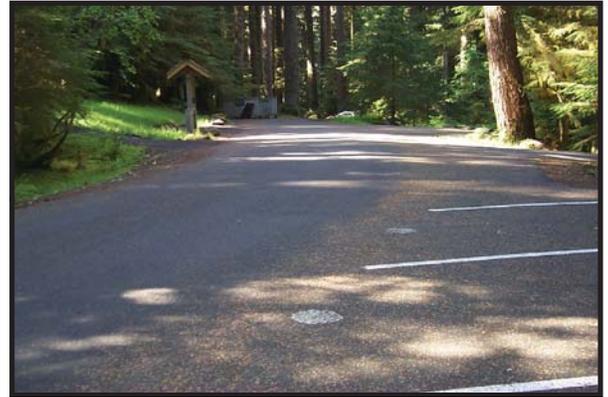
Route 0208

Route	Length (mi)	Width (ft)	Area (sq ft)	Lane Miles *	Condition / PCR	Surface Type
0208	0.52	0.00	30417	0.52	GOOD / 90	AS

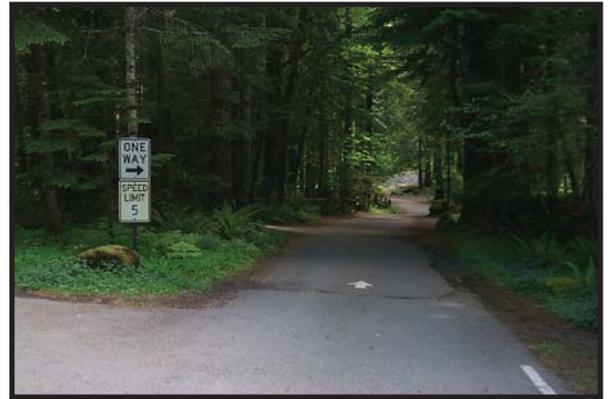
OLYMPIC NATIONAL PARK
Route 0213
 KALALOCH CAMPGROUND
 FROM US 101

Route	Length (mi)	Width (ft)	Area (sq ft)	Lane Miles *	Condition / PCR	Surface Type
0213	2.24	0.00	130351	2.24	GOOD / 90	AS

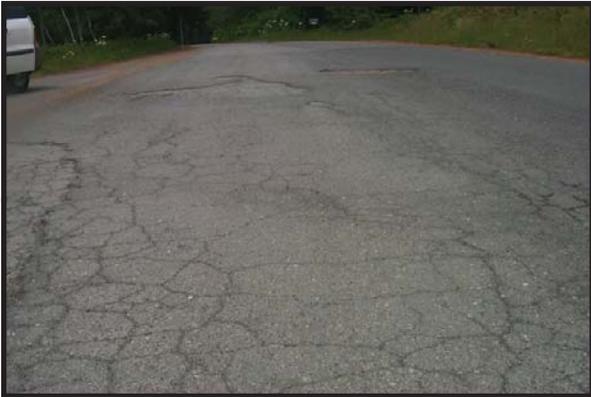
Route 0215

Route	Length (mi)	Width (ft)	Area (sq ft)	Lane Miles *	Condition / PCR	Surface Type
0215	1.53	0.00	89114	1.53	GOOD / 90	AS

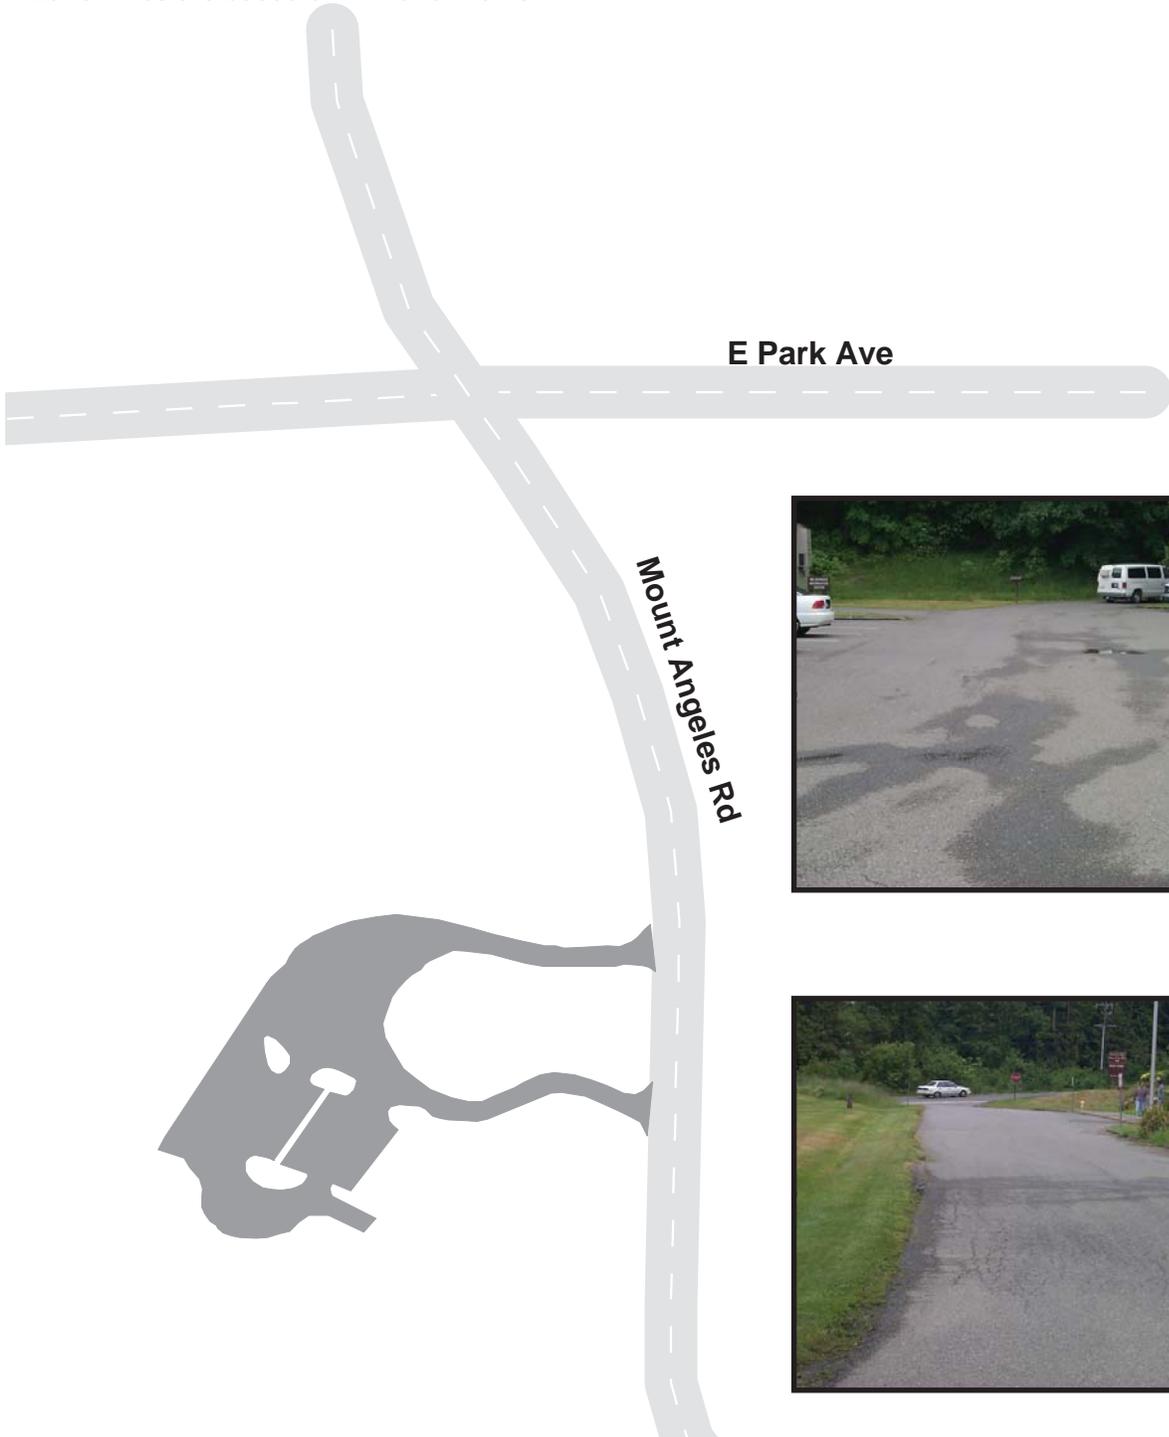
OLYMPIC NATIONAL PARK
Route 0221
 OLYMPIC VISITOR CENTER ROAD
 FROM MOUNT ANGELES ROAD, SOUTH OF PORT ANGELES

Route	Length (mi)	Width (ft)	Area (sq ft)	Lane Miles *	Condition / PCR	Surface Type
0221	0.91	0.00	53072	0.91	FAIR / 73	AS

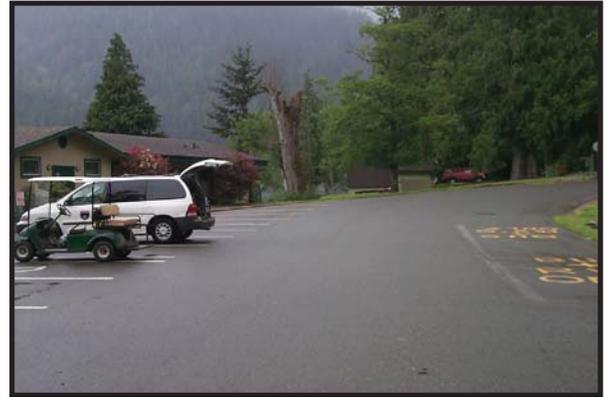
OLYMPIC NATIONAL PARK
Route 0224
 LAKE CRESCENT LODGE ROAD
 FROM ROUTE 0113 AT MP 0.4

Route	Length (mi)	Width (ft)	Area (sq ft)	Lane Miles *	Condition / PCR	Surface Type
0224	1.49	0.00	86804	1.49	GOOD / 90	AS

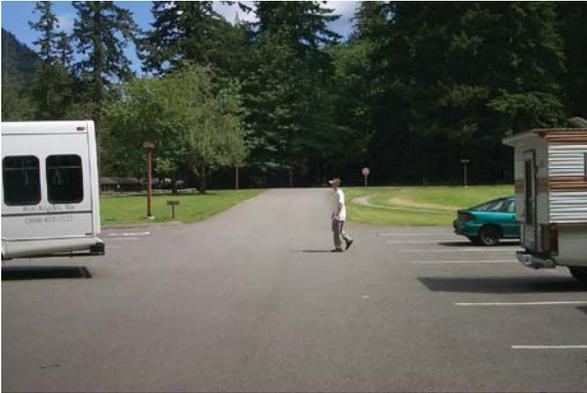
Route 0226

Route	Length (mi)	Width (ft)	Area (sq ft)	Lane Miles *	Condition / PCR	Surface Type
0226	0.38	0.00	44455	0.77	FAIR / 73	AS

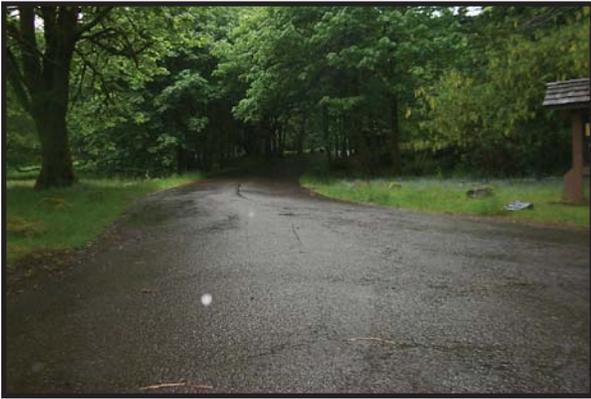
Route 0228

Route	Length (mi)	Width (ft)	Area (sq ft)	Lane Miles *	Condition / PCR	Surface Type
0228	1.58	0.00	91824	1.58	GOOD / 90	AS

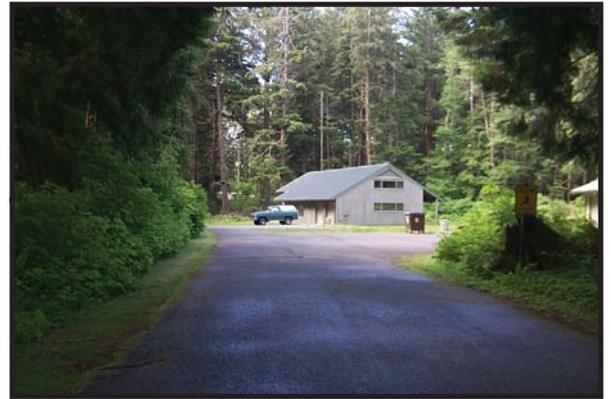
Route 0413

Route	Length (mi)	Width (ft)	Area (sq ft)	Lane Miles *	Condition / PCR	Surface Type
0413	0.39	0.00	22763	0.39	FAIR / 73	AS

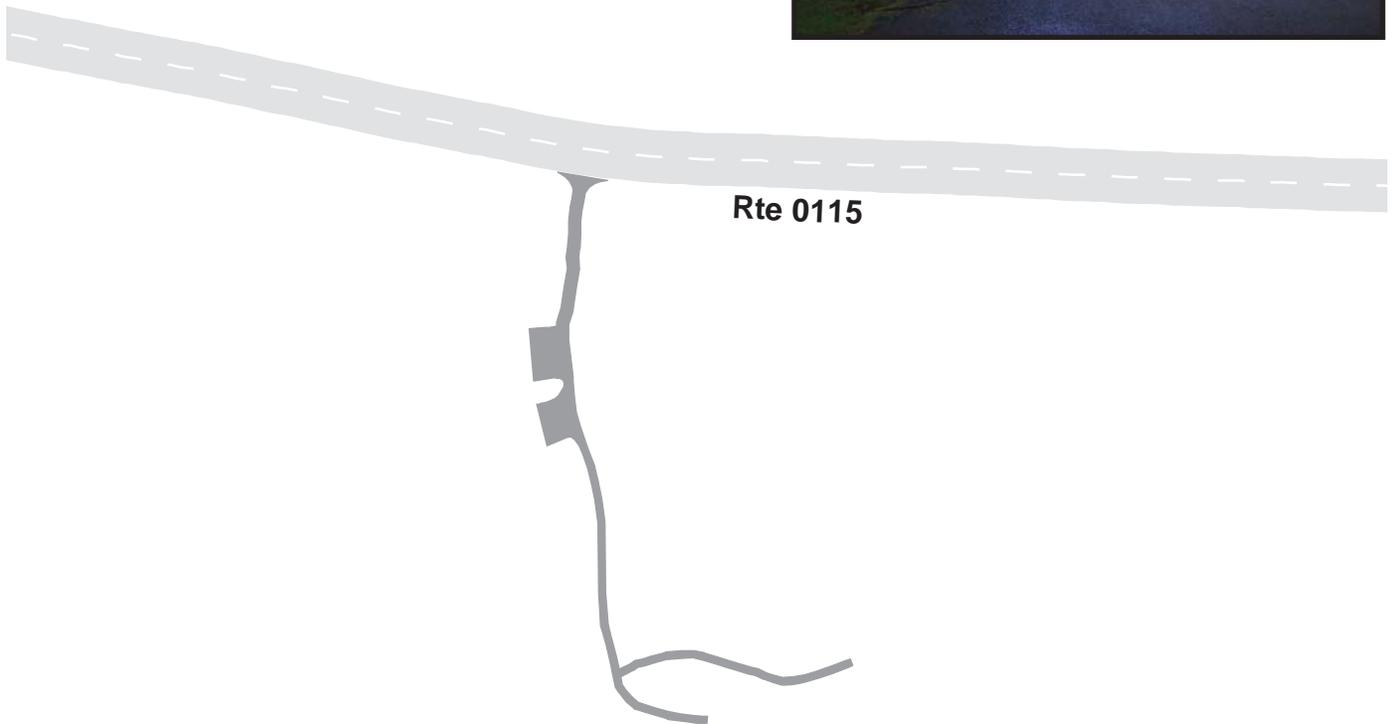
OLYMPIC NATIONAL PARK
Route 0411
 MORA UTILITY AND RESIDENT ROAD
 FROM ROUTE 0115 AT MP 0.54

Route	Length (mi)	Width (ft)	Area (sq ft)	Lane Miles *	Condition / PCR	Surface Type
0411	0.31	0.00	18426	0.32	GOOD / 90	AS

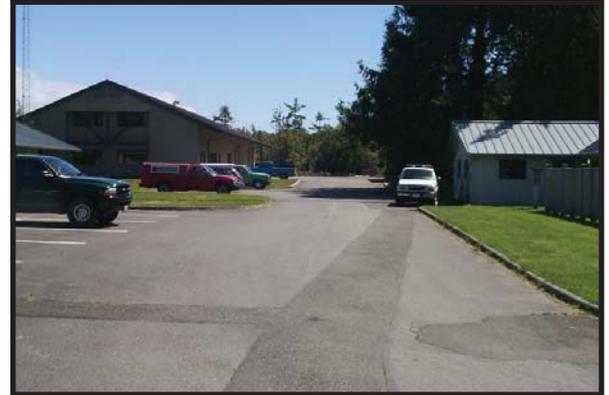
Route 0416

Route	Length (mi)	Width (ft)	Area (sq ft)	Lane Miles *	Condition / PCR	Surface Type
0416	0.20	0.00	11928	0.21	POOR / 45	AS

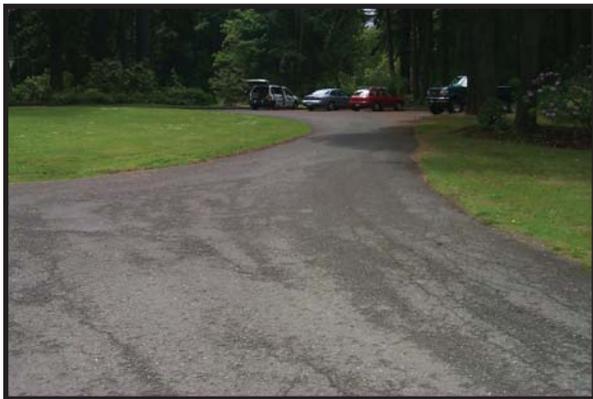
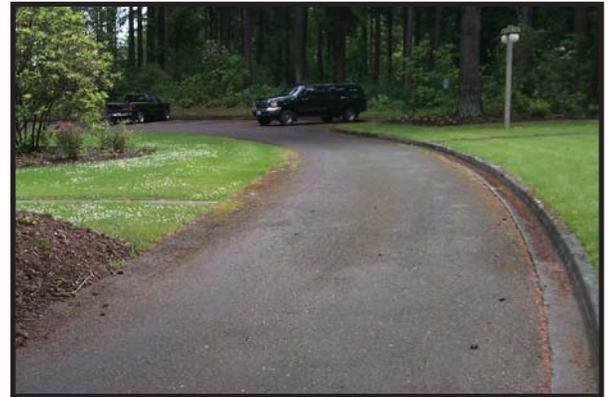
OLYMPIC NATIONAL PARK
Route 0900
 HEADQUARTERS ADMINISTRATIVE PARKING
 FROM E PARK AVENUE, PORT ANGELES

Route	Public / NonPublic	Date Visited	Area (sq ft)	Lane Miles *	Surface Type	Condition / PCR
0900	PUBLIC	6/7/2001	15488	0.27	AS	FAIR / 73

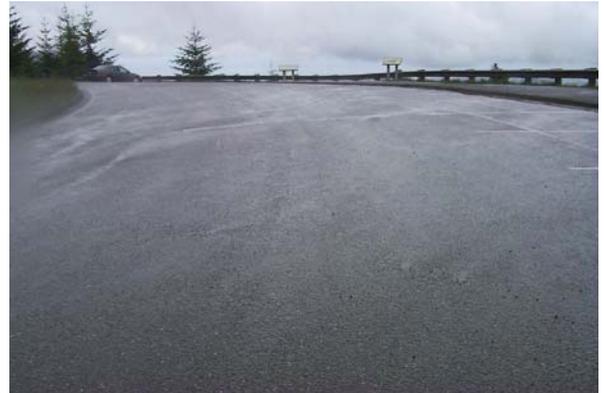
OLYMPIC NATIONAL PARK
Route 0902
 SIEGE OF ICE / RAINSHADOW PARKING
 ADJACENT TO ROUTE 0012 AT MP 3.7

Route	Public / NonPublic	Date Visited	Area (sq ft)	Lane Miles *	Surface Type	Condition / PCR
0902	PUBLIC	6/7/2001	9934	0.17	AS	GOOD / 90

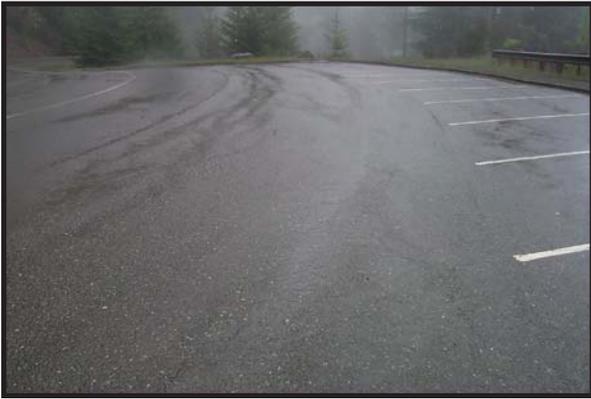
OLYMPIC NATIONAL PARK
Route 0903A
 ANCIENT LAKE MORSE PARKING AREA A
 ADJACENT TO ROUTE 0012 AT MP 6.32

Route	Public / NonPublic	Date Visited	Area (sq ft)	Lane Miles *	Surface Type	Condition / PCR
0903A	PUBLIC	6/7/2001	6486	0.11	AS	GOOD / 90

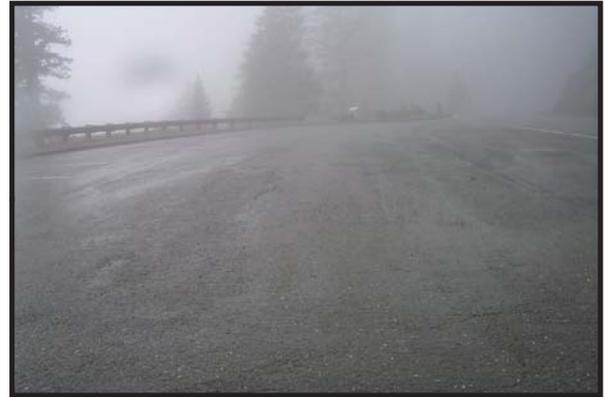
OLYMPIC NATIONAL PARK
Route 0903B
 ANCIENT LAKE MORSE PARKING AREA B
 ADJACENT TO ROUTE 0012 AT MP 6.42

Route	Public / NonPublic	Date Visited	Area (sq ft)	Lane Miles *	Surface Type	Condition / PCR
0903B	PUBLIC	6/5/2001	6514	0.11	AS	GOOD / 90

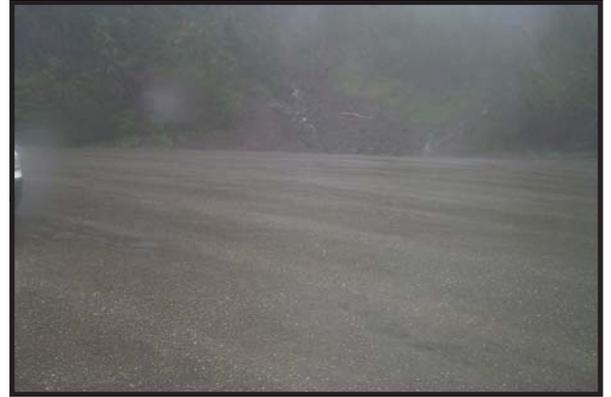
OLYMPIC NATIONAL PARK
Route 0904
 SWITCHBACK TRAILHEAD PARKING
 ADJACENT TO ROUTE 0012 AT MP 9.6

Route	Public / NonPublic	Date Visited	Area (sq ft)	Lane Miles *	Surface Type	Condition / PCR
0904	PUBLIC	6/5/2001	9472	0.16	AS	GOOD / 90

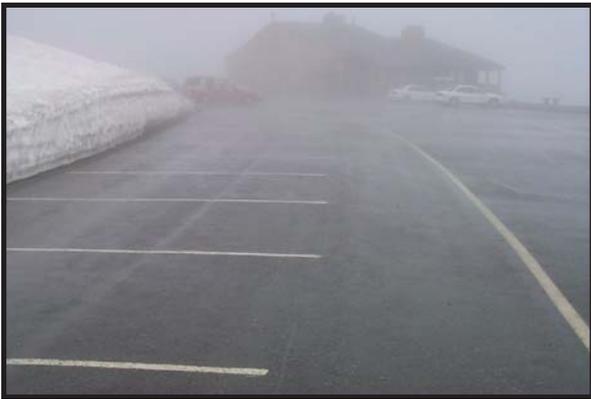
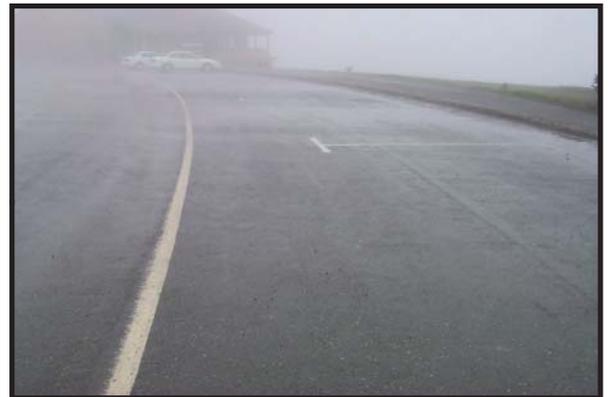
OLYMPIC NATIONAL PARK
Route 0905
HURRICANE RIDGE VISITOR CENTER PARKING
ADJACENT TO ROUTE 0012 AT MP 12.3

Route	Public / NonPublic	Date Visited	Area (sq ft)	Lane Miles *	Surface Type	Condition / PCR
0905	PUBLIC	6/5/2001	84501	1.45	AS	FAIR / 73

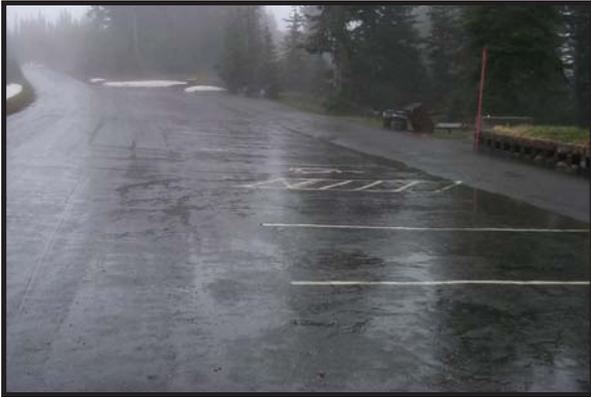
OLYMPIC NATIONAL PARK
Route 0906
 HURRICANE RIDGE PICNIC PARKING #1
 ADJACENT TO ROUTE 0012 AT MP 13.4

Route	Public / NonPublic	Date Visited	Area (sq ft)	Lane Miles *	Surface Type	Condition / PCR
0906	PUBLIC	6/5/2001	27442	0.47	AS	GOOD / 90

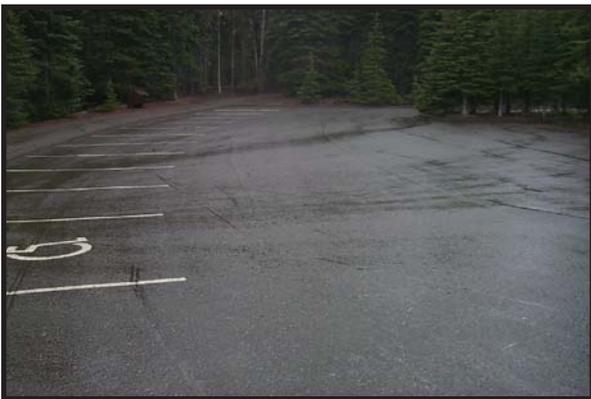
OLYMPIC NATIONAL PARK
Route 0907
 HURRICANE RIDGE PICNIC PARKING #2
 ADJACENT TO ROUTE 012 AT MP 13.5

Route	Public / NonPublic	Date Visited	Area (sq ft)	Lane Miles *	Surface Type	Condition / PCR
0907	PUBLIC	6/5/2001	21450	0.37	AS	FAIR / 73

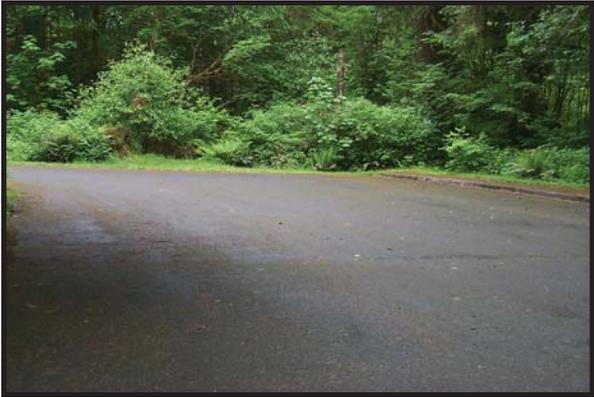
Route 0934

Route	Public / NonPublic	Date Visited	Area (sq ft)	Lane Miles *	Surface Type	Condition / PCR
0934	PUBLIC	6/7/2001	4570	0.08	AS	FAIR / 73

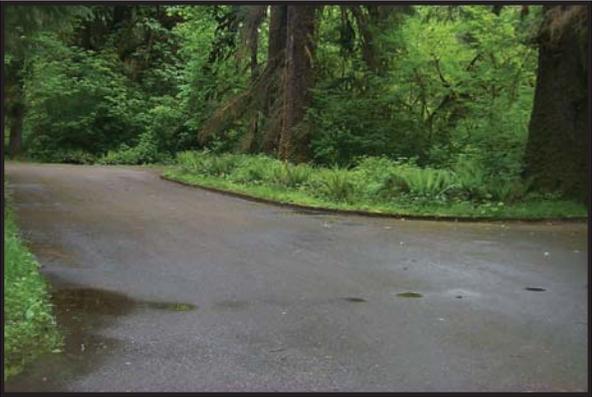
Route 0935

Route	Public / NonPublic	Date Visited	Area (sq ft)	Lane Miles *	Surface Type	Condition / PCR
0935	PUBLIC	6/5/2001	16882	0.29	AS	FAIR / 73

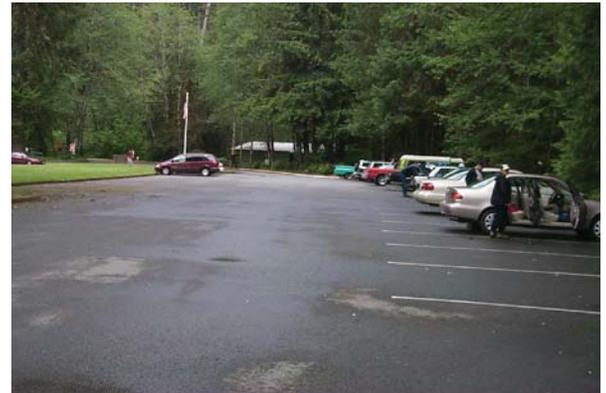
OLYMPIC NATIONAL PARK
Route 0936A
 HOH VISITOR CENTER PARKING AREA A
 ADJACENT TO ROUTE 0107 AT MP 6.10 ON RIGHT

Route	Public / NonPublic	Date Visited	Area (sq ft)	Lane Miles *	Surface Type	Condition / PCR
0936A	PUBLIC	6/5/2001	1414	0.02	AS	FAIR / 73

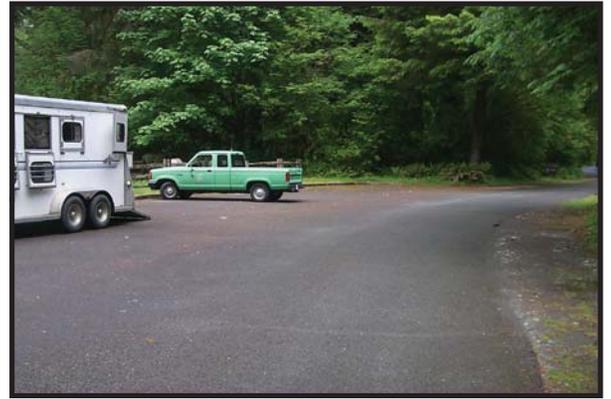
Route 0938

Route	Public / NonPublic	Date Visited	Area (sq ft)	Lane Miles *	Surface Type	Condition / PCR
0938	NONPUBLIC	6/5/2001	16860	0.29	AS	FAIR / 73

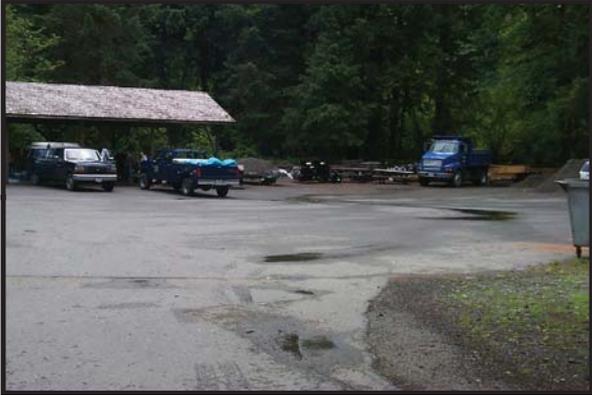
Route 0939

Route	Public / NonPublic	Date Visited	Area (sq ft)	Lane Miles *	Surface Type	Condition / PCR
0939	PUBLIC	6/5/2001	21236	0.37	AS	FAIR / 73

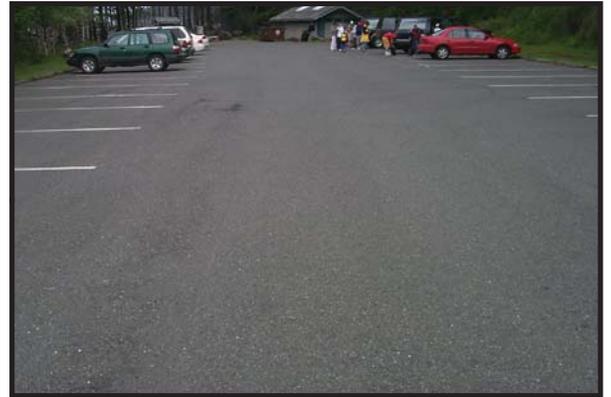
OLYMPIC NATIONAL PARK
Route 0940
 MORA RANGER STATION PARKING
 FROM ROUTE 0411

Route	Public / NonPublic	Date Visited	Area (sq ft)	Lane Miles *	Surface Type	Condition / PCR
0940	PUBLIC	6/7/2001	10913	0.19	AS	GOOD / 90

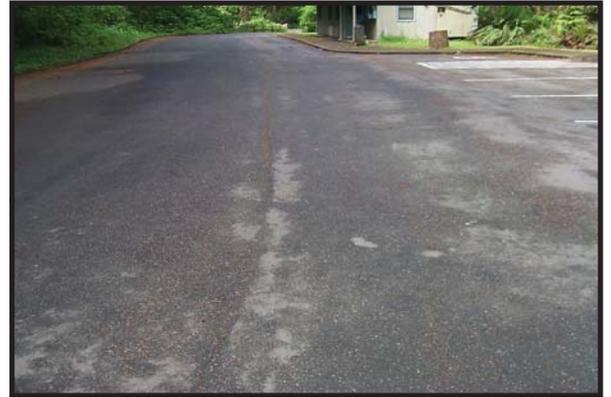
OLYMPIC NATIONAL PARK
Route 0941
KALALOCH VISITOR CENTER PARKING
FROM ROUTE 0415

Route	Public / NonPublic	Date Visited	Area (sq ft)	Lane Miles *	Surface Type	Condition / PCR
0941	PUBLIC	6/7/2001	16294	0.28	AS	GOOD / 90

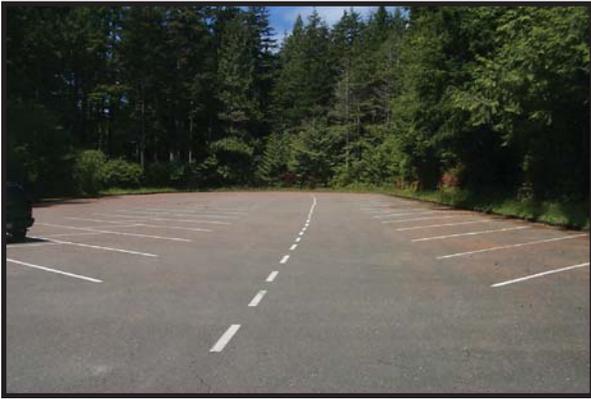
Route 0945

Route	Public / NonPublic	Date Visited	Area (sq ft)	Lane Miles *	Surface Type	Condition / PCR
0945	PUBLIC	6/7/2001	5937	0.10	AS	GOOD / 90

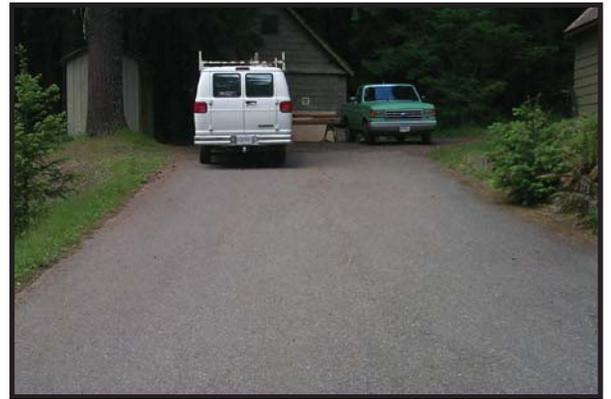
OLYMPIC NATIONAL PARK
Route 0947
 BOVEES MEADOW PARKING
 ADJACENT TO ROUTE 0113 AT MP 0.6 ON RIGHT

Route	Public / NonPublic	Date Visited	Area (sq ft)	Lane Miles *	Surface Type	Condition / PCR
0947	PUBLIC	6/7/2001	3762	0.06	AS	GOOD / 90

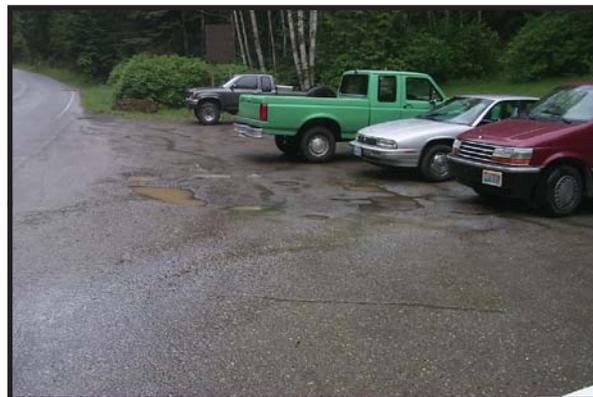
OLYMPIC NATIONAL PARK
Route 0950
 SOL DUC AMPHITHEATER PARKING
 FROM ROUTE 0103 AT MP 12.3

Route	Public / NonPublic	Date Visited	Area (sq ft)	Lane Miles *	Surface Type	Condition / PCR
0950	PUBLIC	6/7/2001	23445	0.40	AS	FAIR / 73
