The Road Inventory of Organ Pipe Cactus National Monument ORPI - 8660

Road Inventory Program

Prepared By:
Federal Highway Administration
Eastern Federal Lands Highway Division
Cycle 3

Organ Pipe Cactus National Monument in Arizona

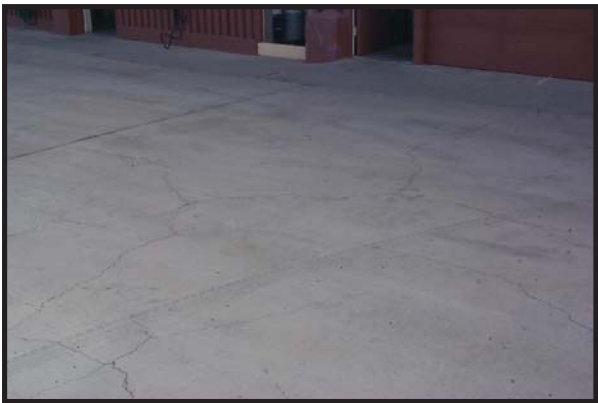
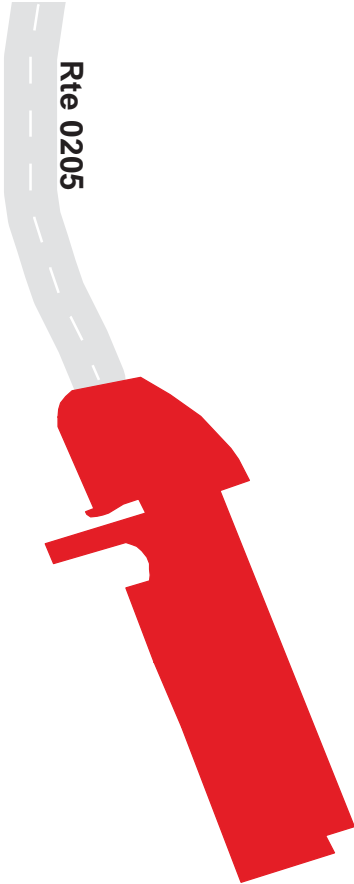
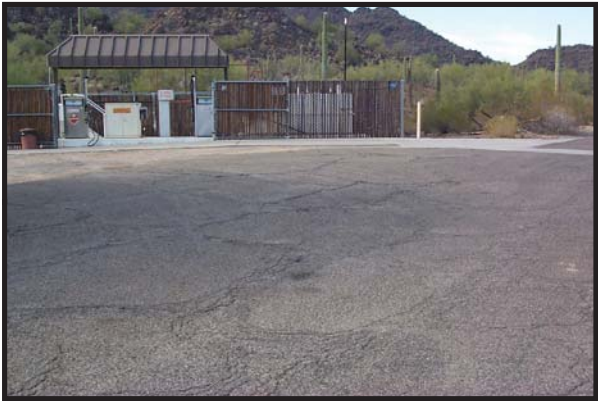
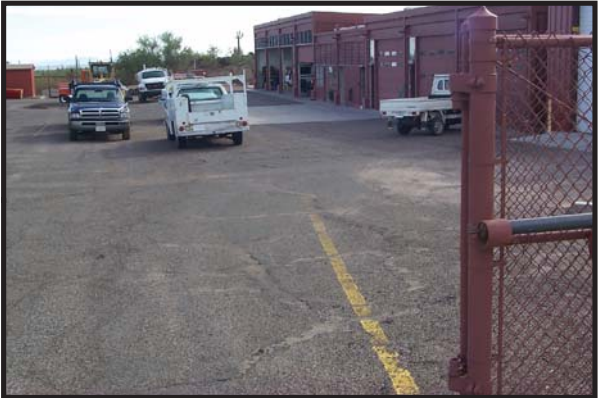
Route	Public / NonPublic	Date Visited	Area (sq ft)	Lane Miles *	Surface Type	Condition / PCR
0903	NonPublic	11/19/2001	25741	0.44	OC	POOR / 45

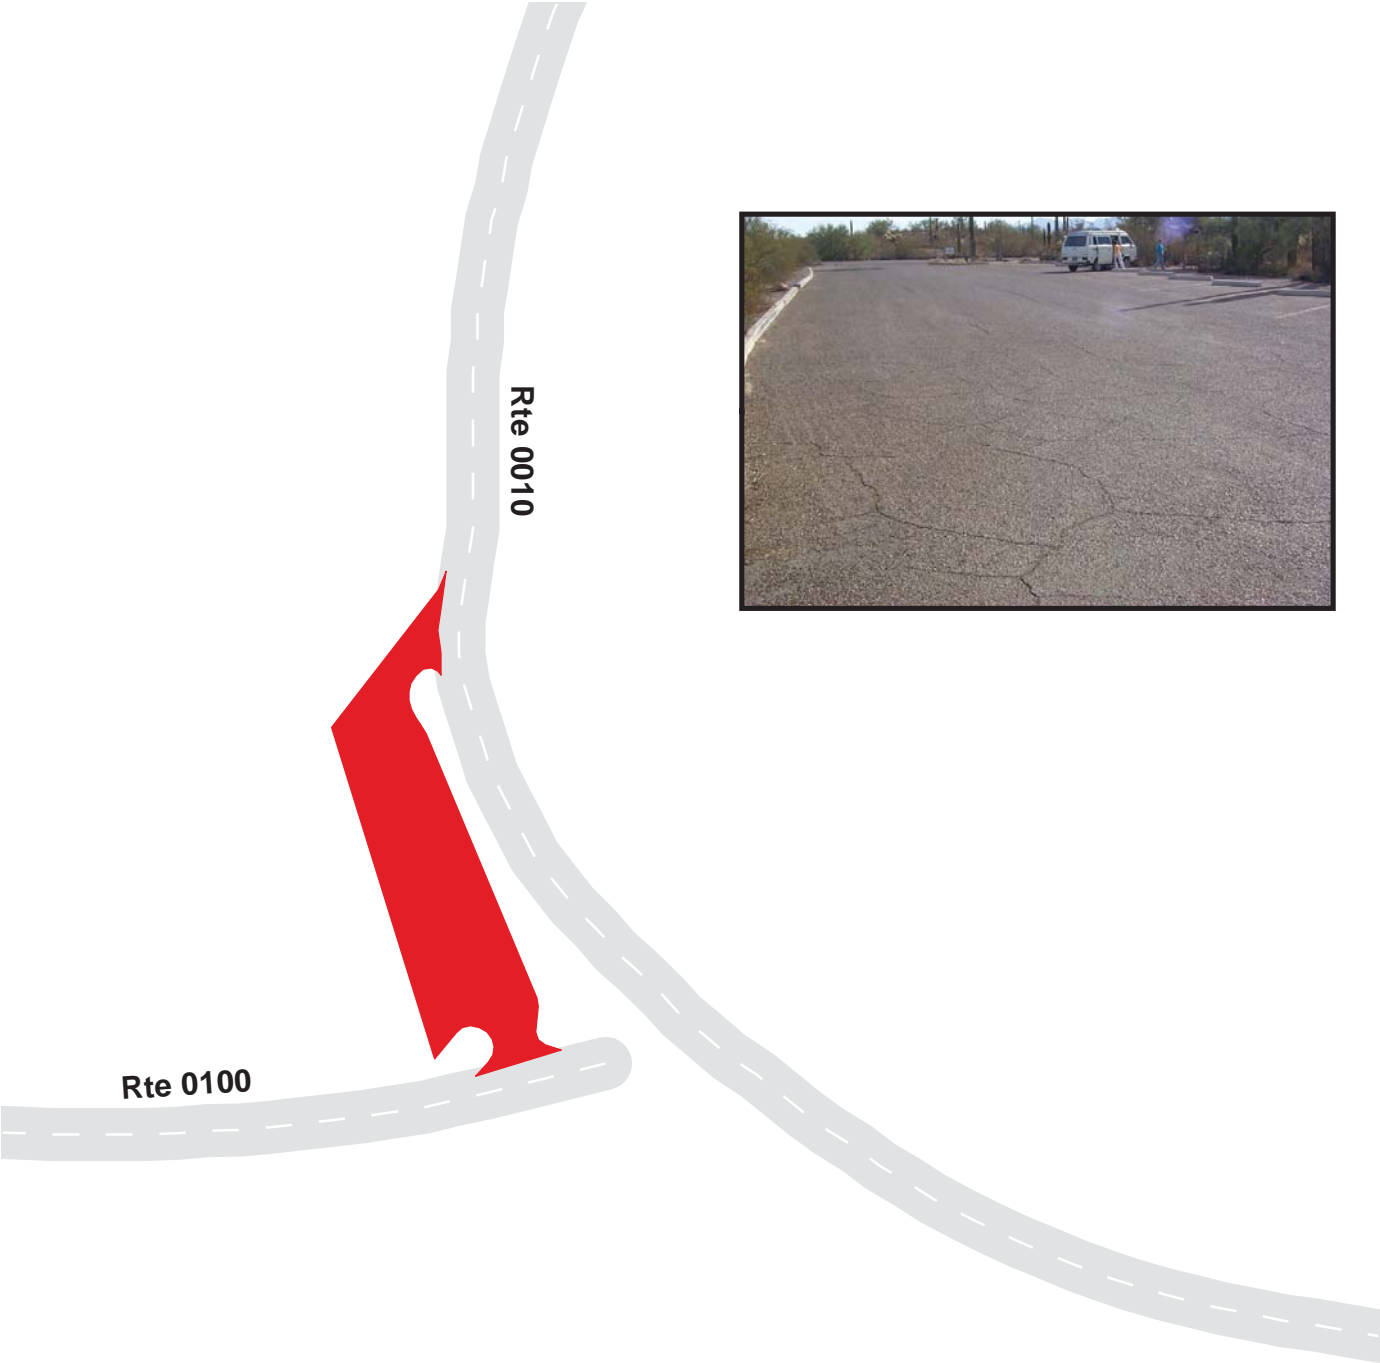
Route 0904A

Route	Public / NonPublic	Date Visited	Area (sq ft)	Lane Miles *	Surface Type	Condition / PCR
0904A	Public	11/19/2001	11976	0.21	OC	FAIR / 73

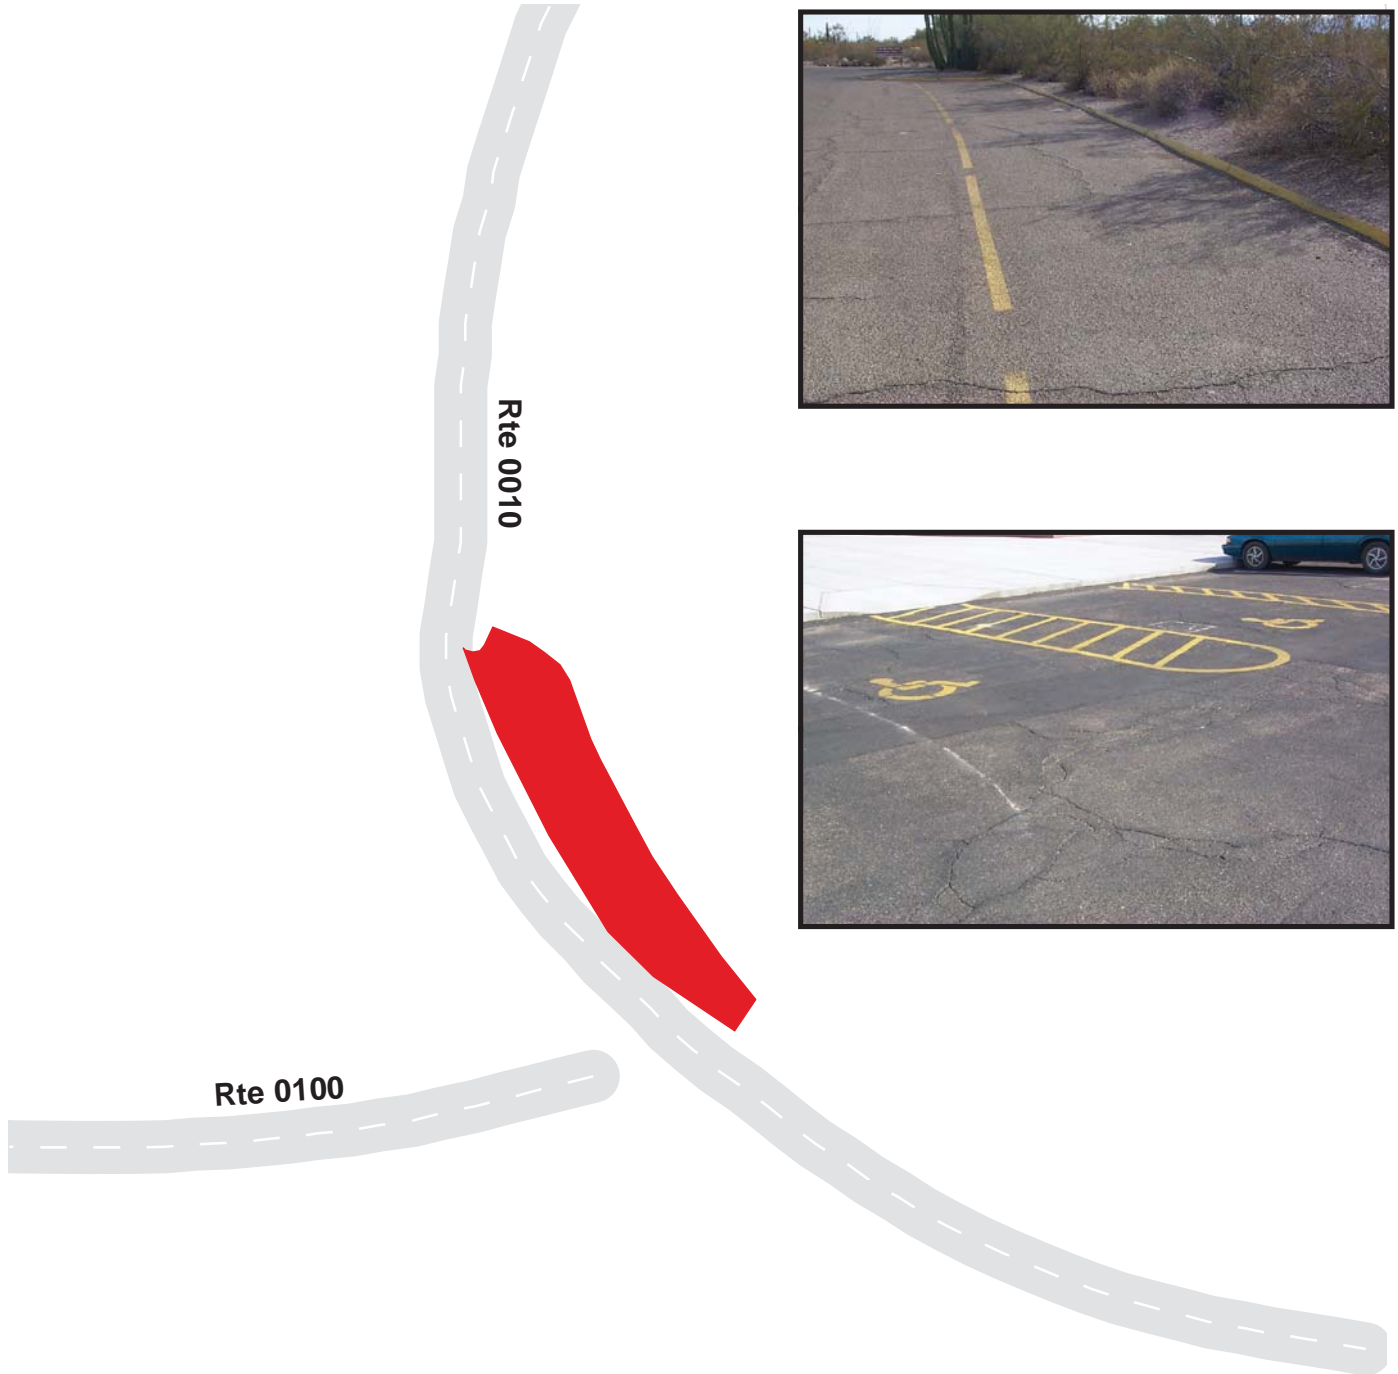
Route 0905

Route	Public / NonPublic	Date Visited	Area (sq ft)	Lane Miles *	Surface Type	Condition / PCR
0905	NonPublic	11/19/2001	5644	0.10	CO	POOR / 45

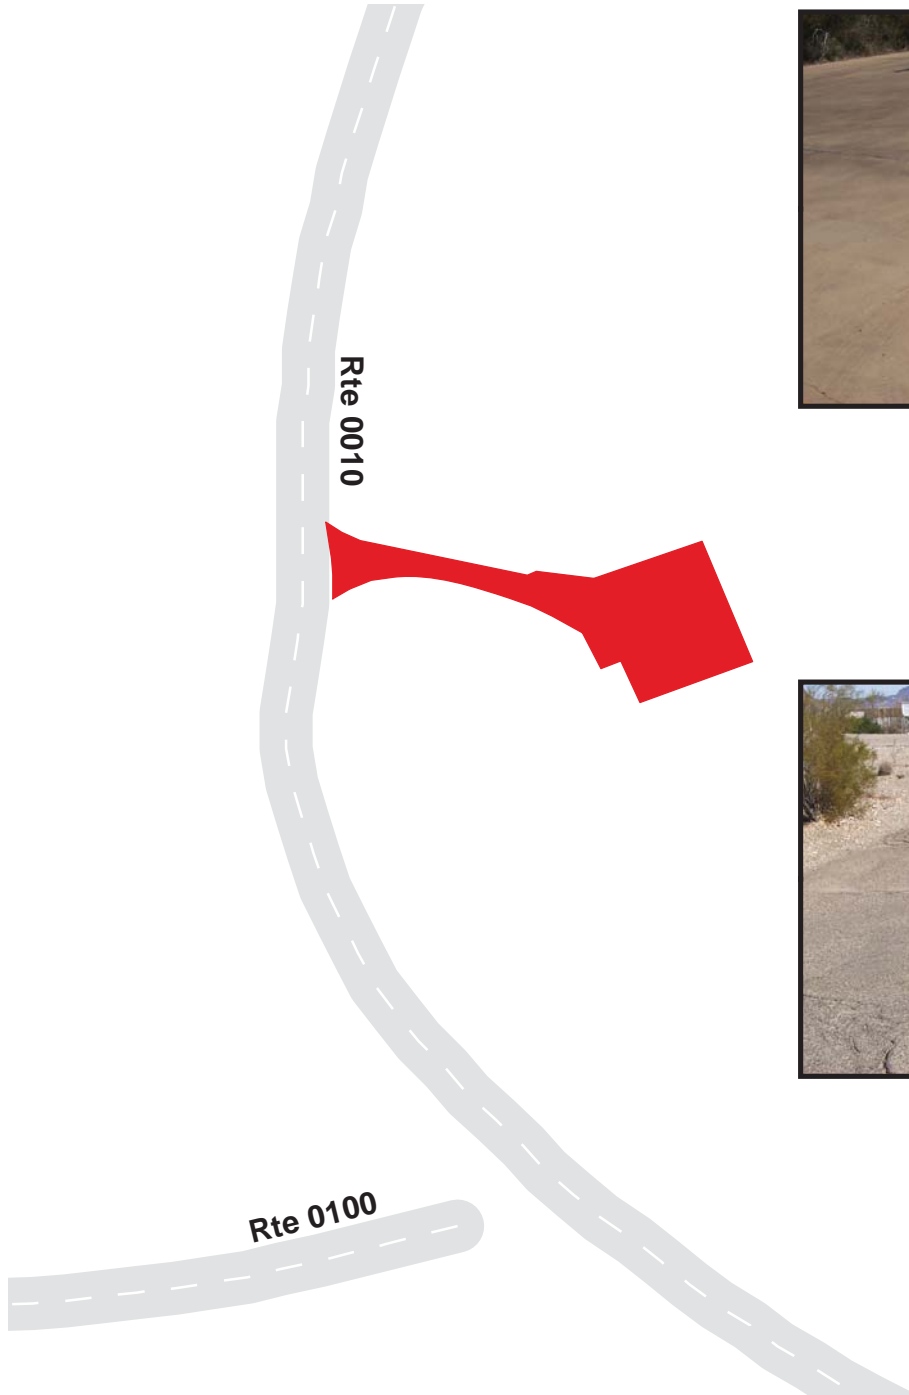
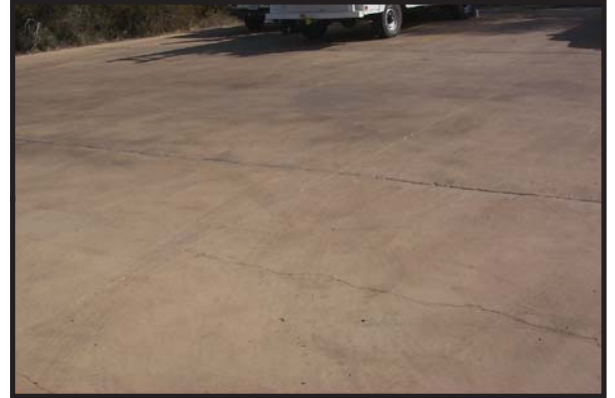
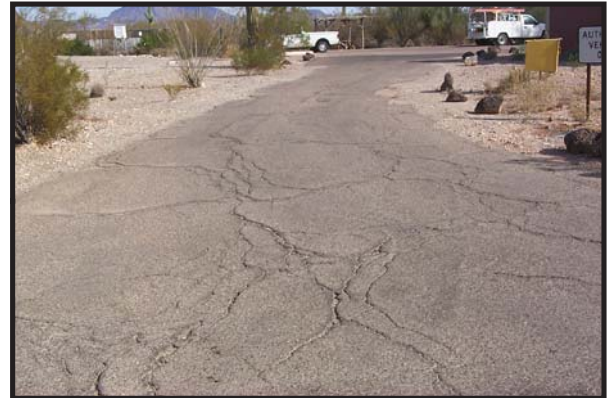
Route 0906

Route	Public / NonPublic	Date Visited	Area (sq ft)	Lane Miles *	Surface Type	Condition / PCR
0906	Public	11/19/2001	10658	0.18	CO	POOR / 45

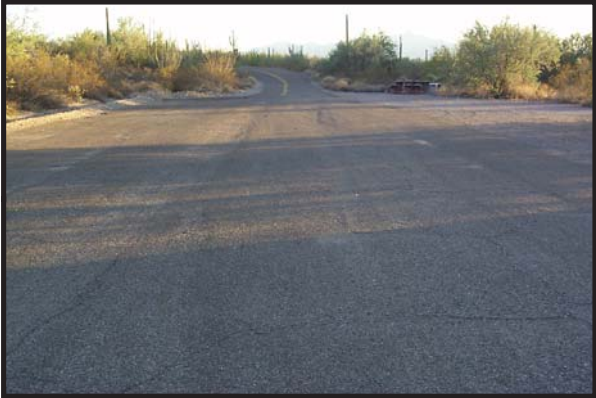
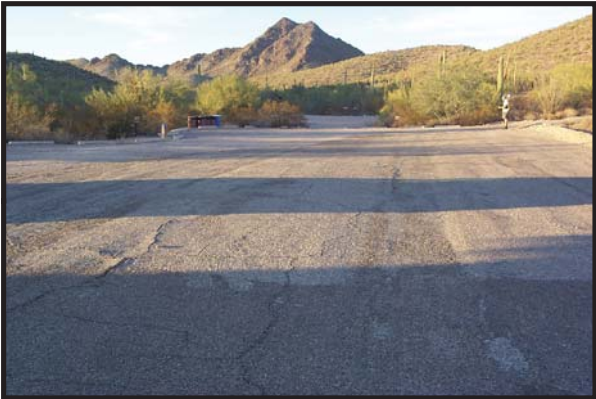
Route 0907

Route	Public / NonPublic	Date Visited	Area (sq ft)	Lane Miles *	Surface Type	Condition / PCR
0907	Public	11/19/2001	903	0.02	OC	FAIR / 73

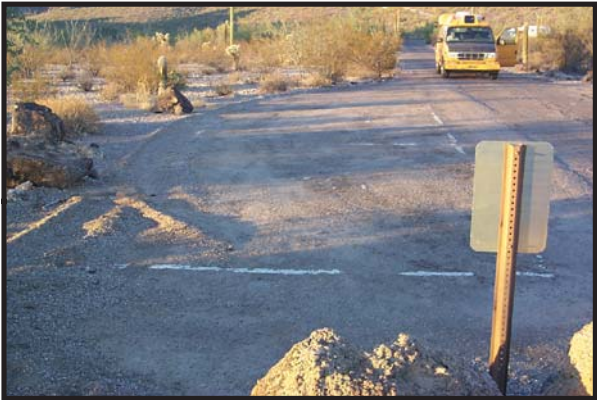
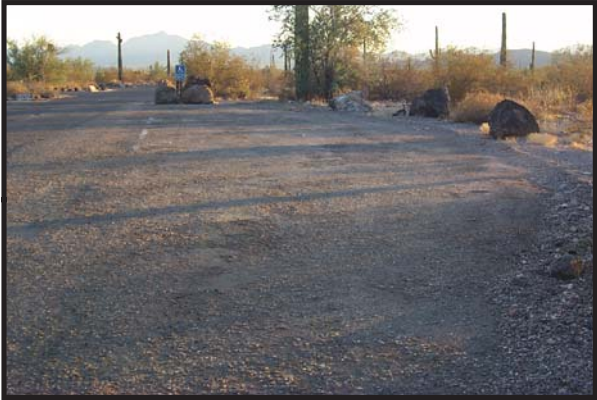
Route 0908

Route	Public / NonPublic	Date Visited	Area (sq ft)	Lane Miles *	Surface Type	Condition / PCR
0908	Public	11/19/2001	7150	0.12	OC	FAIR / 73

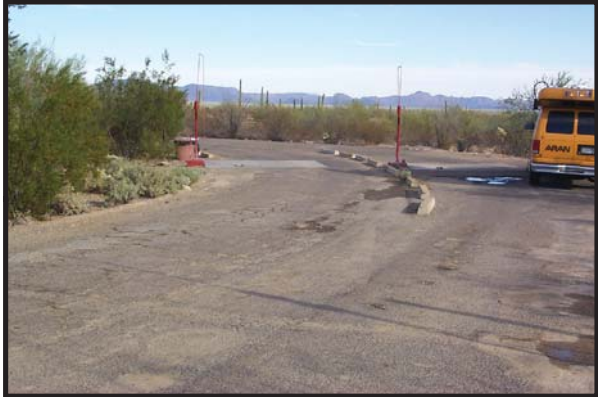
Route 0909

Route	Public / NonPublic	Date Visited	Area (sq ft)	Lane Miles *	Surface Type	Condition / PCR
0909	NonPublic	11/19/2001	2640	0.05	AS	EXCELLENT / 97
