# The Road Inventory of Ozark National Scenic Riverways OZAR – 6640

## Road Inventory Program

Prepared By:  
Federal Highway Administration  
Eastern Federal Lands Highway Division  
Cycle 3

# Ozark National Scenic Riverway in Missouri

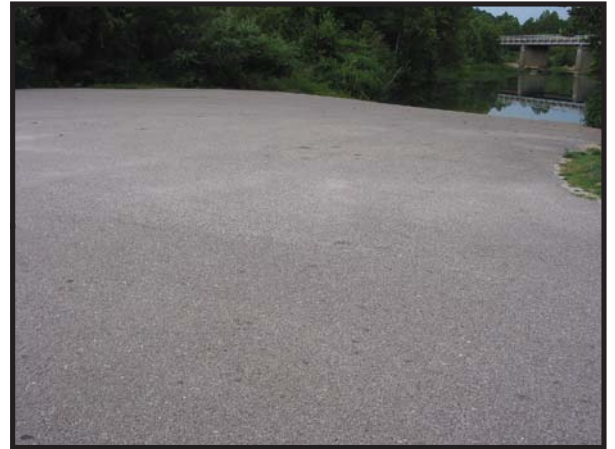
## Route 0800

Route	Public / NonPublic	Date Visited	Area (sq ft)	Lane Miles *	Surface Type	Condition / PCR
0800	Public	8/19/2003	7213	0.12	AS	GOOD / 90

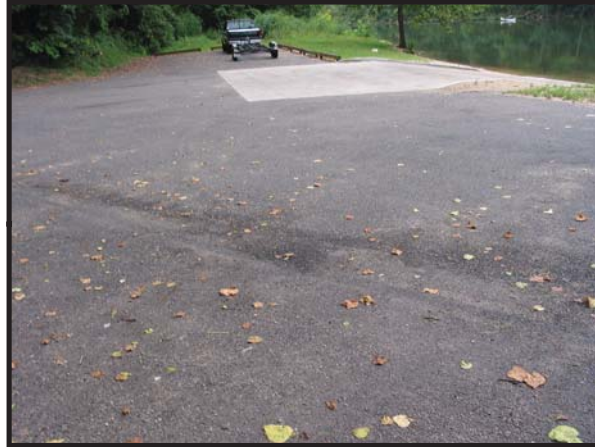
## Route 0801

Route	Public / NonPublic	Date Visited	Area (sq ft)	Lane Miles *	Surface Type	Condition / PCR
0801	Public	8/19/2003	1123	0.02	CO	EXCELLENT / 97

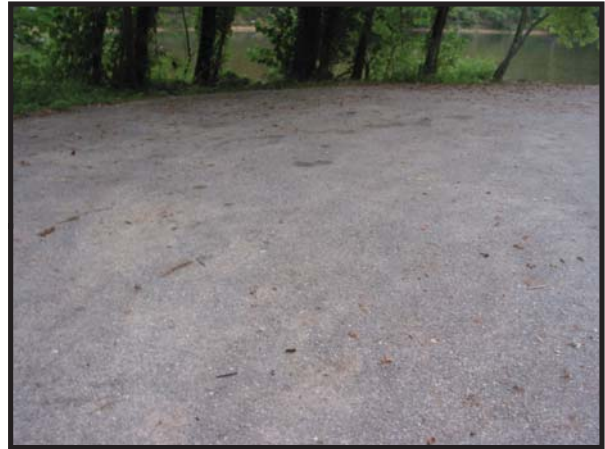
## Route 0803

Route	Public / NonPublic	Date Visited	Area (sq ft)	Lane Miles *	Surface Type	Condition / PCR
0803	Public	8/19/2003	3114	0.05	AS	GOOD / 90

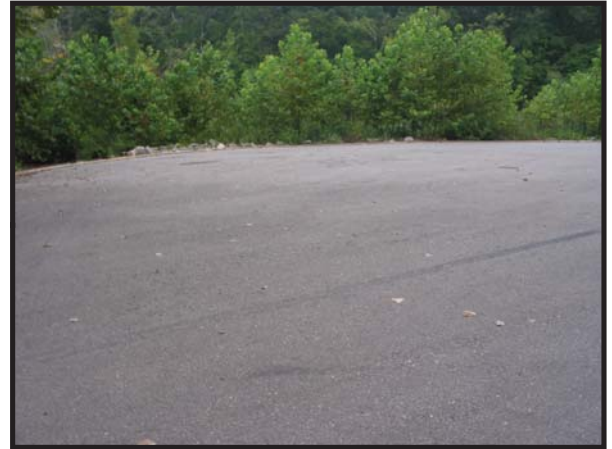
## Route 0804

Route	Public / NonPublic	Date Visited	Area (sq ft)	Lane Miles *	Surface Type	Condition / PCR
0804	Public	8/19/2003	3822	0.07	AS	GOOD / 90

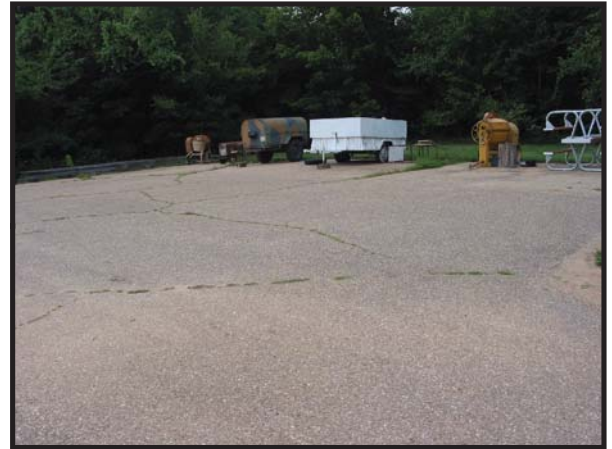
## Route 0900

Route	Public / NonPublic	Date Visited	Area (sq ft)	Lane Miles *	Surface Type	Condition / PCR
0900	Public	8/19/2003	2956	0.05	AS	FAIR / 73

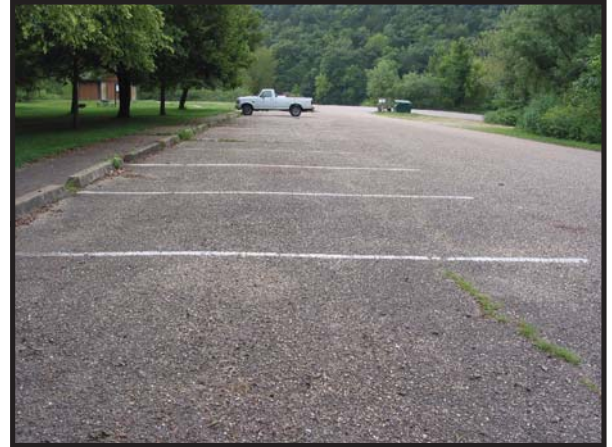
## Route 0901

Route	Public / NonPublic	Date Visited	Area (sq ft)	Lane Miles *	Surface Type	Condition / PCR
0901	Public	8/19/2003	5138	0.09	AS	FAIR / 73

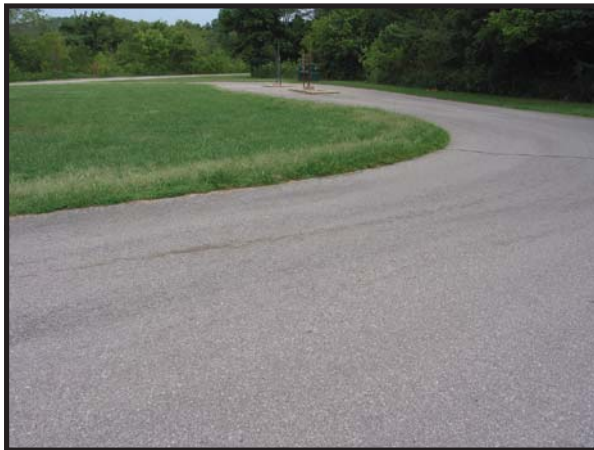
## Route 0902

Route	Public / NonPublic	Date Visited	Area (sq ft)	Lane Miles *	Surface Type	Condition / PCR
0902	Public	8/19/2003	6812	0.12	AS	FAIR / 73

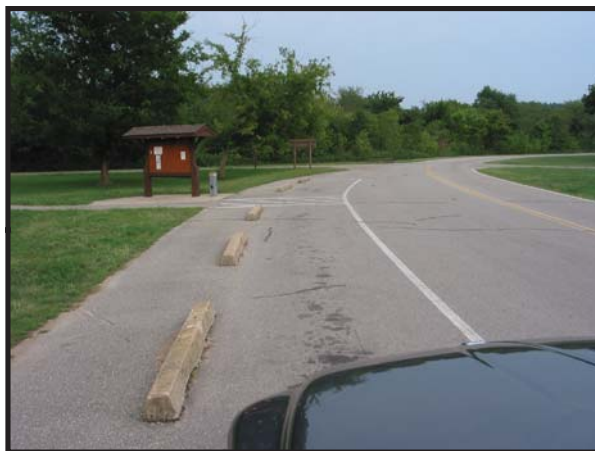
## Route 0903

Route	Public / NonPublic	Date Visited	Area (sq ft)	Lane Miles *	Surface Type	Condition / PCR
0903	NonPublic	8/19/2003	2456	0.04	AS	FAIR / 73

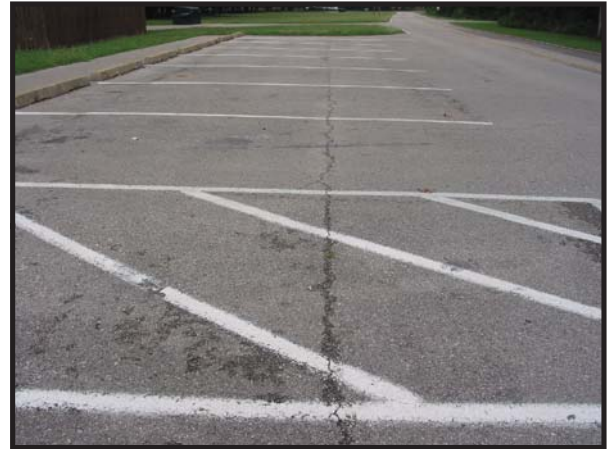
## Route 0904A

Route	Public / NonPublic	Date Visited	Area (sq ft)	Lane Miles *	Surface Type	Condition / PCR
0904A	Public	8/19/2003	3328	0.06	AS	FAIR / 73

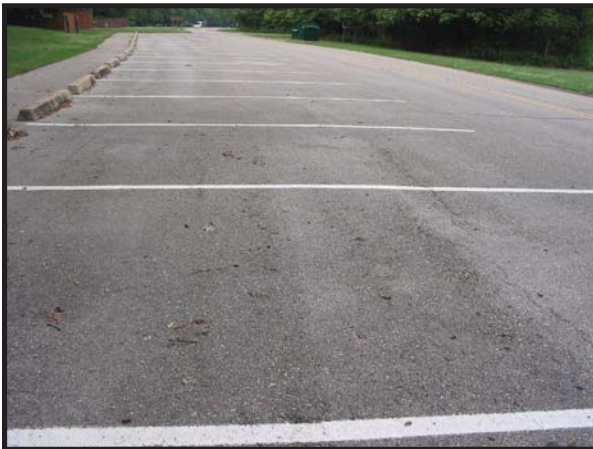
## Route 0904B

Route	Public / NonPublic	Date Visited	Area (sq ft)	Lane Miles *	Surface Type	Condition / PCR
0904B	Public	8/19/2003	7045	0.12	AS	FAIR / 73

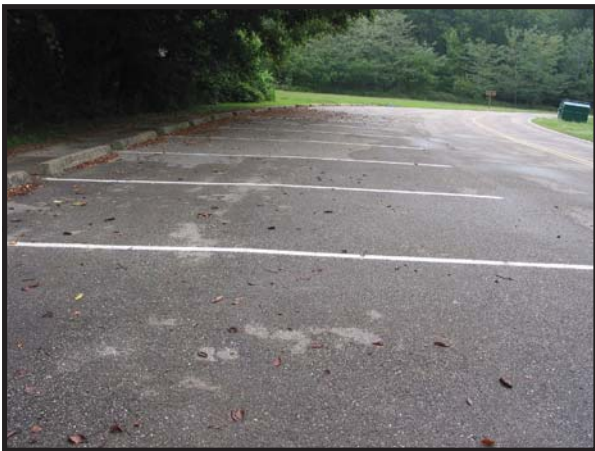
## Route 0904C

Route	Public / NonPublic	Date Visited	Area (sq ft)	Lane Miles *	Surface Type	Condition / PCR
0904C	Public	8/19/2003	5428	0.09	AS	GOOD / 90

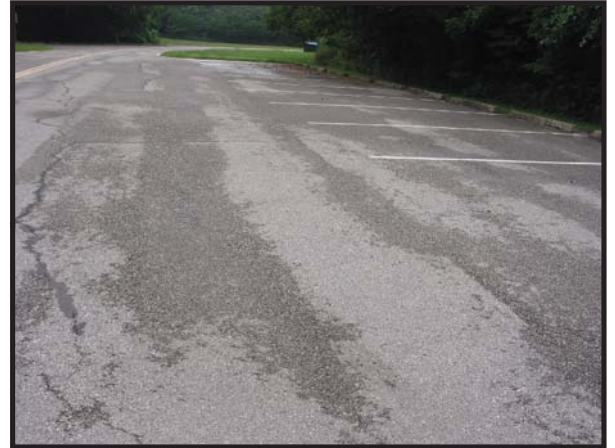
## Route 0904D

Route	Public / NonPublic	Date Visited	Area (sq ft)	Lane Miles *	Surface Type	Condition / PCR
0904D	Public	8/19/2003	2901	0.05	AS	GOOD / 90

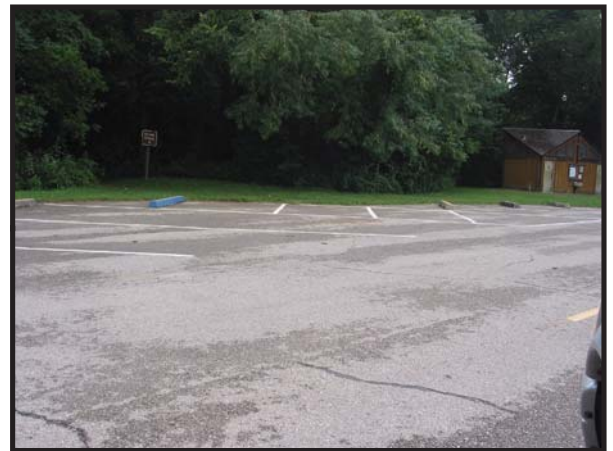
## Route 0904E

Route	Public / NonPublic	Date Visited	Area (sq ft)	Lane Miles *	Surface Type	Condition / PCR
0904E	Public	8/19/2003	2964	0.05	AS	GOOD / 90

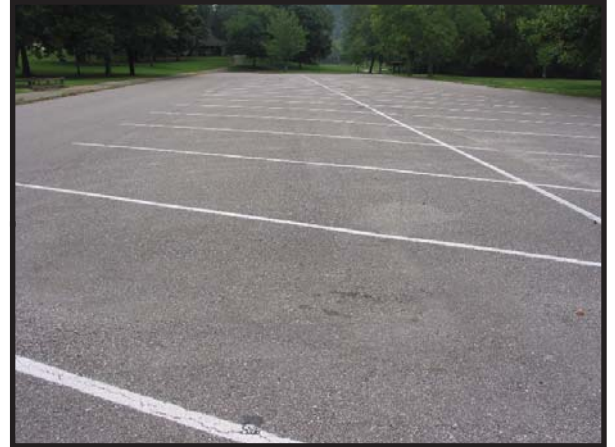
## Route 0905

Route	Public / NonPublic	Date Visited	Area (sq ft)	Lane Miles *	Surface Type	Condition / PCR
0905	Public	8/19/2003	32221	0.55	AS	GOOD / 90

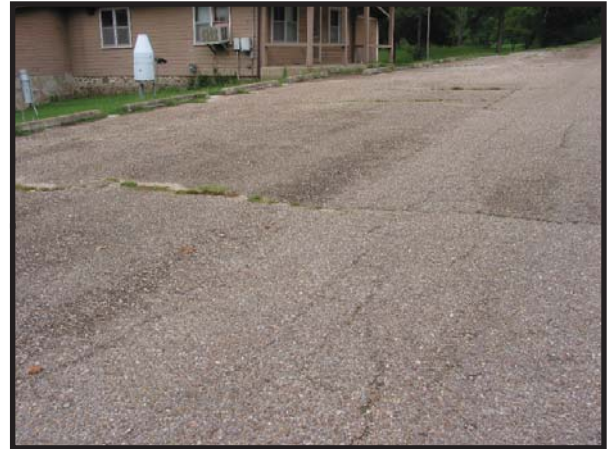
## Route 0907

Route	Public / NonPublic	Date Visited	Area (sq ft)	Lane Miles *	Surface Type	Condition / PCR
0907	Public	8/19/2003	2265	0.04	OC	POOR / 45

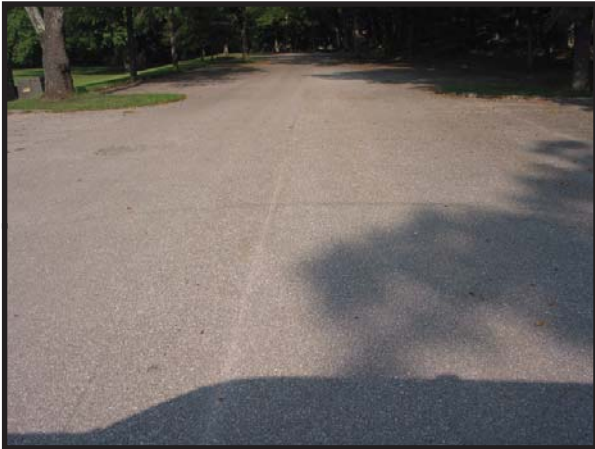
## Route 0910

Route	Public / NonPublic	Date Visited	Area (sq ft)	Lane Miles *	Surface Type	Condition / PCR
0910	Public	8/19/2003	31520	0.54	AS	EXCELLENT / 97

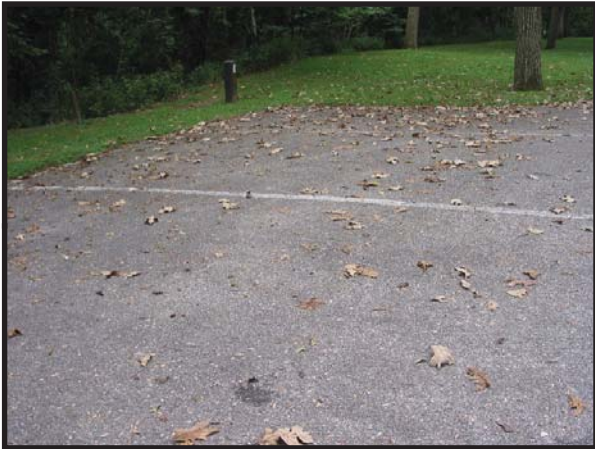
## Route 0911A

Route	Public / NonPublic	Date Visited	Area (sq ft)	Lane Miles *	Surface Type	Condition / PCR
0911A	Public	8/19/2003	1503	0.03	AS	EXCELLENT / 97

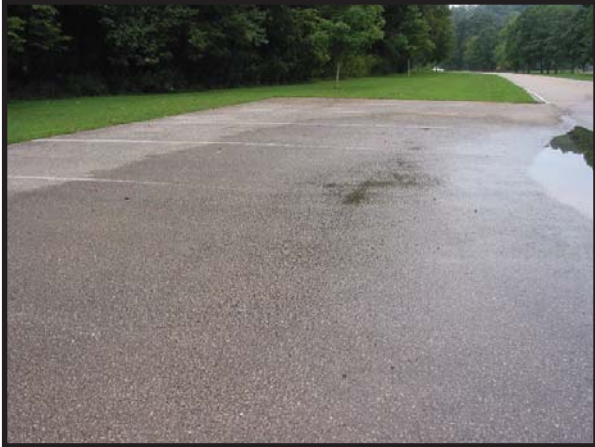
**Ozark National Scenic Riverways**  
**Route 0911B**  
 PEAVINE ROAD PARKING  
 ADJACENT TO ROUTE 0010 AT MP .58 ON RIGHT

Route	Public / NonPublic	Date Visited	Area (sq ft)	Lane Miles *	Surface Type	Condition / PCR
0911B	Public	8/19/2003	2056	0.04	AS	EXCELLENT / 97

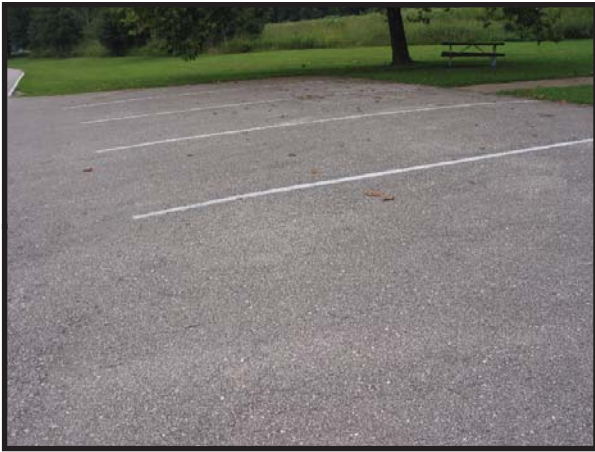
## Route 0911C

Route	Public / NonPublic	Date Visited	Area (sq ft)	Lane Miles *	Surface Type	Condition / PCR
0911C	Public	8/19/2003	988	0.02	AS	EXCELLENT / 97

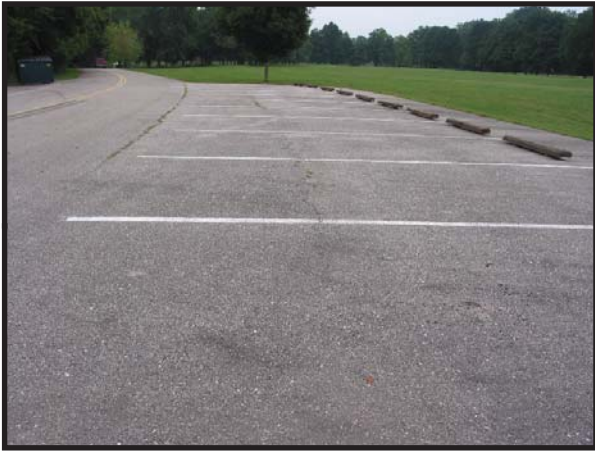
## Route 0912C

Route	Public / NonPublic	Date Visited	Area (sq ft)	Lane Miles *	Surface Type	Condition / PCR
0912C	Public	8/19/2003	4305	0.07	AS	FAIR / 73

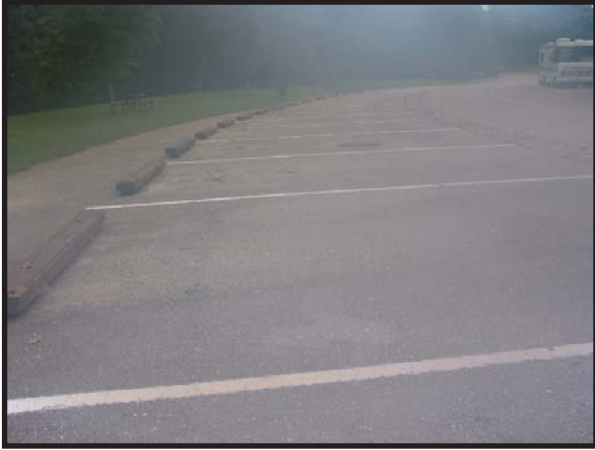
## Route 0912D

Route	Public / NonPublic	Date Visited	Area (sq ft)	Lane Miles *	Surface Type	Condition / PCR
0912D	Public	8/19/2003	5082	0.09	AS	GOOD / 90

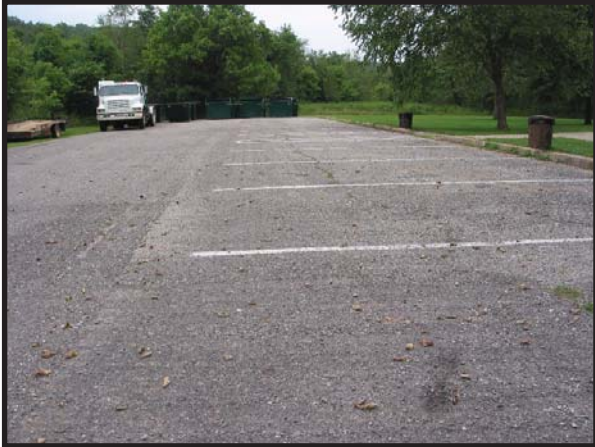
## Route 0914

Route	Public / NonPublic	Date Visited	Area (sq ft)	Lane Miles *	Surface Type	Condition / PCR
0914	Public	8/19/2003	9419	0.16	OC	FAIR / 73

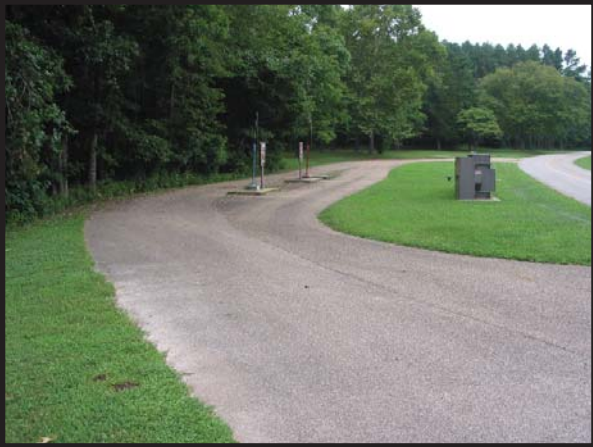
## Route 0915

Route	Public / NonPublic	Date Visited	Area (sq ft)	Lane Miles *	Surface Type	Condition / PCR
0915	Public	8/19/2003	8025	0.14	AS	FAIR / 73

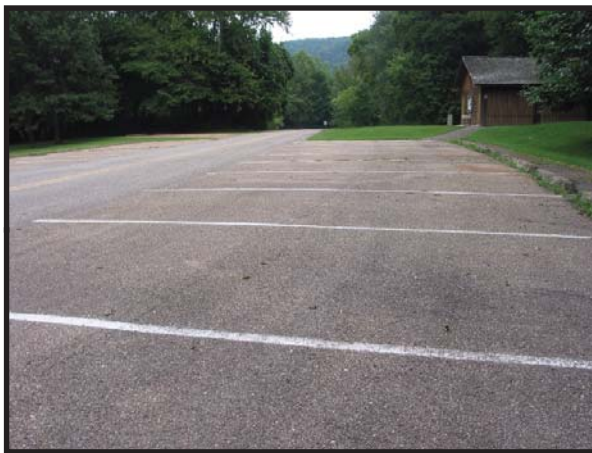
## Route 0916A

Route	Public / NonPublic	Date Visited	Area (sq ft)	Lane Miles *	Surface Type	Condition / PCR
0916A	Public	8/19/2003	2449	0.04	AS	FAIR / 73

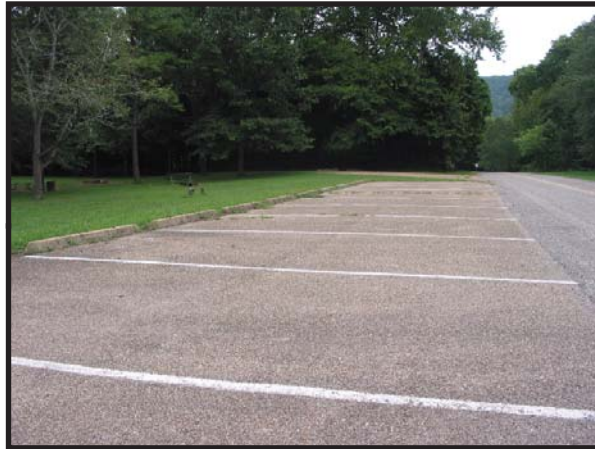
## Route 0916B

Route	Public / NonPublic	Date Visited	Area (sq ft)	Lane Miles *	Surface Type	Condition / PCR
0916B	Public	8/19/2003	2140	0.04	AS	FAIR / 73

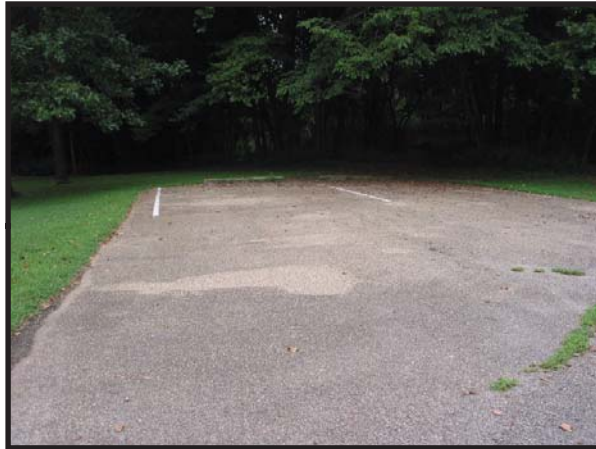
## Route 0916C

Route	Public / NonPublic	Date Visited	Area (sq ft)	Lane Miles *	Surface Type	Condition / PCR
0916C	Public	8/19/2003	1369	0.02	AS	FAIR / 73

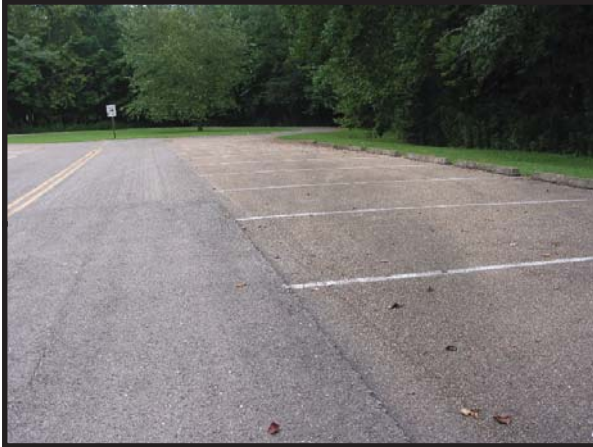
## Route 0916D

Route	Public / NonPublic	Date Visited	Area (sq ft)	Lane Miles *	Surface Type	Condition / PCR
0916D	Public	8/19/2003	1968	0.03	AS	FAIR / 73

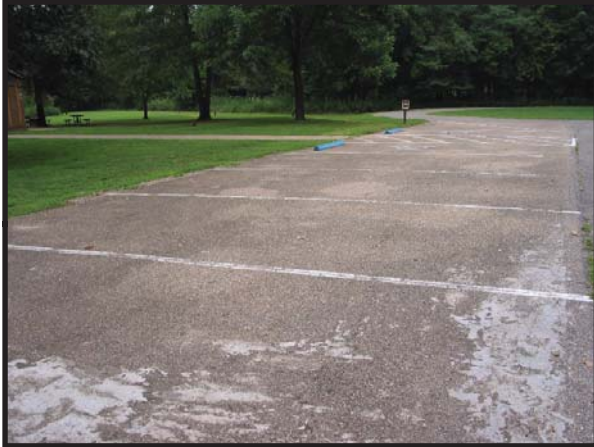
## Route 0916E

Route	Public / NonPublic	Date Visited	Area (sq ft)	Lane Miles *	Surface Type	Condition / PCR
0916E	Public	8/19/2003	2146	0.04	AS	FAIR / 73

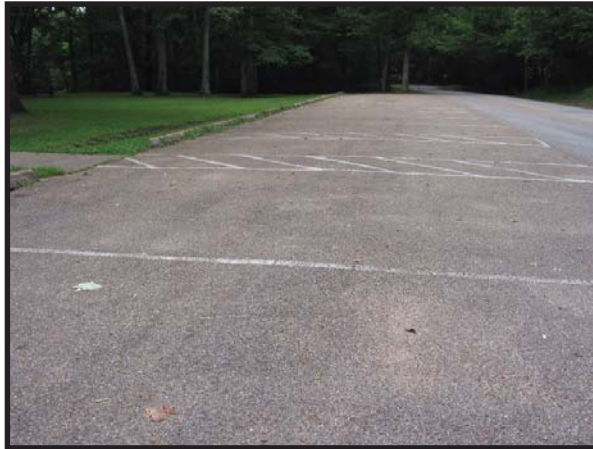
## Route 0917A

Route	Public / NonPublic	Date Visited	Area (sq ft)	Lane Miles *	Surface Type	Condition / PCR
0917A	Public	8/19/2003	4467	0.08	AS	FAIR / 73

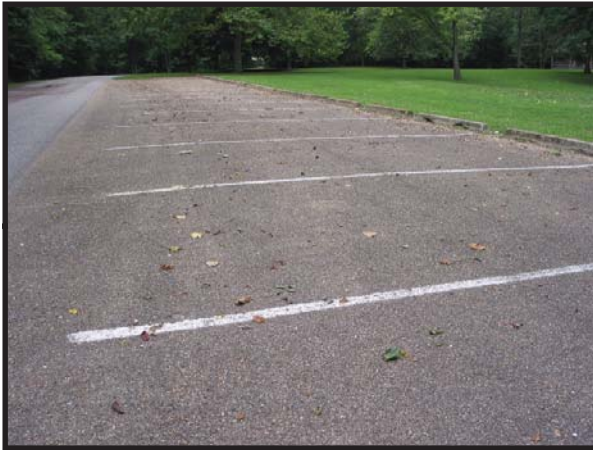
## Route 0917B

Route	Public / NonPublic	Date Visited	Area (sq ft)	Lane Miles *	Surface Type	Condition / PCR
0917B	Public	8/19/2003	3808	0.07	AS	FAIR / 73

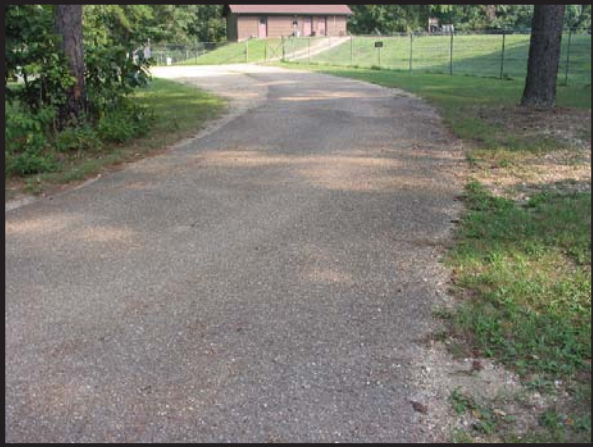
**Ozark National Scenic Riverways**  
**Route 0918**  
**BIG SPRING SEWAGE LAGOON PARKING**  
**FROM ROUTE 0405**

Route	Public / NonPublic	Date Visited	Area (sq ft)	Lane Miles *	Surface Type	Condition / PCR
0918	NonPublic	8/19/2003	3758	0.06	OC	FAIR / 73

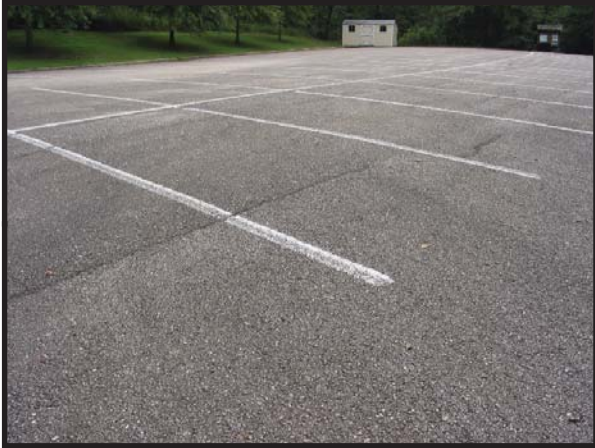
**Ozark National Scenic Riverways**  
**Route 0930**  
 ROUND SPRING CAVE ACCESS PARKING  
 AT END OF ROUTE 0170

Route	Public / NonPublic	Date Visited	Area (sq ft)	Lane Miles *	Surface Type	Condition / PCR
0930	Public	8/19/2003	27150	0.47	AS	FAIR / 73

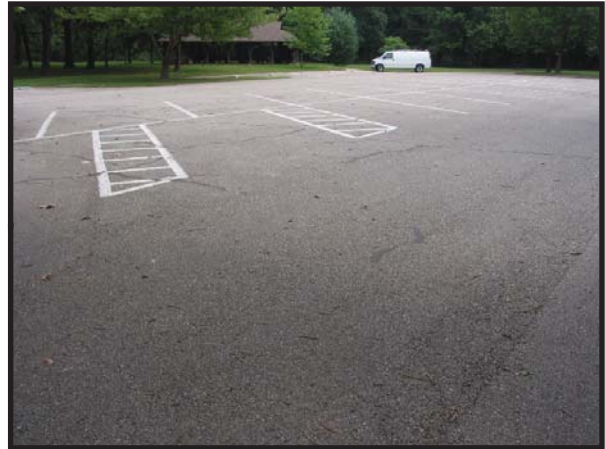
## Route 0931A

Route	Public / NonPublic	Date Visited	Area (sq ft)	Lane Miles *	Surface Type	Condition / PCR
0931A	Public	8/19/2003	8406	0.14	AS	FAIR / 73

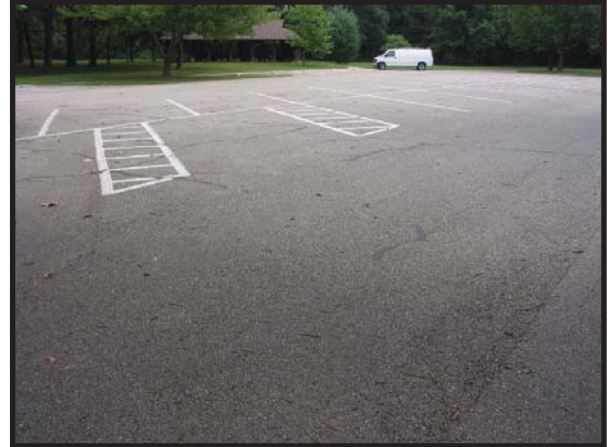
## Route 0931B

Route	Public / NonPublic	Date Visited	Area (sq ft)	Lane Miles *	Surface Type	Condition / PCR
0931B	Public	8/19/2003	1233	0.02	AS	FAIR / 73

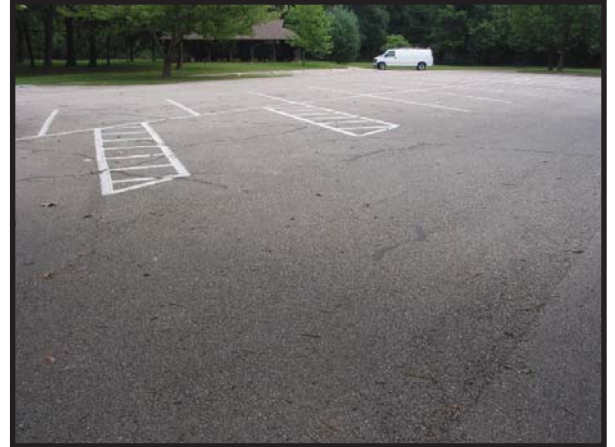
## Route 0931C

Route	Public / NonPublic	Date Visited	Area (sq ft)	Lane Miles *	Surface Type	Condition / PCR
0931C	Public	8/19/2003	1609	0.03	AS	FAIR / 73

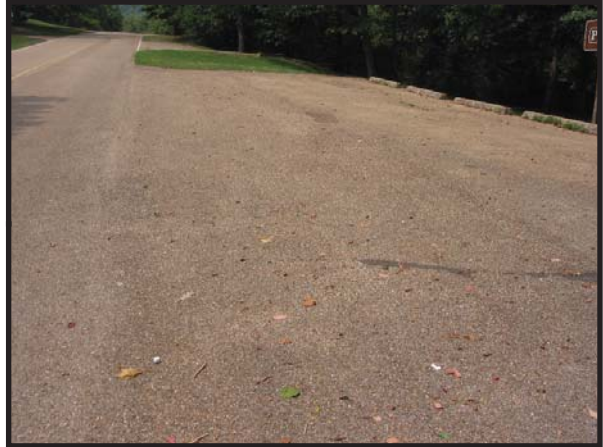
## Route 0932A

Route	Public / NonPublic	Date Visited	Area (sq ft)	Lane Miles *	Surface Type	Condition / PCR
0932A	Public	8/19/2003	2158	0.04	AS	FAIR / 73

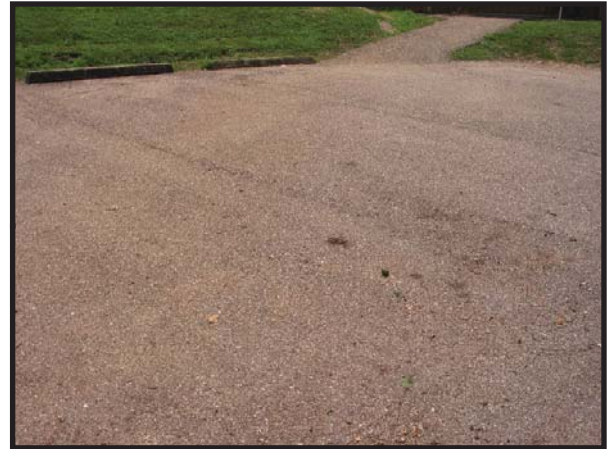
## Route 0932B

Route	Public / NonPublic	Date Visited	Area (sq ft)	Lane Miles *	Surface Type	Condition / PCR
0932B	Public	8/19/2003	1670	0.03	AS	FAIR / 73

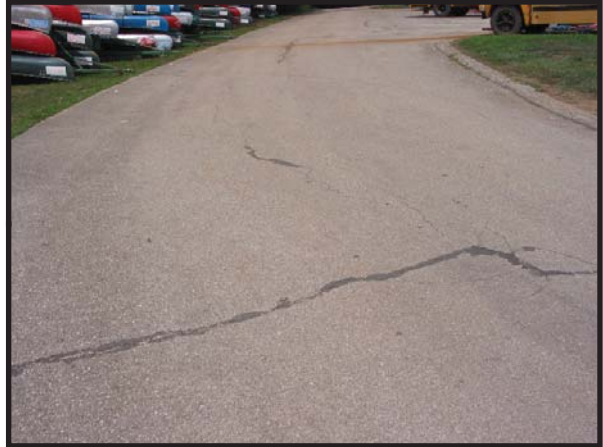
## Route 0934

Route	Public / NonPublic	Date Visited	Area (sq ft)	Lane Miles *	Surface Type	Condition / PCR
0934	Public	8/19/2003	15775	0.27	AS	FAIR / 73

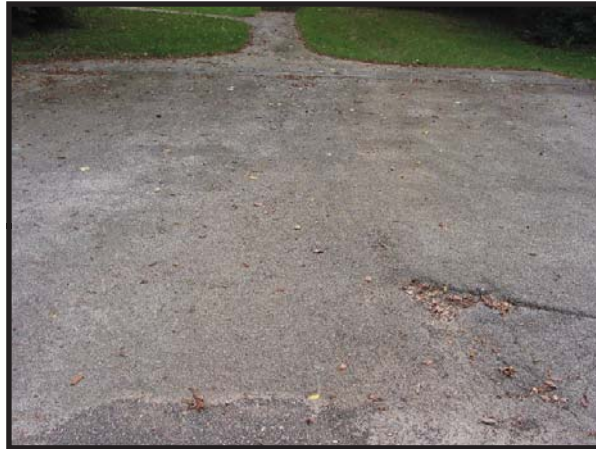
## Route 0935A

Route	Public / NonPublic	Date Visited	Area (sq ft)	Lane Miles *	Surface Type	Condition / PCR
0935A	Public	8/19/2003	484	0.01	AS	POOR / 45

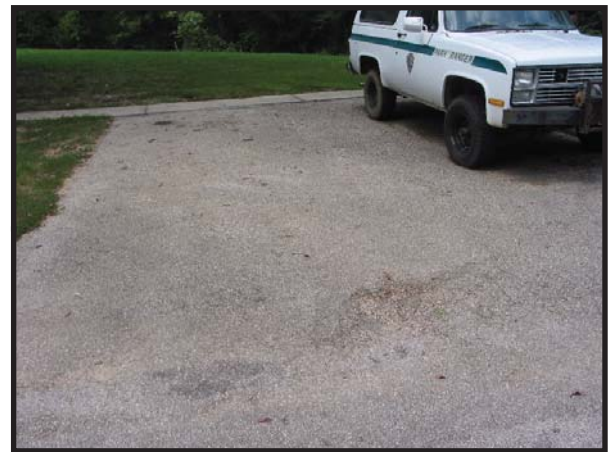
## Route 0935C

Route	Public / NonPublic	Date Visited	Area (sq ft)	Lane Miles *	Surface Type	Condition / PCR
0935C	Public	8/19/2003	691	0.01	AS	POOR / 45

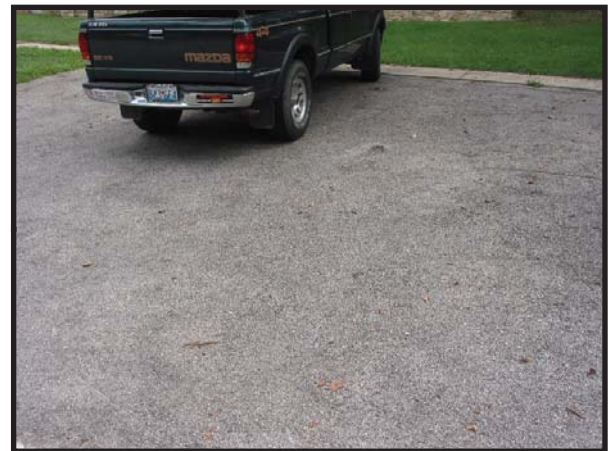
## Route 0935D

Route	Public / NonPublic	Date Visited	Area (sq ft)	Lane Miles *	Surface Type	Condition / PCR
0935D	Public	8/19/2003	1847	0.03	AS	POOR / 45

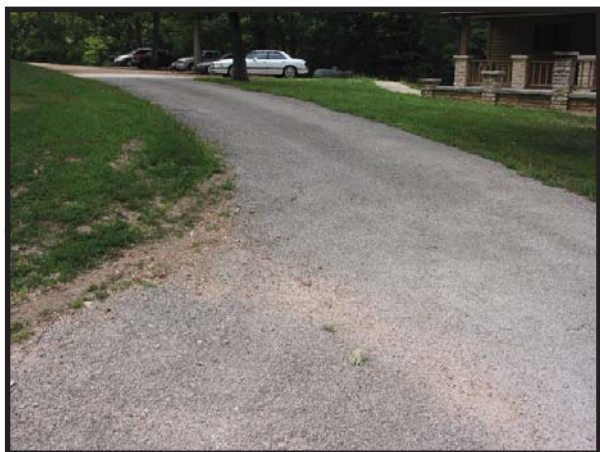
## Route 0935E

Route	Public / NonPublic	Date Visited	Area (sq ft)	Lane Miles *	Surface Type	Condition / PCR
0935E	Public	8/19/2003	2248	0.04	AS	POOR / 45

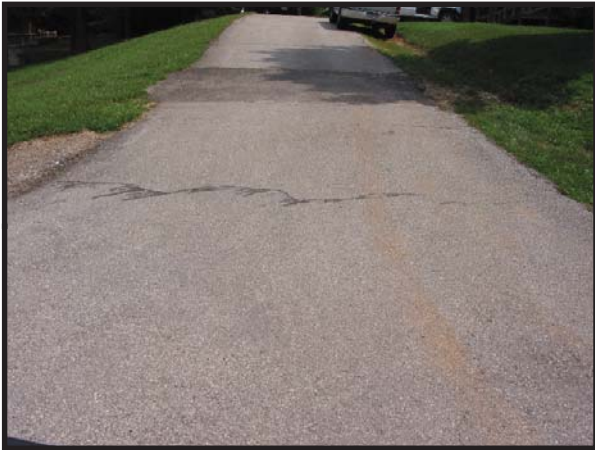
## Route 0935F

Route	Public / NonPublic	Date Visited	Area (sq ft)	Lane Miles *	Surface Type	Condition / PCR
0935F	Public	8/19/2003	4420	0.08	AS	FAIR / 73

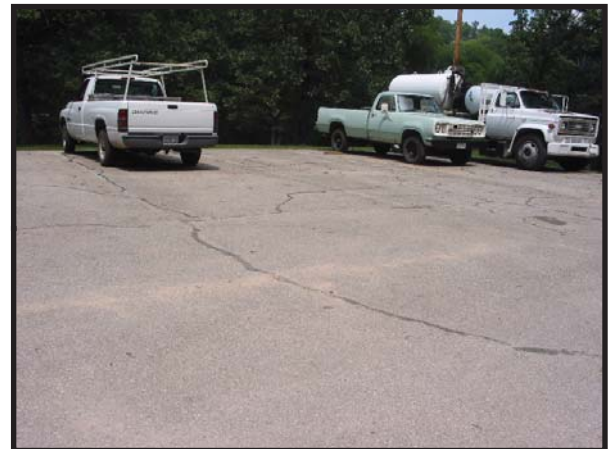
## Route 0936

Route	Public / NonPublic	Date Visited	Area (sq ft)	Lane Miles *	Surface Type	Condition / PCR
0936	NonPublic	8/19/2003	2283	0.04	AS	POOR / 45

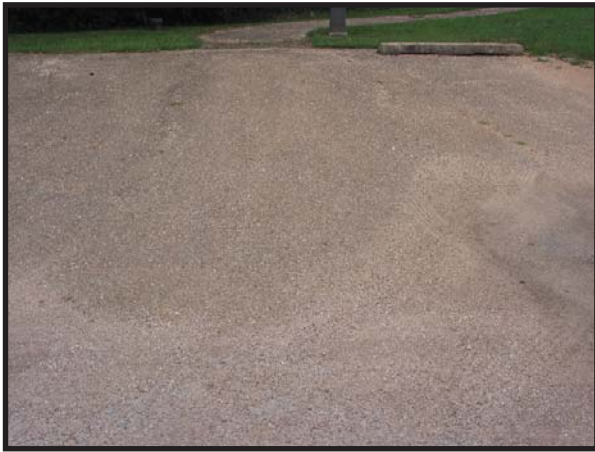
## Route 0937

Route	Public / NonPublic	Date Visited	Area (sq ft)	Lane Miles *	Surface Type	Condition / PCR
0937	NonPublic	8/19/2003	1548	0.03	OC	GOOD / 90

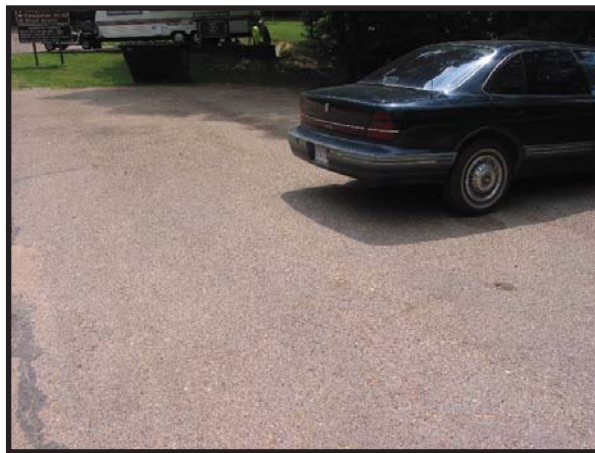
## Route 0938

Route	Public / NonPublic	Date Visited	Area (sq ft)	Lane Miles *	Surface Type	Condition / PCR
0938	NonPublic	8/19/2003	1038	0.02	OC	FAIR / 73

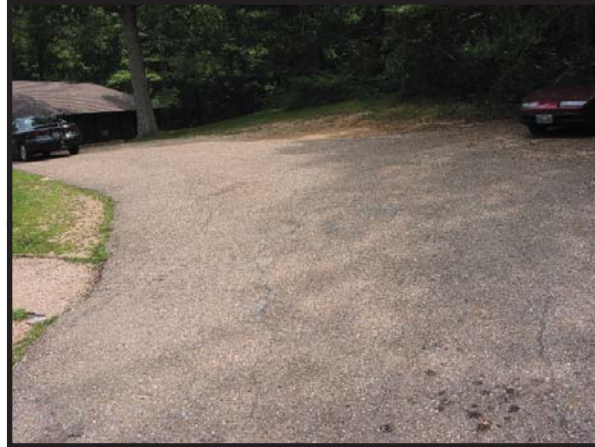
## Route 0940

Route	Public / NonPublic	Date Visited	Area (sq ft)	Lane Miles *	Surface Type	Condition / PCR
0940	Public	8/19/2003	27676	0.48	NC	GOOD / 90

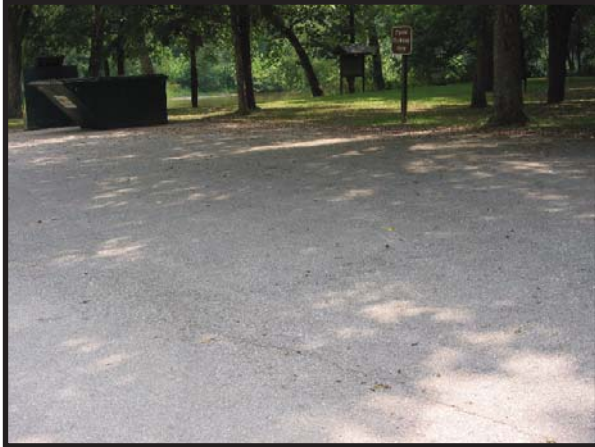
## Route 0942A

Route	Public / NonPublic	Date Visited	Area (sq ft)	Lane Miles *	Surface Type	Condition / PCR
0942A	NonPublic	8/19/2003	2558	0.04	AS	POOR / 45

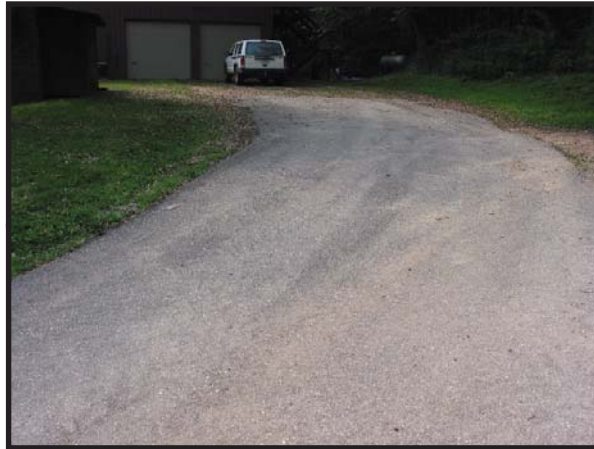
## Route 0943A

Route	Public / NonPublic	Date Visited	Area (sq ft)	Lane Miles *	Surface Type	Condition / PCR
0943A	NonPublic	8/19/2003	26710	0.46	AS	POOR / 45

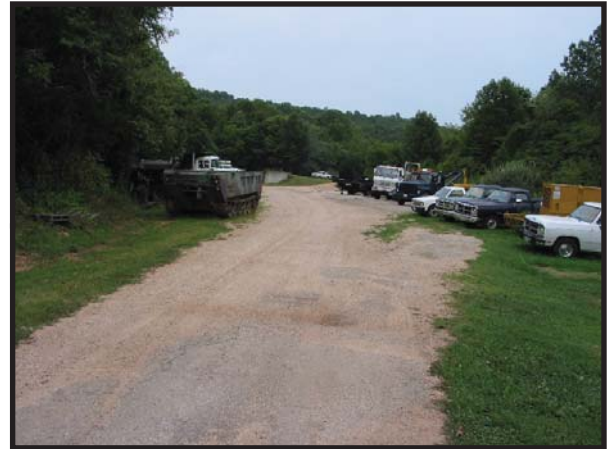
## Route 0944

Route	Public / NonPublic	Date Visited	Area (sq ft)	Lane Miles *	Surface Type	Condition / PCR
0944	Public	8/19/2003	24016	0.41	OC	GOOD / 90

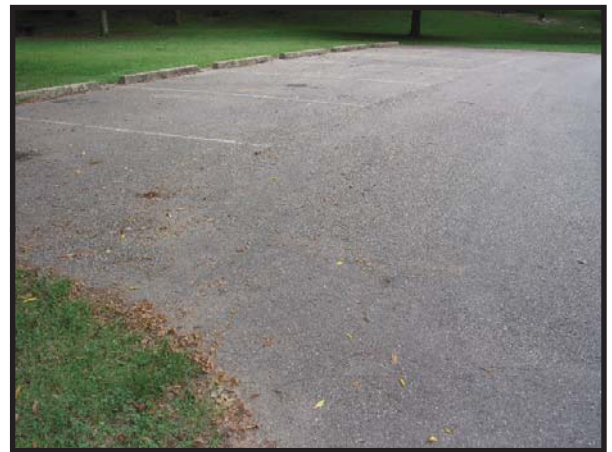
## Route 0945B

Route	Public / NonPublic	Date Visited	Area (sq ft)	Lane Miles *	Surface Type	Condition / PCR
0945B	Public	8/19/2003	1128	0.02	AS	GOOD / 90

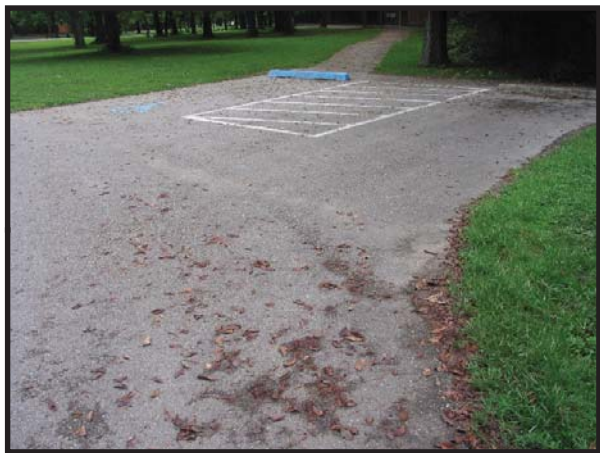
## Route 0945C

Route	Public / NonPublic	Date Visited	Area (sq ft)	Lane Miles *	Surface Type	Condition / PCR
0945C	Public	8/19/2003	1534	0.03	AS	GOOD / 90

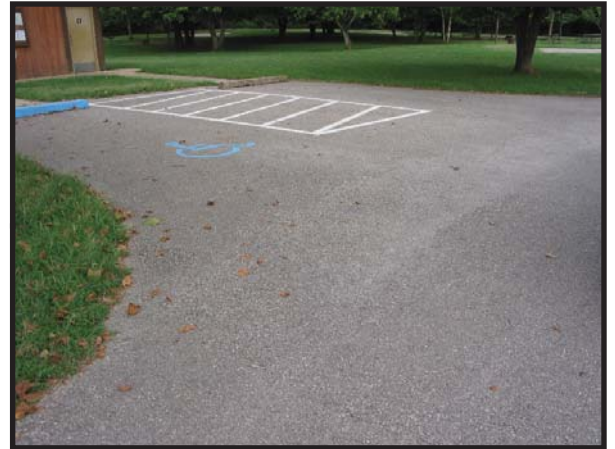
## Route 0945D

Route	Public / NonPublic	Date Visited	Area (sq ft)	Lane Miles *	Surface Type	Condition / PCR
0945D	Public	8/19/2003	1082	0.02	AS	GOOD / 90

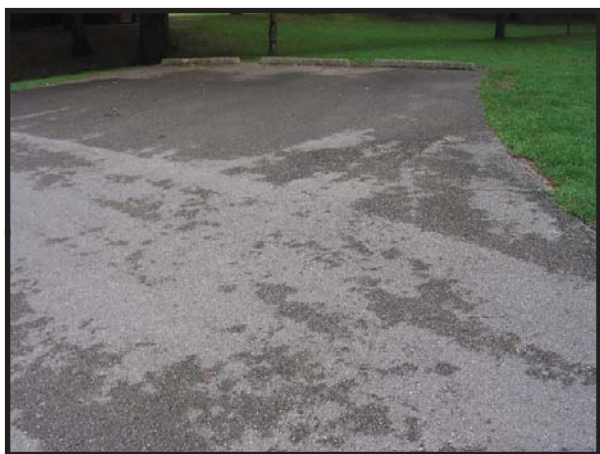
## Route 0945E

Route	Public / NonPublic	Date Visited	Area (sq ft)	Lane Miles *	Surface Type	Condition / PCR
0945E	Public	8/19/2003	1670	0.03	AS	GOOD / 90

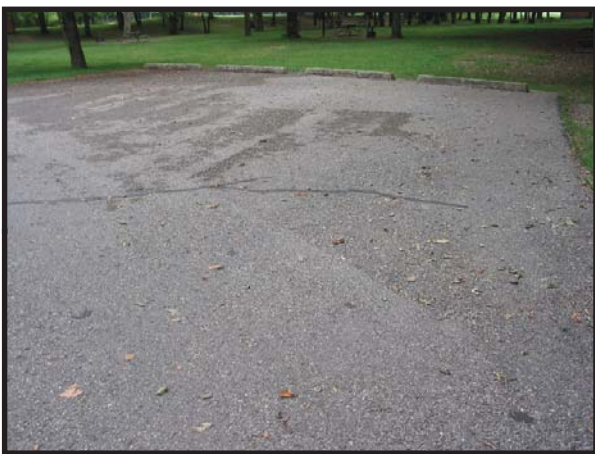
## Route 0945F

Route	Public / NonPublic	Date Visited	Area (sq ft)	Lane Miles *	Surface Type	Condition / PCR
0945F	Public	8/19/2003	974	0.02	AS	FAIR / 73

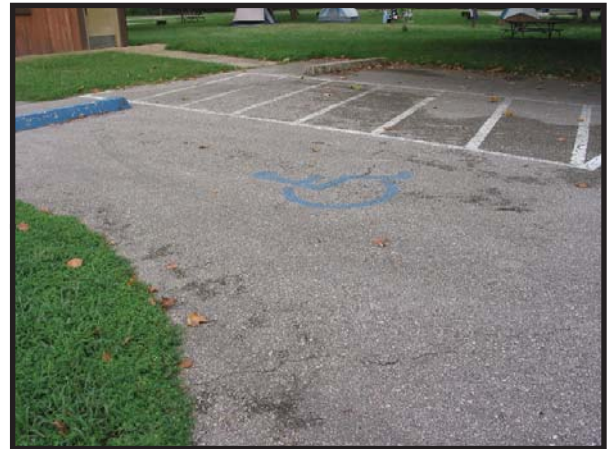
## Route 0945G

Route	Public / NonPublic	Date Visited	Area (sq ft)	Lane Miles *	Surface Type	Condition / PCR
0945G	Public	8/19/2003	1158	0.02	AS	GOOD / 90

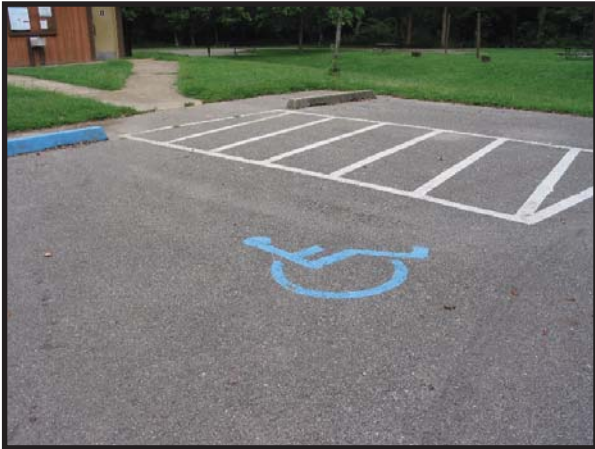
## Route 0945H

Route	Public / NonPublic	Date Visited	Area (sq ft)	Lane Miles *	Surface Type	Condition / PCR
0945H	Public	8/19/2003	1626	0.03	AS	GOOD / 90

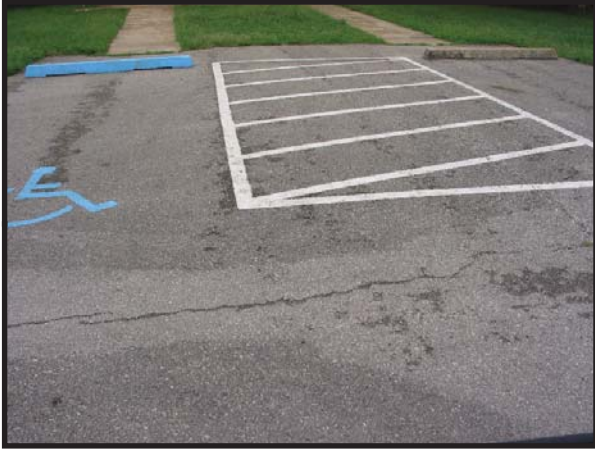
## Route 0946

Route	Public / NonPublic	Date Visited	Area (sq ft)	Lane Miles *	Surface Type	Condition / PCR
0946	Public	8/19/2003	1232	0.02	AS	EXCELLENT / 97

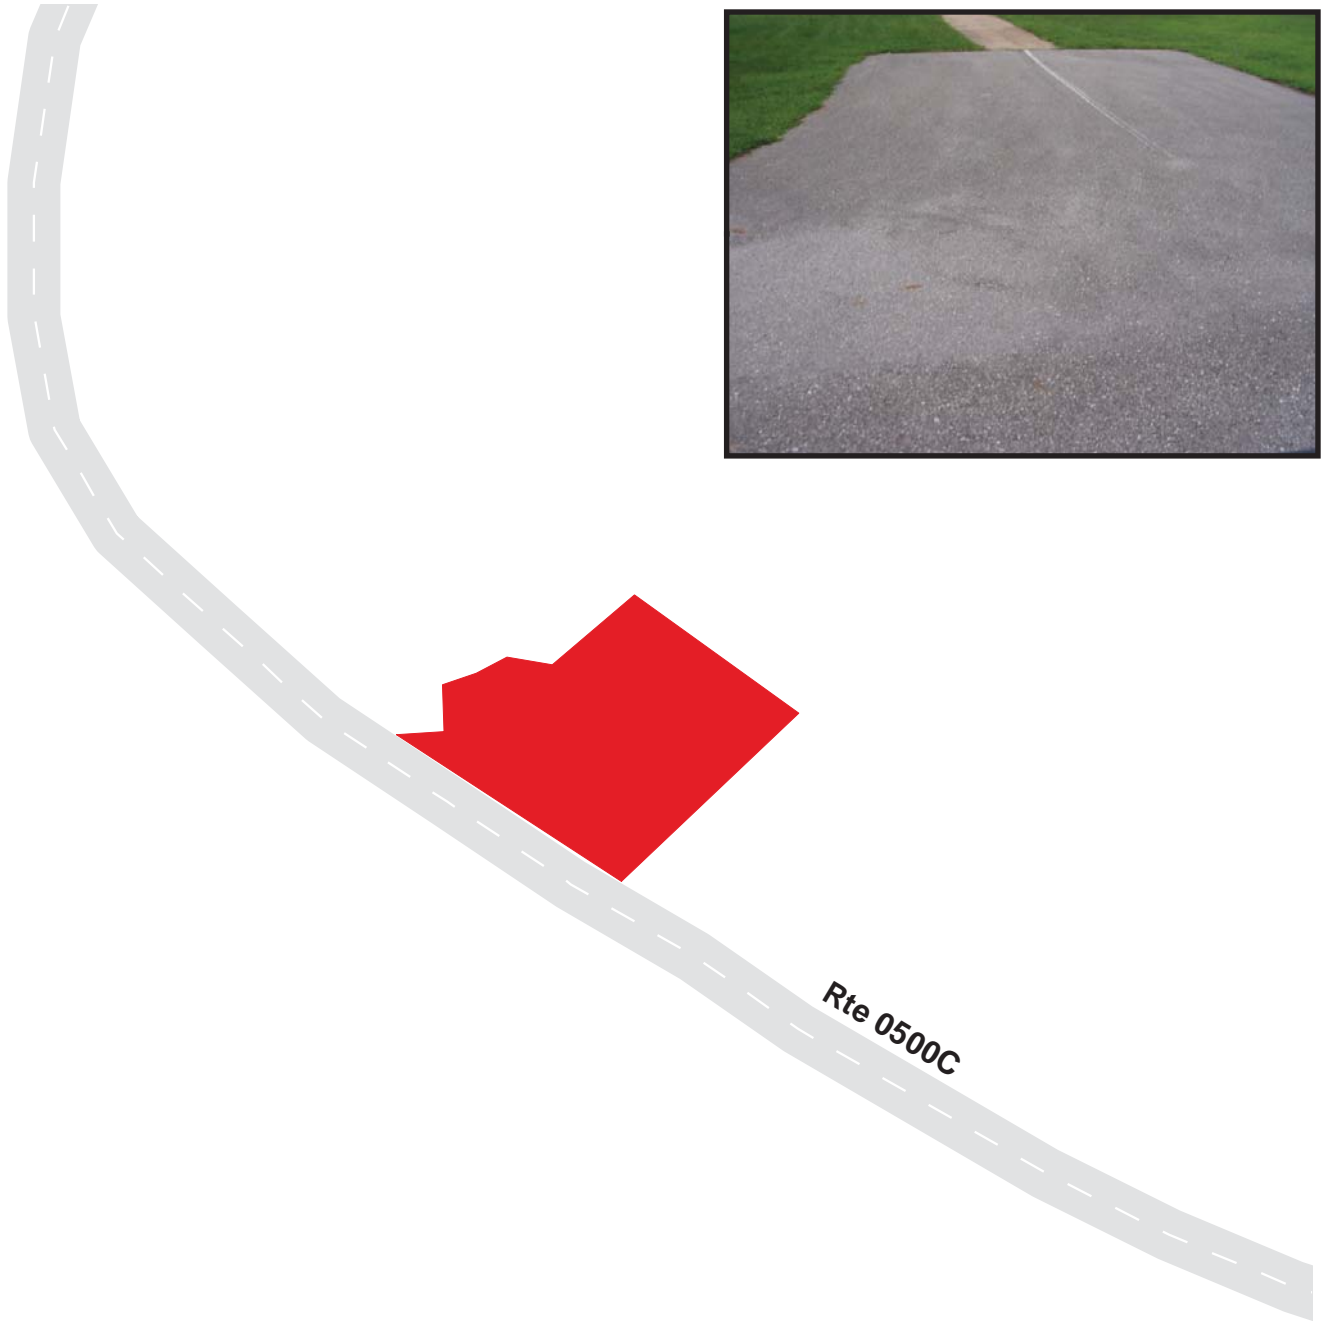
## Route 0947A

Route	Public / NonPublic	Date Visited	Area (sq ft)	Lane Miles *	Surface Type	Condition / PCR
0947A	Public	8/19/2003	829	0.01	AS	GOOD / 90

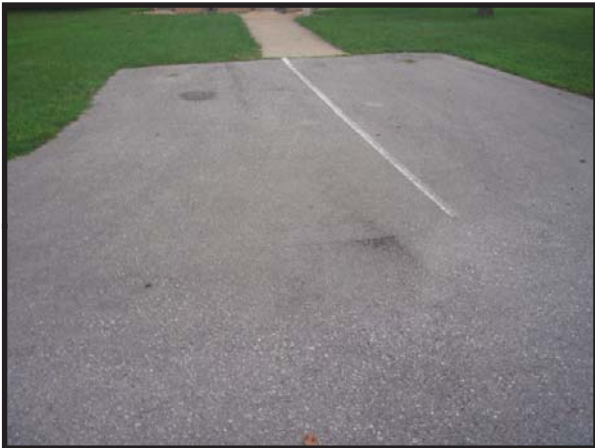
## Route 0947B

Route	Public / NonPublic	Date Visited	Area (sq ft)	Lane Miles *	Surface Type	Condition / PCR
0947B	Public	8/19/2003	643	0.01	AS	FAIR / 73

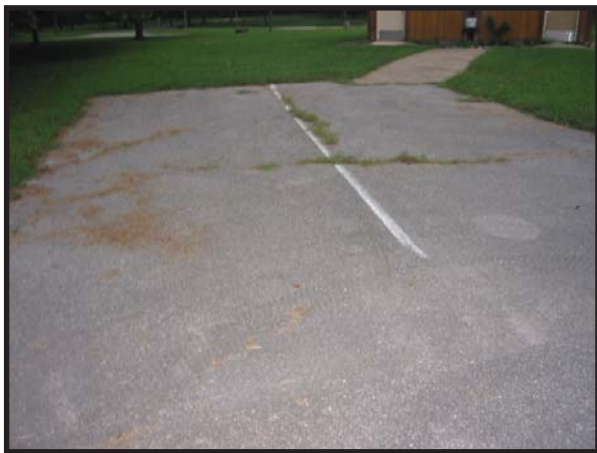
## Route 0947C

Route	Public / NonPublic	Date Visited	Area (sq ft)	Lane Miles *	Surface Type	Condition / PCR
0947C	Public	8/19/2003	595	0.01	AS	POOR / 45

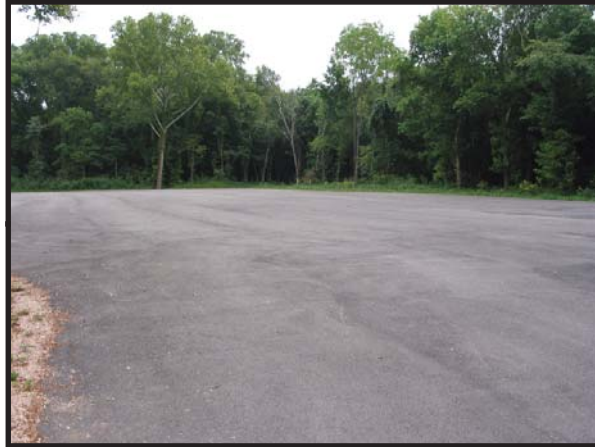
## Route 0956

Route	Public / NonPublic	Date Visited	Area (sq ft)	Lane Miles *	Surface Type	Condition / PCR
0956	Public	8/19/2003	41256	0.71	AS	EXCELLENT / 97

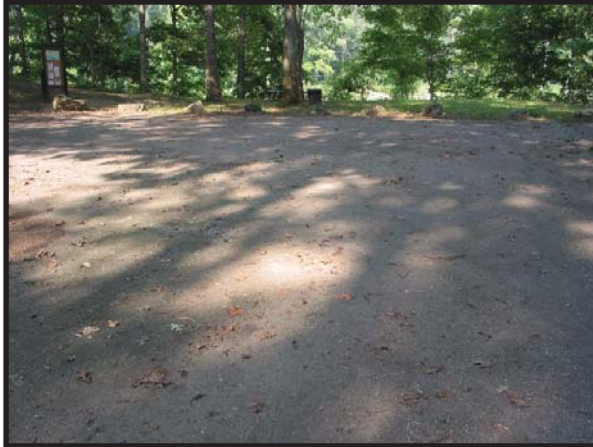
## Route 0959

Route	Public / NonPublic	Date Visited	Area (sq ft)	Lane Miles *	Surface Type	Condition / PCR
0959	Public	8/19/2003	819	0.01	AS	FAIR / 73
