**The Road Inventory
of
Palo Alto Battlefield National Historic Site
PAAL – 7580**

Road Inventory Program

Prepared By:
Federal Highway Administration
Eastern Federal Lands Highway Division
Cycle 3

Palo Alto Battlefield National Historic Site in Texas

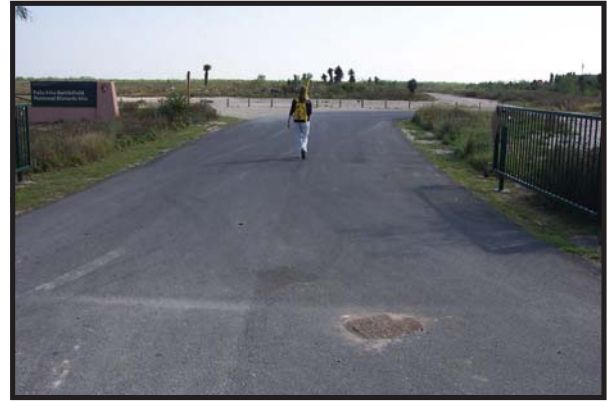
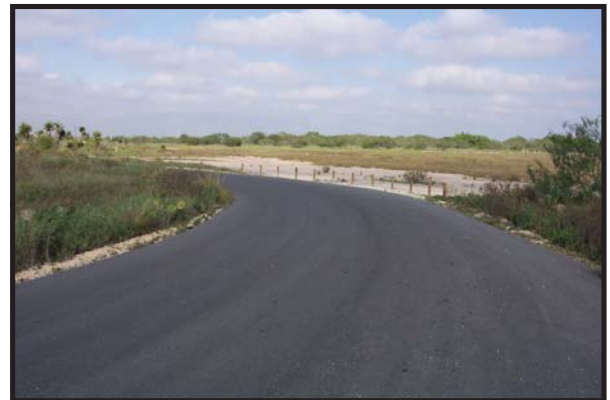
Route 0010

Visitor Center Entrance Road
FROM PAREDES LINE ROAD (FM 1847)

| Route | Length (mi) | Width (ft) | Area (sq ft) | Lane Miles * | Condition / PCR | Surface Type |
|---|---|---|---|---|---|---|
| 0010 | 0.32 | 20.00 | 33264 | 0.57 | GOOD / 90 | AS |

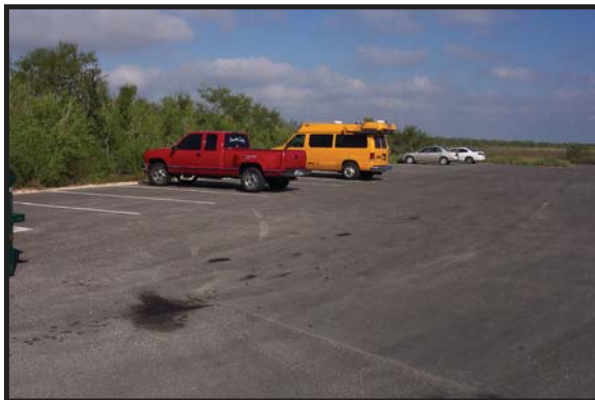
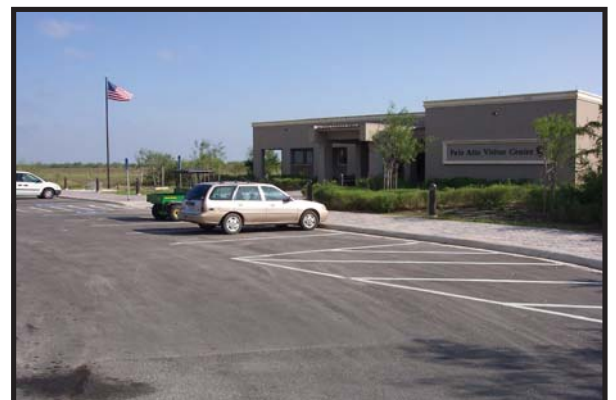
Route 0900

MAIN PARKING AREA
FROM ROUTE 0010

| Route | Public / NonPublic | Date Visited | Area (sq ft) | Lane Miles * | Surface Type | Condition / PCR |
|---|---|---|---|---|---|---|
| 0900 | Public | 12/13/2004 | 12730 | 0.22 | AS | GOOD / 90 |

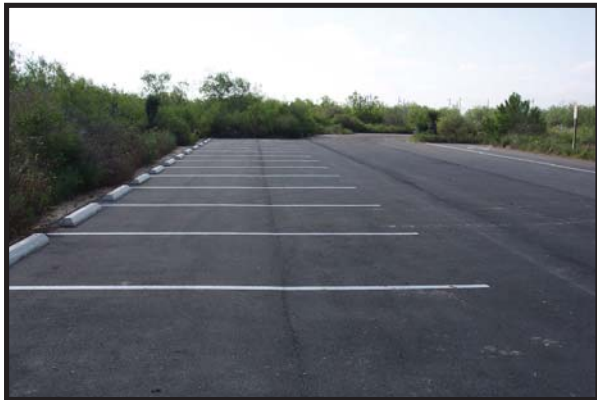
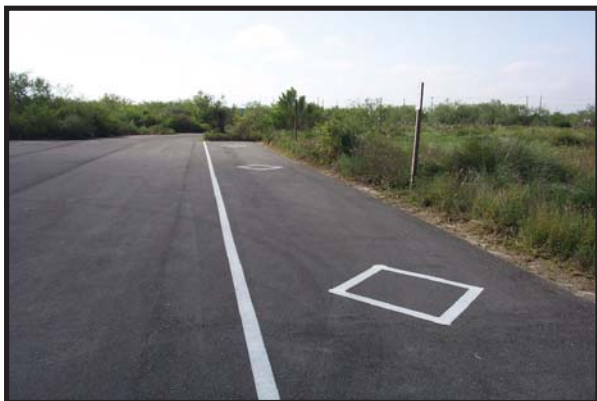
Route 0901

OVERFLOW PARKING AREA FROM ROUTE 0010

| Route | Public / NonPublic | Date Visited | Area (sq ft) | Lane Miles * | Surface Type | Condition / PCR |
|---|---|---|---|---|---|---|
| 0901 | Public | 12/13/2004 | 8516 | 0.15 | AS | GOOD / 90 |
