# The Road Inventory of Padre Island National Seashore PAIS - 7490

## Road Inventory Program

Prepared By:  
Federal Highway Administration  
Eastern Federal Lands Highway Division  
Cycle 3

# Padre Island National Seashore in Texas

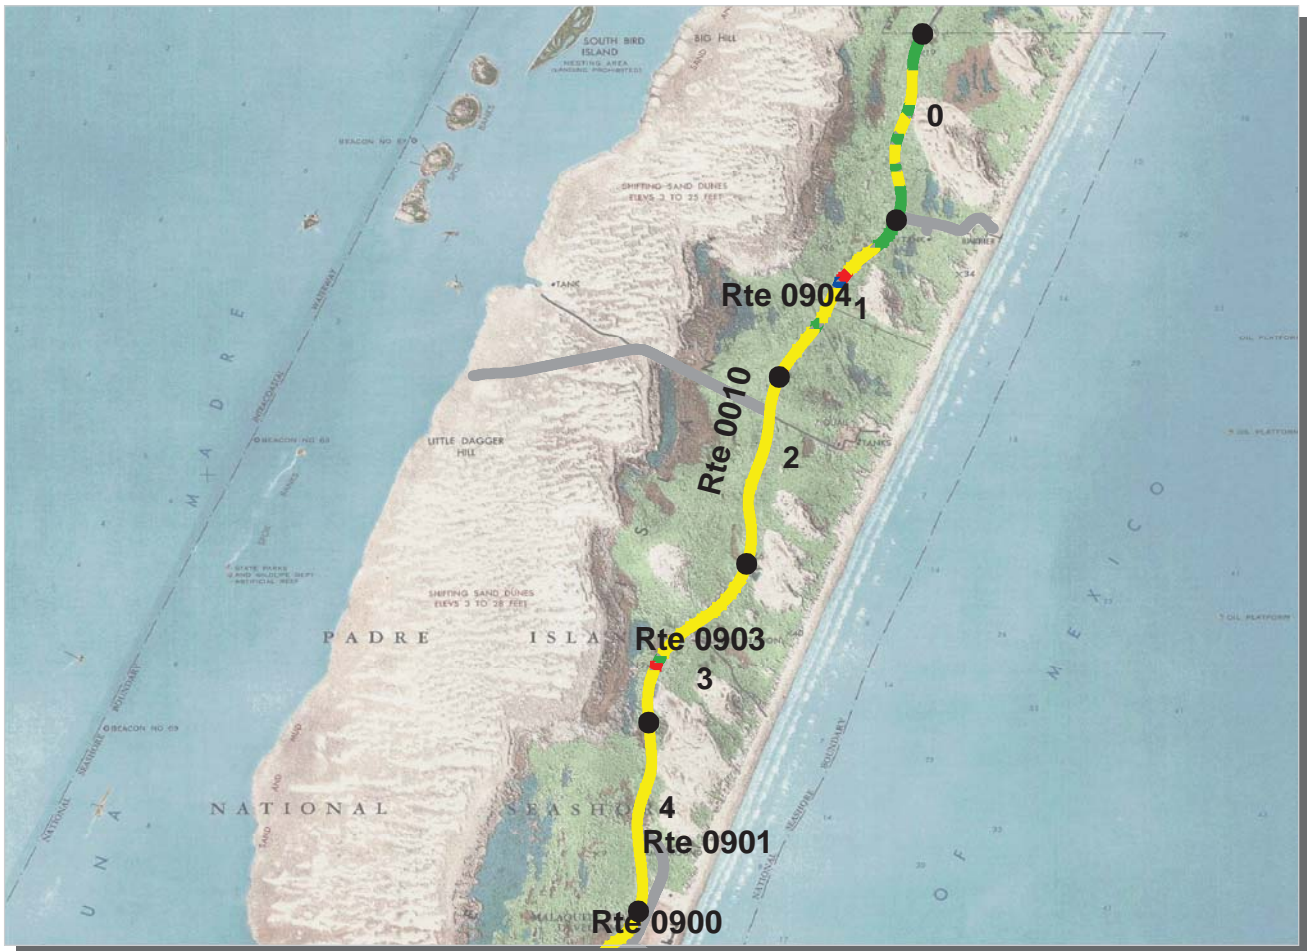
**ROUTE: 0010 Padre Island Entrance Road**

PCR    Poor ■    Fair ■    Good ■    Excellent ■  
          (<=60)                    (61 - 84)                    (85 - 94)                    (95 - 100)

Section Number	0	1	2	3	4
Section Length (mi)	1.00	1.00	1.00	1.00	1.00
AADT	**				
SADT	**				
ADT Date	**				
<b>Cross Section Information</b>					
Number of Lanes	2	2	2	2	2
Paved Width (ft)	24	25	24	24	24
Lane Width (ft)	11	12	12	12	13
Shoulder Width (ft)	6	6	7	7	8
<b>Roadway Condition Information</b>					
PCR (Pavement Condition Rating)	81	73	74	75	71
RCI (Roughness Condition Index)	92	92	89	93	85
SCR (Surface Condition Rating)	74	66	65	62	62
Alligator Cracking Index	100	100	100	100	100
Rutting Index	74	66	65	62	62
Patching Index	100	99	100	100	100
Transverse Cracking Index	99	99	99	100	99
Longitudinal Cracking Index	99	100	100	100	100
Shoulder Condition Rating	N/C	N/C	N/C	N/C	N/C
Drainage Condition Rating	N/C	N/C	N/C	N/C	N/C

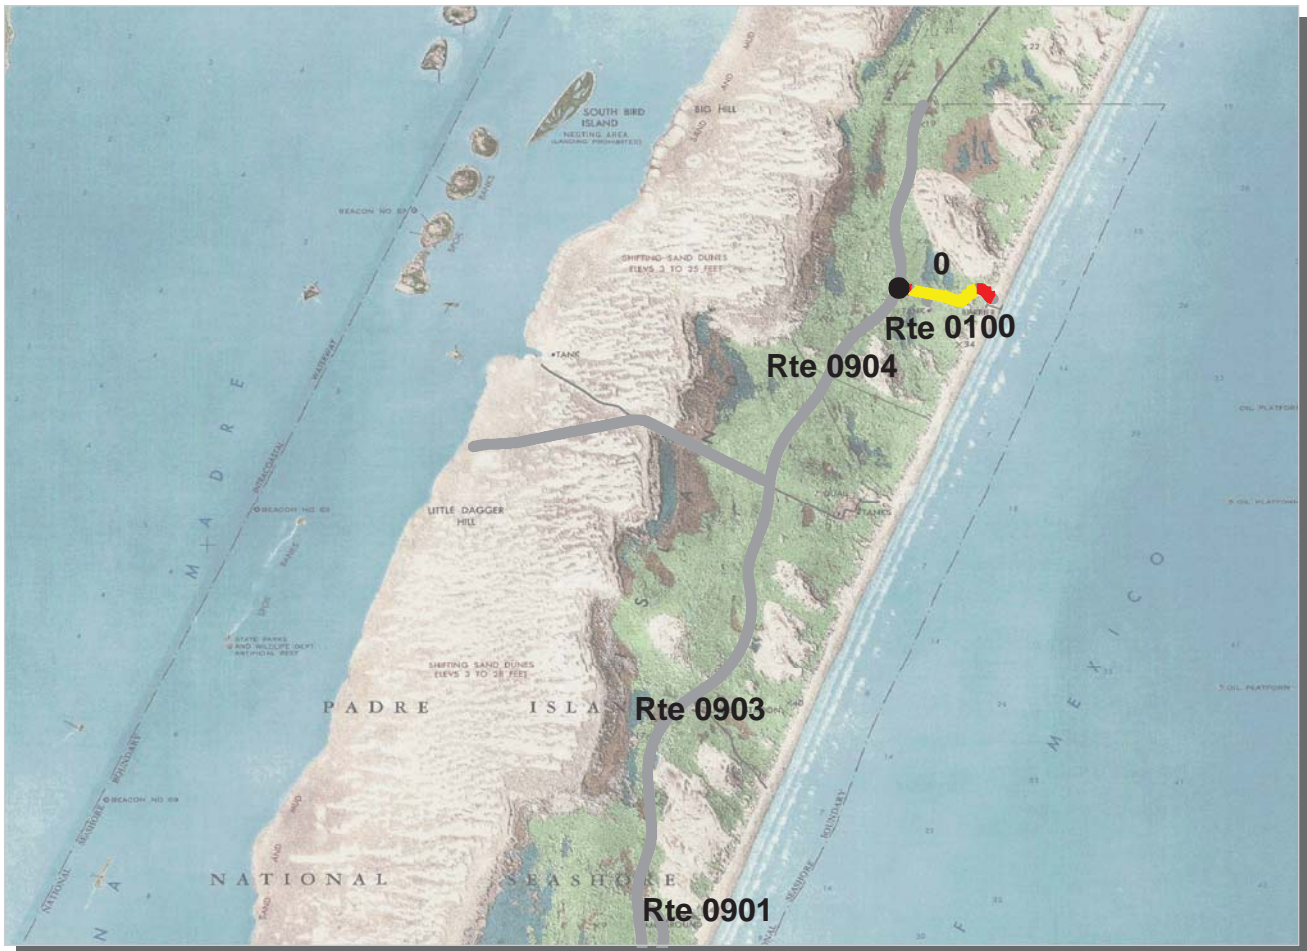
**ROUTE: 0100 North Beach Access Road** **TOTAL LENGTH: 0.51 Miles**

Section Number	0				
Section Length (mi)	0.51				
AADT	**				
SADT	**				
ADT Date	**				
<b>Cross Section Information</b>					
Number of Lanes	2				
Paved Width (ft)	24				
Lane Width (ft)	12				
Shoulder Width (ft)	5				
<b>Roadway Condition Information</b>					
PCR (Pavement Condition Rating)	61				
RCI (Roughness Condition Index)	86				
SCR (Surface Condition Rating)	51				
Alligator Cracking Index	100				
Rutting Index	51				
Patching Index	99				
Transverse Cracking Index	99				
Longitudinal Cracking Index	100				
Shoulder Condition Rating	N/C				
Drainage Condition Rating	N/C

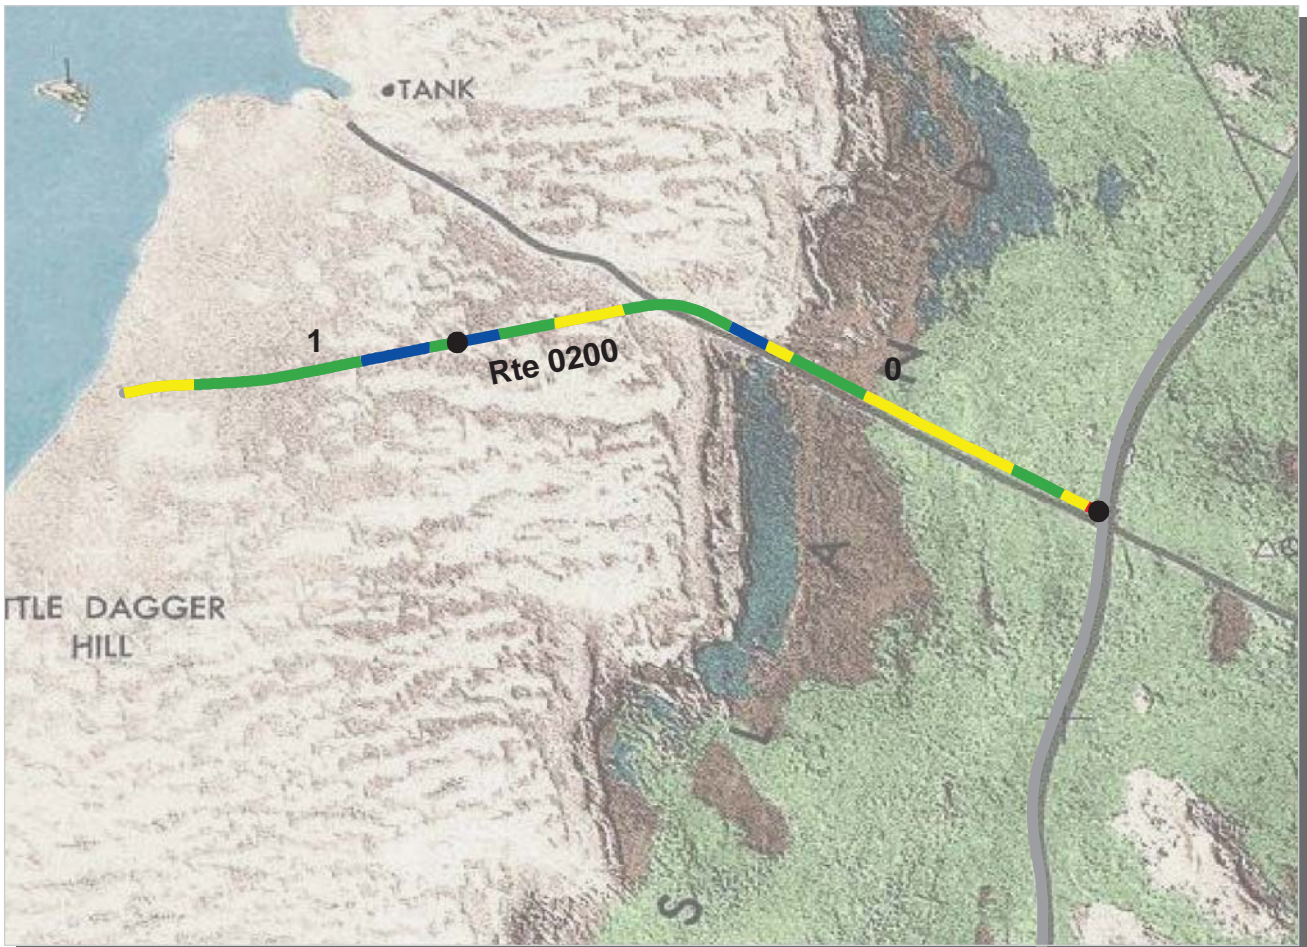
**ROUTE: 0200 Bird Island Basin Road** **TOTAL LENGTH: 1.50 Miles**

Section Number	0	1			
Section Length (mi)	1.00	0.50			
AADT	**				
SADT	**				
ADT Date	**				
<b>Cross Section Information</b>					
Number of Lanes	2	2			
Paved Width (ft)	19	19			
Lane Width (ft)	10	10			
Shoulder Width (ft)	6	6			
<b>Roadway Condition Information</b>					
PCR (Pavement Condition Rating)	85	85			
RCI (Roughness Condition Index)	91	97			
SCR (Surface Condition Rating)	82	80			
Alligator Cracking Index	100	100			
Rutting Index	82	80			
Patching Index	99	100			
Transverse Cracking Index	100	100			
Longitudinal Cracking Index	100	100			
Shoulder Condition Rating	N/C	N/C			
Drainage Condition Rating	N/C	N/C

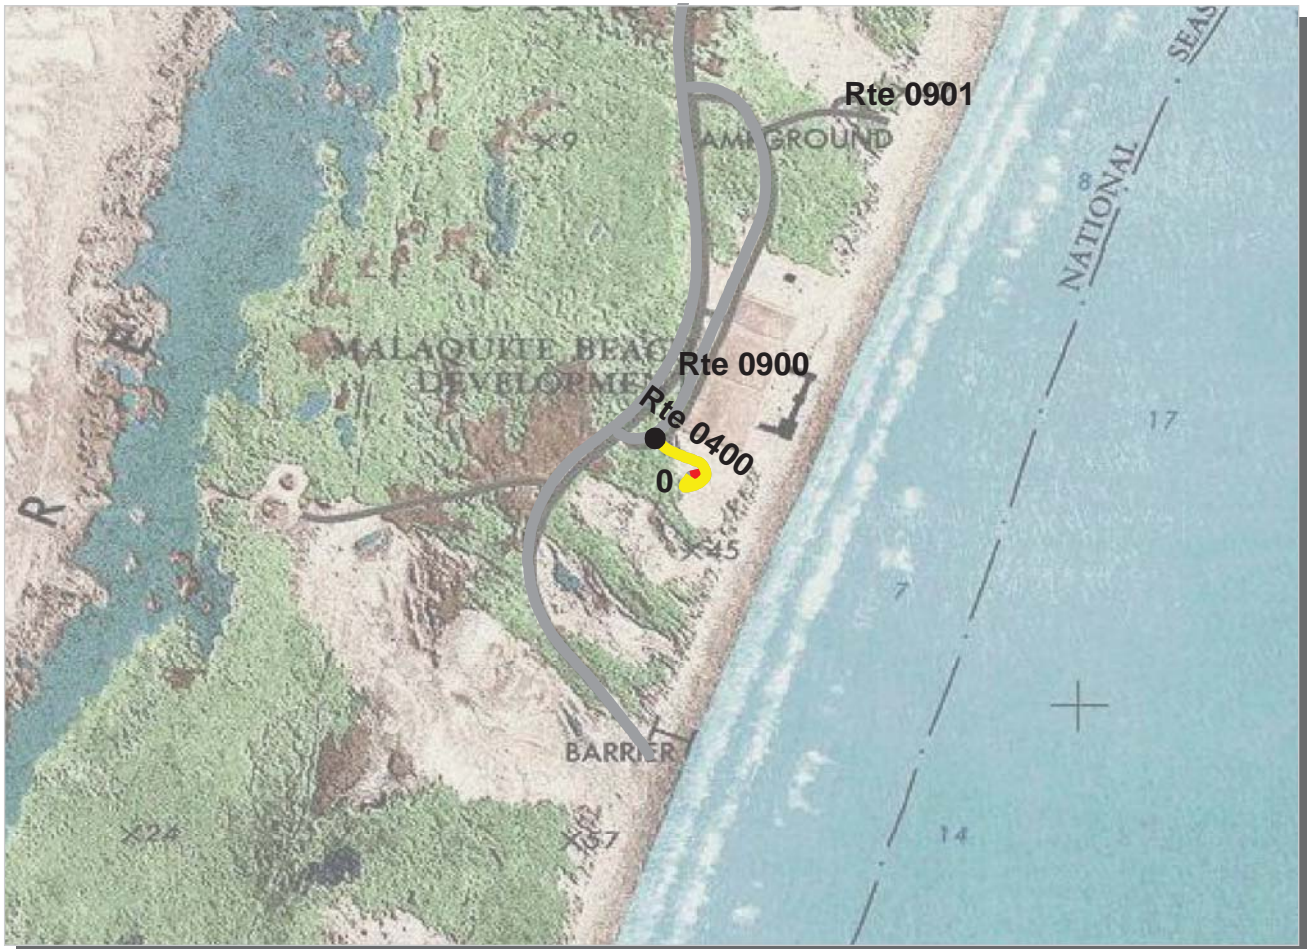
**ROUTE: 0400 Sewage Treatment Plant Road** **TOTAL LENGTH: 0.20 Miles**

Section Number	0				
Section Length (mi)	0.20				
AADT	**				
SADT	**				
ADT Date	**				
<b>Cross Section Information</b>					
Number of Lanes	2				
Paved Width (ft)	18				
Lane Width (ft)	9				
Shoulder Width (ft)	6				
<b>Roadway Condition Information</b>					
PCR (Pavement Condition Rating)	52				
RCI (Roughness Condition Index)	NC				
SCR (Surface Condition Rating)	52				
Alligator Cracking Index	100				
Rutting Index	55				
Patching Index	97				
Transverse Cracking Index	99				
Longitudinal Cracking Index	99				
Shoulder Condition Rating	N/C				
Drainage Condition Rating	N/C

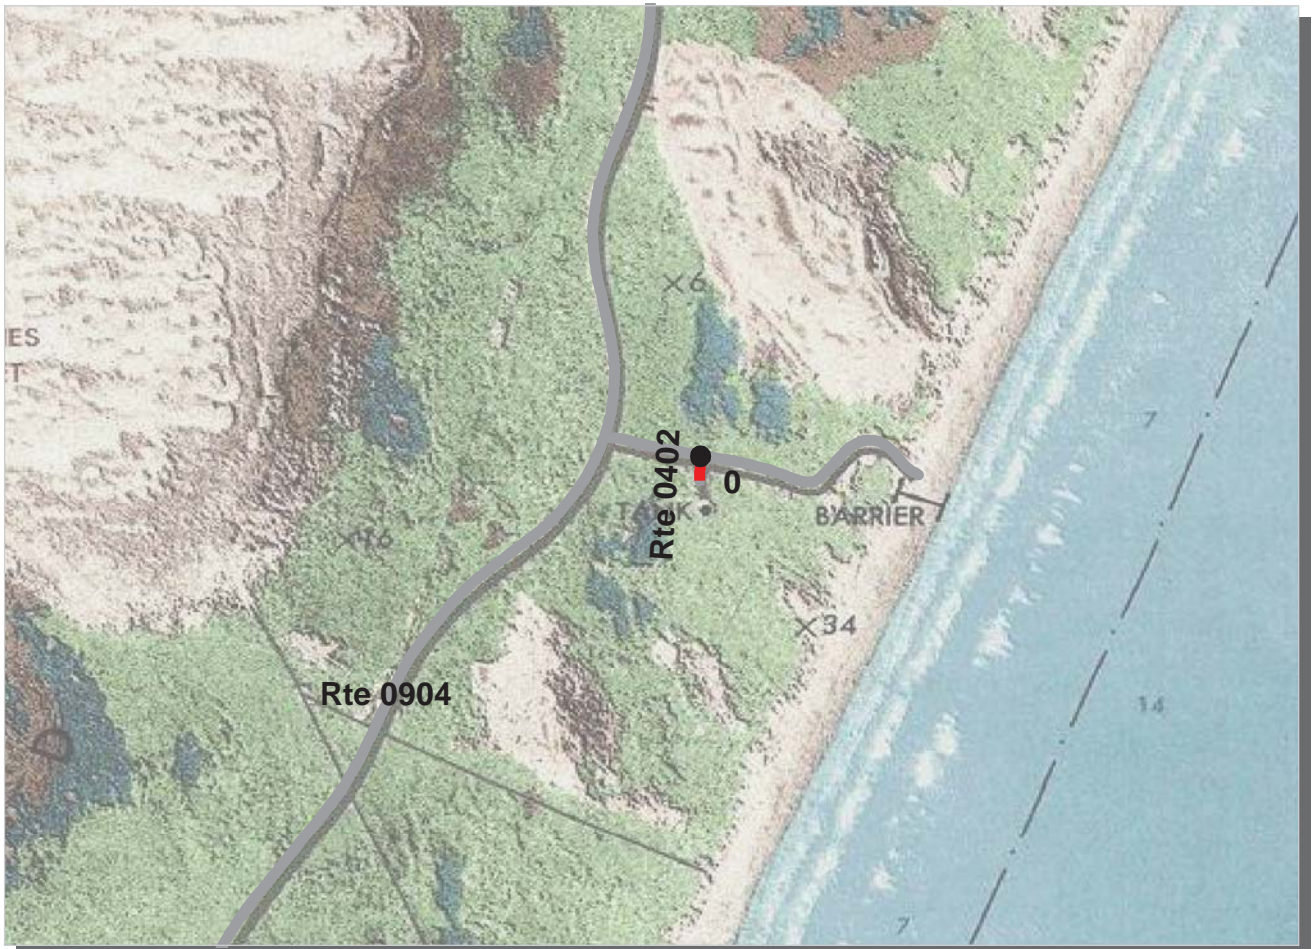
**ROUTE: 0402 Water Tank Road** **TOTAL LENGTH: 0.05 Miles**

Section Number	0				
Section Length (mi)	0.05				
AADT	**				
SADT	**				
ADT Date	**				
<b>Cross Section Information</b>					
Number of Lanes	2				
Paved Width (ft)	20				
Lane Width (ft)	10				
Shoulder Width (ft)	8				
<b>Roadway Condition Information</b>					
PCR (Pavement Condition Rating)	45				
RCI (Roughness Condition Index)	NC				
SCR (Surface Condition Rating)	45				
Alligator Cracking Index	100				
Rutting Index	46				
Patching Index	100				
Transverse Cracking Index	99				
Longitudinal Cracking Index	99				
Shoulder Condition Rating	N/C				
Drainage Condition Rating	N/C

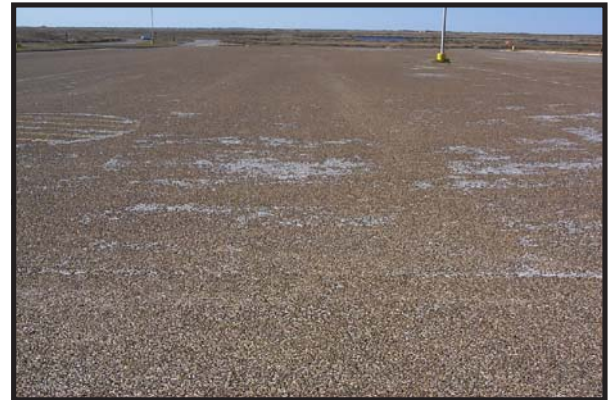
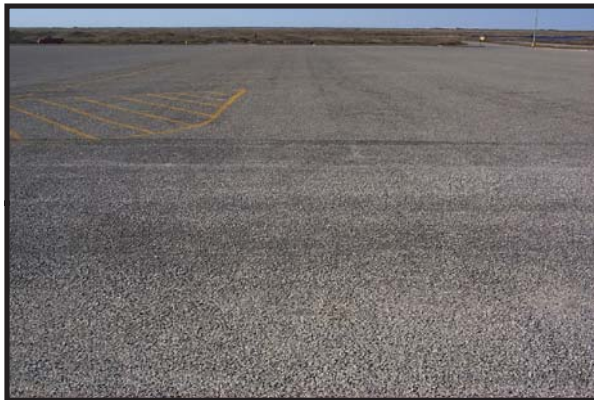
## Route 0901

Route	Public / NonPublic	Date Visited	Area (sq ft)	Lane Miles *	Surface Type	Condition / PCR
0901	Public	1/8/2002	134590	2.32	NC	GOOD / 90

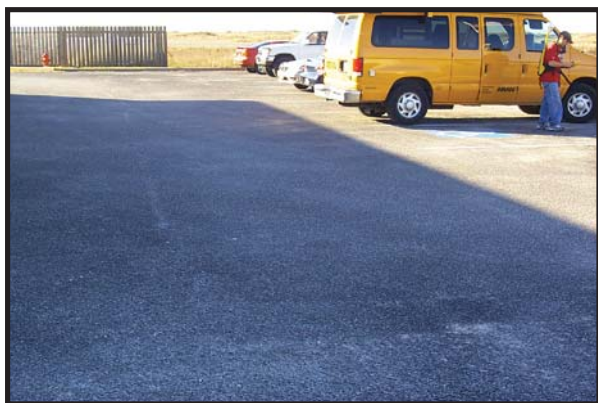
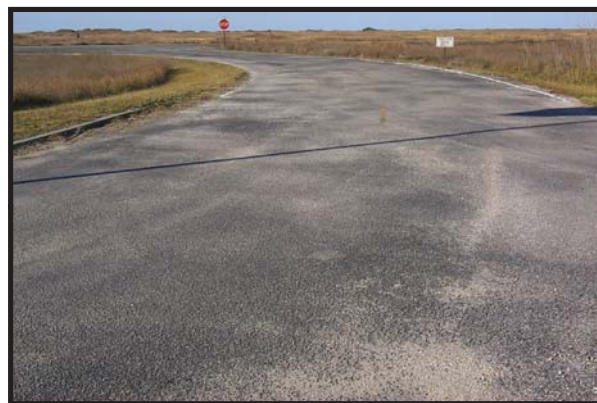
## Route 0903

Route	Public / NonPublic	Date Visited	Area (sq ft)	Lane Miles *	Surface Type	Condition / PCR
0903	NonPublic	1/8/2002	43153	0.74	CO	EXCELLENT / 97

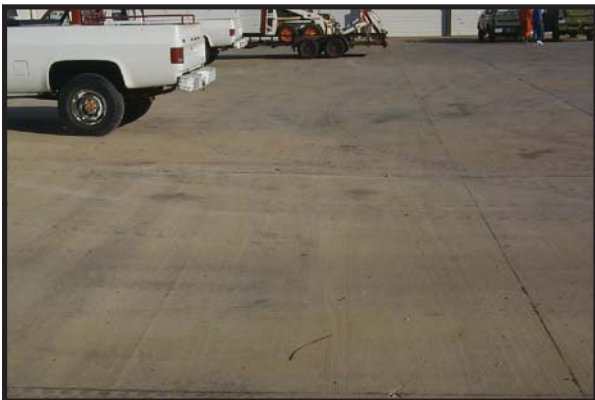
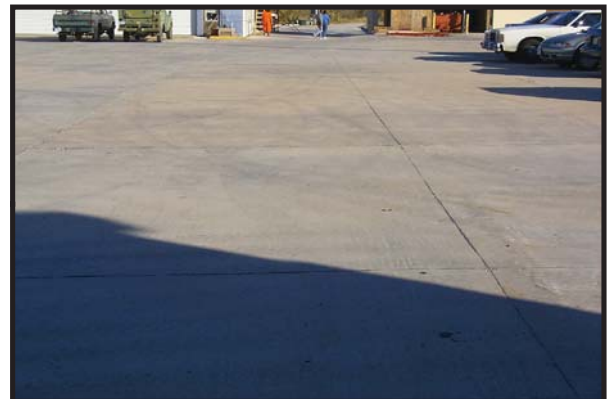
## Route 0904

Route	Public / NonPublic	Date Visited	Area (sq ft)	Lane Miles *	Surface Type	Condition / PCR
0904	Public	1/8/2002	7527	0.13	NC	GOOD / 90
