**The Road Inventory  
of  
Pecos National Historical Park  
PECO - 7500**

**Road Inventory Program**

Prepared By:  
Federal Highway Administration  
Eastern Federal Lands Highway Division  
Cycle 3

# Pecos National Historical Park in New Mexico

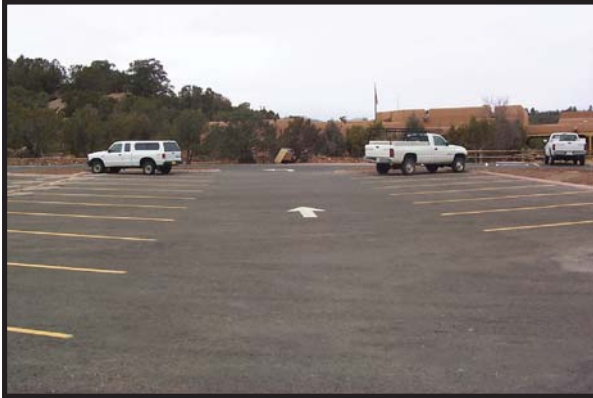
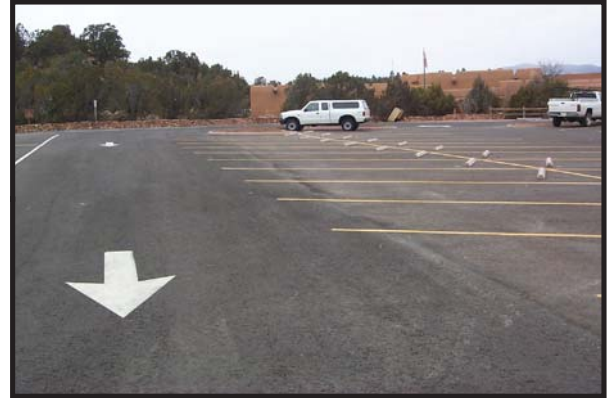
Route	Public / NonPublic	Date Visited	Area (sq ft)	Lane Miles *	Surface Type	Condition / PCR
0900	Public	12/11/2001	29164	0.50	NC	GOOD / 90

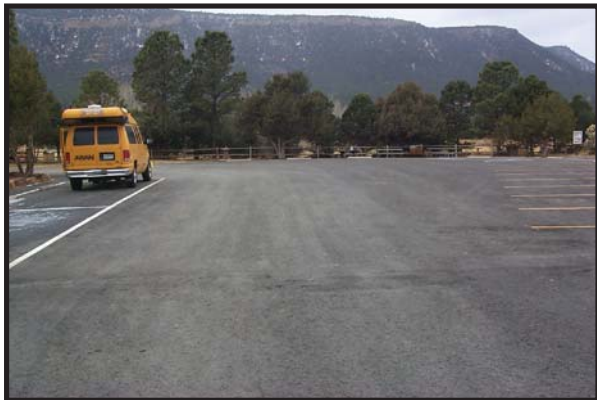
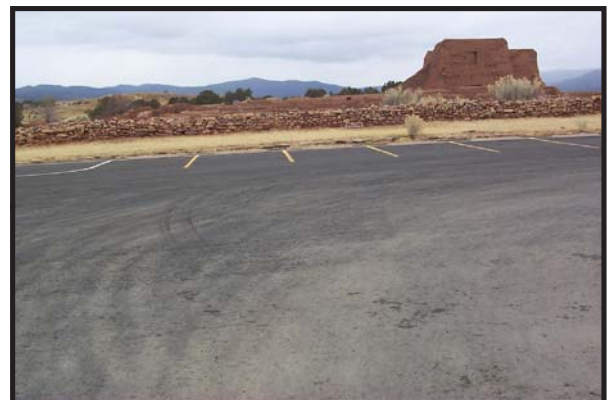
## Route 0901

Route	Public / NonPublic	Date Visited	Area (sq ft)	Lane Miles *	Surface Type	Condition / PCR
0901	Public	12/11/2001	15192	0.26	NC	EXCELLENT / 97
