The Road Inventory of Petrified Forest National Park PEFO – 8430

Prepared By:
Federal Highway Administration
Eastern Federal Lands Highway Division
Cycle 3

Petrified Forest National Park in Arizona

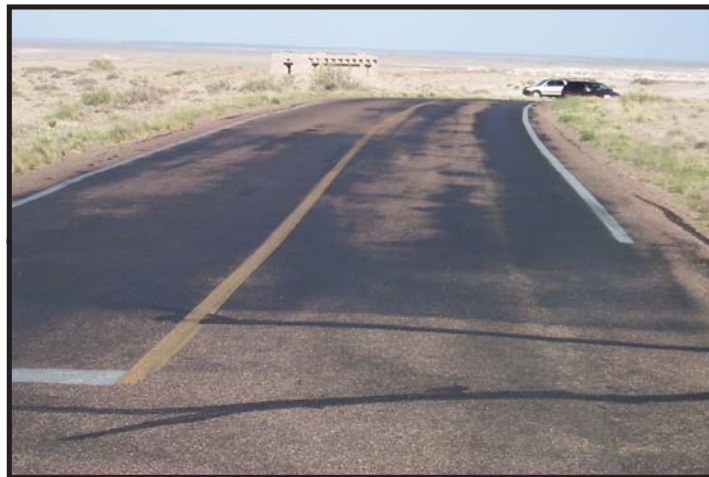
Route	Length (mi)	Width (ft)	Area (sq ft)	Lane Miles *	Condition / PCR	Surface Type
0015	0.16	0.00	8105	0.14	FAIR / 73	OC

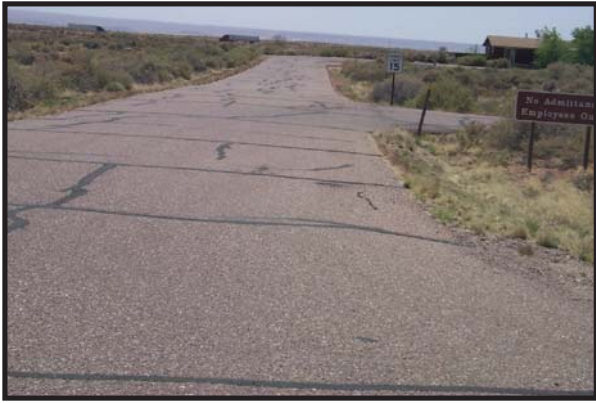
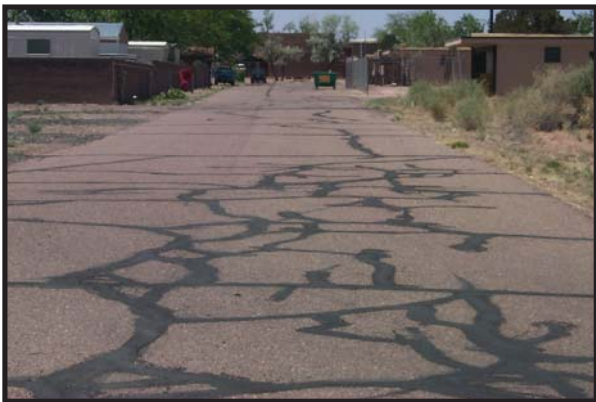
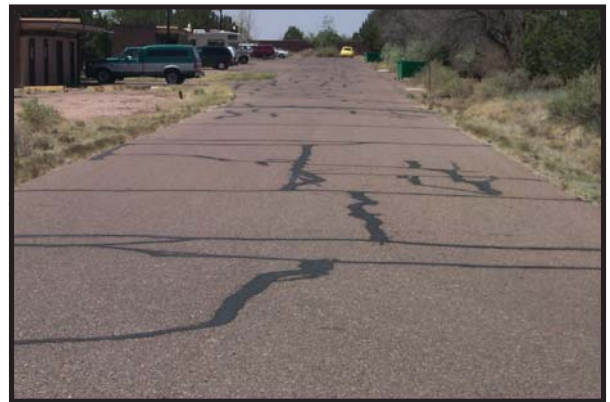
Petrified Forest National Park Route 0415

Painted Desert Residence Area
From Route 0010 at MP 0.55

Route	Length (mi)	Width (ft)	Area (sq ft)	Lane Miles *	Condition / PCR	Surface Type
0415	1.40	0.00	81350	1.40	POOR / 45	AS

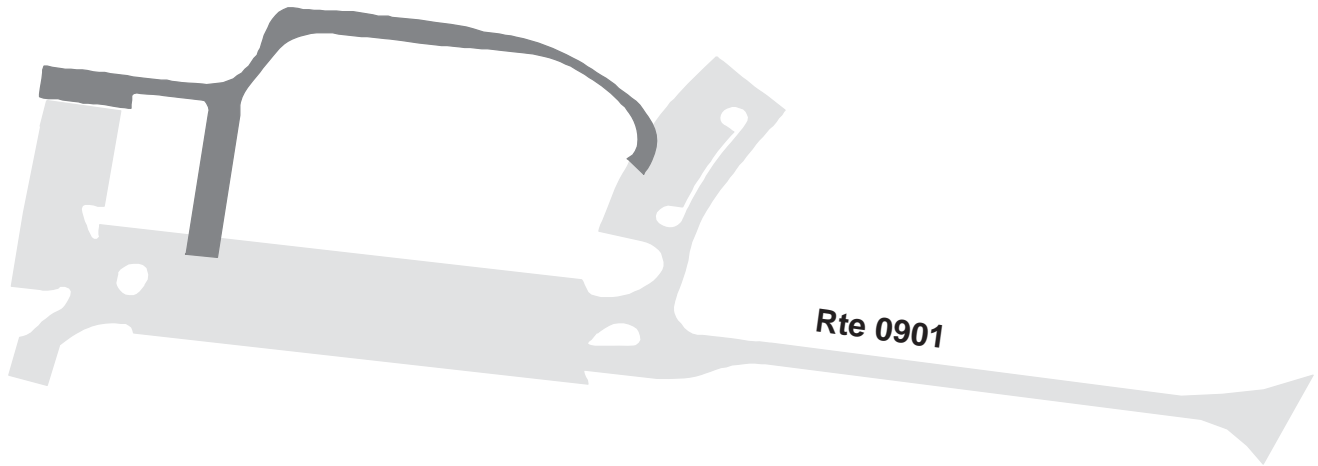
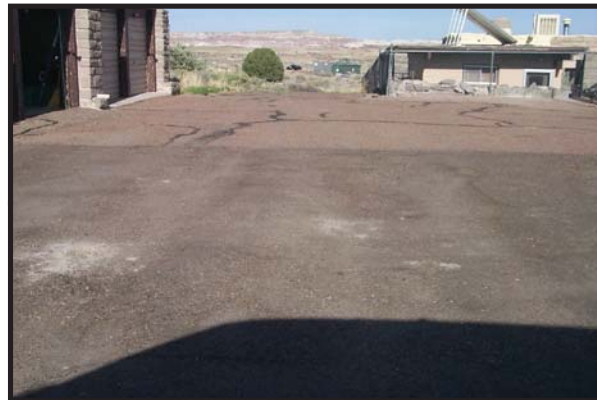
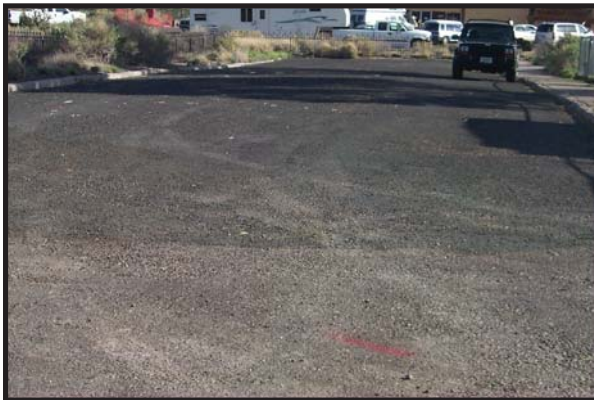
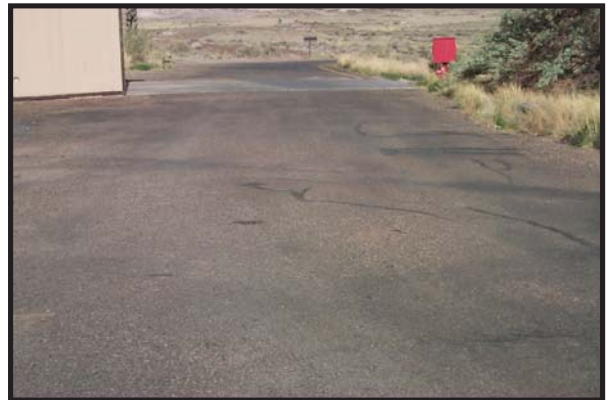
Route 0416

Route	Length (mi)	Width (ft)	Area (sq ft)	Lane Miles *	Condition / PCR	Surface Type
0416	0.34	0.00	19781	0.34	FAIR / 73	OC

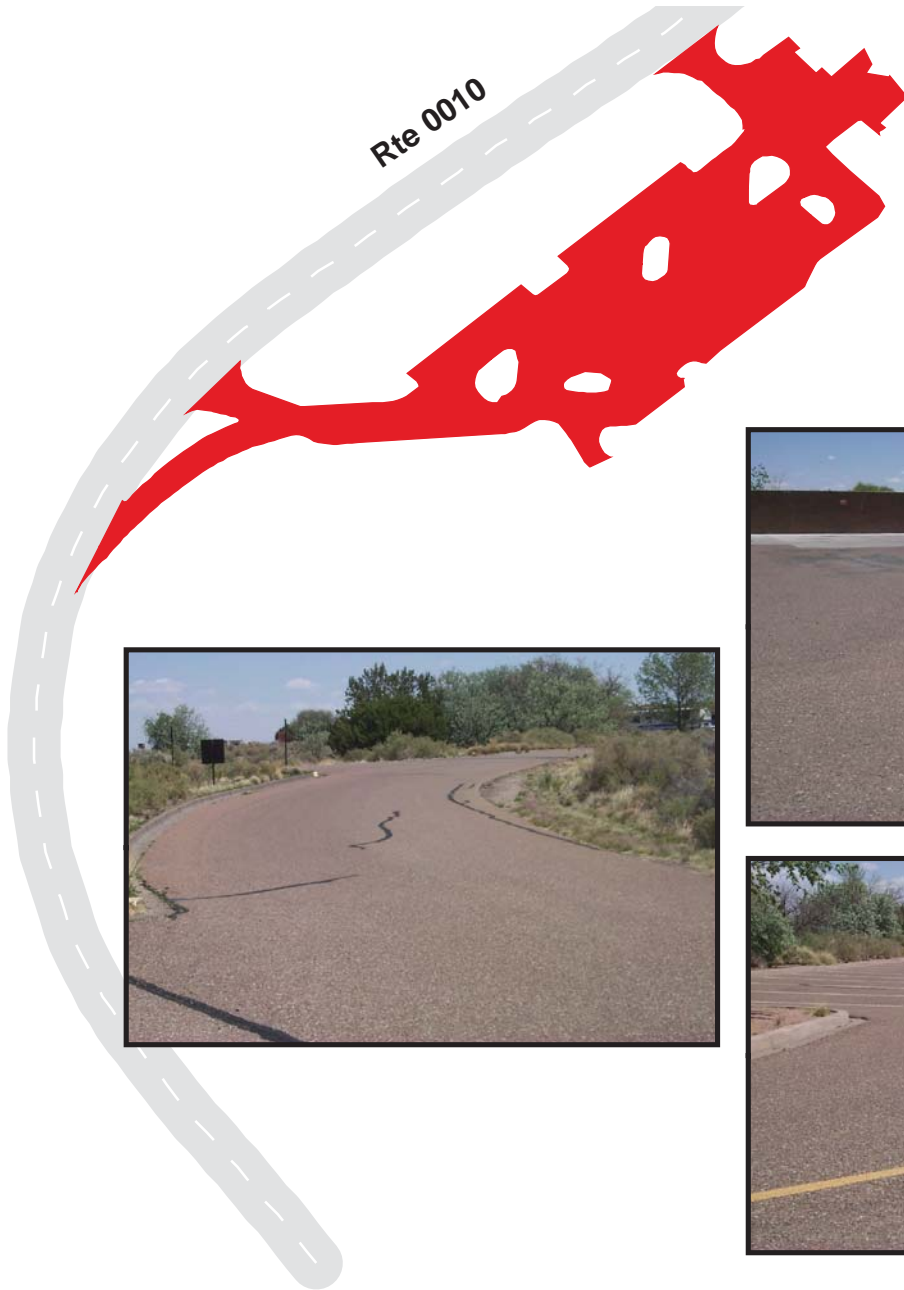
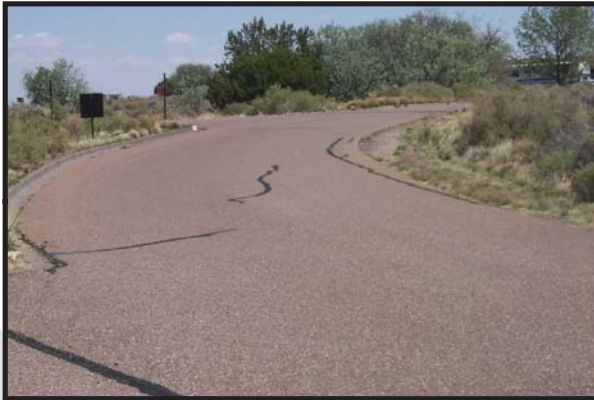
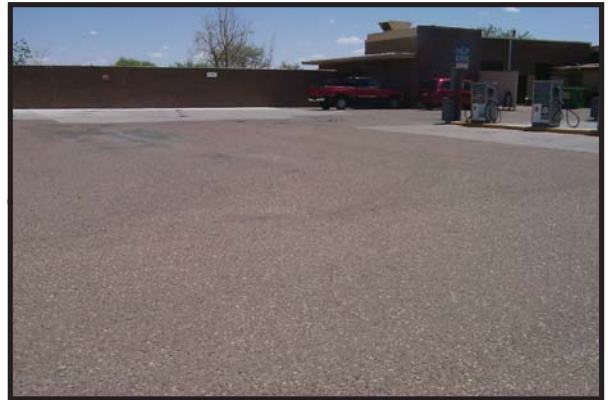
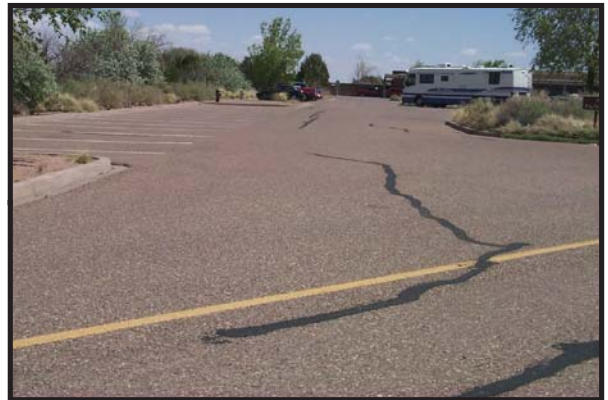
Route 0900

Route	Public / NonPublic	Date Visited	Area (sq ft)	Lane Miles *	Surface Type	Condition / PCR
0900	Public	1/23/1999	105186	1.81	OC	GOOD / 90

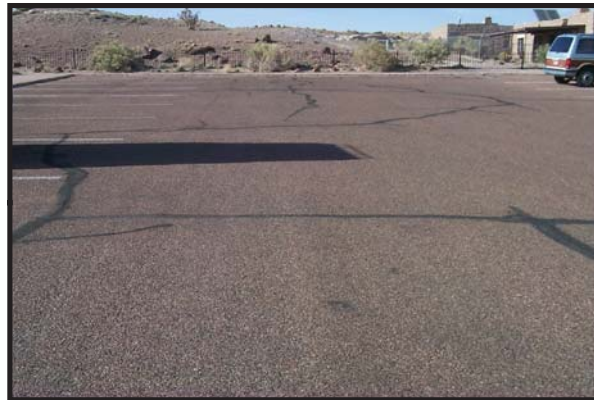
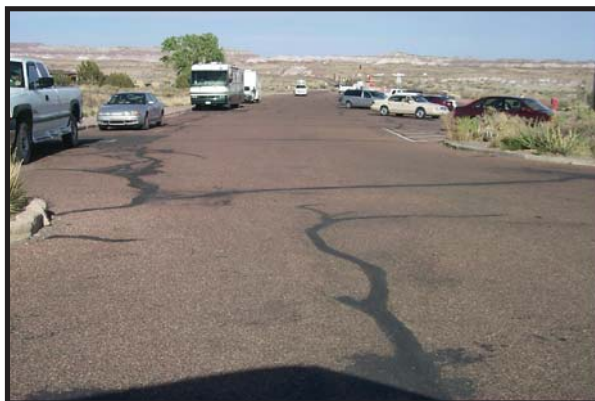
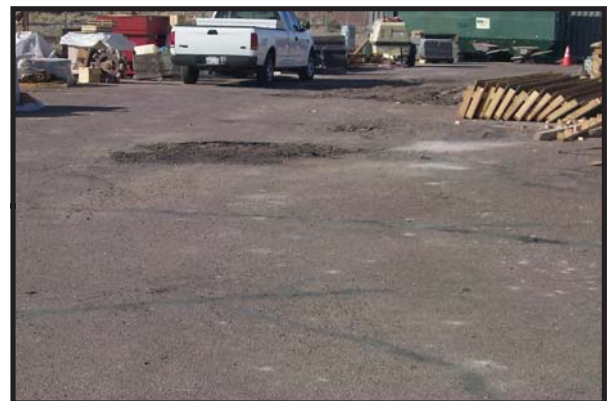
Route 0901

Route	Public / NonPublic	Date Visited	Area (sq ft)	Lane Miles *	Surface Type	Condition / PCR
0901	Public	1/23/1999	115207	1.98	OC	FAIR / 73

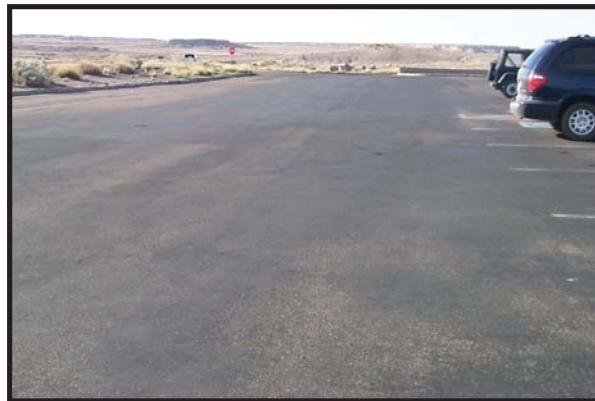
Route 0902

Route	Public / NonPublic	Date Visited	Area (sq ft)	Lane Miles *	Surface Type	Condition / PCR
0902	Public	1/23/1999	19359	0.33	AS	FAIR / 73

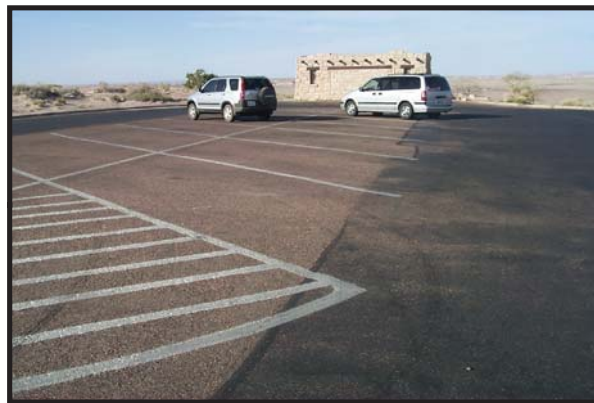
Route 0904

Route	Public / NonPublic	Date Visited	Area (sq ft)	Lane Miles *	Surface Type	Condition / PCR
0904	Public	1/23/1999	18285	0.31	OC	FAIR / 73

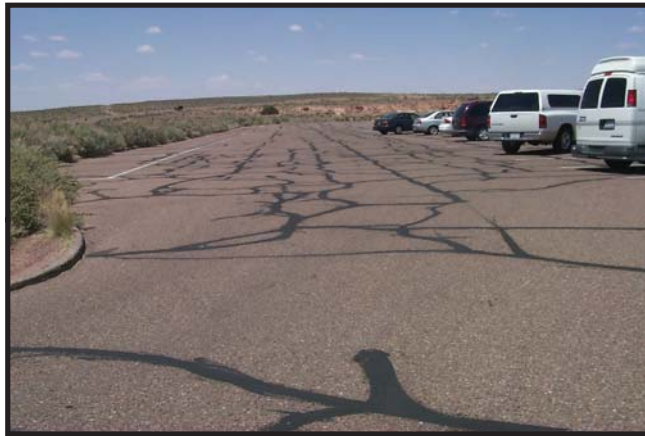
Route 0905

Route	Public / NonPublic	Date Visited	Area (sq ft)	Lane Miles *	Surface Type	Condition / PCR
0905	Public	1/22/1999	39034	0.67	AS	POOR / 45

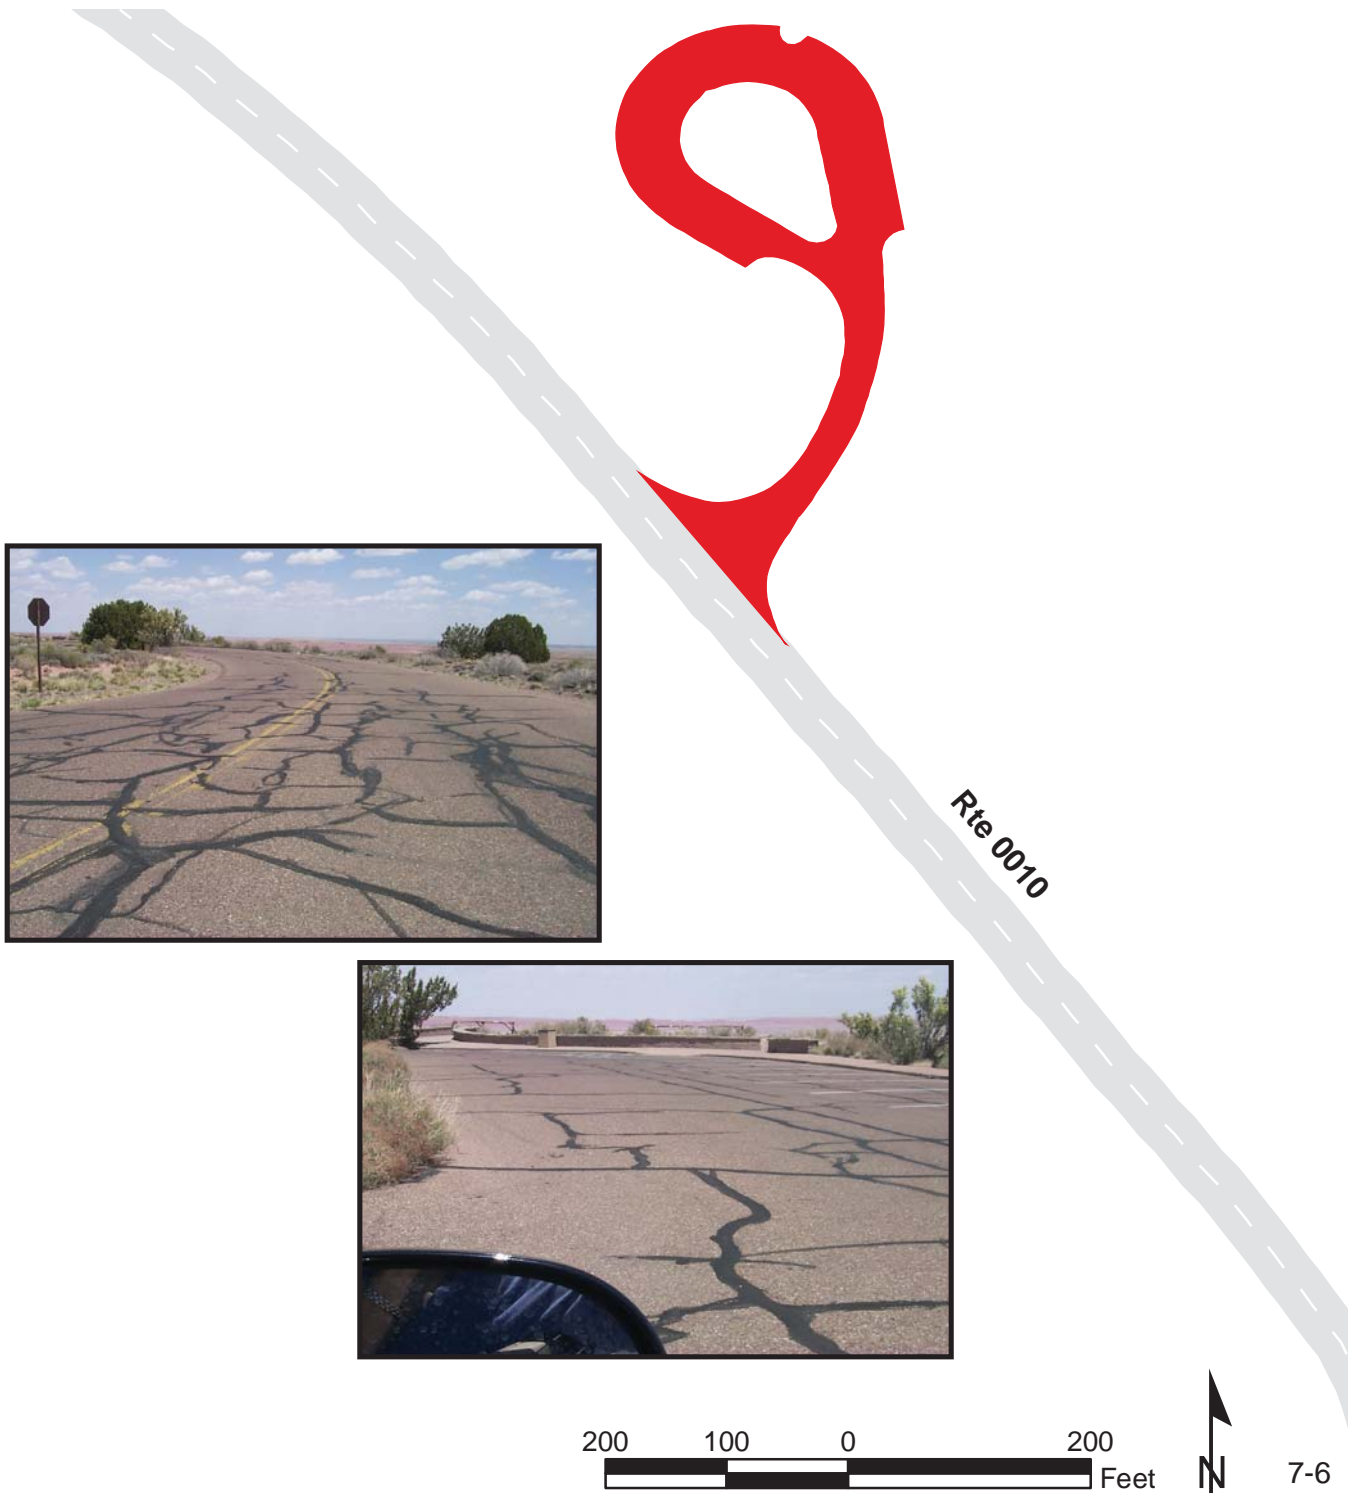
Petrified Forest National Park Route 0906

Tawa Point Parking
Adjacent to Route 0010 at MP 1.8

Route	Public / NonPublic	Date Visited	Area (sq ft)	Lane Miles *	Surface Type	Condition / PCR
0906	Public	1/22/1999	30350	0.52	AS	POOR / 45

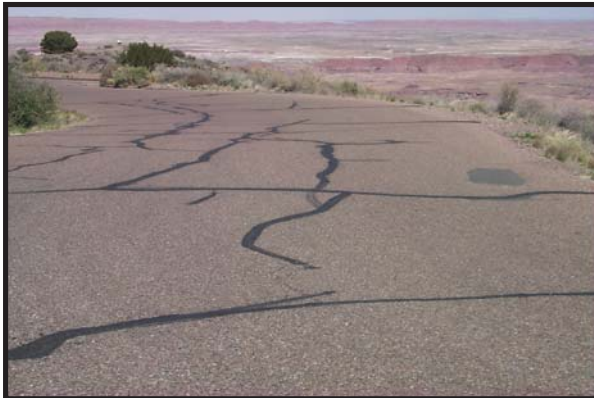
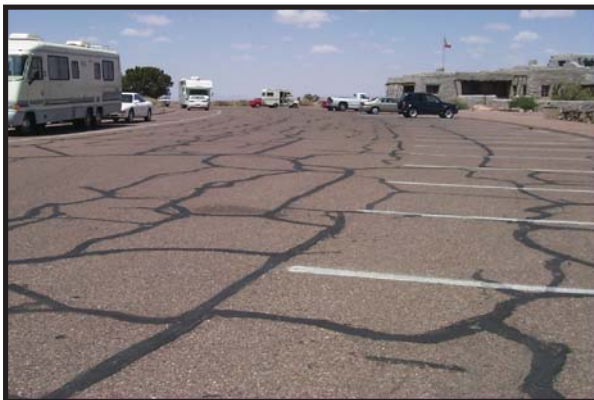
Route 0907

Route	Public / NonPublic	Date Visited	Area (sq ft)	Lane Miles *	Surface Type	Condition / PCR
0907	Public	1/23/1999	38344	0.66	AS	POOR / 45

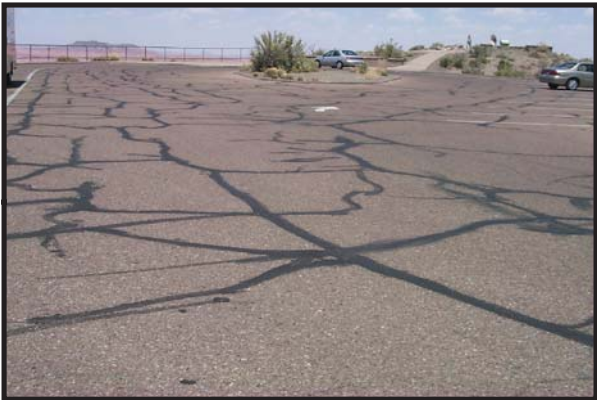
Route 0908

Route	Public / NonPublic	Date Visited	Area (sq ft)	Lane Miles *	Surface Type	Condition / PCR
0908	Public	1/23/1999	16855	0.29	AS	POOR / 45

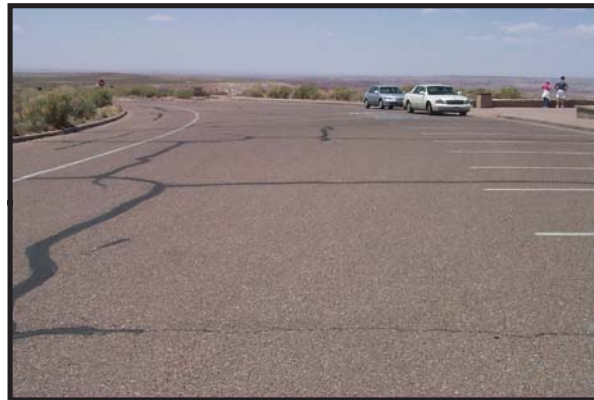
Route 0909

Route	Public / NonPublic	Date Visited	Area (sq ft)	Lane Miles *	Surface Type	Condition / PCR
0909	Public	1/23/1999	23135	0.40	AS	FAIR / 73

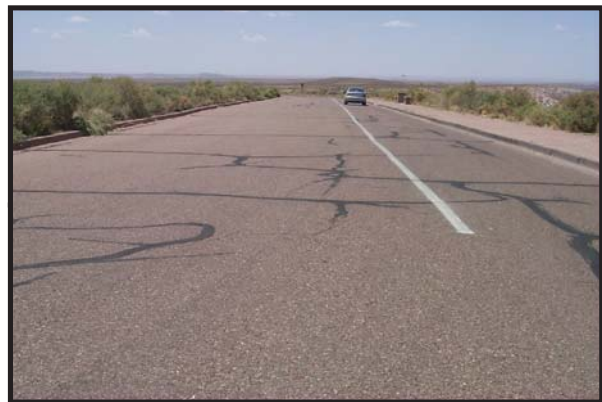
Petrified Forest National Park Route 0910

Whipple Point Parking
Adjacent to Route 0010 at MP 4.34

Route	Public / NonPublic	Date Visited	Area (sq ft)	Lane Miles *	Surface Type	Condition / PCR
0910	Public	1/23/1999	20474	0.35	AS	FAIR / 73

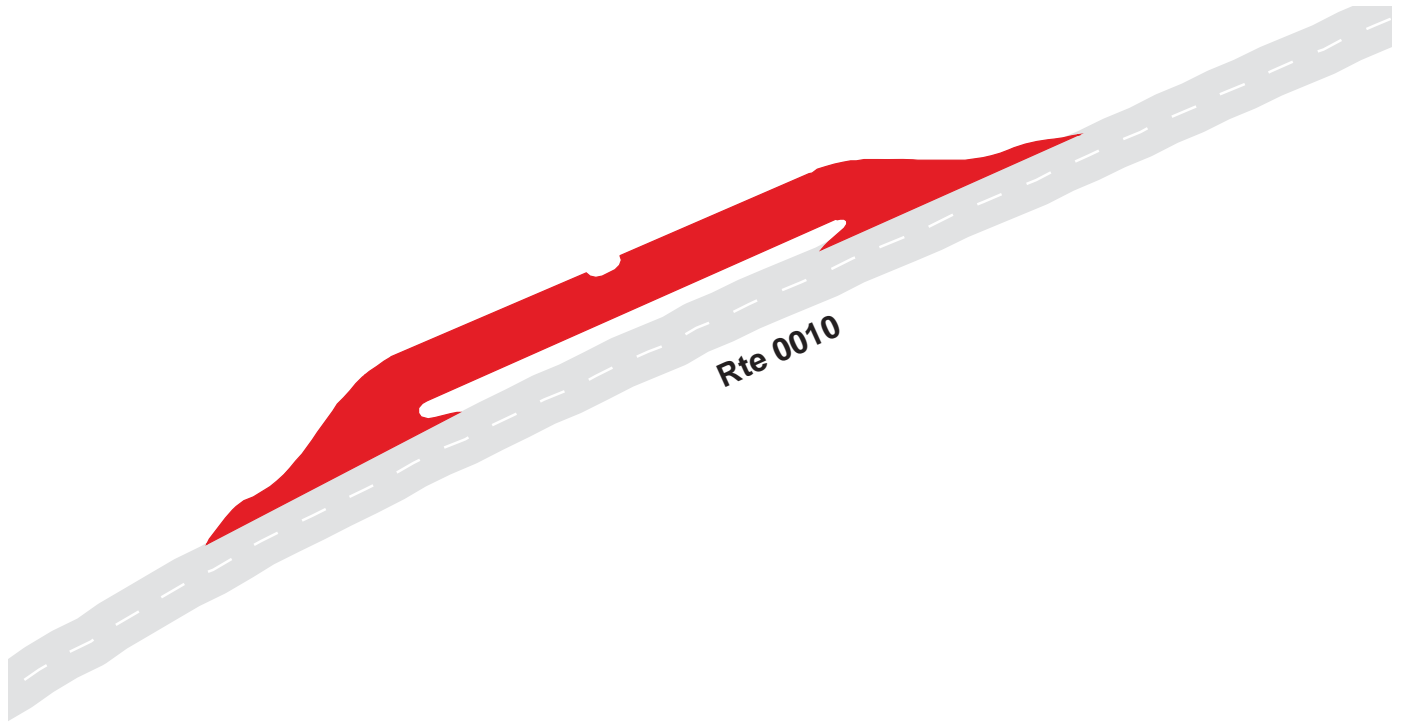
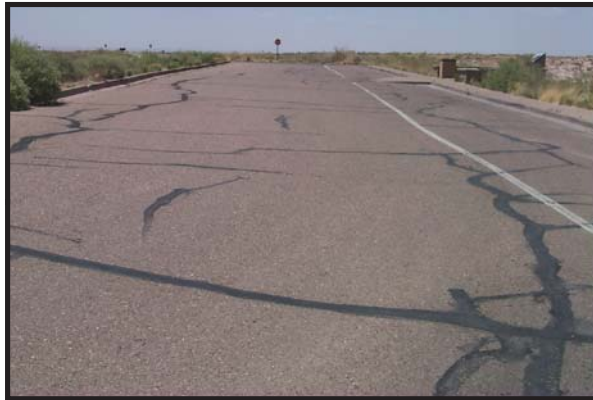
Route 0911

Route	Public / NonPublic	Date Visited	Area (sq ft)	Lane Miles *	Surface Type	Condition / PCR
0911	Public	1/23/1999	14646	0.25	AS	FAIR / 73

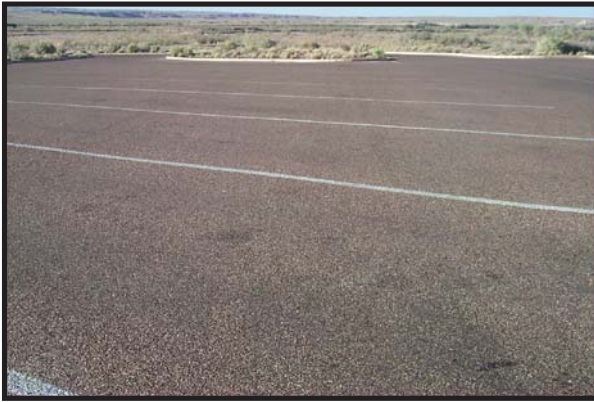
Route 0912

Route	Public / NonPublic	Date Visited	Area (sq ft)	Lane Miles *	Surface Type	Condition / PCR
0912	Public	1/23/1999	32450	0.56	OC	GOOD / 90

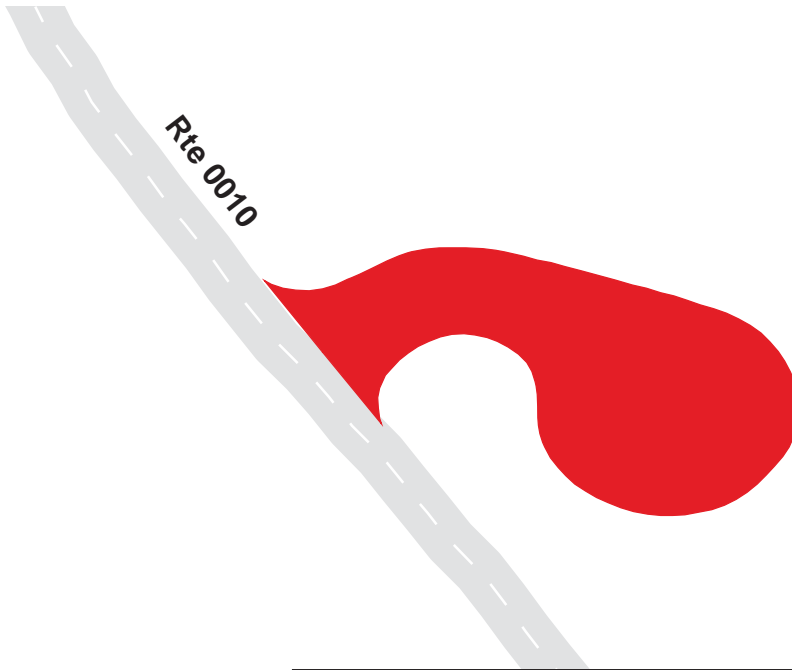
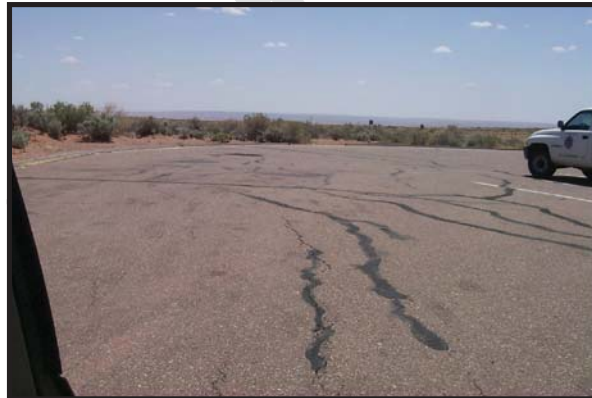
Route 0913

Route	Public / NonPublic	Date Visited	Area (sq ft)	Lane Miles *	Surface Type	Condition / PCR
0913	Public	1/23/1999	13843	0.24	AS	FAIR / 73

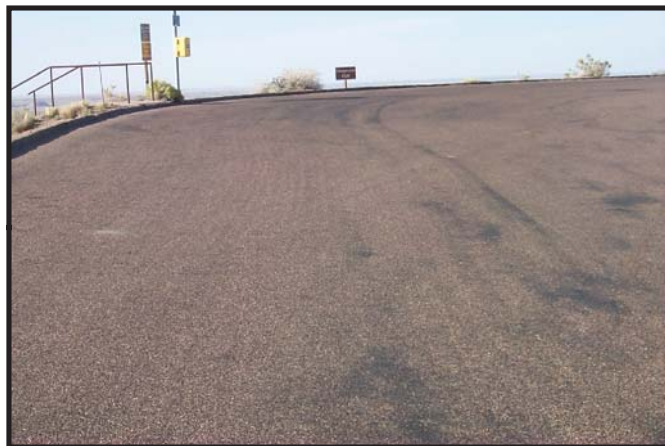
Route 0914

Route	Public / NonPublic	Date Visited	Area (sq ft)	Lane Miles *	Surface Type	Condition / PCR
0914	Public	1/23/1999	7364	0.13	OC	GOOD / 90

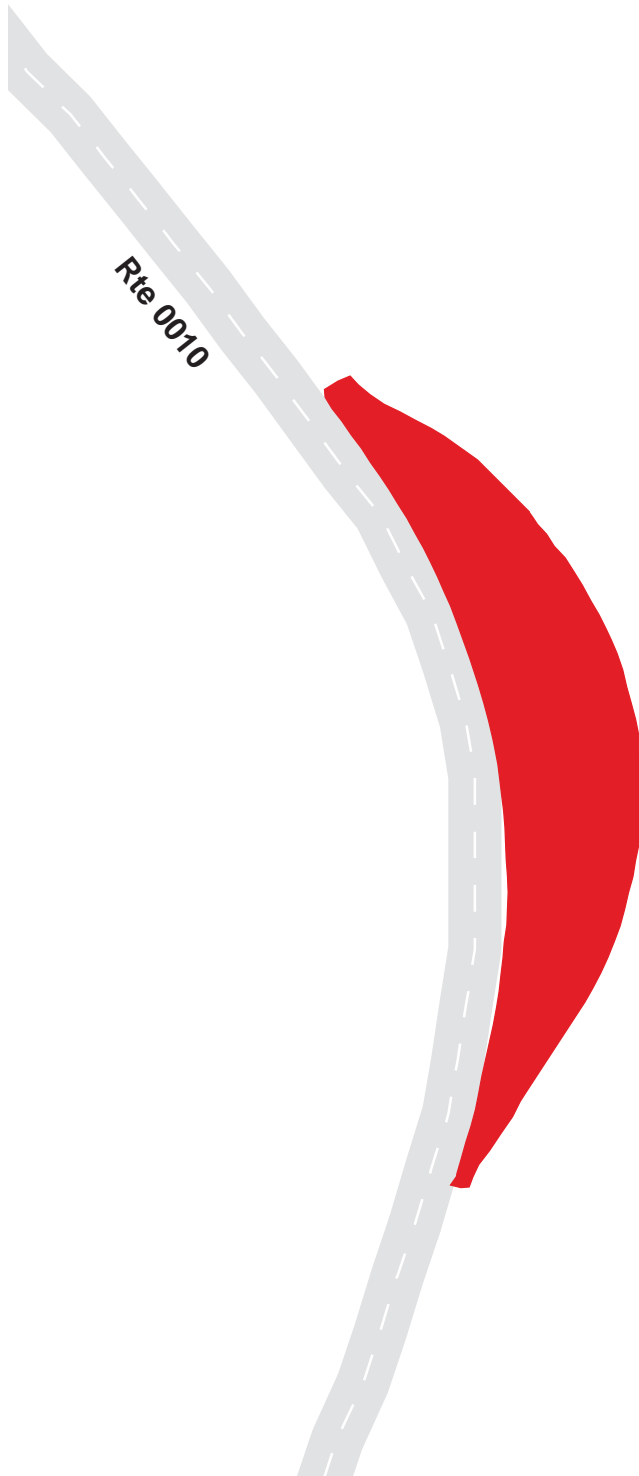
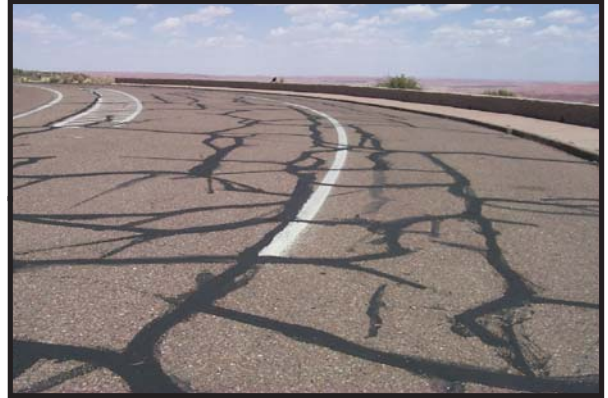
Route 0915

Route	Public / NonPublic	Date Visited	Area (sq ft)	Lane Miles *	Surface Type	Condition / PCR
0915	Public	1/23/1999	7319	0.13	AS	POOR / 45

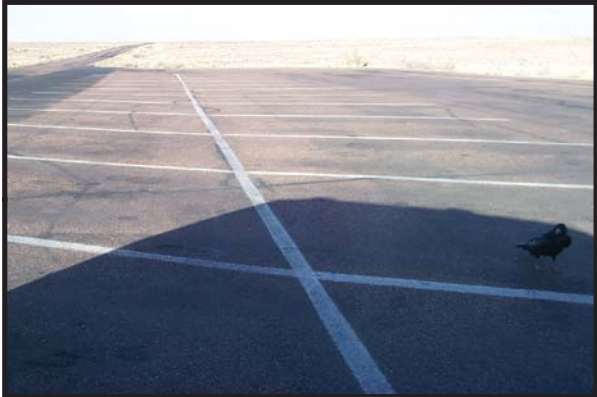
**Petrified Forest National Park
Route 0916**

Newspaper Rock Parking Area
At End of Route 0012

Route	Public / NonPublic	Date Visited	Area (sq ft)	Lane Miles *	Surface Type	Condition / PCR
0916	Public	1/23/1999	24380	0.42	OC	FAIR / 73

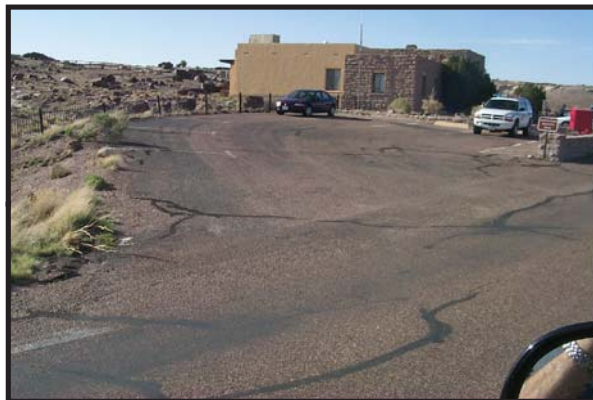
Route 0919

Route	Public / NonPublic	Date Visited	Area (sq ft)	Lane Miles *	Surface Type	Condition / PCR
0919	NonPublic	1/23/1999	4524	0.08	OC	FAIR / 73
