The Road Inventory of Pea Ridge National Military Park PERI - 7330

Road Inventory Program

Prepared By:
Federal Highway Administration
Eastern Federal Lands Highway Division
Cycle 3

Pea Ridge National Military Park in Arkansas

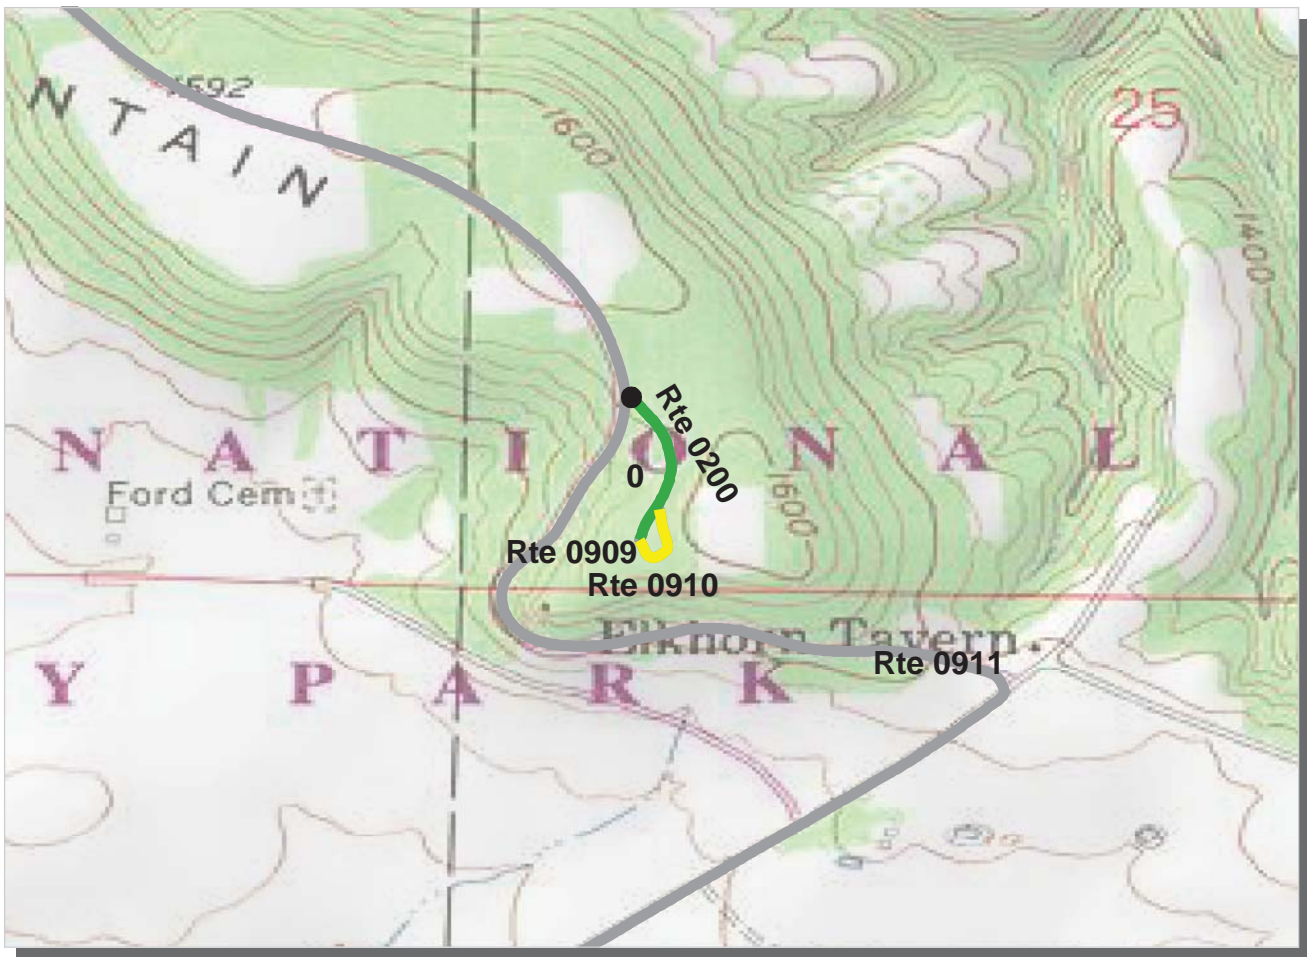
ROUTE: 0200 East Overlook Road **TOTAL LENGTH: 0.25 Miles**

Section Number	0				
Section Length (mi)	0.25				
AADT	**				
SADT	**				
ADT Date	**				
Cross Section Information					
Number of Lanes	2				
Paved Width (ft)	16				
Lane Width (ft)	8				
Shoulder Width (ft)	5				
Roadway Condition Information					
PCR (Pavement Condition Rating)	79				
RCI (Roughness Condition Index)	94				
SCR (Surface Condition Rating)	75				
Alligator Cracking Index	100				
Rutting Index	77				
Patching Index	100				
Transverse Cracking Index	99				
Longitudinal Cracking Index	98				
Shoulder Condition Rating	GOOD				
Drainage Condition Rating	GOOD

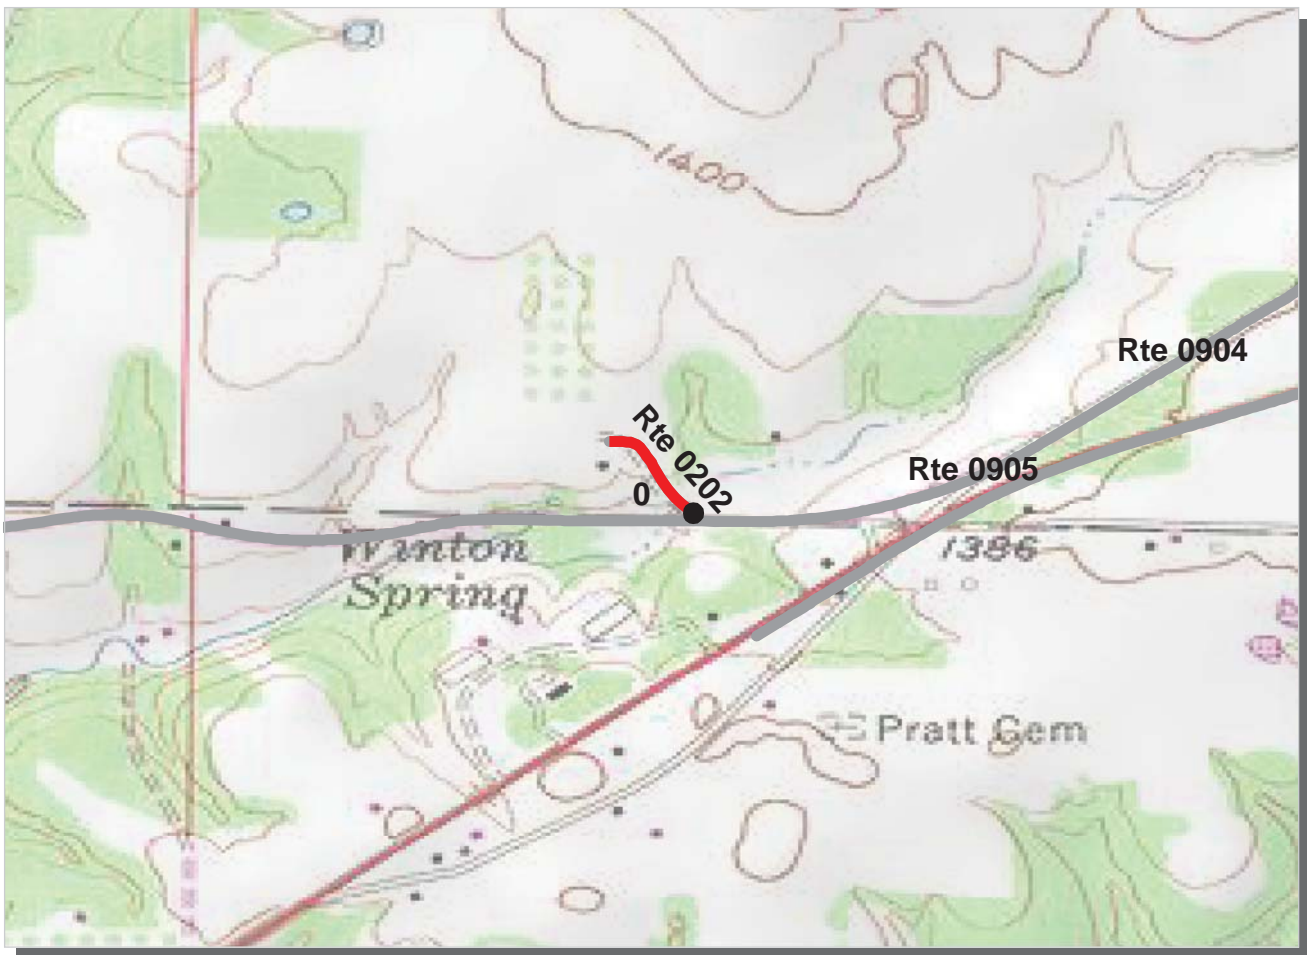
ROUTE: 0202 Winton Springs Road **TOTAL LENGTH: 0.11 Miles**

Section Number	0			
Section Length (mi)	0.11			
AADT	**			
SADT	**			
ADT Date	**			
Cross Section Information				
Number of Lanes	1			
Paved Width (ft)	7			
Lane Width (ft)	7			
Shoulder Width (ft)	0			
Roadway Condition Information				
PCR (Pavement Condition Rating)	26			
RCI (Roughness Condition Index)	NC			
SCR (Surface Condition Rating)	26			
Alligator Cracking Index	99			
Rutting Index	28			
Patching Index	99			
Transverse Cracking Index	98			
Longitudinal Cracking Index	98			
Shoulder Condition Rating	N/A			
Drainage Condition Rating	GOOD

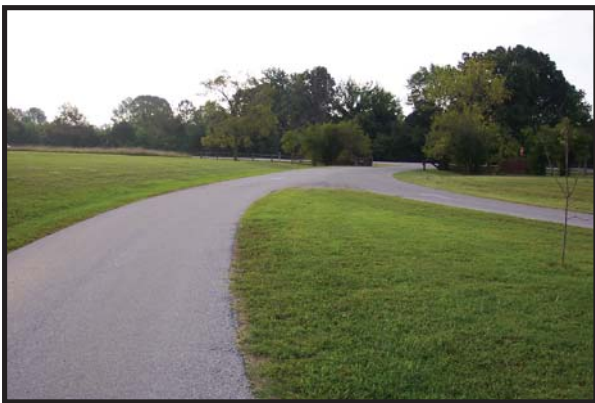
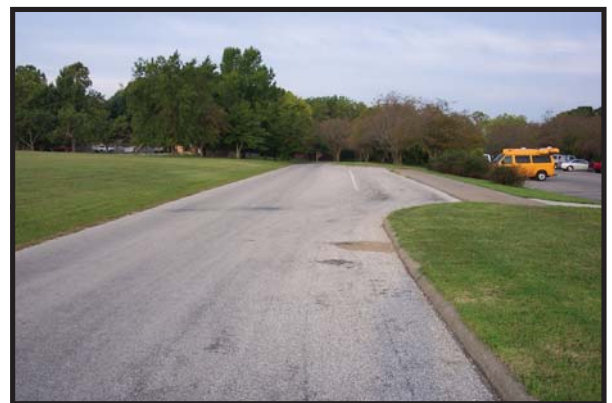
Route 0901

Route	Public / NonPublic	Date Visited	Area (sq ft)	Lane Miles *	Surface Type	Condition / PCR
0901	NonPublic	9/11/2003	5898	0.10	AS	POOR / 45

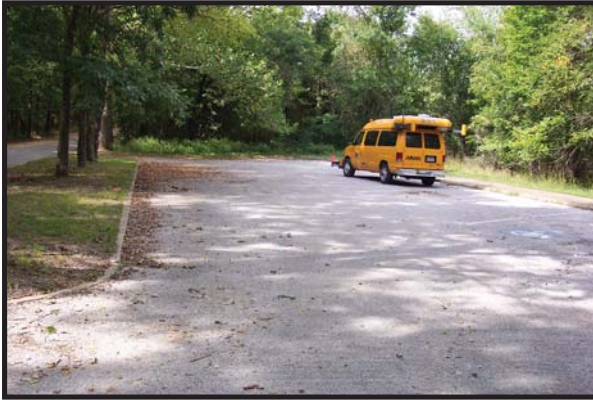
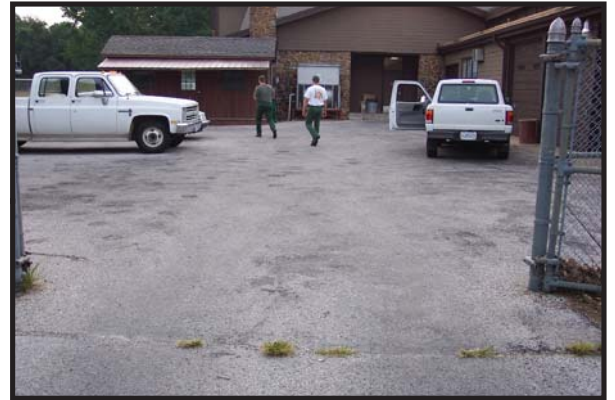
Route 0905

Route	Public / NonPublic	Date Visited	Area (sq ft)	Lane Miles *	Surface Type	Condition / PCR
0905	Public	9/11/2003	7747	0.13	NC	GOOD / 90

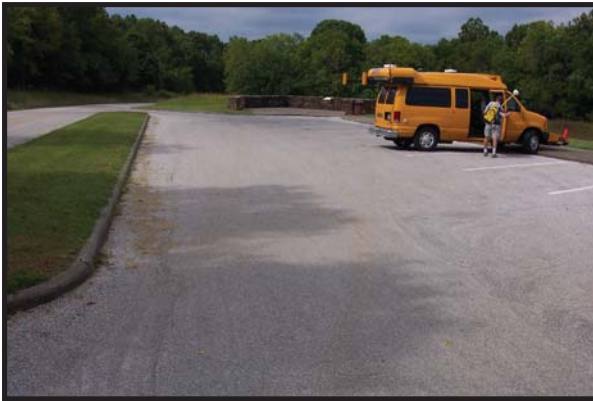
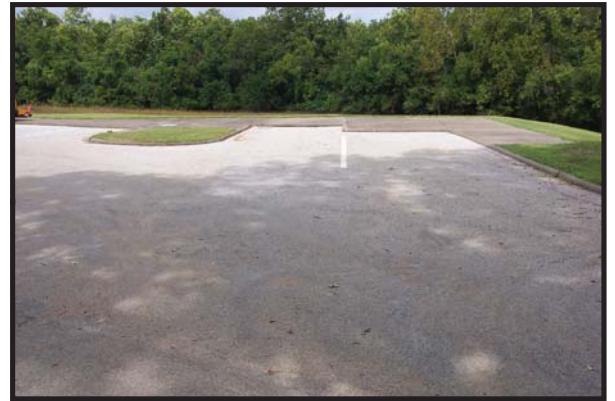
Route 0906

Route	Public / NonPublic	Date Visited	Area (sq ft)	Lane Miles *	Surface Type	Condition / PCR
0906	Public	9/11/2003	3553	0.06	NC	GOOD / 90

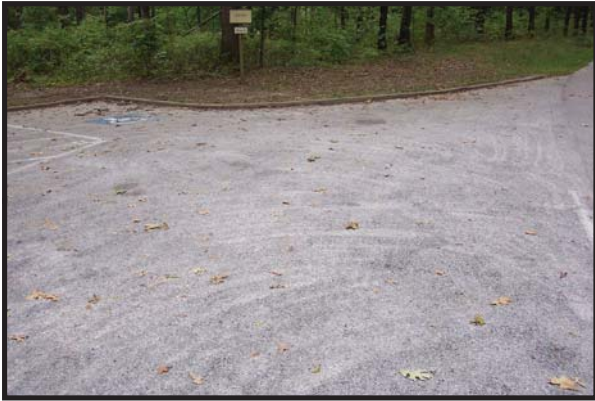
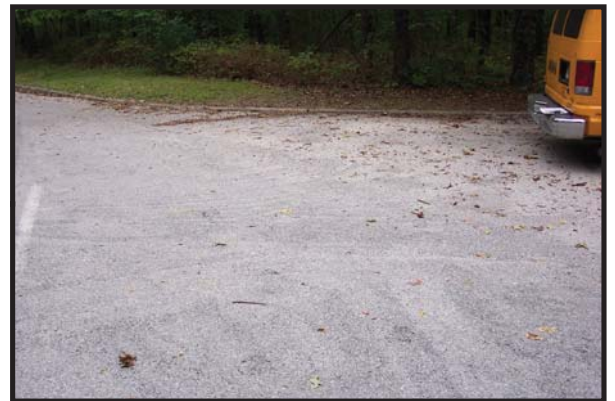
Route 0907

Route	Public / NonPublic	Date Visited	Area (sq ft)	Lane Miles *	Surface Type	Condition / PCR
0907	Public	9/11/2003	8677	0.15	NC	FAIR / 73

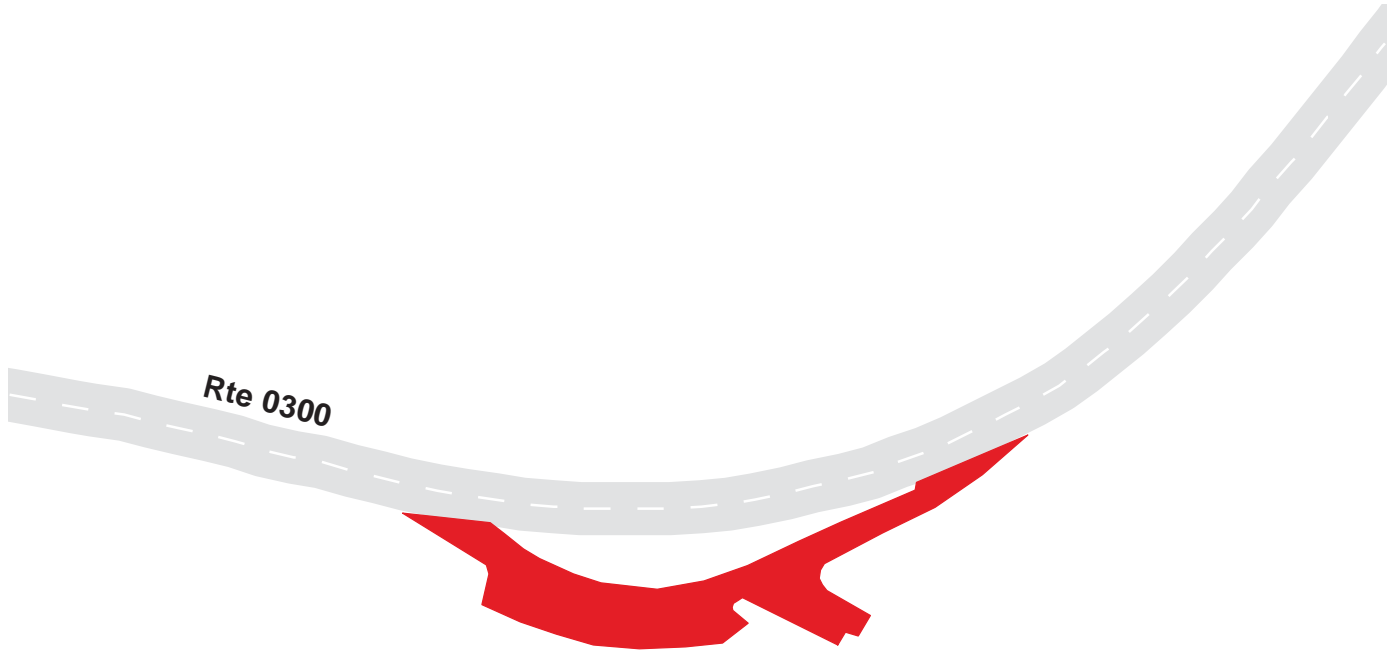
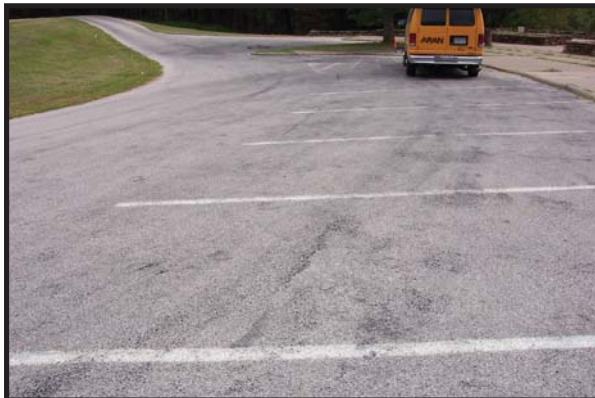
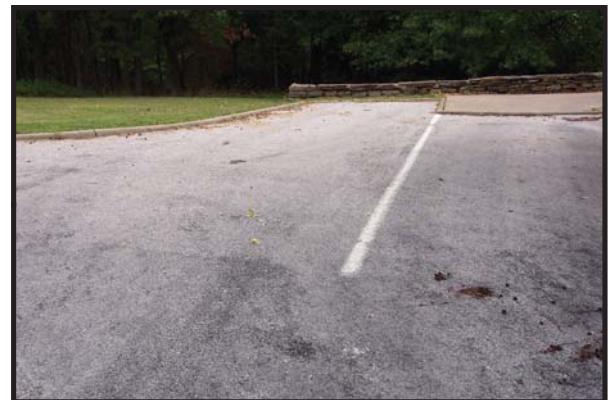
Route 0909

Route	Public / NonPublic	Date Visited	Area (sq ft)	Lane Miles *	Surface Type	Condition / PCR
0909	Public	9/11/2003	3009	0.05	NC	GOOD / 90

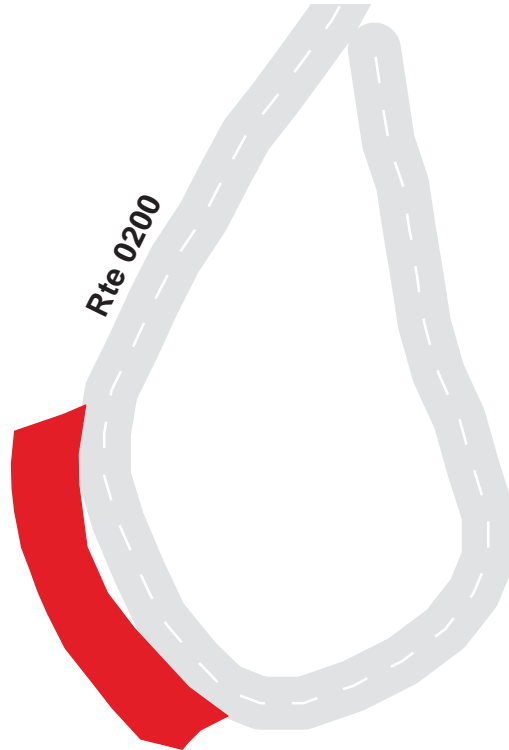
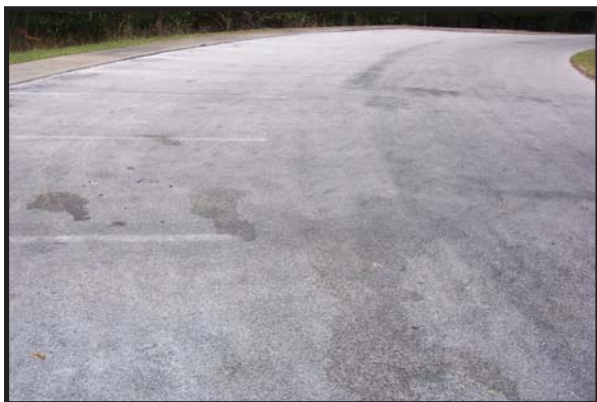
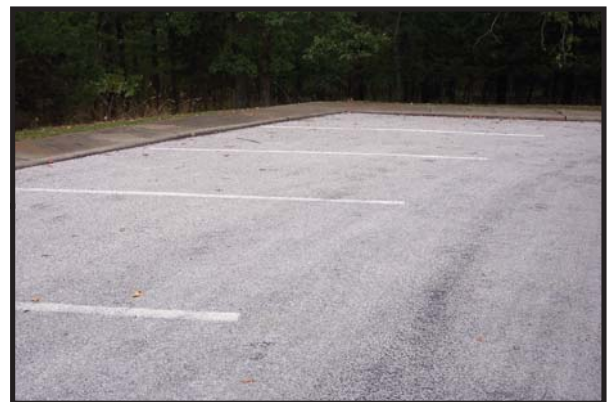
Route 0910

Route	Public / NonPublic	Date Visited	Area (sq ft)	Lane Miles *	Surface Type	Condition / PCR
0910	Public	9/11/2003	1756	0.03	NC	GOOD / 90

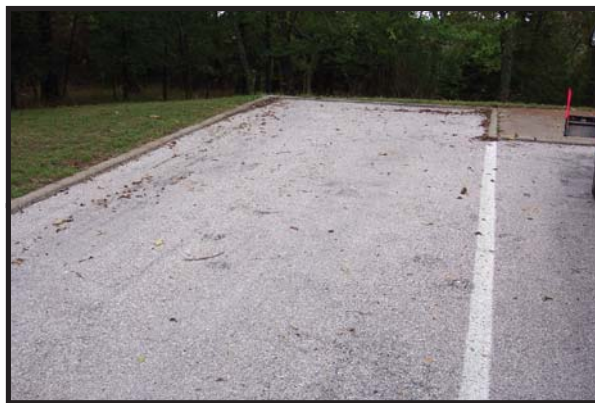
Route 0911

Route	Public / NonPublic	Date Visited	Area (sq ft)	Lane Miles *	Surface Type	Condition / PCR
0911	Public	9/11/2003	8110	0.14	NC	GOOD / 90

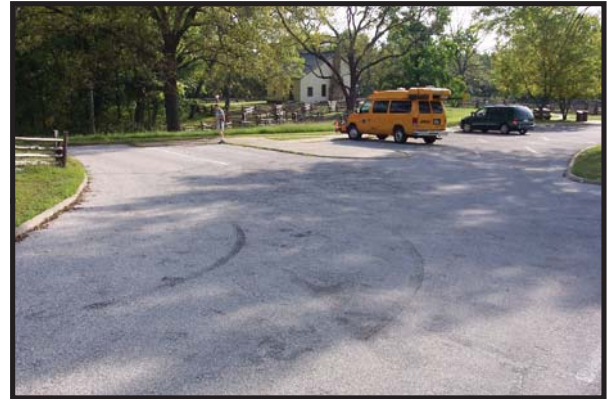
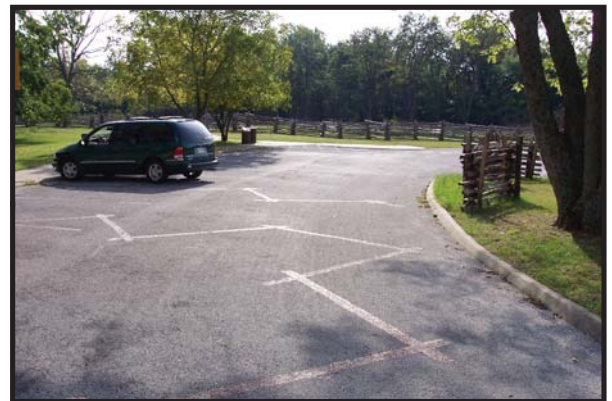
Route 0912

Route	Public / NonPublic	Date Visited	Area (sq ft)	Lane Miles *	Surface Type	Condition / PCR
0912	Public	9/11/2003	5503	0.09	AS	FAIR / 73

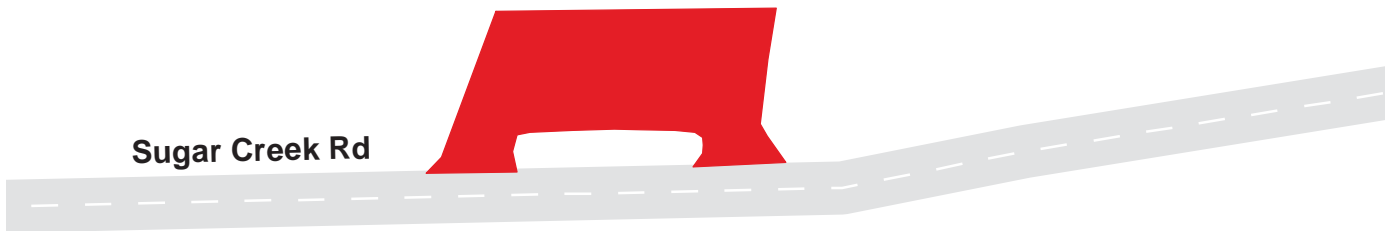
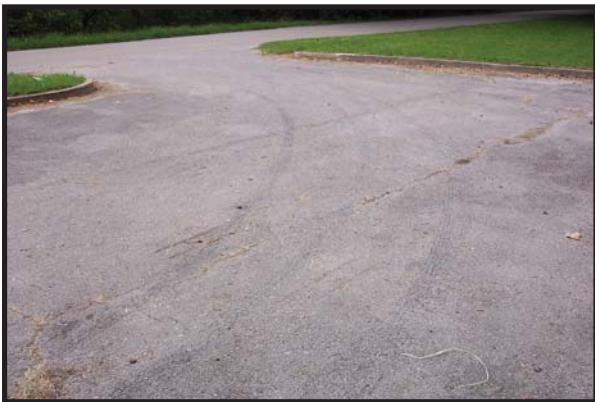
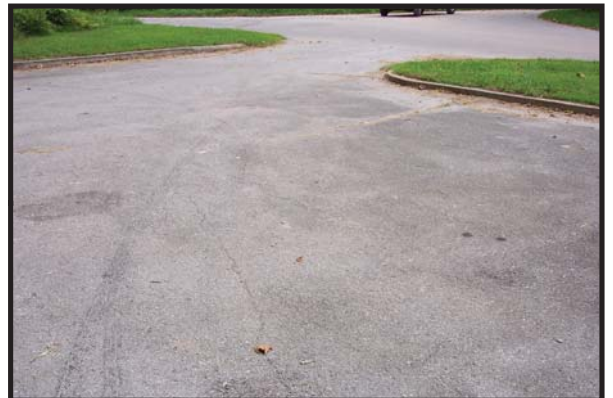
Route 0913

Route	Public / NonPublic	Date Visited	Area (sq ft)	Lane Miles *	Surface Type	Condition / PCR
0913	NonPublic	9/11/2003	1573	0.03	NC	GOOD / 90
