The Road Inventory of Petroglyph National Monument PETR – 7570

Road Inventory Program

Prepared By:
Federal Highway Administration
Eastern Federal Lands Highway Division
Cycle 3

Petroglyph National Monument in New Mexico

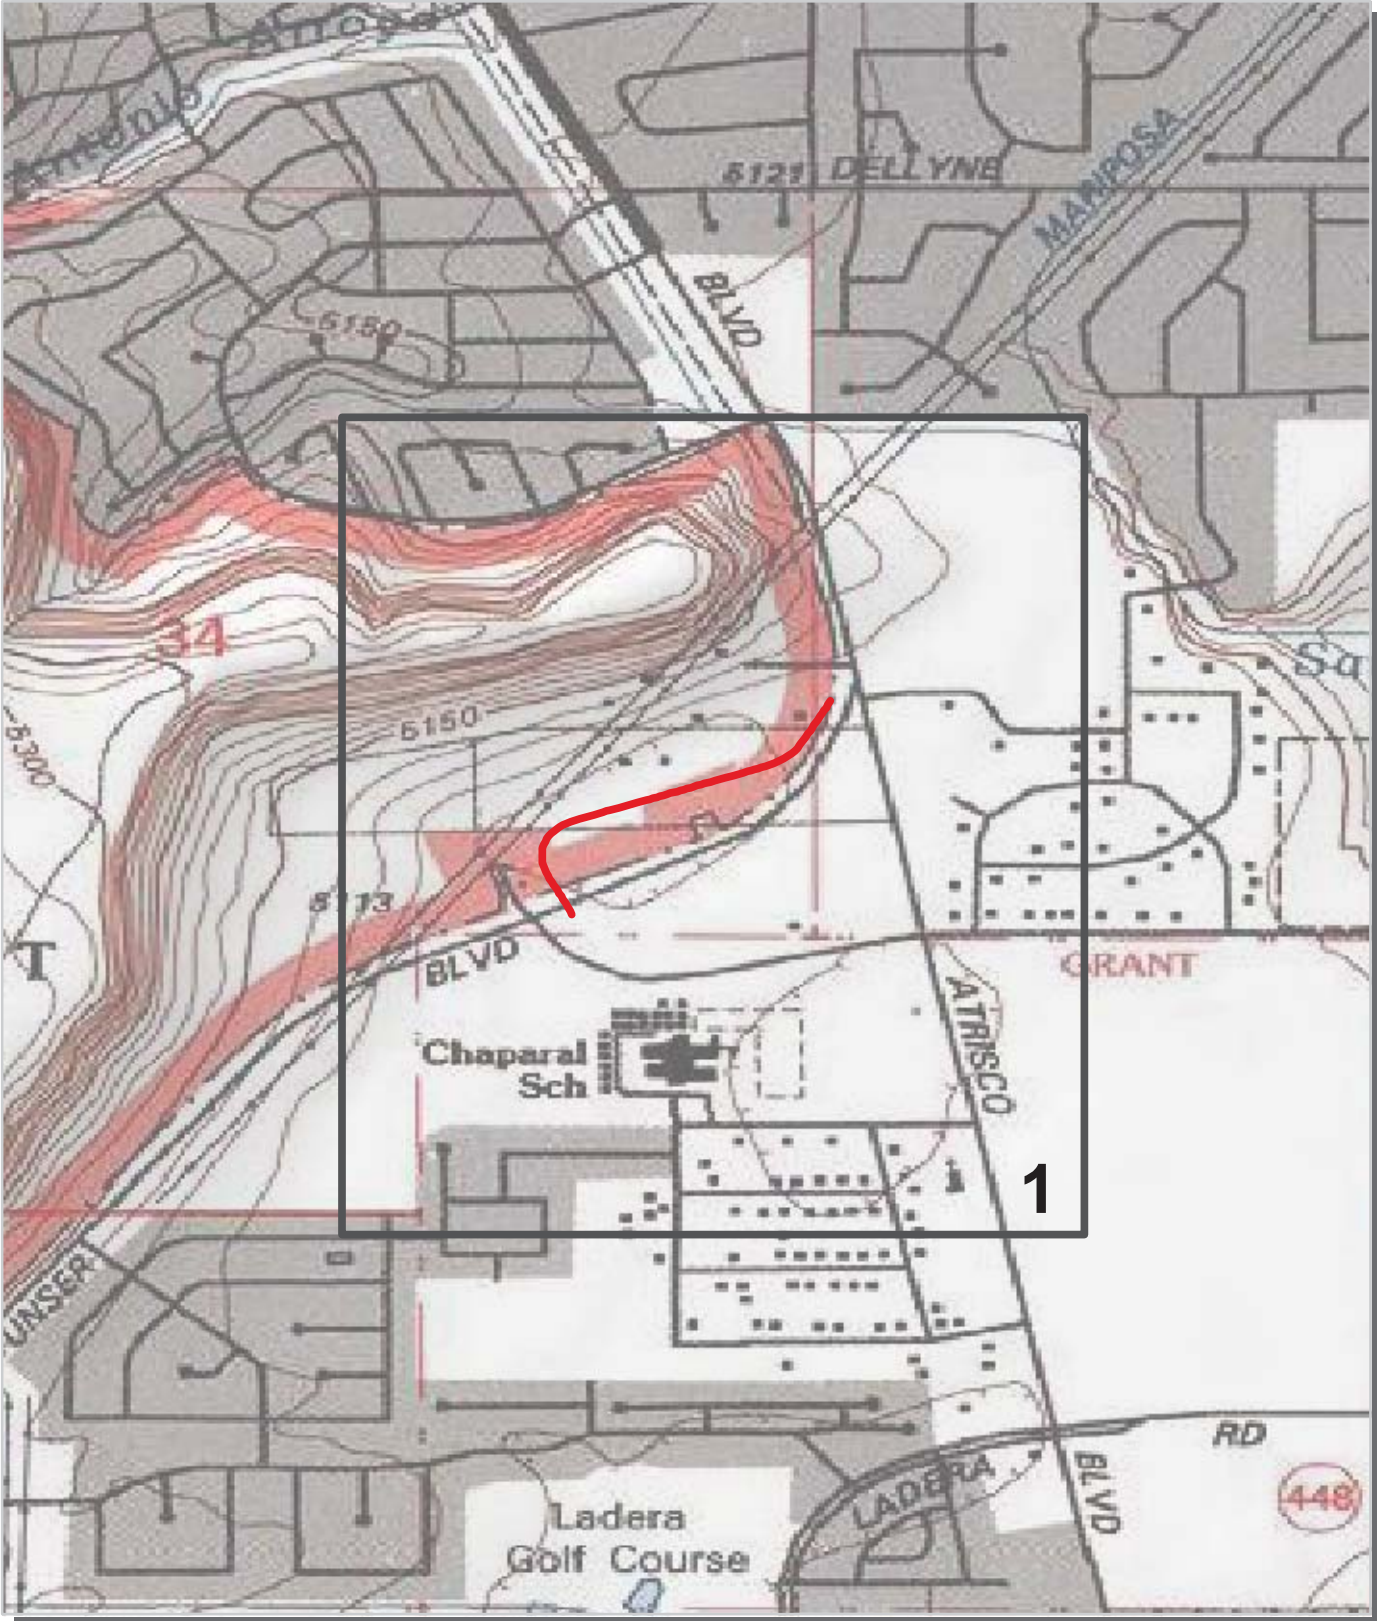
Petroglyph National Monument Route Location Key Map

Park Owned Routes

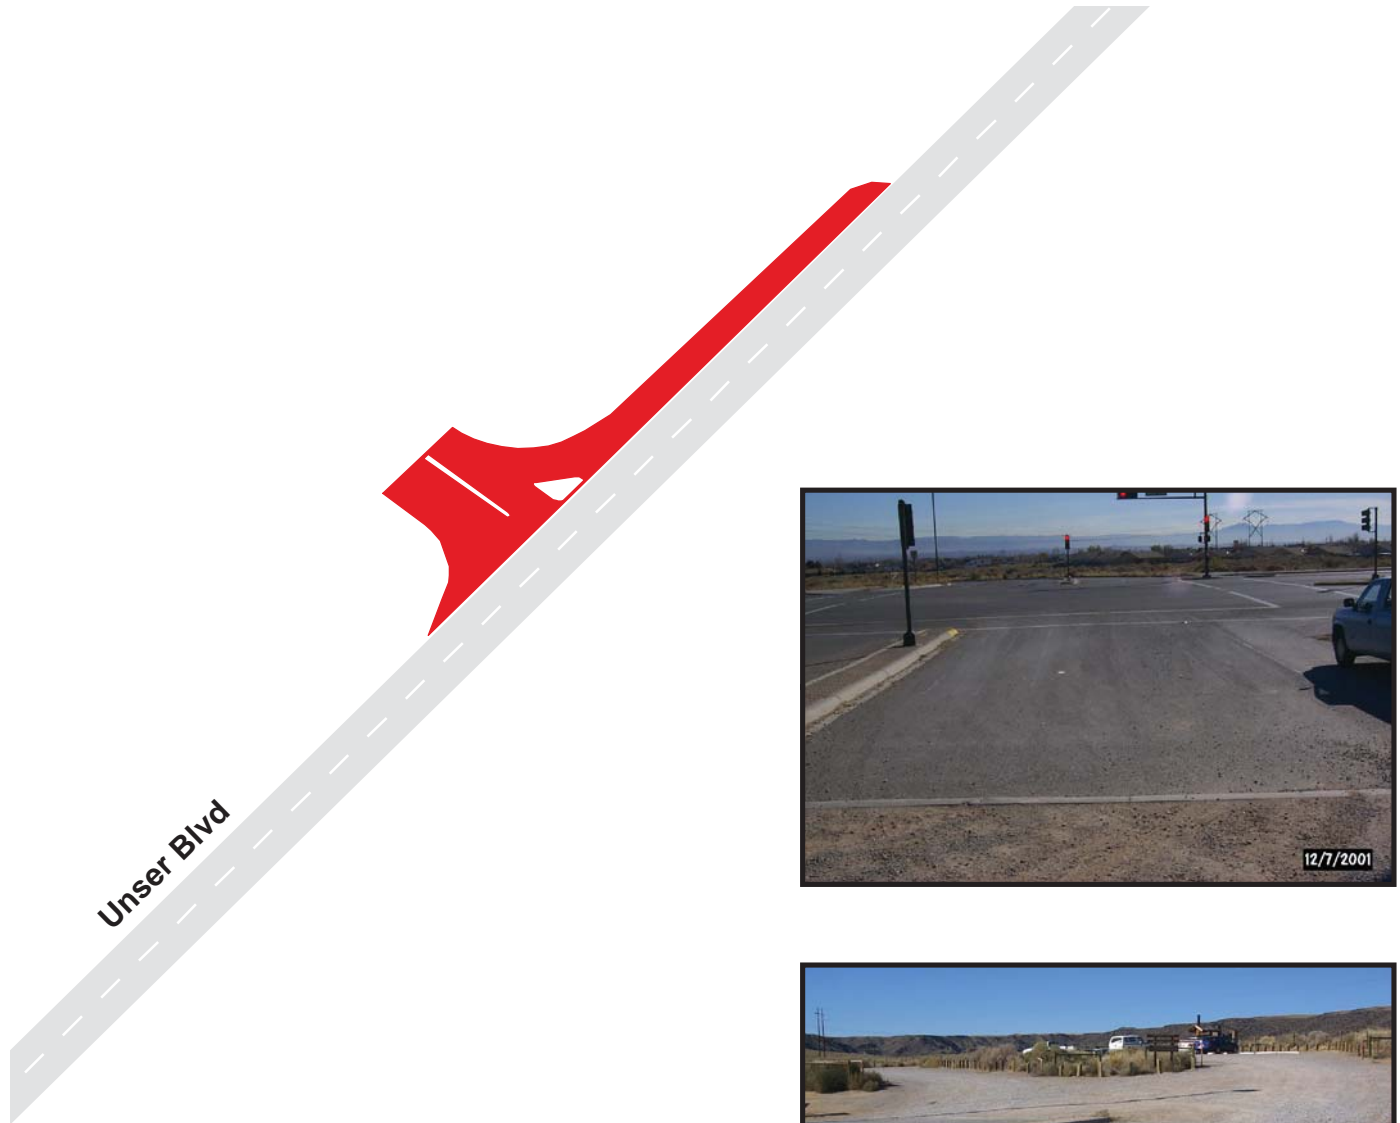
Route 0902

RINCONADA CANYON PARKING

Route	Public / NonPublic	Date Visited	Area (sq ft)	Lane Miles *	Surface Type	Condition / PCR
0902	Public	12/7/2001	11818	0.20	AS	GOOD / 90
