**The Road Inventory
of
Perry's Victory & International Peace
Memorial
PEVI – 6516**

Road Inventory Program

Prepared By:
Federal Highway Administration
Eastern Federal Lands Highway Division
Cycle 3

Perry's Victory and International Peace in Ohio

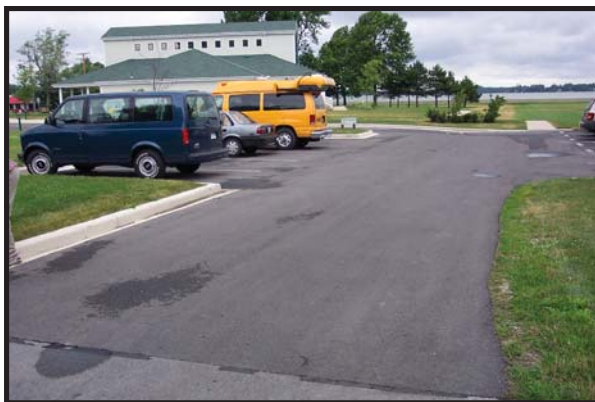
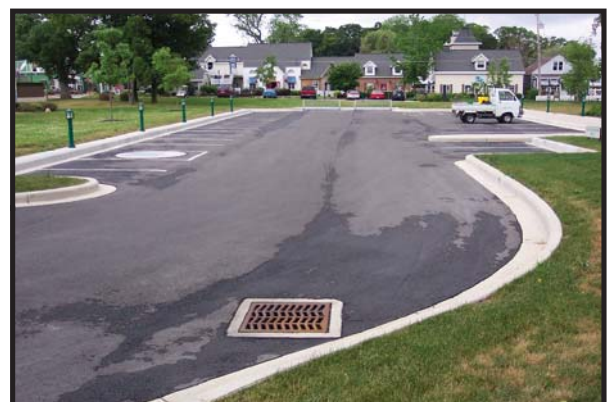
Route 0900

VISITOR CENTER PARKING
FROM DELAWARE AVENUE

Route	Public / NonPublic	Date Visited	Area (sq ft)	Lane Miles *	Surface Type	Condition / PCR
0900	Public	7/11/2003	9431	0.16	AS	GOOD / 90

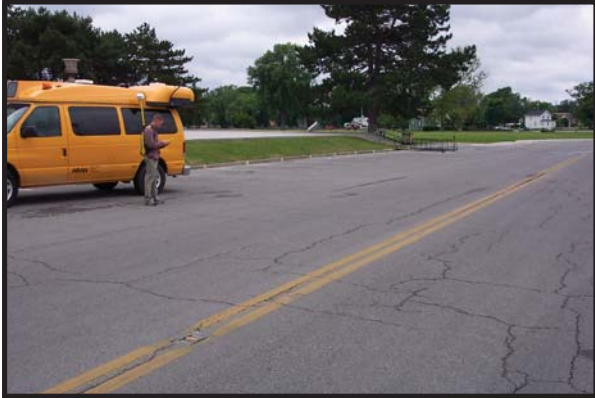
Route 0901

MONUMENT PARKING
FROM S.R. 357 (BAY VIEW AVENUE)

Route	Public / NonPublic	Date Visited	Area (sq ft)	Lane Miles *	Surface Type	Condition / PCR
0901	Public	7/11/2003	2864	0.05	AS	FAIR / 73

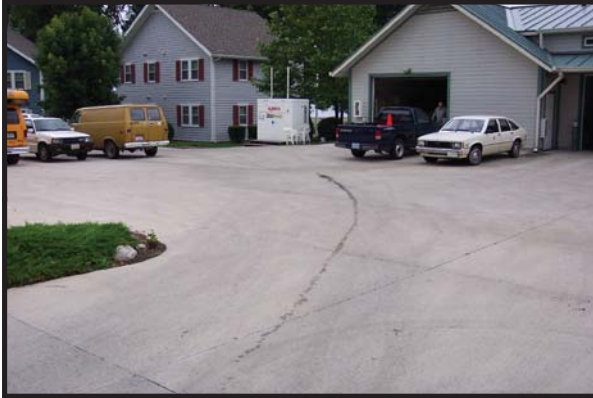
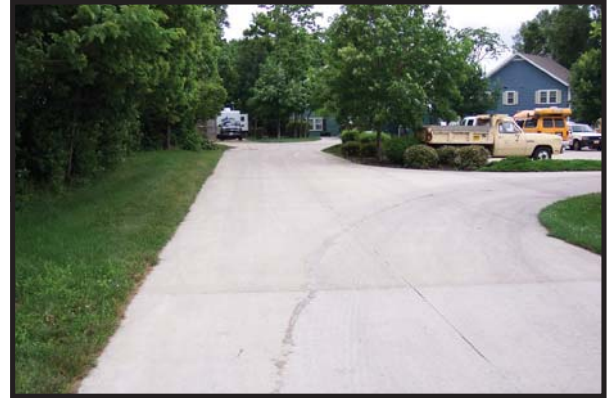
Route 0902

MAINTENANCE PARKING
FROM S.R. 357 (BAY VIEW AVENUE)

Route	Public / NonPublic	Date Visited	Area (sq ft)	Lane Miles *	Surface Type	Condition / PCR
0902	NonPublic	7/11/2003	21776	0.37	CO	GOOD / 90

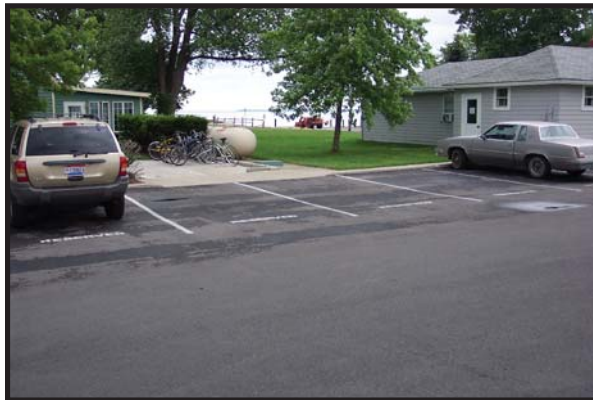
Route 0903

RANGER/RESIDENCE PARKING
FROM ROUTE 0900

Route	Public / NonPublic	Date Visited	Area (sq ft)	Lane Miles *	Surface Type	Condition / PCR
0903	NonPublic	7/11/2003	1554	0.03	AS	GOOD / 90

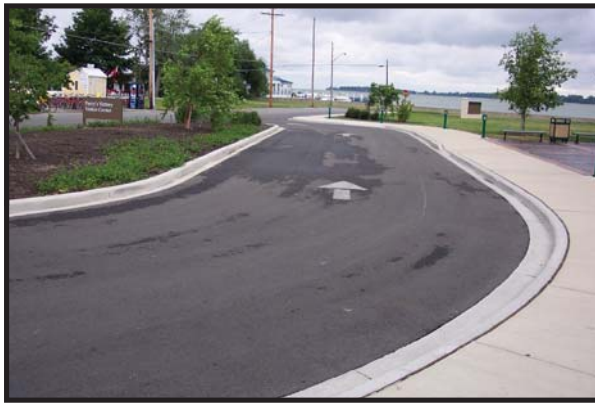
Route 0904

VISITOR CENTER DROP OFF AREA
FROM TOLEDO AVENUE

Route	Public / NonPublic	Date Visited	Area (sq ft)	Lane Miles *	Surface Type	Condition / PCR
0904	Public	7/11/2003	3784	0.07	AS	GOOD / 90

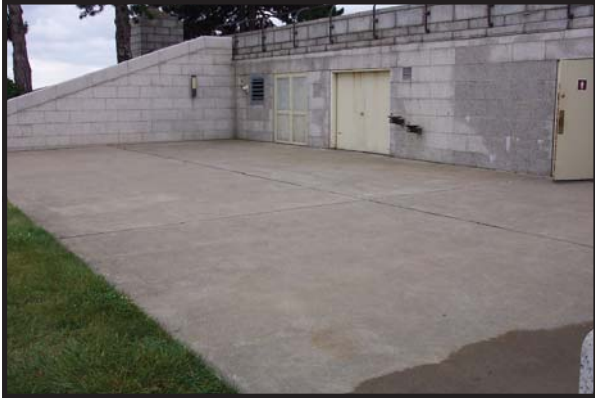
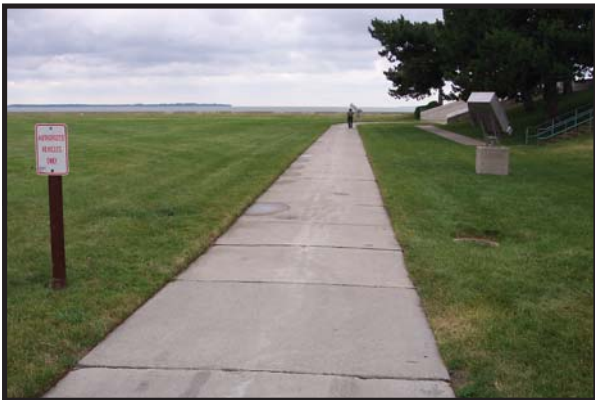
Route 0905

MONUMENT SERVICE AREA
FROM S.R. 357 (BAY VIEW AVENUE)

Route	Public / NonPublic	Date Visited	Area (sq ft)	Lane Miles *	Surface Type	Condition / PCR
0905	NonPublic	7/11/2003	4070	0.07	CO	GOOD / 90
