The Road Inventory of Pinnacles National Monument PINN – 8450

Road Inventory Program

Prepared By:
Federal Highway Administration
Eastern Federal Lands Highway Division
Cycle 3

Pinnacles National Monument in California

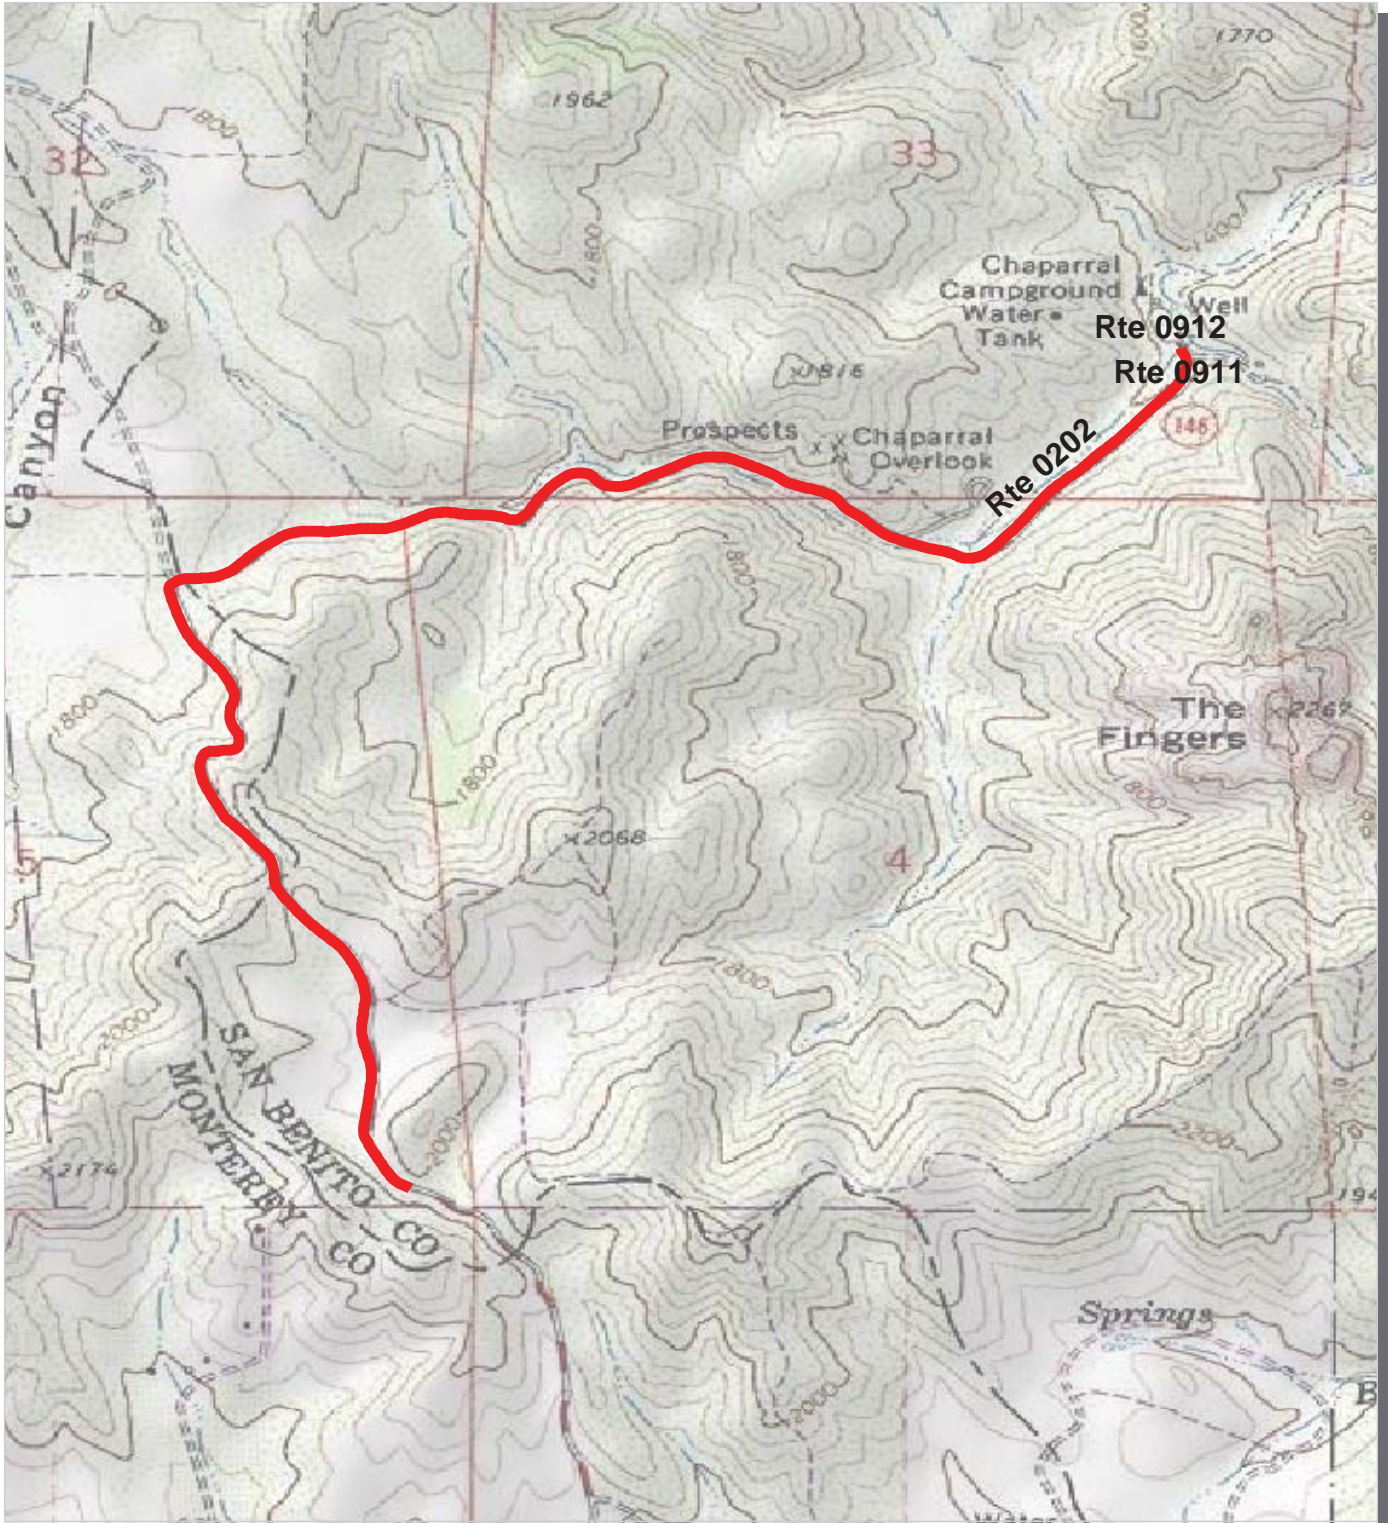
Pinnacles National Monument Route Condition Area Map 1 PCR - Mile by Mile

PCR	Poor		Fair		Good		Excellent	
	(<=60)		(61 - 84)		(85 - 94)		(95 - 100)

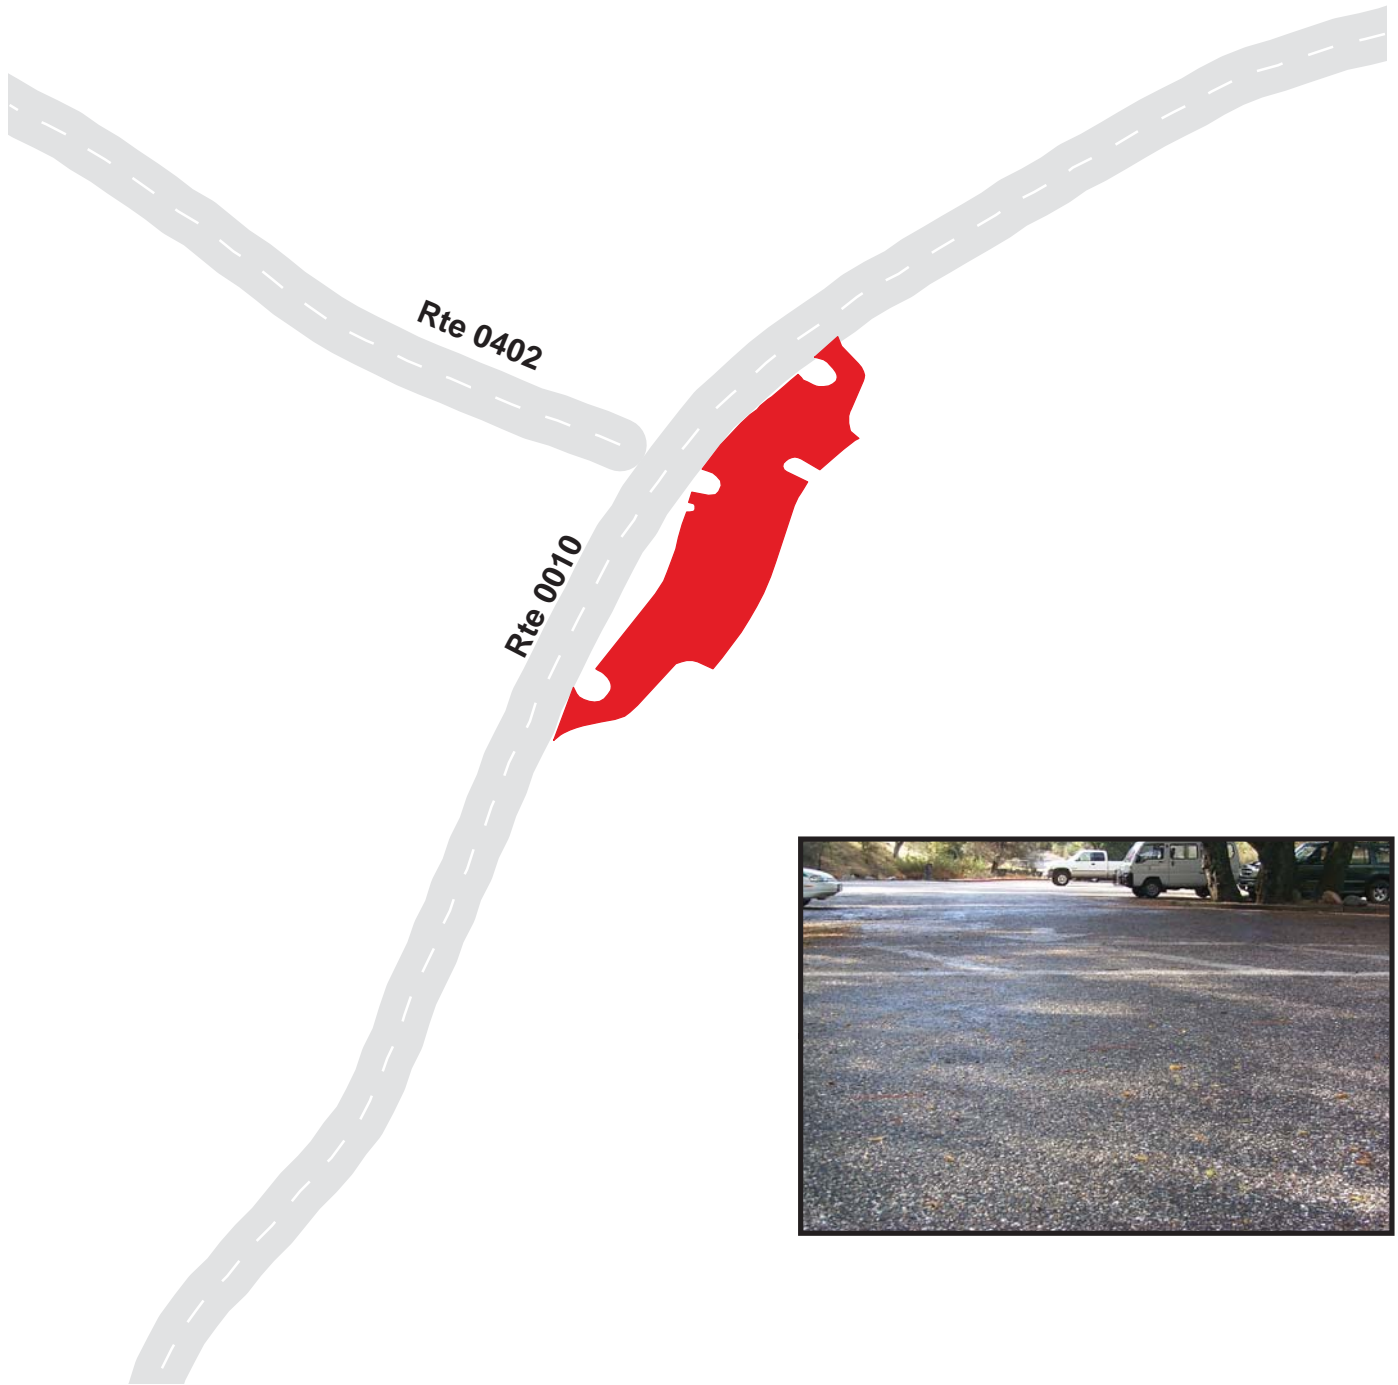
Pinnacles National Monument
Route 0901
 HEADQUARTERS SERVICE PARKING
 From Route 0900

Route	Public / NonPublic	Date Visited	Area (sq ft)	Lane Miles *	Surface Type	Condition / PCR
0901	NonPublic	11/13/2001	5149	0.09	AS	GOOD / 90

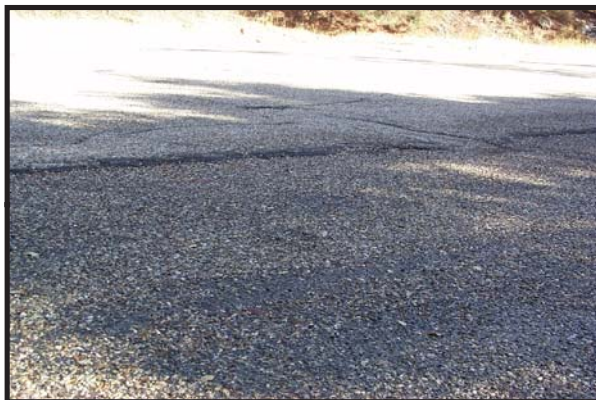
Pinnacles National Monument
Route 0903
 CONDOR GULCH RESTROOM PARKING
 From Route 0402

Route	Public / NonPublic	Date Visited	Area (sq ft)	Lane Miles *	Surface Type	Condition / PCR
0903	Public	11/13/2001	4508	0.08	OC	FAIR / 73

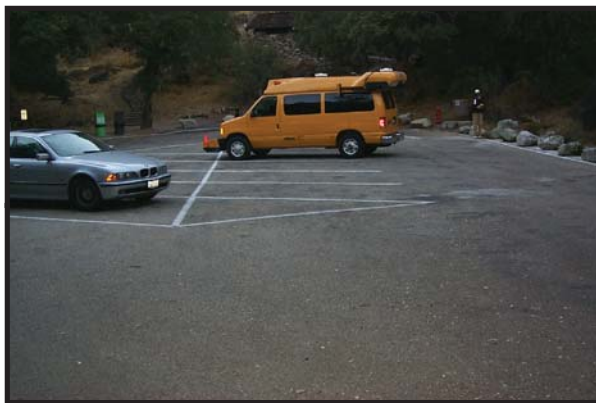
Pinnacles National Monument
Route 0908A
 CHALONE CREEK PICNIC AREA PARKING A
 From Route 0200

Route	Public / NonPublic	Date Visited	Area (sq ft)	Lane Miles *	Surface Type	Condition / PCR
0908A	Public	11/6/2001	1972	0.03	OC	POOR / 45

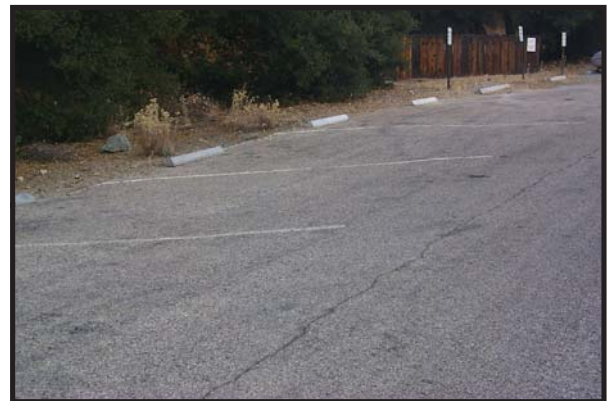
Pinnacles National Monument
Route 0908B
 CHALONE CREEK PICNIC AREA PARKING B
 From Route 0200

Route	Public / NonPublic	Date Visited	Area (sq ft)	Lane Miles *	Surface Type	Condition / PCR
0908B	Public	11/6/2001	1246	0.02	OC	POOR / 45

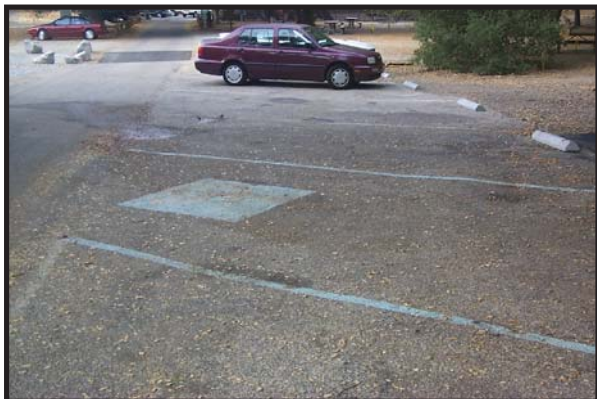
Pinnacles National Monument
Route 0908C
 CHALONE CREEK PICNIC AREA PARKING C
 From Route 0200

Route	Public / NonPublic	Date Visited	Area (sq ft)	Lane Miles *	Surface Type	Condition / PCR
0908C	Public	11/6/2001	2892	0.05	OC	POOR / 45

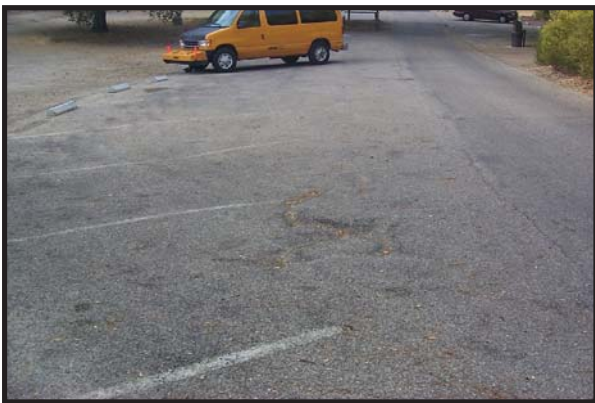
Pinnacles National Monument
Route 0909
 CHALONE CREEK MAINTENANCE AREA
 From Route 0200

Route	Public / NonPublic	Date Visited	Area (sq ft)	Lane Miles *	Surface Type	Condition / PCR
0909	NonPublic	11/6/2001	14520	0.25	OC	POOR / 45

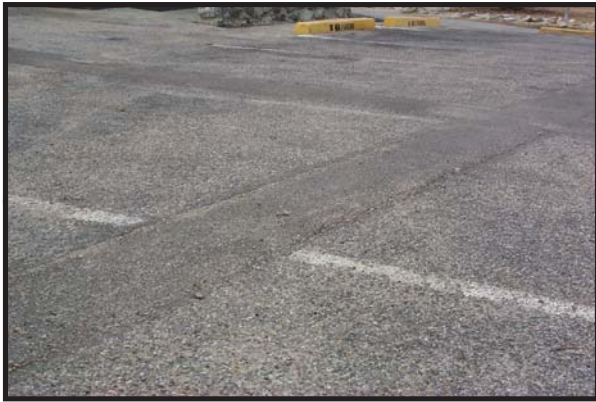
Pinnacles National Monument
Route 0912
 CHAPARRAL DAY USE AREA PARKING
 From Route 0202

Route	Public / NonPublic	Date Visited	Area (sq ft)	Lane Miles *	Surface Type	Condition / PCR
0912	Public	11/13/2001	19588	0.34	OC	FAIR / 73
