The Road Inventory of Pipestone National Monument PIPE – 6540

Road Inventory Program

Prepared By:
Federal Highway Administration
Eastern Federal Lands Highway Division
Cycle 3

Pipestone National Monument in Minnesota

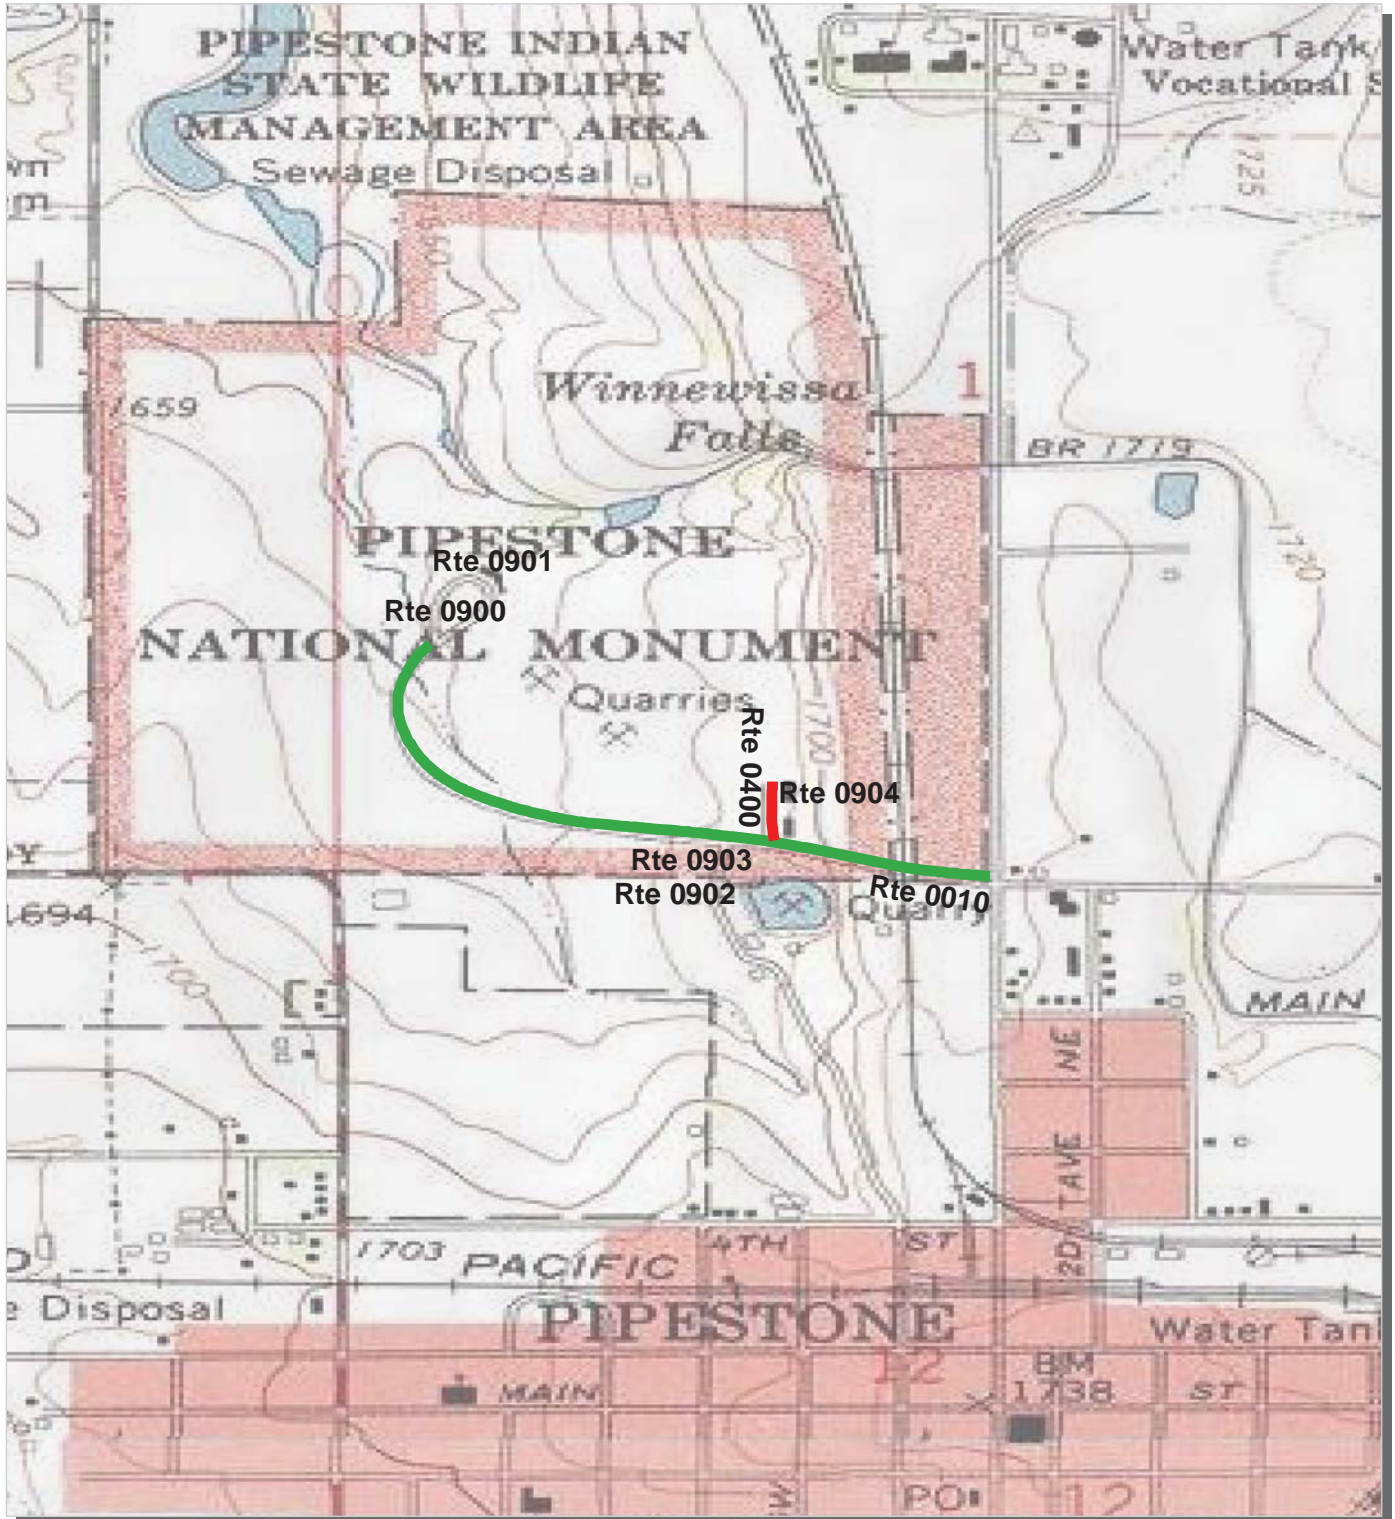
Pipestone National Monument Route Condition Key Map PCR - Mile by Mile

PCR	Poor		Fair		Good		Excellent	
		(≤60)		(61 - 84)		(85 - 94)		(95 - 100)

* If the PCR rating is not available for a section, the SCR rating will be displayed. See appendix for definitions and formulas.

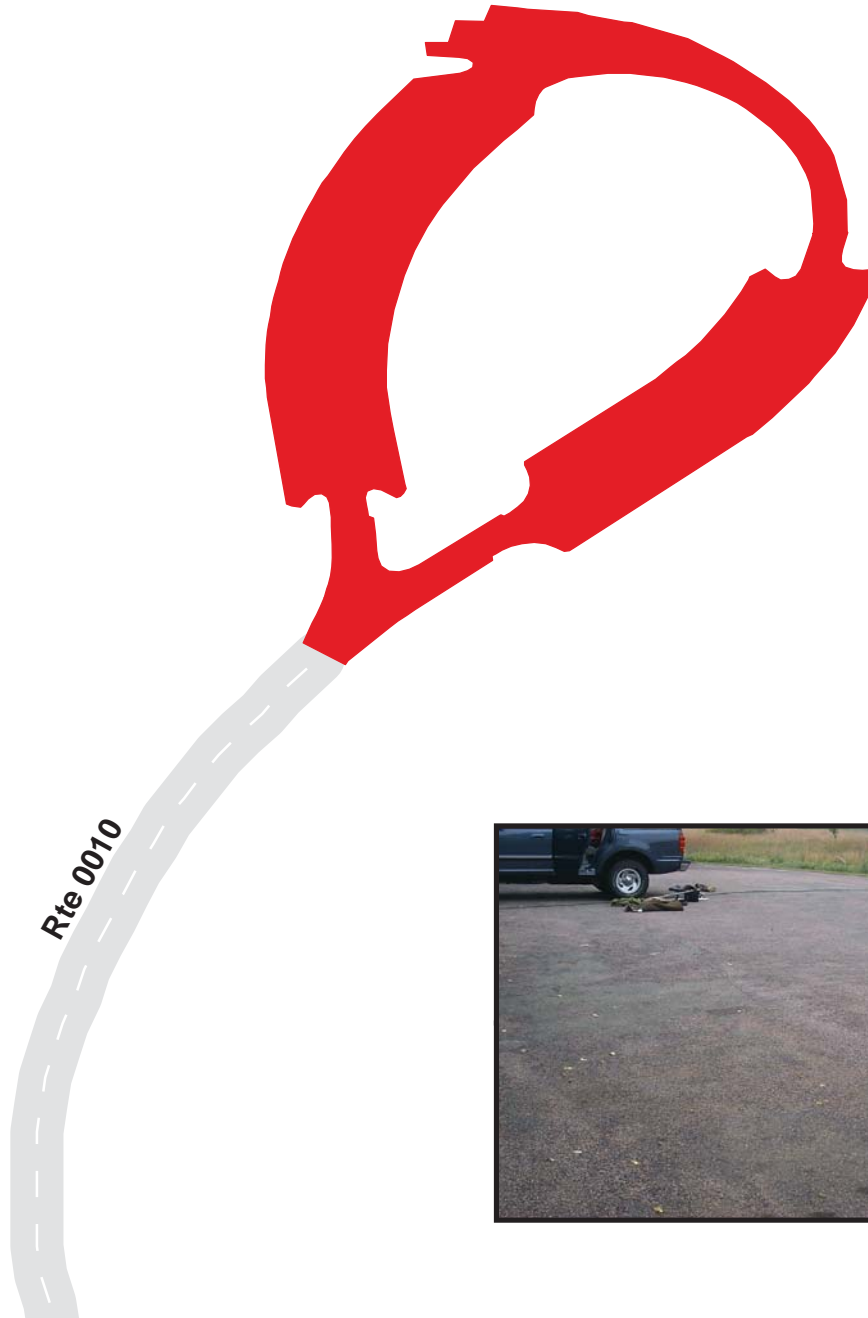
Route 0901

Route	Public / NonPublic	Date Visited	Area (sq ft)	Lane Miles *	Surface Type	Condition / PCR
0901	NonPublic	10/11/2001	5399	0.09	OC	FAIR / 73

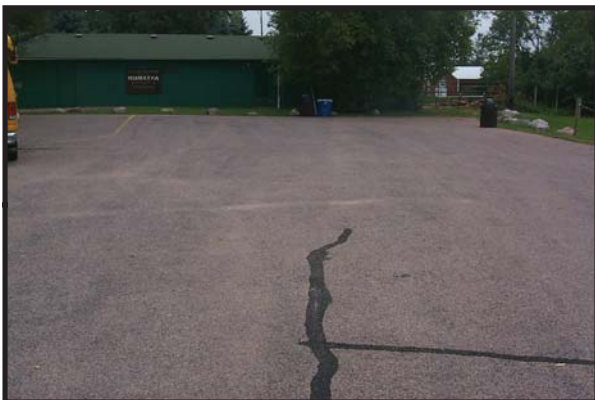
Route 0903

Route	Public / NonPublic	Date Visited	Area (sq ft)	Lane Miles *	Surface Type	Condition / PCR
0903	Public	10/11/2001	1231	0.02	OC	FAIR / 73

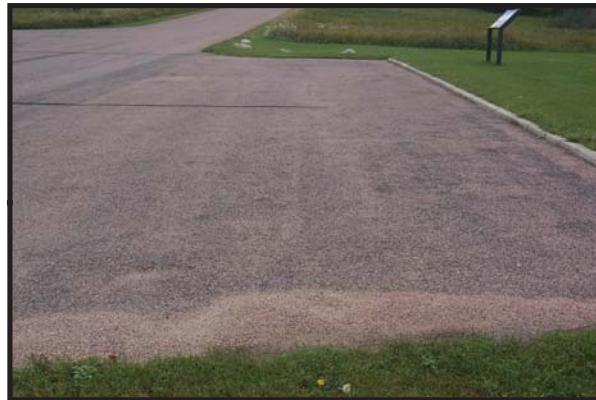
Route 0904

Route	Public / NonPublic	Date Visited	Area (sq ft)	Lane Miles *	Surface Type	Condition / PCR
0904	NonPublic	10/11/2001	1392	0.02	OC	FAIR / 73
