**The Road Inventory
of
Pictured Rocks National Lakeshore
PIRO - 6320**

Road Inventory Program

Prepared By:
Federal Highway Administration
Eastern Federal Lands Highway Division
Cycle 3

Pictured Rocks National Lakeshore in Michigan

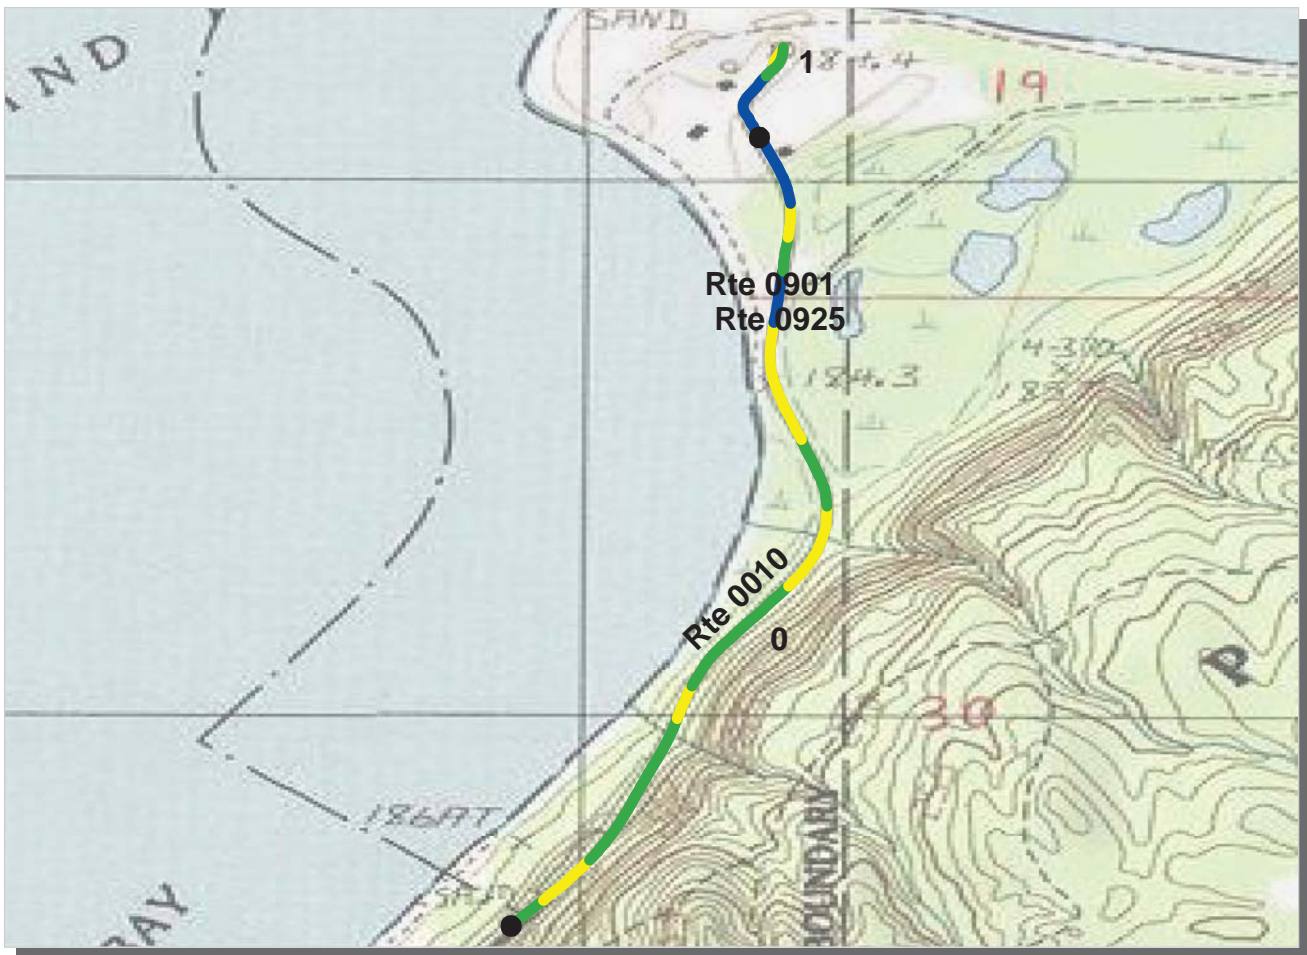
ROUTE: 0010 Sand Point Road

Section Number	0	1			
Section Length (mi)	1.00	0.15			
AADT	**				
SADT	**				
ADT Date	**				
Cross Section Information					
Number of Lanes	2	2			
Paved Width (ft)	21	22			
Lane Width (ft)	10	11			
Shoulder Width (ft)	0	5			
Roadway Condition Information					
PCR (Pavement Condition Rating)	86	90			
RCI (Roughness Condition Index)	84	100			
SCR (Surface Condition Rating)	87	89			
Alligator Cracking Index	99	100			
Rutting Index	88	90			
Patching Index	100	100			
Transverse Cracking Index	99	99			
Longitudinal Cracking Index	99	100			
Shoulder Condition Rating	N/A	GOOD			
Drainage Condition Rating	GOOD	GOOD

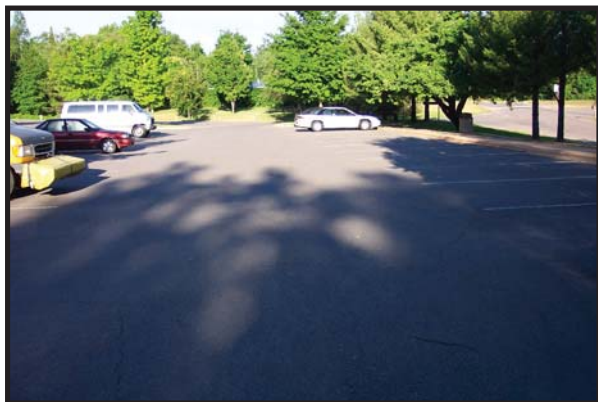
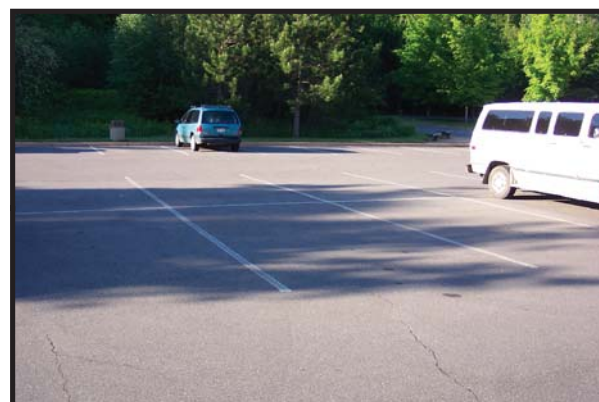
Route	Public / NonPublic	Date Visited	Area (sq ft)	Lane Miles *	Surface Type	Condition / PCR
0900	Public	6/28/2003	38807	0.67	AS	FAIR / 73

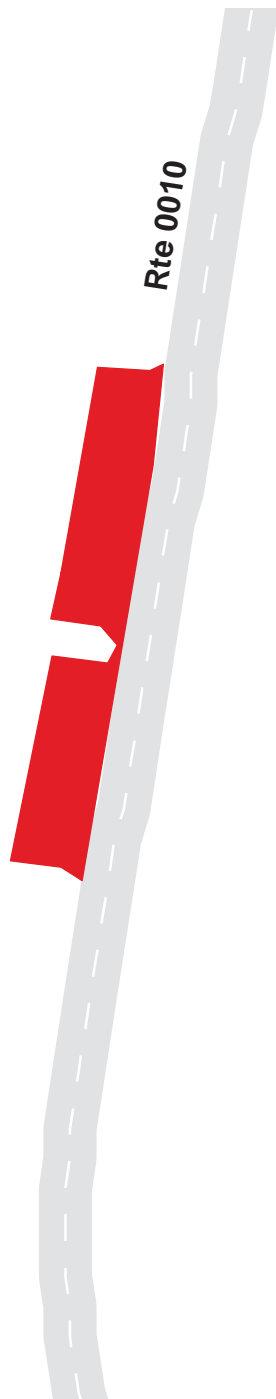
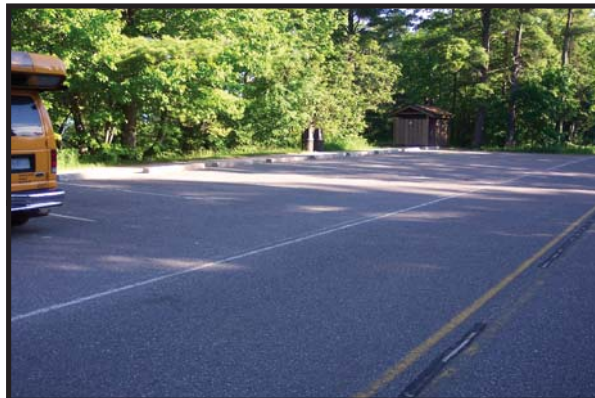
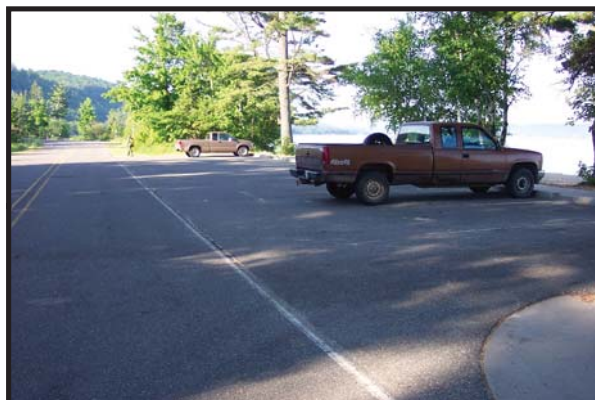
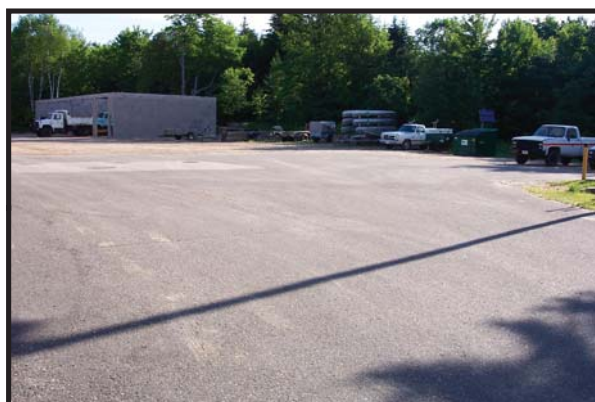
Route 0901

Route	Public / NonPublic	Date Visited	Area (sq ft)	Lane Miles *	Surface Type	Condition / PCR
0901	Public	6/28/2003	8959	0.15	AS	GOOD / 90

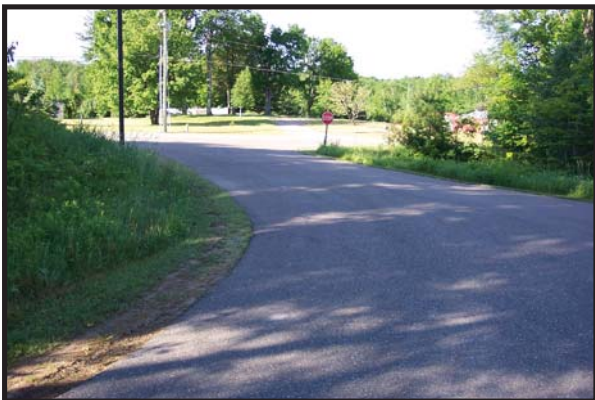
Route 0903A

Route	Public / NonPublic	Date Visited	Area (sq ft)	Lane Miles *	Surface Type	Condition / PCR
0903A	NonPublic	6/28/2003	22594	0.39	AS	GOOD / 90

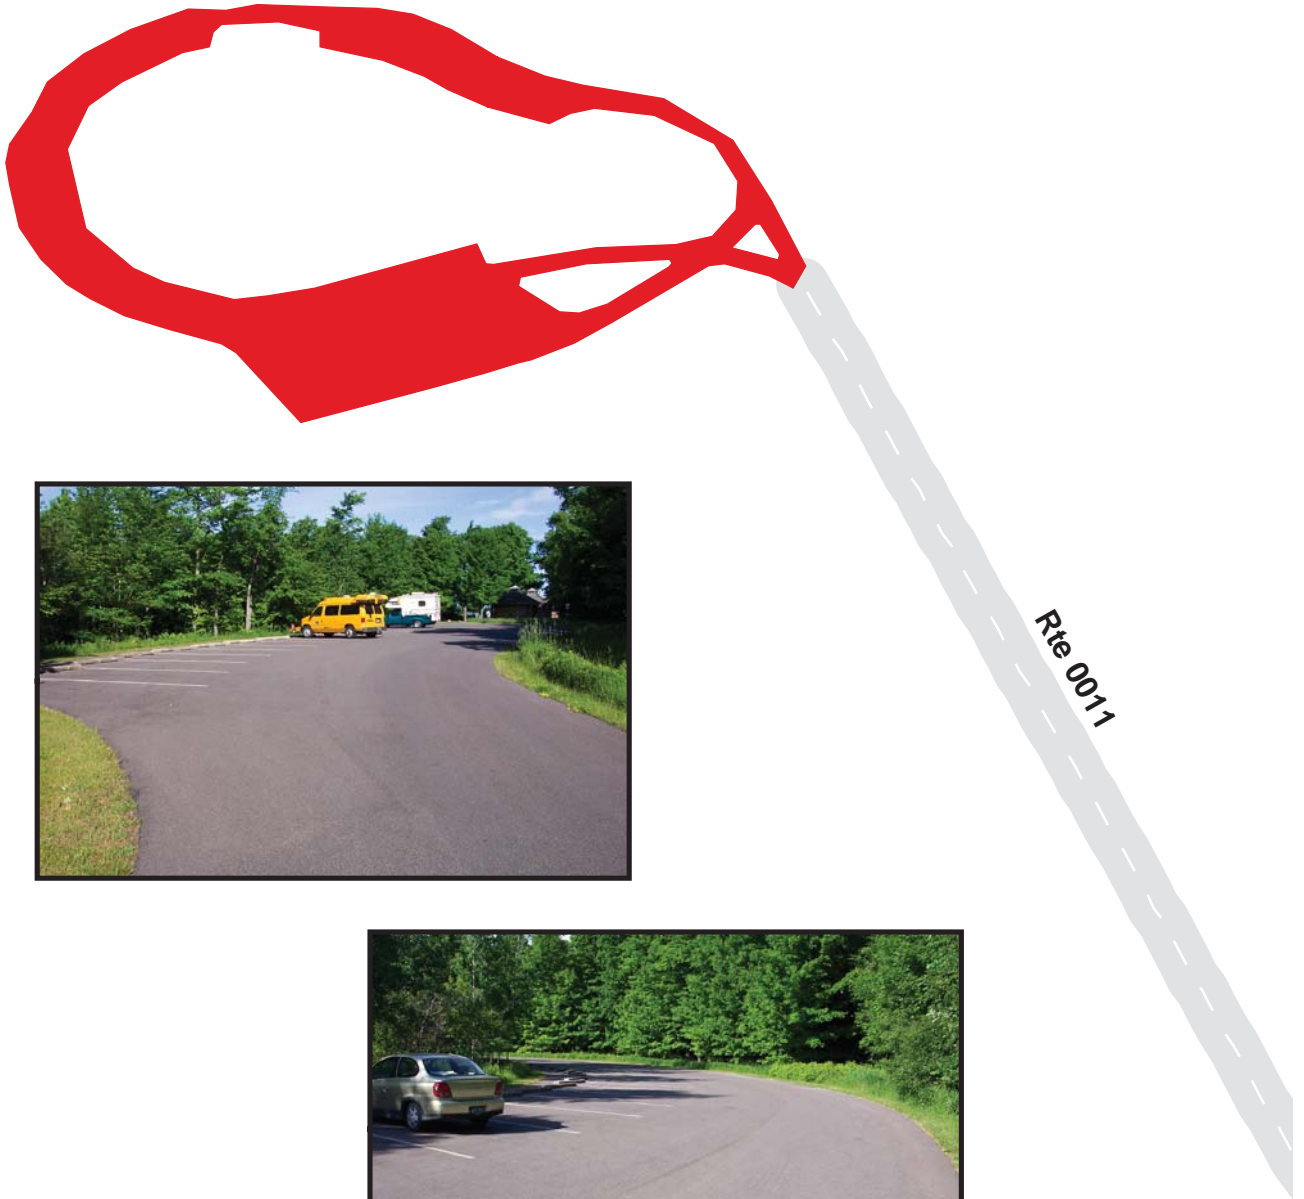
Pictured Rocks National Lakeshore
Route 0906
 GRAND SABLE VISITOR CENTER PARKING
 FROM COUNTY ROAD H58

Route	Public / NonPublic	Date Visited	Area (sq ft)	Lane Miles *	Surface Type	Condition / PCR
0906	Public	6/28/2003	12331	0.21	AS	GOOD / 90

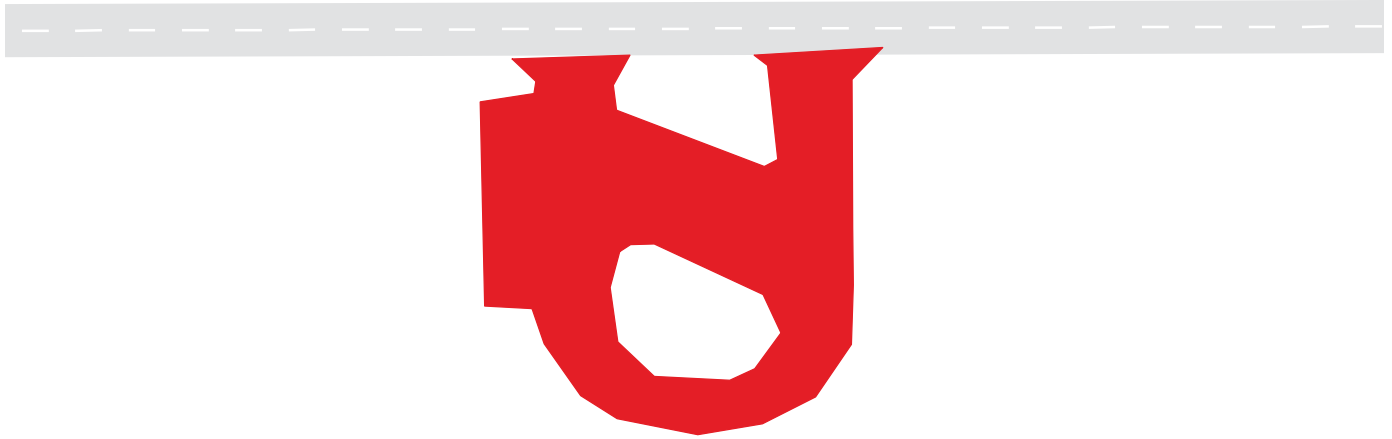
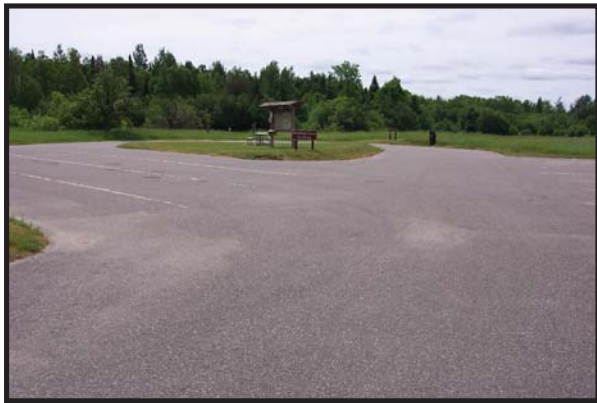
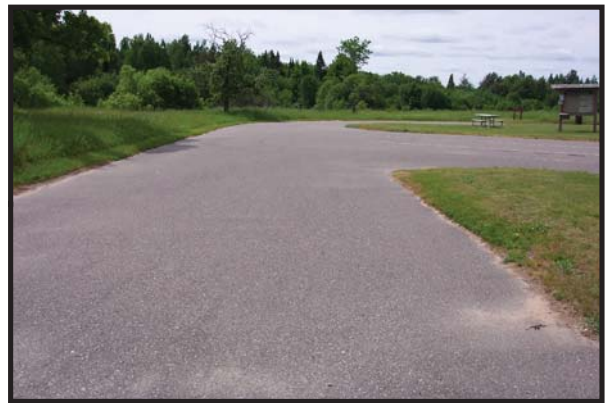
Route 0908

Route	Public / NonPublic	Date Visited	Area (sq ft)	Lane Miles *	Surface Type	Condition / PCR
0908	Public	6/28/2003	56501	0.97	AS	GOOD / 90
