# The Road Inventory of Pipe Spring National Monument PISP - 1510

## Road Inventory Program

Prepared By:  
Federal Highway Administration  
Eastern Federal Lands Highway Division  
Cycle 3

# Pipe Spring National Monument in Arizona

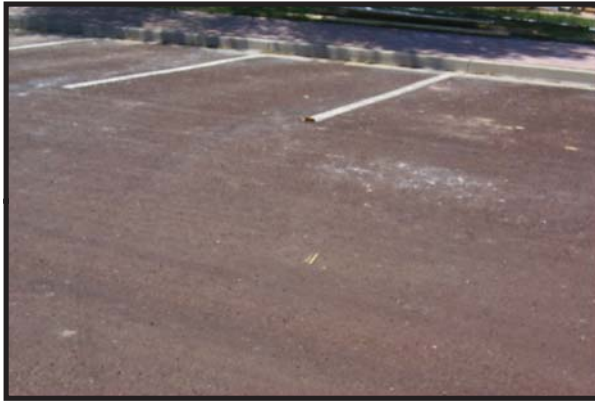
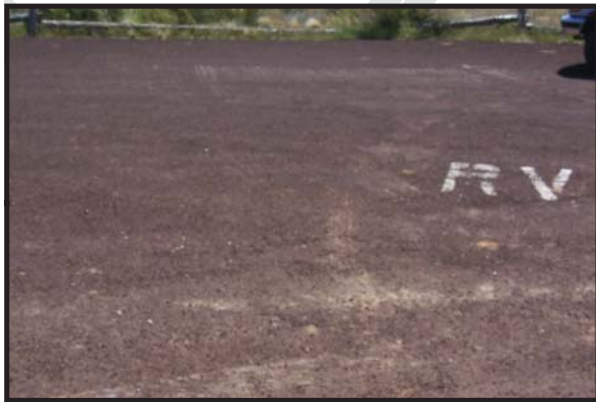
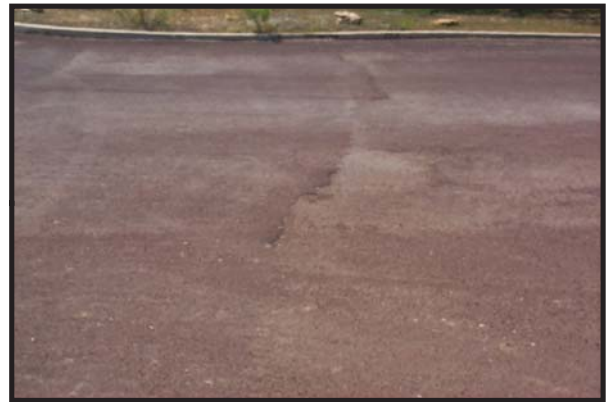
Route	Public / NonPublic	Date Visited	Area (sq ft)	Lane Miles *	Surface Type	Condition / PCR
0900	Public	4/25/2003	40768	0.70	OC	GOOD / 90

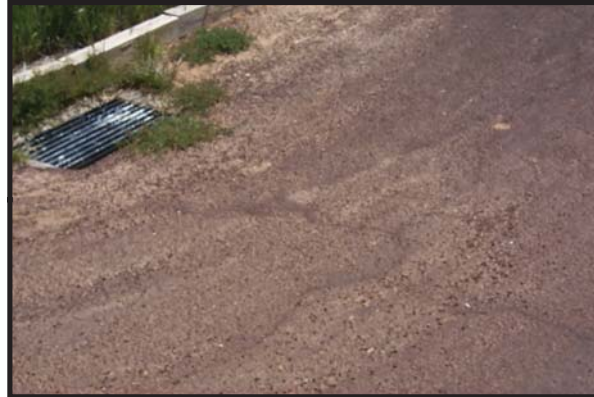
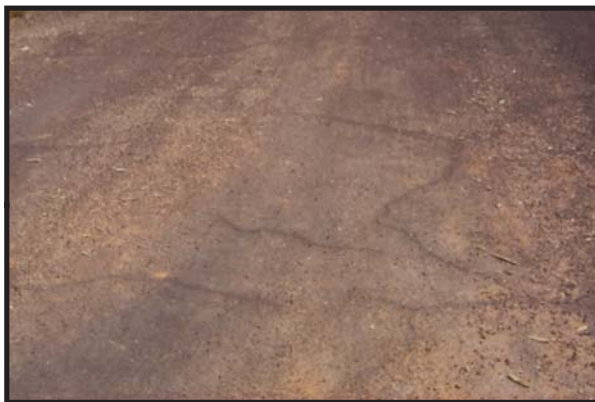
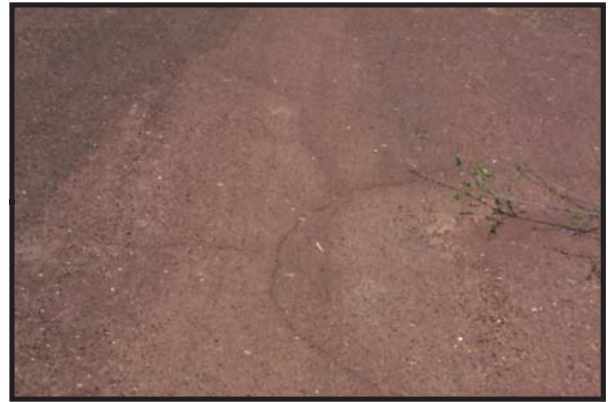
## Route 0901

Route	Public / NonPublic	Date Visited	Area (sq ft)	Lane Miles *	Surface Type	Condition / PCR
0901	NonPublic	4/25/2003	7129	0.12	OC	FAIR / 73
